Supplementary Report of Roger Hawkins

Concerning the lifts at Grenfell Tower

For the Grenfell Tower Inquiry

April 2021

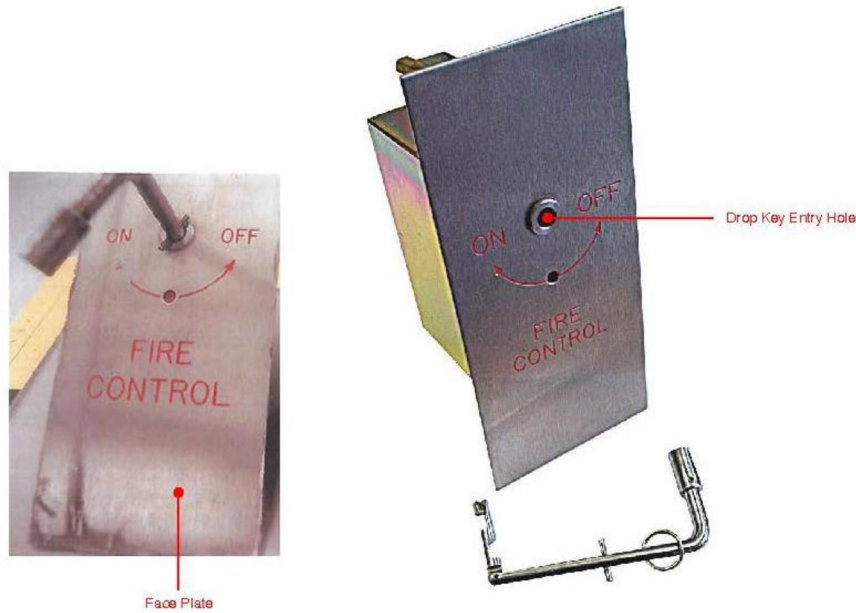
** During the examination the micro switch became free and the microswitch operated. It is not known what caused the micro switch to jam, but there were plaster grains on the work bench.*

** It is considered that the build up of builders' material on the top of the switch was from the original works and not caused by the extraction of the switch. This is also my opinion.*

153. I have included two diagrams which identify the elements of a fire control switch.
154. This diagram shows the front of the fire control switch, i.e. the faceplate. It also shows the drop key entry hole.

158. We observed deformation of the side wards which is discussed separately in my previous report and the other reports in the Appendices. As set out above, we also observed debris on the switch casing and the micro switch. I have indicated in the diagram where this debris was observed.
