# **GRENFELL TOWER INQUIRY**

## **Final Report of**

**Rodney Denver Hancox B.Sc., C.Eng, MIGEM**

## **Gas Engineering**

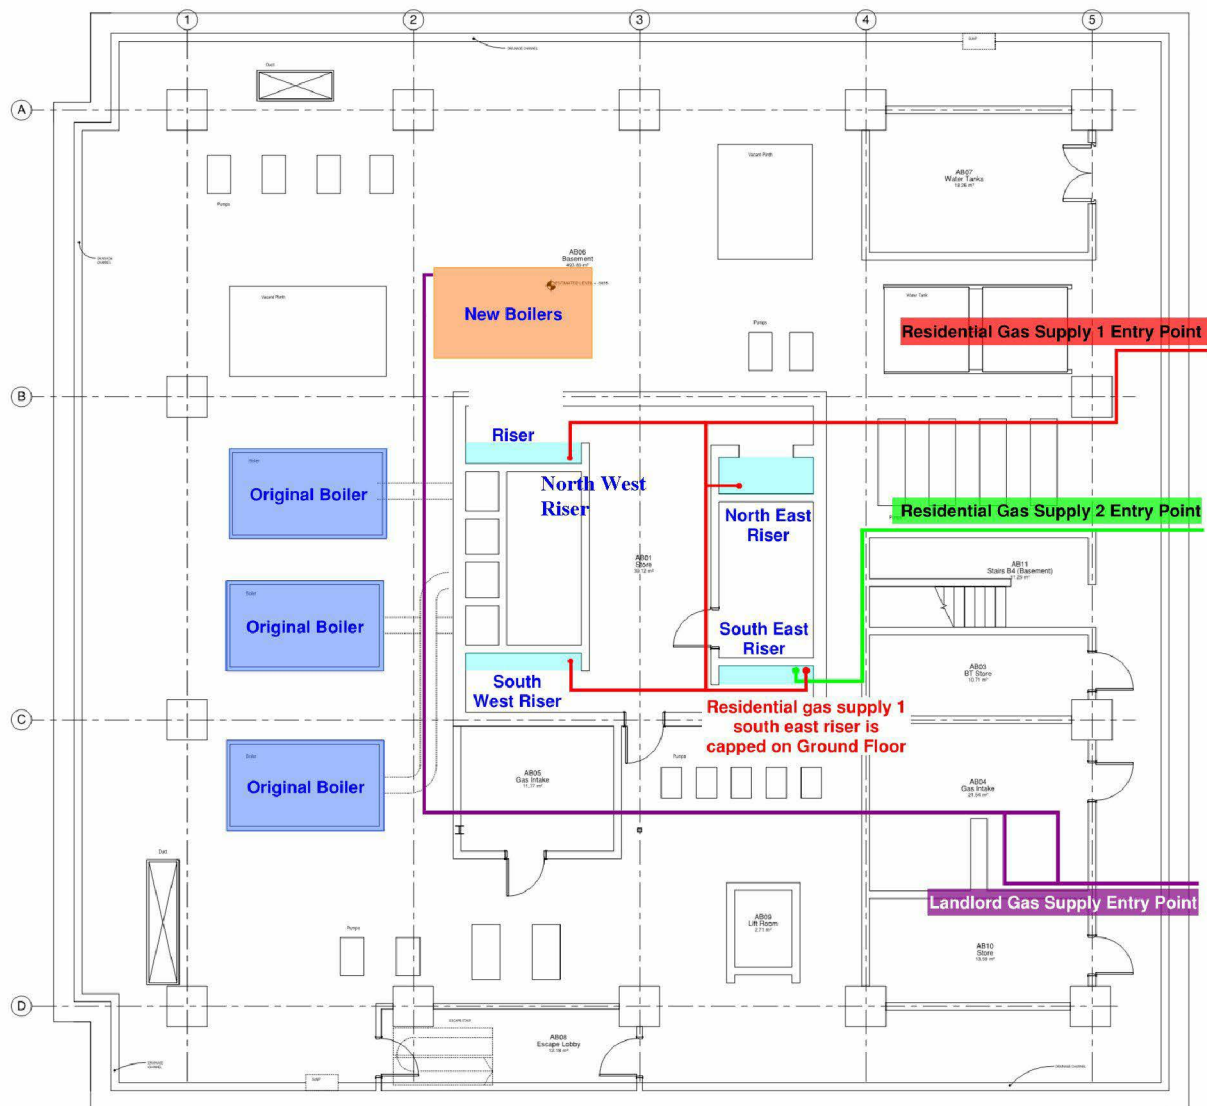
**Fig.4 Gas Services/Network Pipelines at Basement Level  
Serving Grenfell Tower {RYD00000577}**

25. Steve Mason of Cadent Gas Ltd., states in his witness statement {CAD000000004} that the Tower originally had two supplies of gas. The first, a 10” steel service, supplied a communal heating and hot water system in the basement of the tower block. The second, a 4” steel “service”, supplied gas for cooking in residential flats on the 4th to the 23rd floors. The “service” supplied 6 risers (vertical gas pipes) in all. These gas risers were installed when the Tower was built. Cadent Gas Ltd has not been able to find records relating to their installation and so they are unable to state precisely when those supplies were installed and commissioned. (See Figure 4 below for a plan of the gas pipes in the basement.)

42. The route of Residential Gas Supply No.1 has been traced to the central core, where it splits into 4 vertical risers, shown as northeast, northwest, southeast, and southwest risers in Figure 4. Riser or Branch Isolation Valves (BIV) were identified at the base of each of the (4) four risers. However, these valves were at a high level in the basement and in the absence of a fixed ladder or similar to each of them were therefore not readily accessible for use in an emergency.

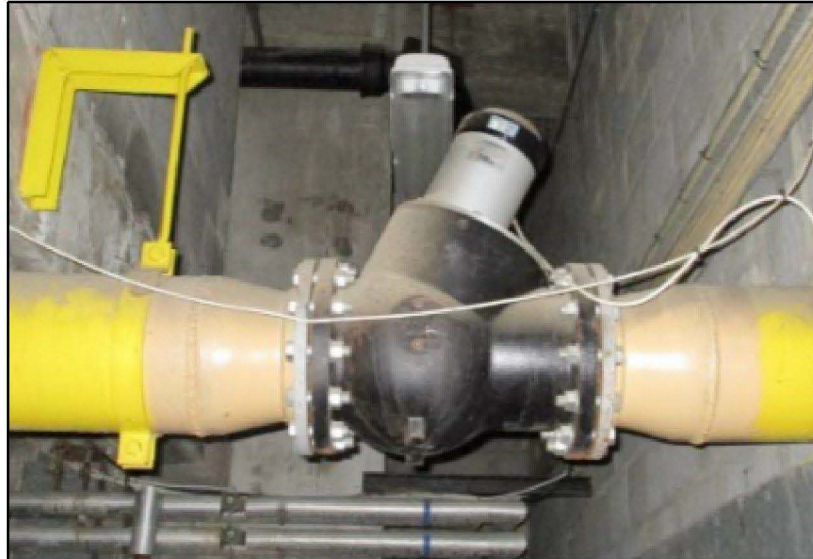
**Fig. 10 – Automatic Isolation Valve (AIV)**

36. The pipe work leaves the gas meter room via the west wall to the main basement area. At this point, an Automatic Isolation Valve (AIV) has been installed that can be used for automatic gas shut off to the landlord system, see Figure 10.

39. The statement that the “entire gas supply to the building is cut off” is factually incorrect. For the avoidance of doubt, it is only the gas supply to the boilers which is cut off when the AIV is operated.

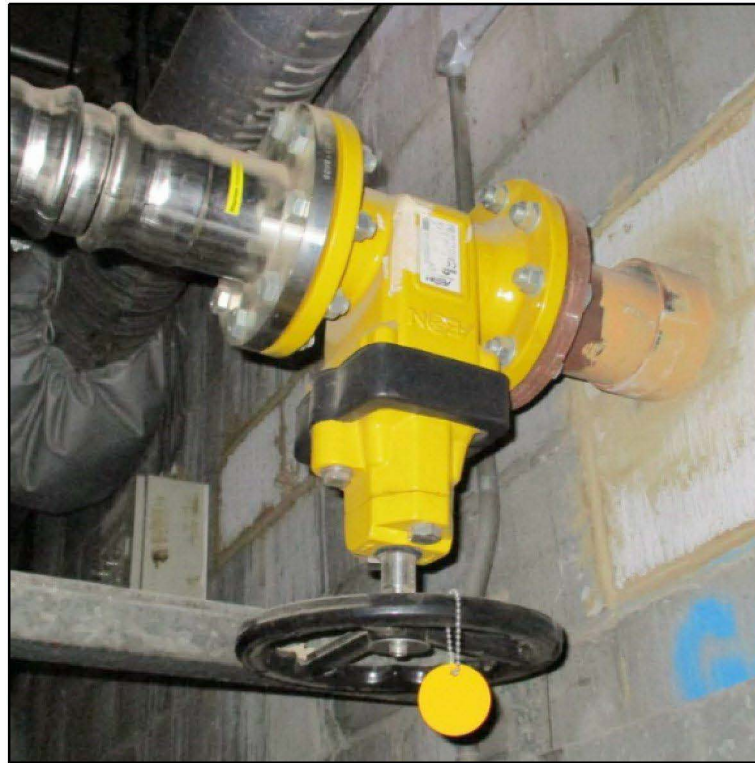
**Fig. 14: Manual isolation valve for the gas pipework<sup>3</sup> serving the new boilers, as it exits gas intake room 2**

<sup>3</sup> Note the use of press fit jointed stainless steel pipe, which is permissible for use at pressures less than 100 mbar as per IGEM/UP/2 Edition 3 – Installation Pipework on Industrial and Commercial Premises.  
01/10/2019

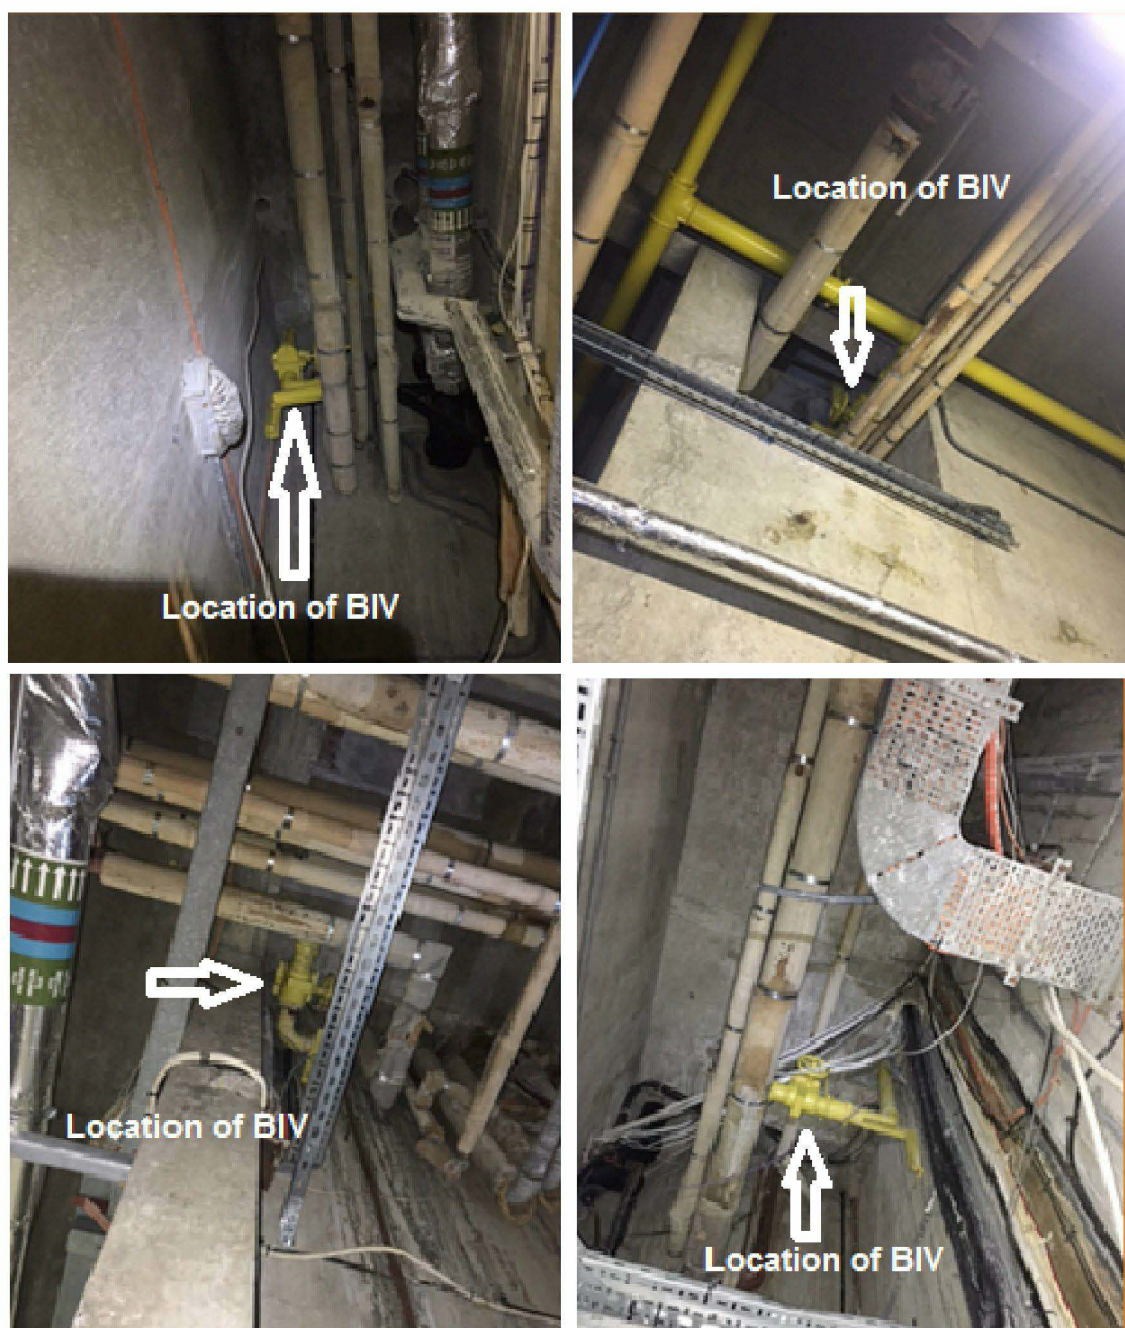
**Figures 16: BIVs at High Level {CAD00002993}**

43. Cadent Gas Ltd’s survey report of 30<sup>th</sup> September 2016 {CAD00000031} includes photographs of each of the 4 Branch Isolation Valves. James Harrison attached better quality photographs as Exhibit JAH13 to his witness statement to the Inquiry {CAD00002993} and {CAD00002985} respectively). The photographs from {CAD00002993} are as follows:

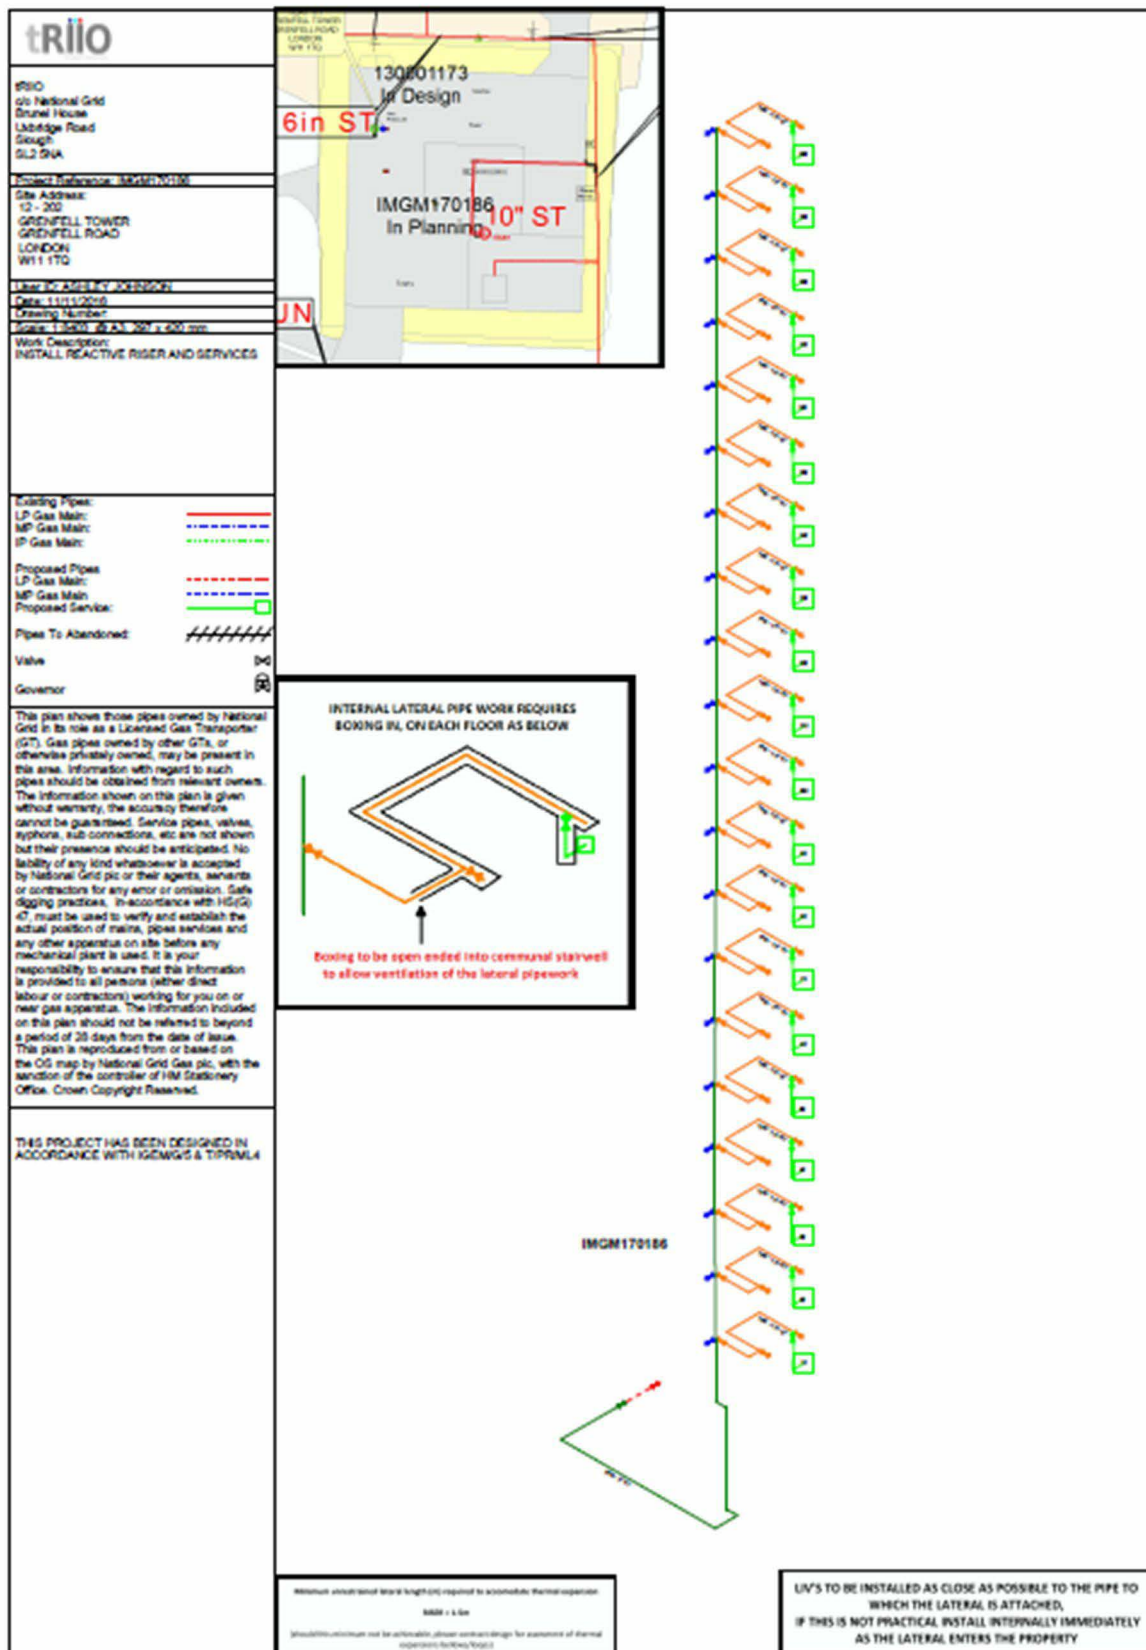
**Fig. 20 – Initial Design Drawing of Replacement Riser {TRI000000263}**

Floor 1	16732, 16703, 16565, 16739
Ground Floor	16601, 16707, 16602, 16537, 16660, 16611, 16573, 16582

51. Following an inspection by Cadent on the 30<sup>th</sup> September 16 {CAD00000031}, gas leaks were identified in flats 22 and 32. This riser was decommissioned and a replacement riser, referenced in this report as Residential Gas Supply No.2, has been installed to serve those flats ending with the number 2.
52. I understand from Stephen Mason’s witness statement {CAD00000004} that the initial design was drawn up by tRIIO Design Team in November 2016. The replacement riser (Residential Gas Supply No.2) was to be located in the stairwell and laterals were to be installed in the communal lift lobbies to supply gas to the flats. This is shown diagrammatically in the following drawing, Figure 20 – {TRI000000263}. This drawing is reproduced at A3 size as Appendix 3 to this report.

57. This gas supply system is then routed through the protected stairway to Level 23, as shown in Figure 20. See also Figure 24 below.

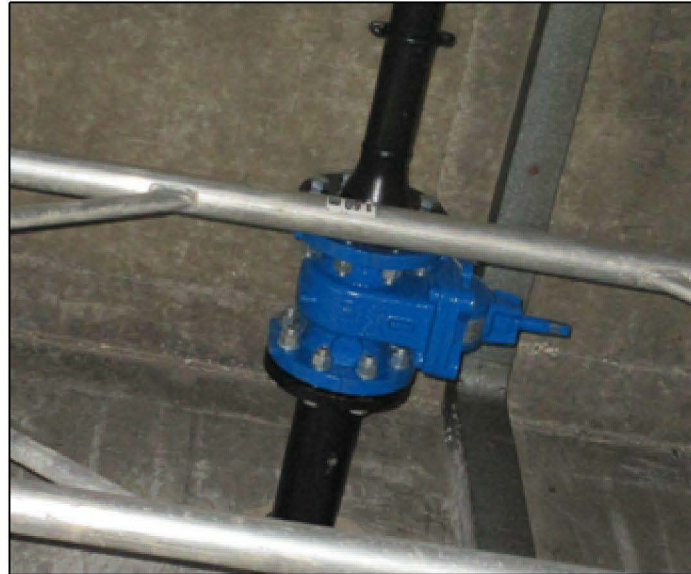
**Fig. 21 – IIV of Residential Gas Supply 2**

53. The replacement riser, Residential Gas Supply No. 2 enters the basement on the east elevation of the building in 4" steel at a high level, reducing to 3" steel as shown in Figure 21. An inlet isolation valve (IIV) is provided at this location (blue valve shown in Figure 21). It is noted that this valve is at a high level in the basement.

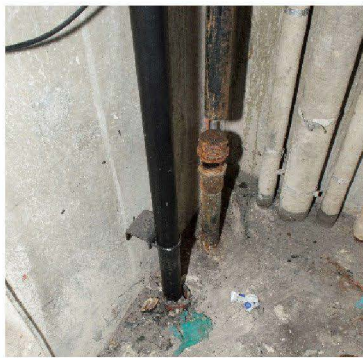
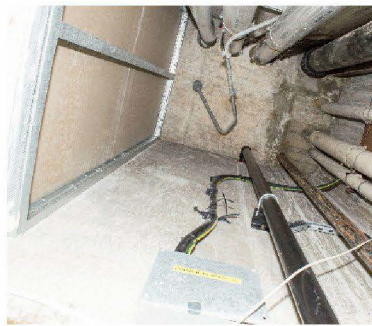
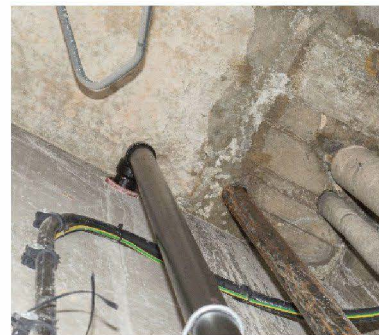
**Fig. 22 Riser in Utilities Shaft**

54. This gas pipe has been traced to the southeast riser duct in the central core in the basement, as shown in Figure 4. It runs vertically from the basement level to Level 2 through the southeast utilities shaft, which, by any stretch of the imagination, is not ventilated in accordance with Section 12 of BS 8313.
55. For the southeast utilities shaft to have complied with paragraph 8.41 of Approved Document B2 of the Building Regulations and hence Section 12 of BS 8313, there would have had to have been ventilation openings at high and low level leading to a safe space, preferably to outside air. In addition, the minimum free ventilation area of each opening would have been  $0.05 \text{ m}^2$  ( $500 \text{ cm}^2$  or  $50,000 \text{ mm}^2$ ). No such ventilation openings were in evidence.

386. On visiting site I noted that the utilities duct rising from the ground floor level to Level 2 (see Figure 22) did not, in any way, have any ventilation to outside in accordance with Section 12 of BS 8313.

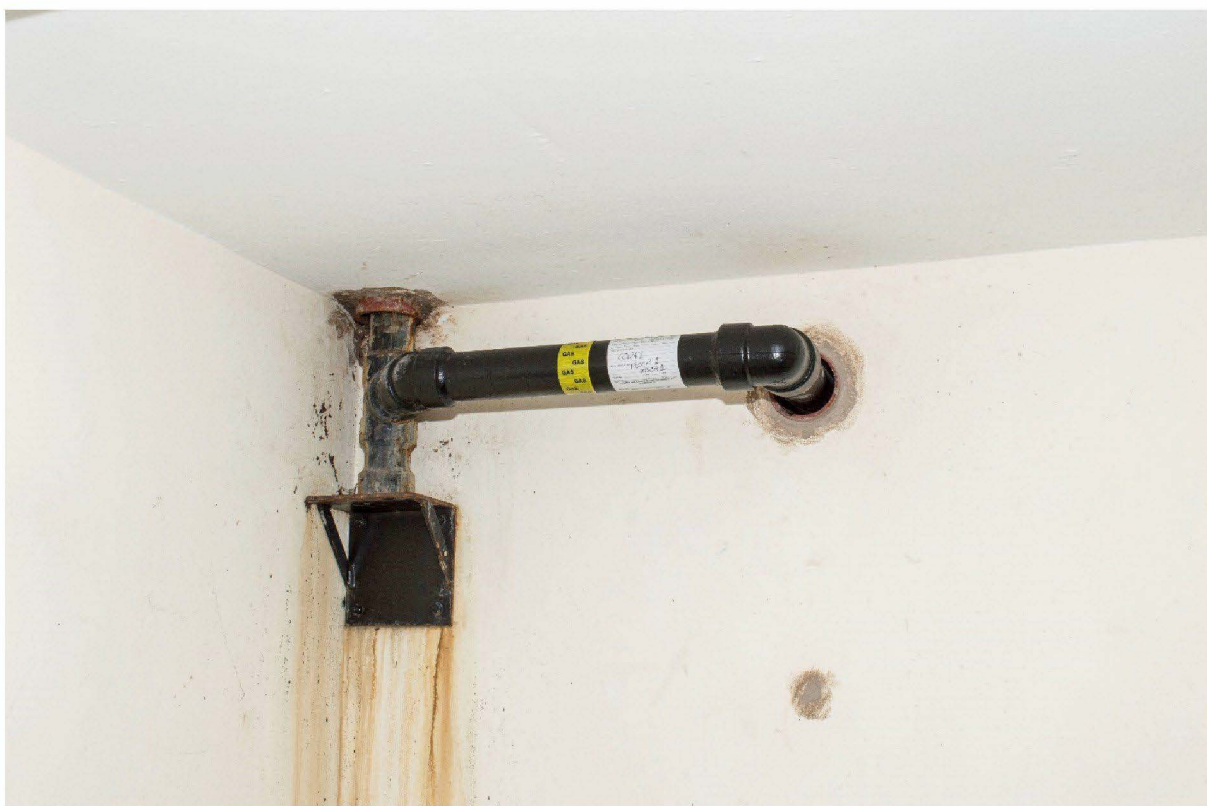
56. On Level 2, the gas pipe leaves the southeast riser duct, enters the windowless storeroom adjacent to the Community Meeting Room and then turns and enters the protected stairway (see Figure 20).

**Fig. 23 - Residential gas supply system 2 gas piping in storeroom adjacent to the Community Meeting Room (Level 2) and below Protected Stairway {MET00016703}**

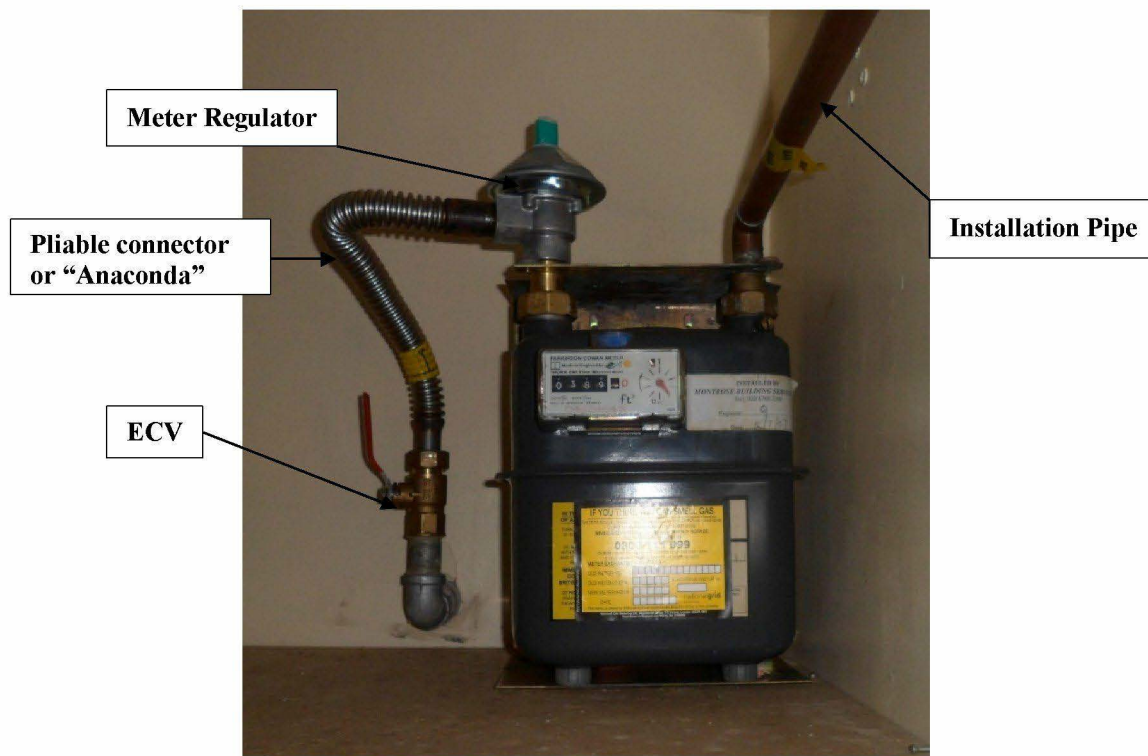
**Fig. 27 – Typical Repositioned Gas Meter Installation**

61. The gas meters within flats ending with the number “2” were repositioned immediately on the inside of the lobby wall in a cupboard adjacent to the sole means of escape from the flat. Copper installation pipe was then run to the old meter position and connected to the flat’s existing installation pipework. See Figure 27.

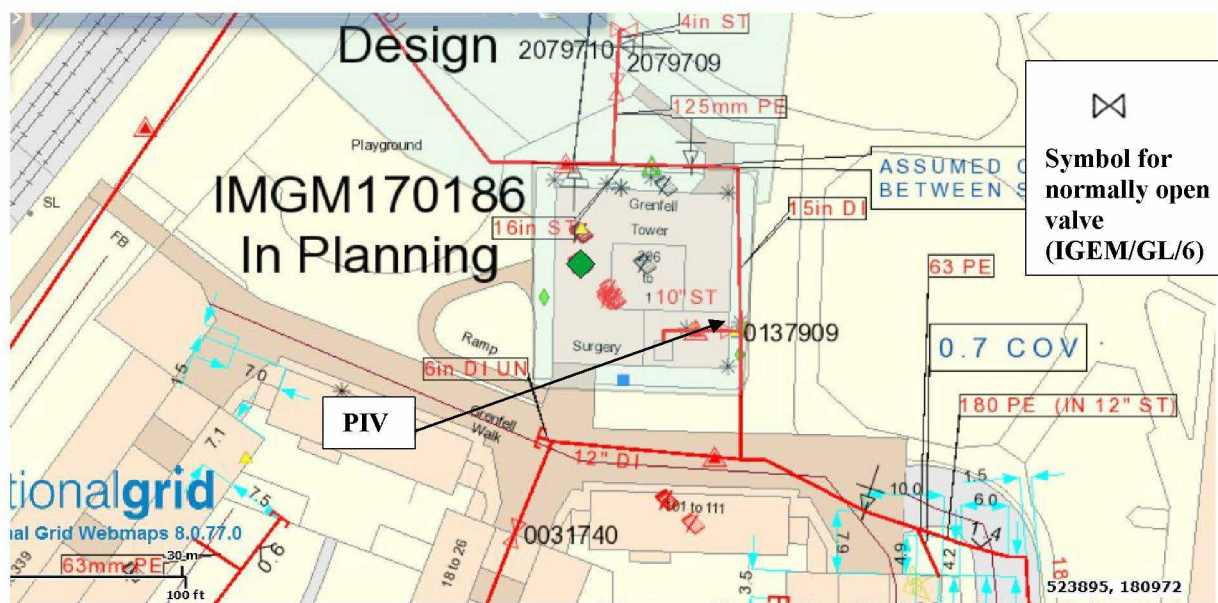
**Fig. 29 – Cadent Gas Ltd's Network Plan {CAD00002174}**

It can be seen that the plan<sup>7</sup> shows the 10" service for the Landlord's supply including its service valve/PIV. The plan does not show either of the service/network pipelines supplying Residential Supply No. 1 and Residential Supply No.2.

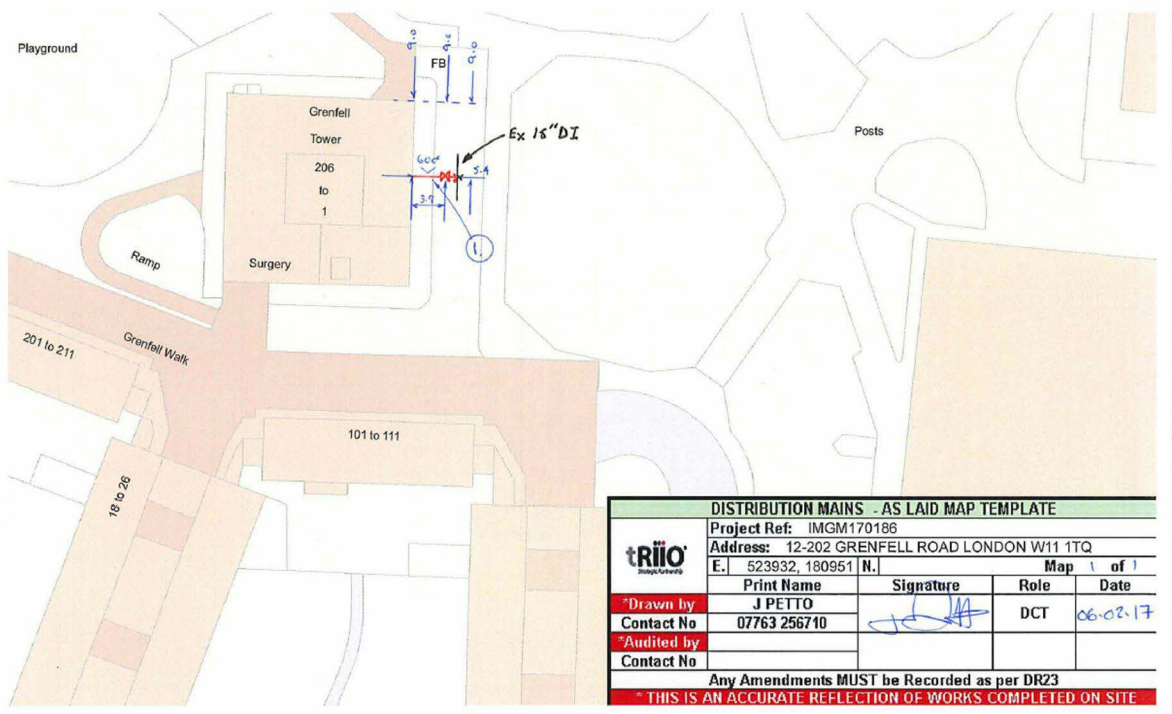
Fig. 37 – {TRI000001417} – As Installed Drawing

163. As can be seen from Figure 37 – {TRI000001417} above, the valve was fitted 3.9 metres out from the eastern wall and 9.0 metres south west of the north east corner of Grenfell Tower. Its location was determined by the location of the 15” Ductile Iron gas main to which the service was connected and its location is compliant with sections 7.3.4 and 7.3.5 of IGEN/G/5 as detailed in paragraph 132 above.

164. It is also noted that the as-installed drawing was signed off on 6<sup>th</sup> February 2017 (see date box in Figure 37 and {TRI000001425}); the commissioning of the pipe having been carried out on 25<sup>th</sup> January 2017 (see timeline {CAD00000731}). It has been industry practice since at least 2001 to record graphically all low pressure gas services of diameter greater than or equal to 2”/50mm steel or 63mm PE and the appropriate network plans should be updated within 30 working days of the “service” being commissioned. Therefore, I believe that Cadent Gas Ltd’s network plan, Figures 2

- 213. Given the quality of the as installed drawing, Fig. 37 above, I believe it is reasonable to assume that the PIV for Residential Supply No.2, would have been able to have been located and operated under normal circumstances.

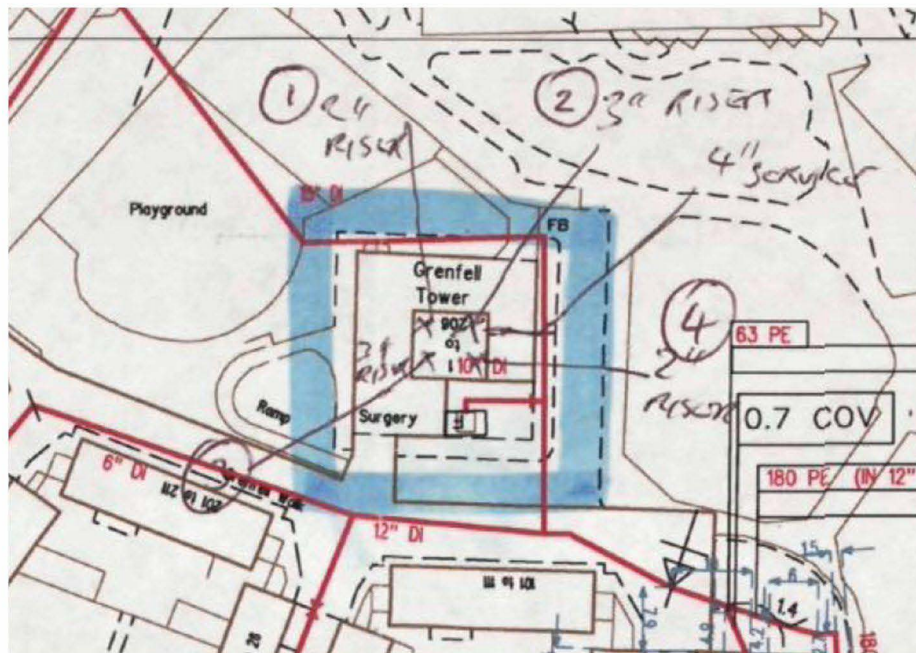
**Fig. 41 – Marked-up Plan from {CAD00002989}**

173. The multi-occupancy building survey record of the survey carried out in 2008, {CAD00002989}, included a marked up plan. This shows both gas supplies entering the Tower together with the locations and sizes of the 4 risers exiting the basement.

174. It appears to me that National Grid Gas Ltd, as it then was, did not initiate its DR4 Asset Management Error Management Process on receipt of the above survey information from the field.

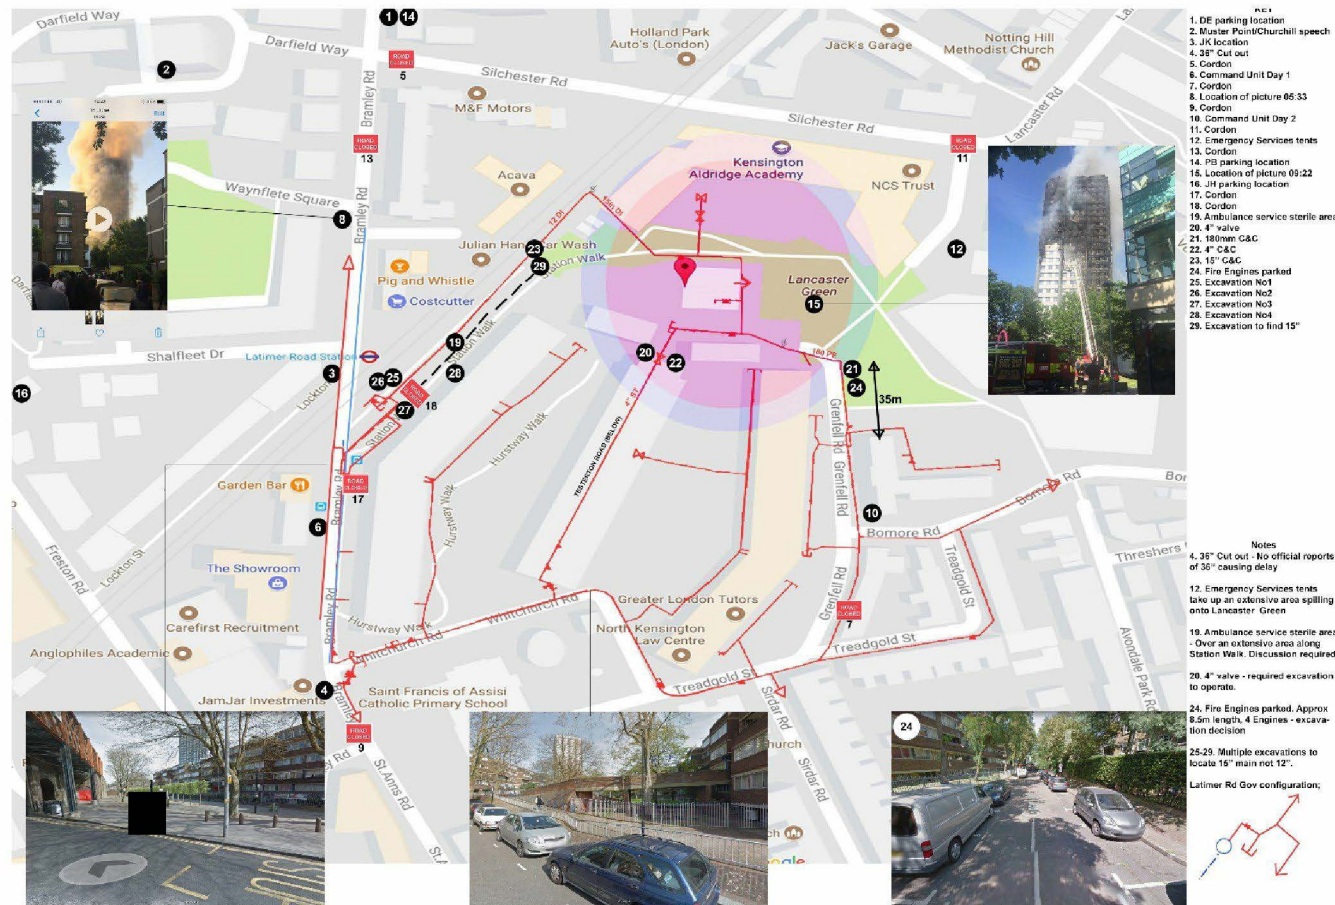
Fig. 46 - Post Incident Annotated Plan {CAD00002274}

192. From Figure 46, the following should be noted:

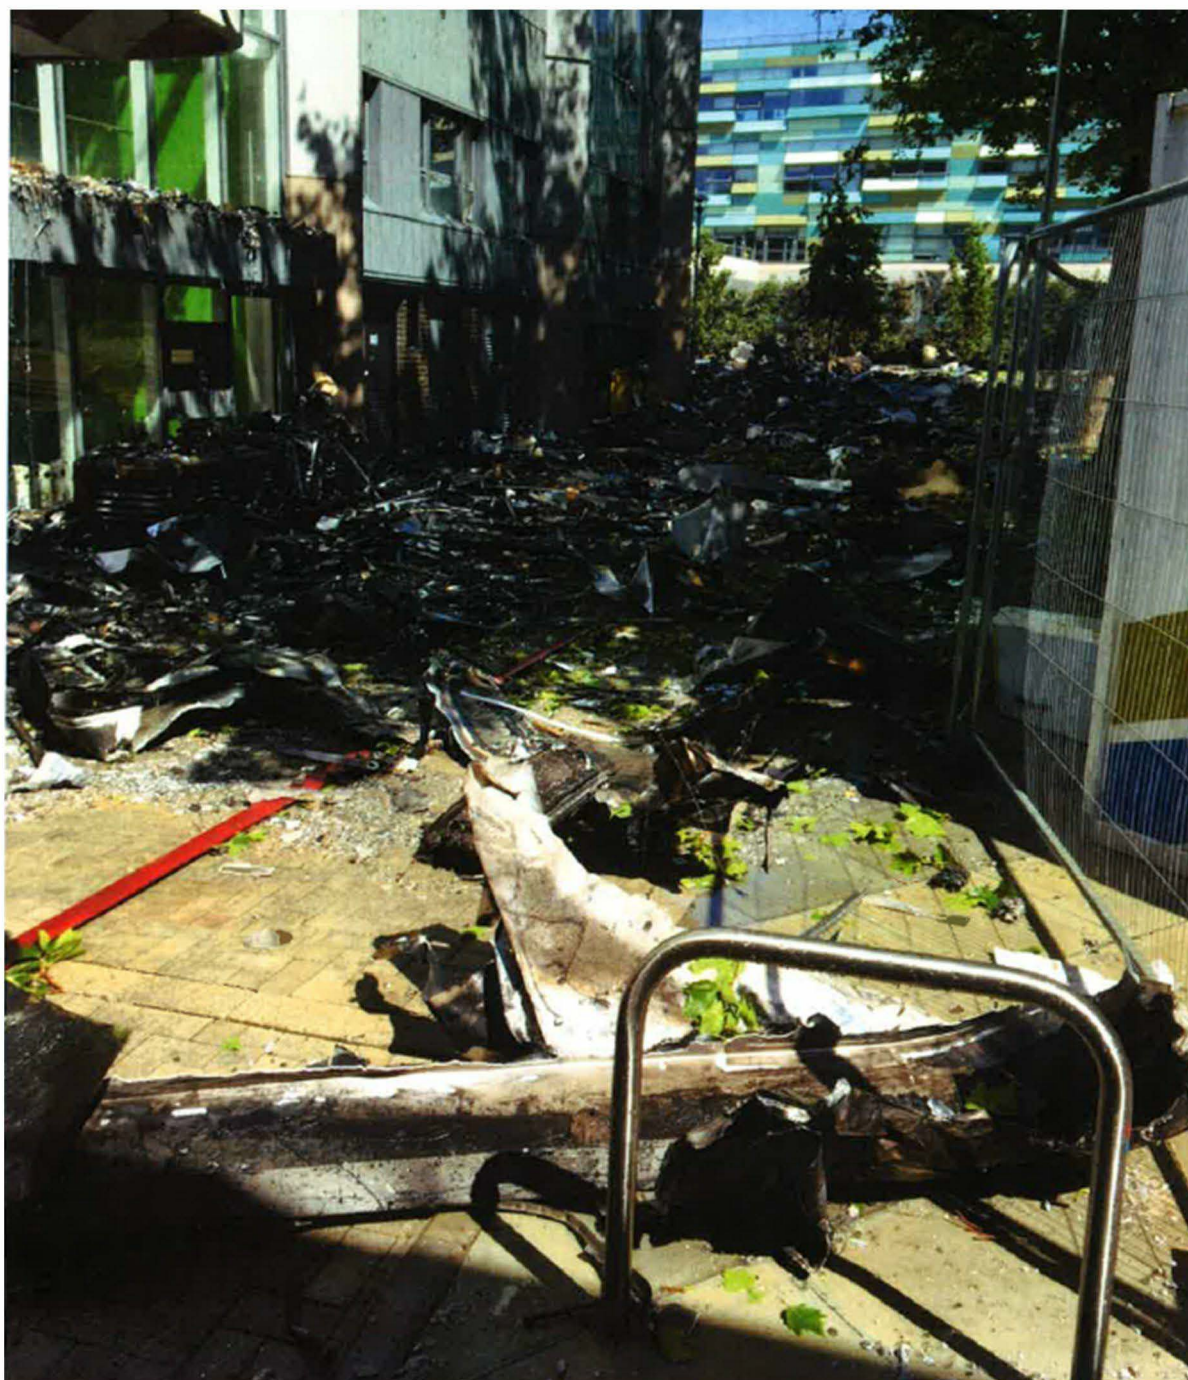
**Fig. 47 – Debris at Ground Floor Level {MET00015909}**

195. It is very apparent to me from the contents of Table 2 above and paragraphs 52 – 58 of James Allday’s Witness Statement {MET00012710} that there were significant risks to life associated with accessing the various valves located at high level in the basement during the afternoon of 14<sup>th</sup> June. From reading his and other witness statements, I believe those risks included building collapse, live electricity in a

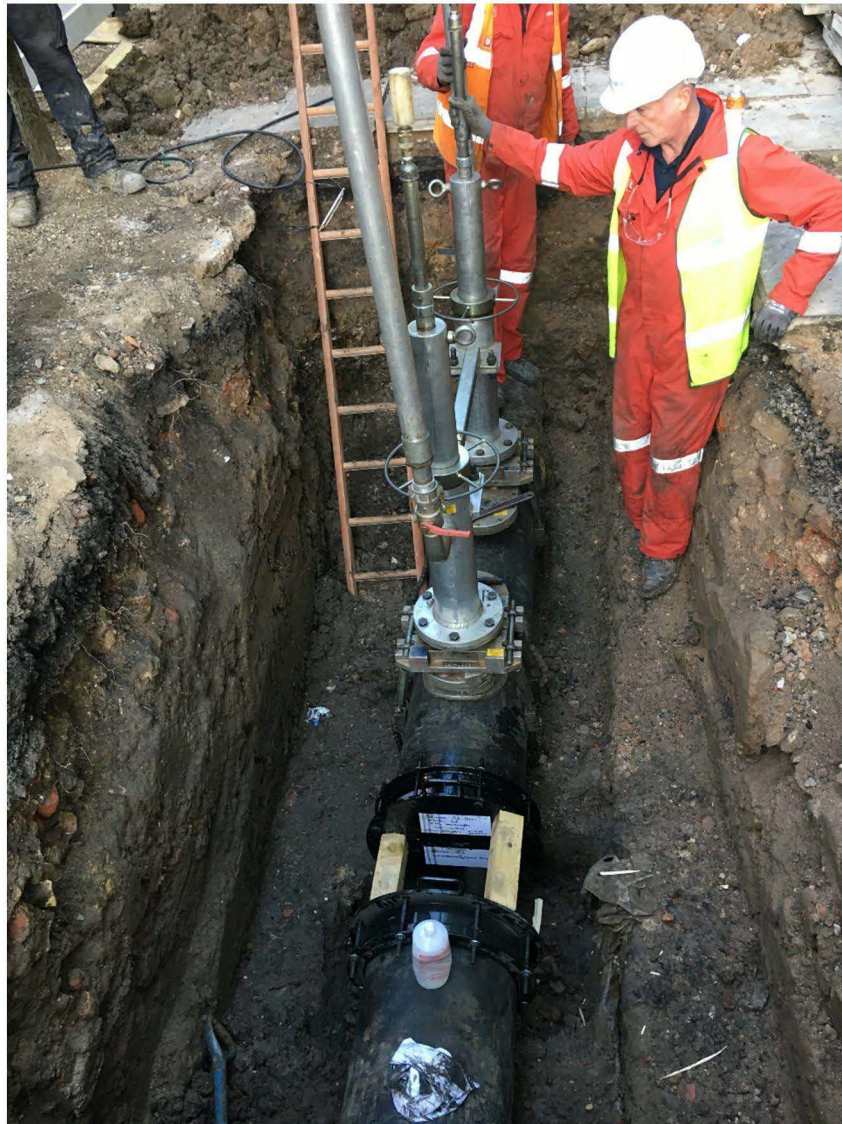
**Fig. 54 – Permanently Cut and Capped 15” Ductile Iron Main**

201. The following photograph {CAD00002832} shows the cut and capped 15" main.  
01/10/2019

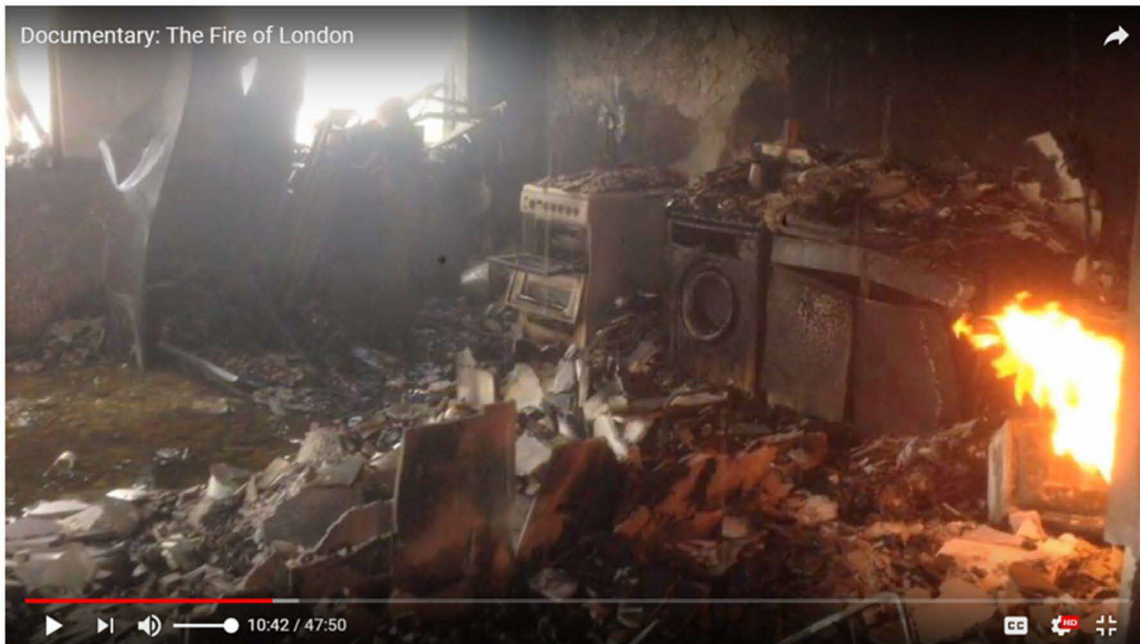
**Fig. 59 - Extract from {CAD00002970}.**

**This is believed to be a flat ending with either the number '3' or '6' with the gas service pipe/meter installation on fire**

240. It is noted that the flames are yellow in colour, which is consistent with the absence of primary air. Air for combustion in this case is coming from the surrounding atmosphere i.e. it is secondary air. (See paragraphs 228 - 231 and Figures 57A and 57B above.)
241. In addition to observing “burnt out” meter installations I observed that the riser supplying flats with numbers ending in 5 was ruptured in Flat 5 on the 14<sup>th</sup> floor i.e. Flat no. 115. Just above the point where the riser reduces in diameter from 2 inches to 1½ inches there is a tee, the branch of which is for the lateral supplying the flat, and the rupture at the in-line socket can be seen in Figures 60 and 61 below.

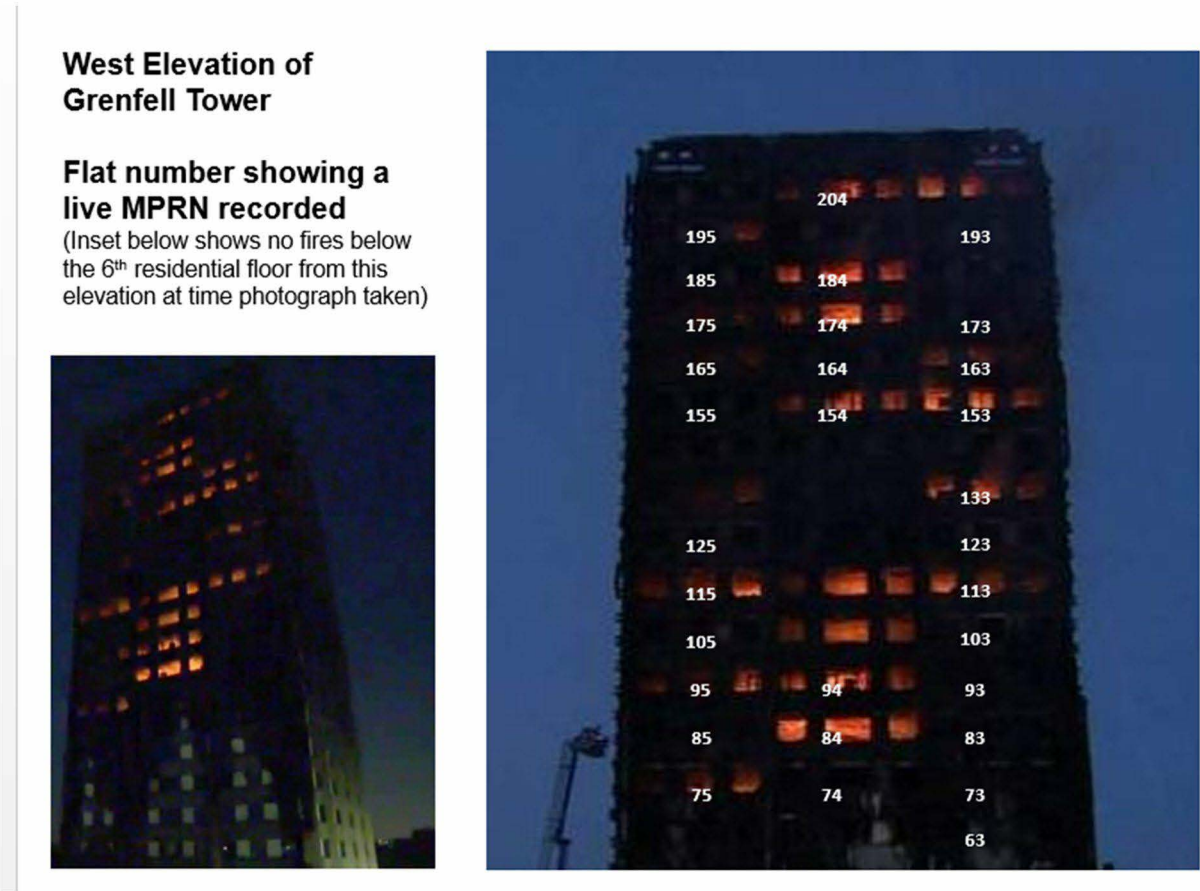
Fig. 62 - Extract from {CAD00002970}.

245. I noted from the CORGI Technical Services Examination Log {MET00016762}, taken between 18 December 2017 to 3 April 2018, that their surveyors observed numerous cases of distortion or warping of the risers making up Residential Gas Supply No.1 as follows:

The riser serving flats with the number ending in	Observed to be distorted/warped at Floors
1	11, 13, 15, 16, 18, 20, 21, 22 and 23
3	15, 16, 17, 18, 19, 20, 21 and 22
4	10, 11, 16, 17, 18, 20, 21, and 22
5	20 <sup>30</sup>
6	10, 11, 15 and 21

<sup>31</sup> See Table 5 and Figure 64 above for evidence of distorted pipes which may have been caused by a combination of building movement and thermal expansion given that the pipes were held rigid in the concrete floors.

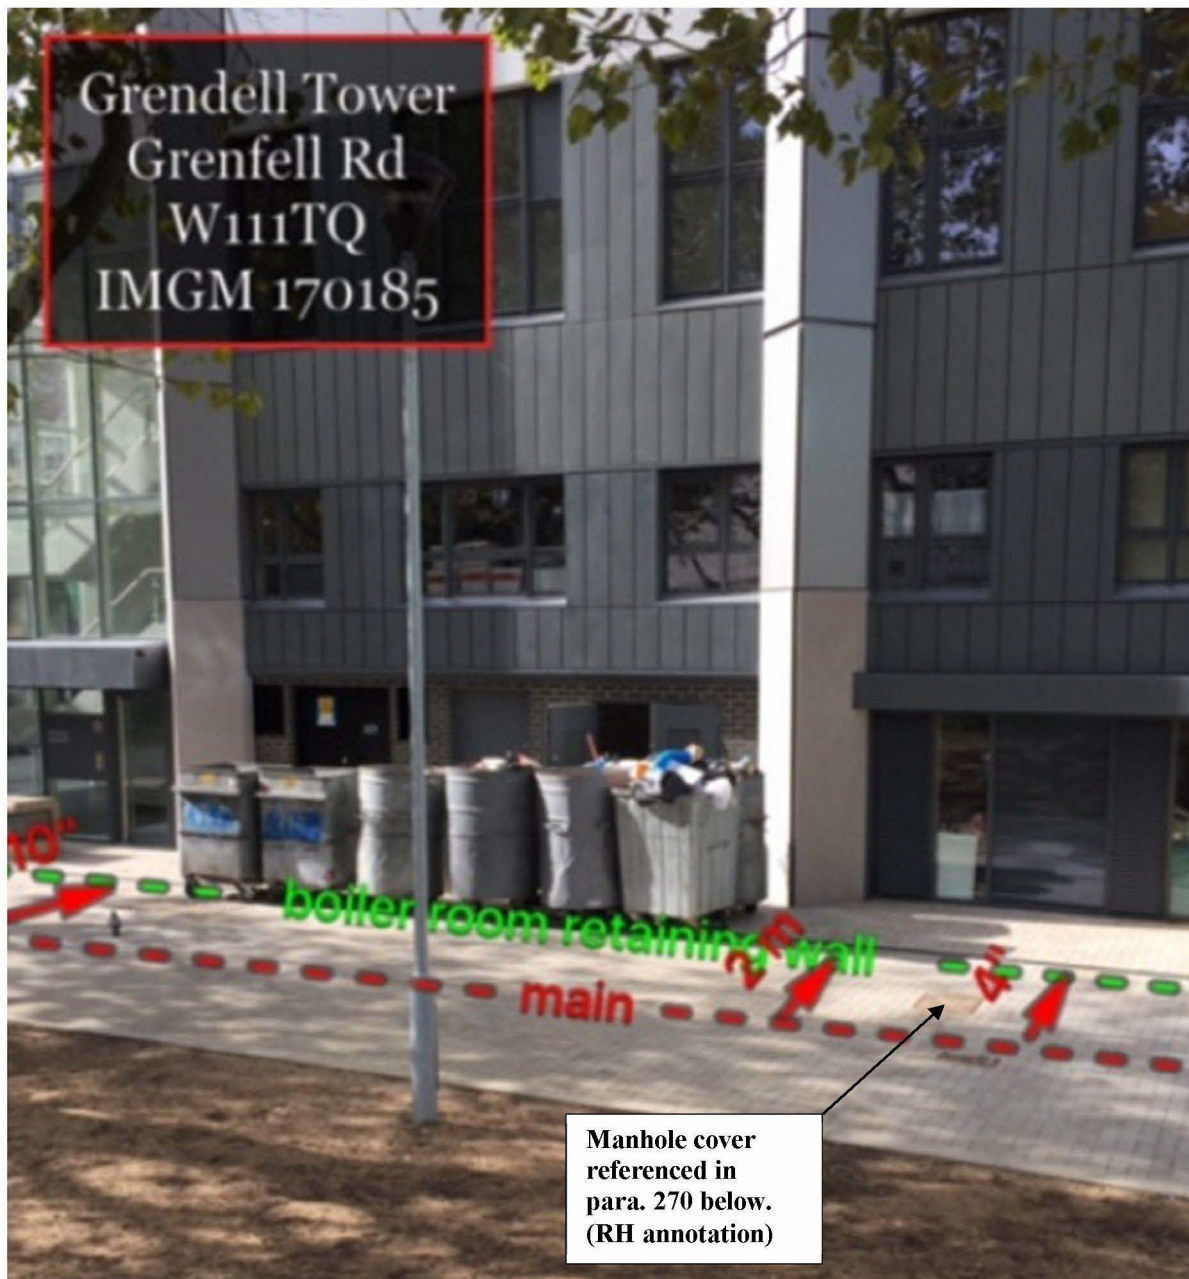
**Figure 68 – Annotated Photograph {TRI0000000050}**

269. Figure 68 shows the 15" main, to which the gas supplies into Grenfell Tower were connected, was located under a block paved road that was in pristine condition. A manhole cover can be seen to the left of the marked route of the 4" Residential gas supply No. 1. There is no sign of a valve box on the route of Residential gas supply No. 1.

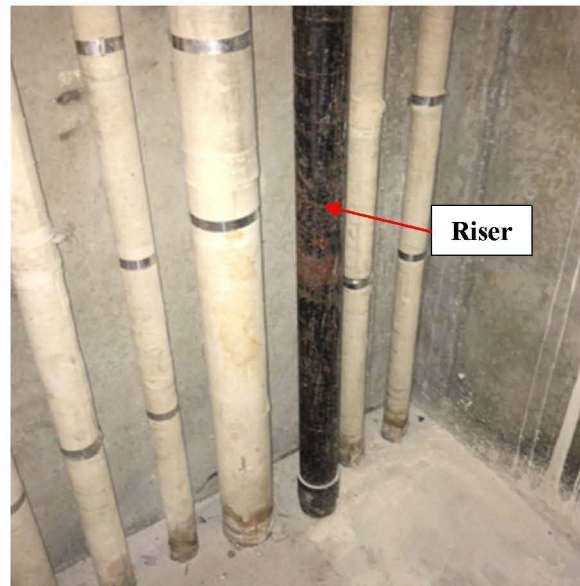
b) Riser in service cupboard believed to be showing original painting

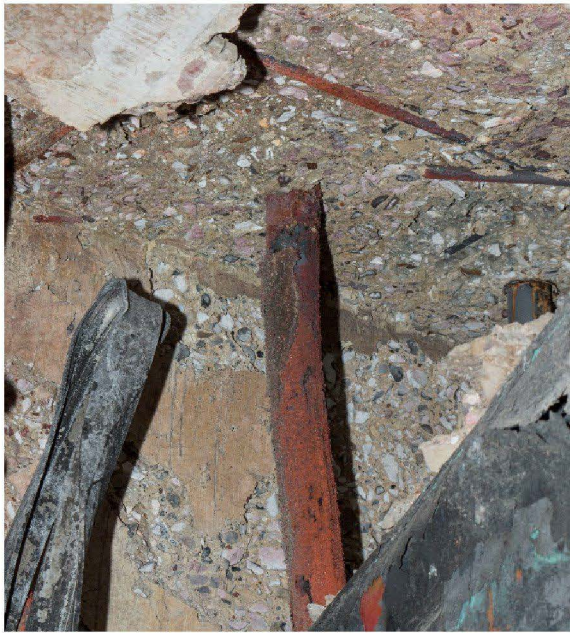
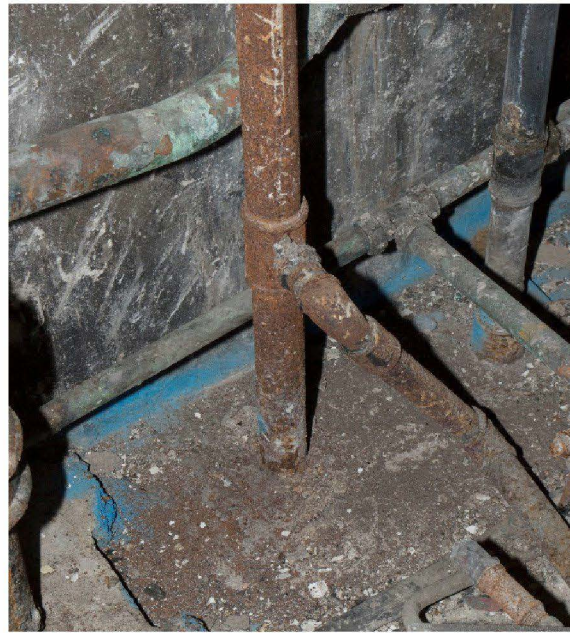
**Fig. 72 - Examples of Unsleeved Risers Going Through Floors as seen on 30<sup>th</sup> May 2018**

296. Neither I nor the Cadent Gas Ltd Survey Team {CAD00000031} nor CORGI Technical Services {MET00012524} observed any evidence that the risers had been sleeved as required by the Gas Safety Regulations 1972 and IGE/TD/4 – Edition 1.

297. As can be seen from Figure 72 above, the existing risers were not sleeved and they were fixed rigid in position at each floor. One hypothesis to explain the rupture of the riser at Flat 5 on the 14<sup>th</sup> floor (see Figures 60 and 61 above) is that the stress caused by the application of prolonged extreme heat on a pipe rigidly fixed at the floor and ceiling that were also subject to extreme heat, coupled with the presence of a corrosion induced weak point, was sufficient to rupture the pipe at the point of weakness<sup>35</sup>.

<sup>35</sup> If the pipes had been sleeved through the floor then there would have been some accommodation of differential movement of the pipes and the building during the fire and hence less stress on the pipe at the point of weakness.

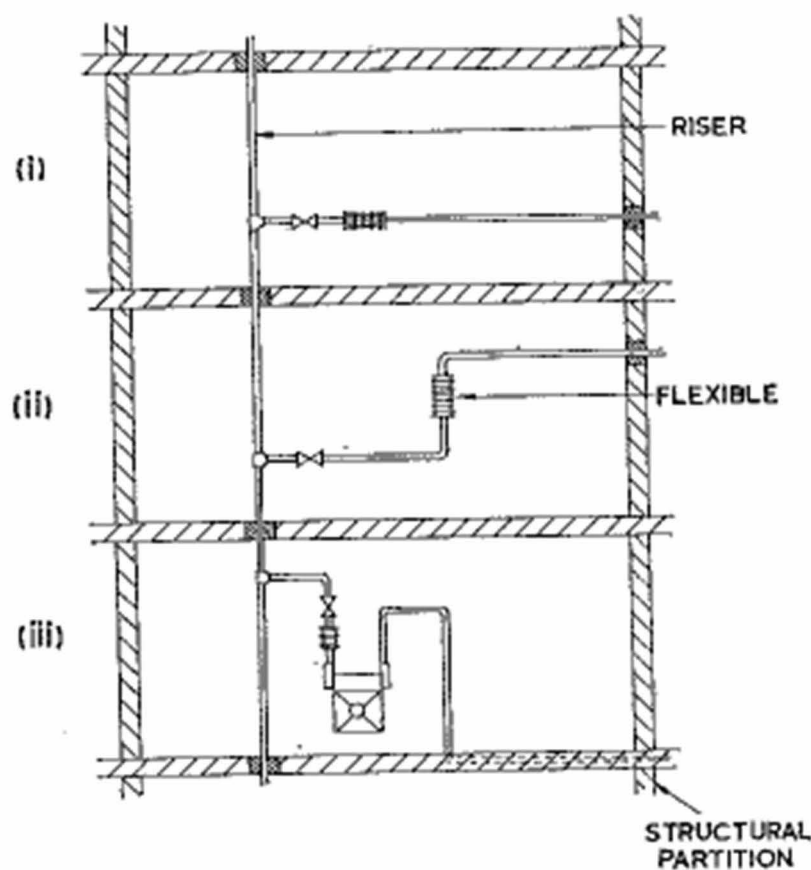
**Fig. 73 – Extract from IGE/TD/4 Ed.1 – Methods of Incorporating Flexibles in Laterals**

300. No provision appears to have been made in the construction of Residential Gas System No.1 for thermal expansion and contraction. If it had been, it is my opinion that the rupturing of the pipe in Flat 5 on the 14<sup>th</sup> floor would have been less likely to have occurred.
