# **GRENFELL TOWER INQUIRY**

## **Final Report of**

**Rodney Denver Hancox B.Sc., C.Eng, MIGEM**

## **Gas Engineering**

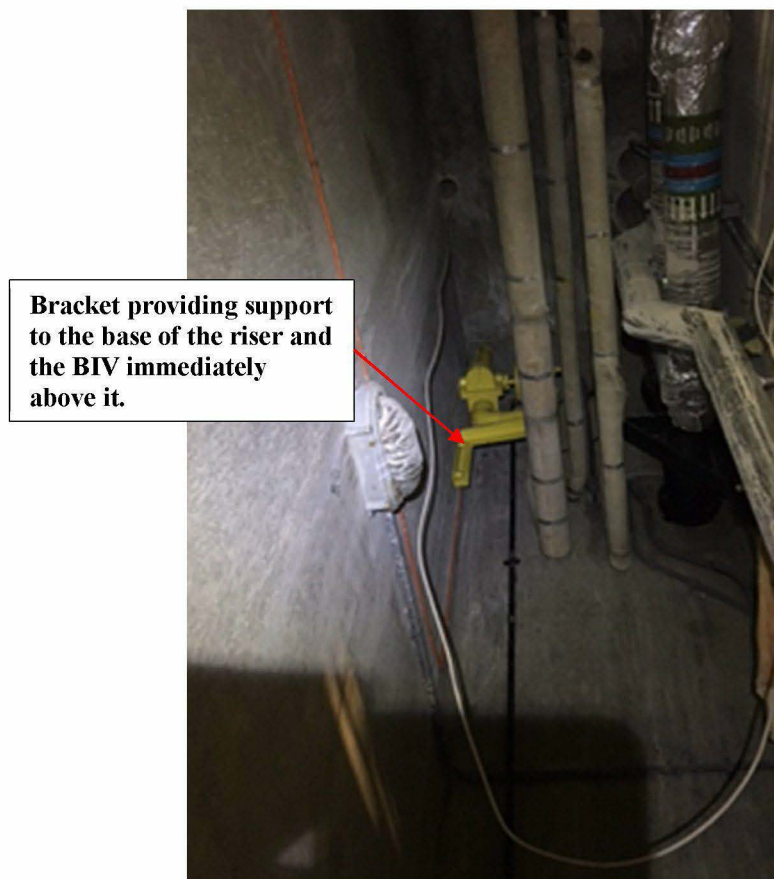
**Fig. 74 – Riser Support**

306. The only document which addresses the topic of support at the base of the risers at or around the time of construction is IGE/TD/4 Edition 1 in paragraph 7.1.3.1. The 4 risers emanating from the basement were each supported. See Figure 16 above and Figure 74 below.

307. Residential gas supply No.1 was compliant in this respect.

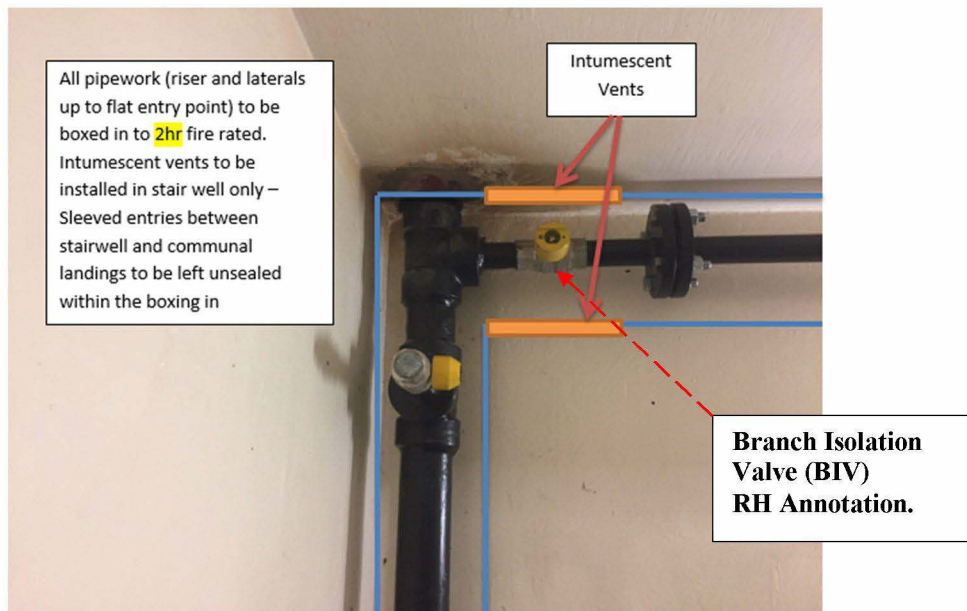
**Fig. 75 – Updated Boxing/Ventilation Requirements {TRI000001206}**

399. It has already been noted that the updated design drawing, Figure 76 {TRI000001223}, included an annotated photograph, Figure 75 {TRI000001206}, specifying the installation of an intumescent vent on the underside of the horizontal

412. In addition, signage as specified in the 8<sup>th</sup> and 9<sup>th</sup> bullet points of paragraph 7.4.2 of IGEM/G/5 was not present.
413. Lock shut Branch Isolation Valves (BIVs) were installed on each branch/lateral coming off the riser in the stairwell. See Figure 75 above. Future access to them for maintenance purposes would have involved unscrewing the boxing. I believe they were compliant with section 7.5 of IGEM/G/5 Edition 2.

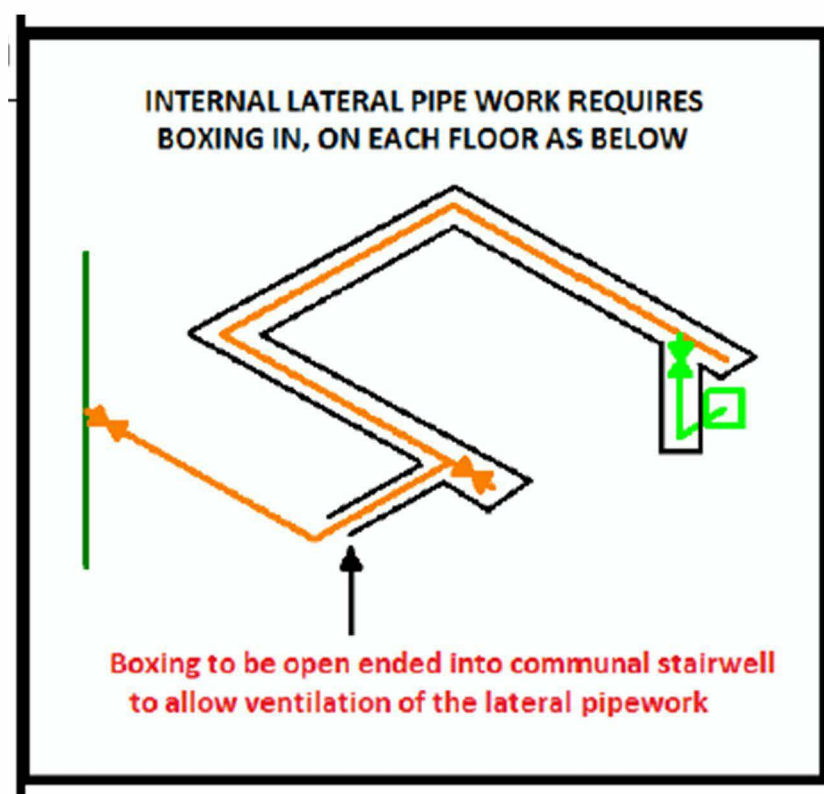
**Fig. 79 – Extract from Initial Design Drawing of Replacement Riser {TRI000000263}**

342. It can be seen that, the intent of the design involved changing the configuration of the fire compartmentation. From the e-mail from Patrick Kelly of Cadent Gas Ltd to Martin Loveday of TRIO dated 21/03/17 – {CAD000000175} and Matthew Dolan's witness statement {MET00012711}, I understand the intent was to make the boxed in pipework in the lobbies part of the stairwell fire compartment. Oversized holes were to be drilled in the compartment wall to enable the boxed in pipework in the lobby to be vented into the stairwell. This is illustrated by the following photographs:

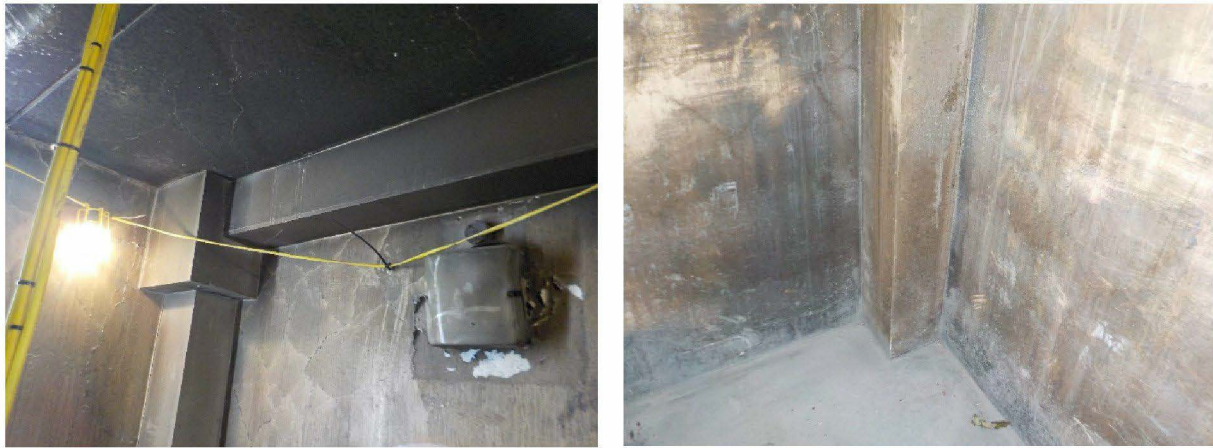
**Fig. 83 – Boxed in pipework in stairwell**

346. The boxing around the pipework in the stairwell between the 2<sup>nd</sup> and 22<sup>nd</sup> floors had been fitted by 14<sup>th</sup> June 2017. When I visited the Tower on 28<sup>th</sup> February 2018 I noted that approximately 50% of the boxing had been stripped out. I was able to take some photographs of the boxed in riser which have been reproduced below. It will be noted that intumescent vents had not been fitted as specified in the updated design drawing.

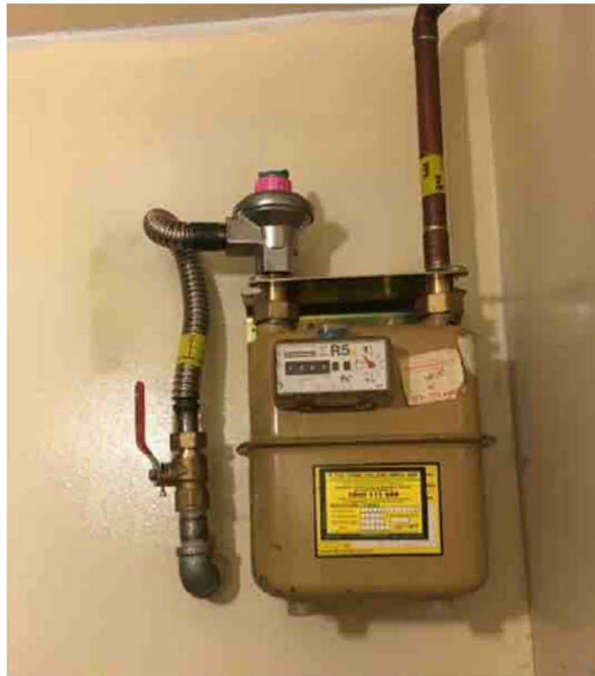
**Fig. 86 – Repositioned Gas Meter Installation in Flat No. 182 {TRI000001733}**

<sup>50</sup> The repositioned meter installation in Flat No. 182 was unaffected by the fire. See Figure 86.  
01/10/2019

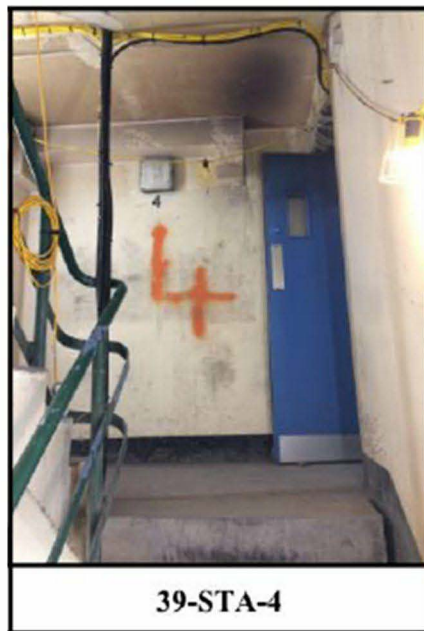
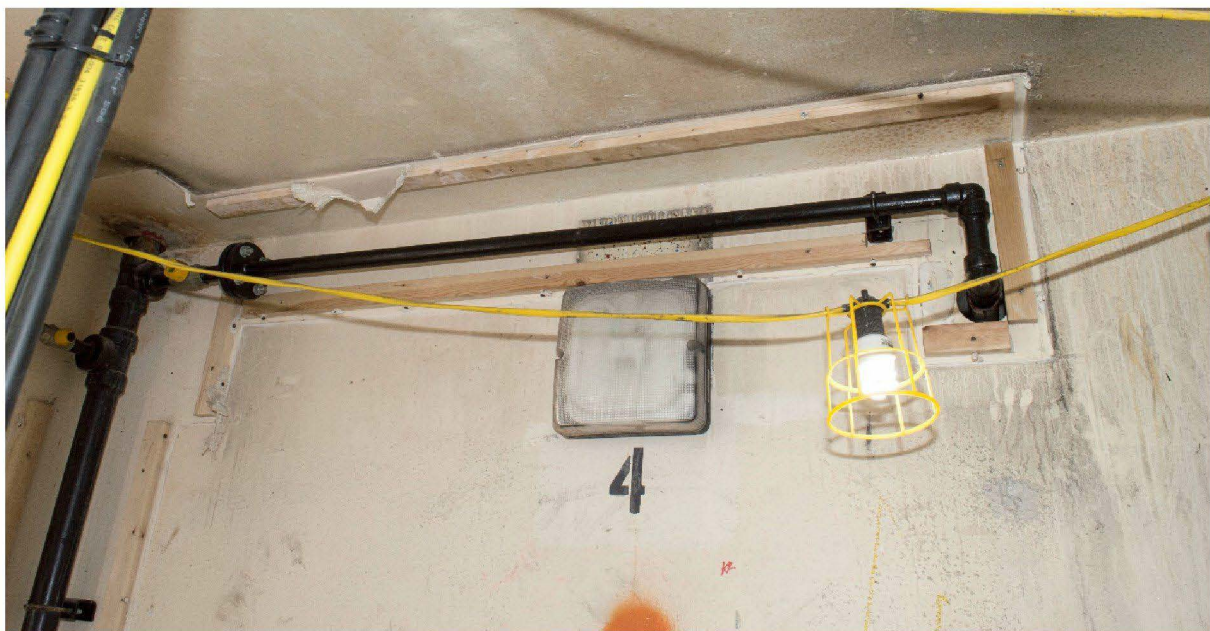
**Report of:** Rodney Hancox  
**Specialist Field:** Gas Engineering  
**Prepared for:** Grenfell Tower Inquiry  
4<sup>th</sup> Floor

Boxing appears to have been intact at the time of the fire. Photograph {MET00016596} indicates that smoke did not enter the boxing and hence stairwell via the oversized penetration of the compartment wall through which the gas pipe passed.

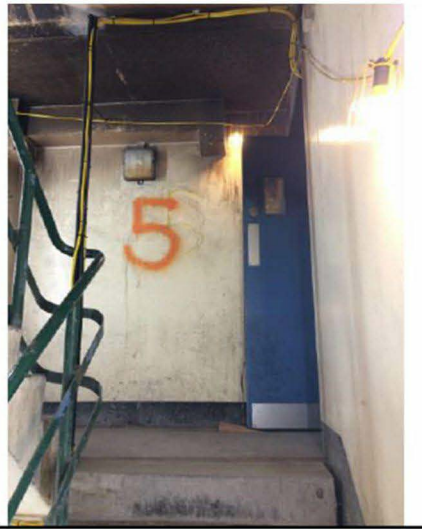
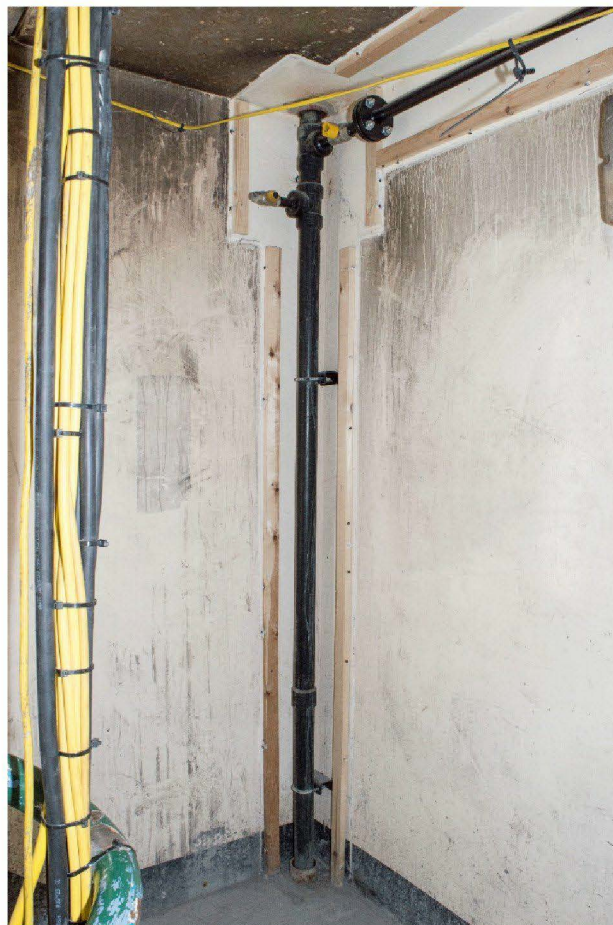
**Report of:**  
**Specialist Field:**  
**Prepared for:**  
**5<sup>th</sup> Floor**

Boxing appears to have been intact at the time of the fire. Photograph {MET00016751} indicates that smoke did not enter the boxing and hence stairwell via the oversized penetration of the compartment wall through which the gas pipe passed.

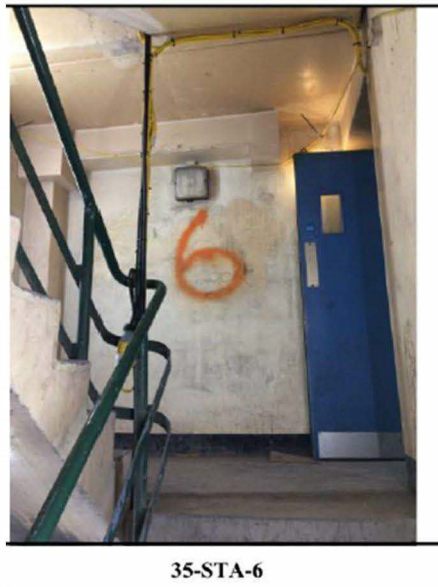
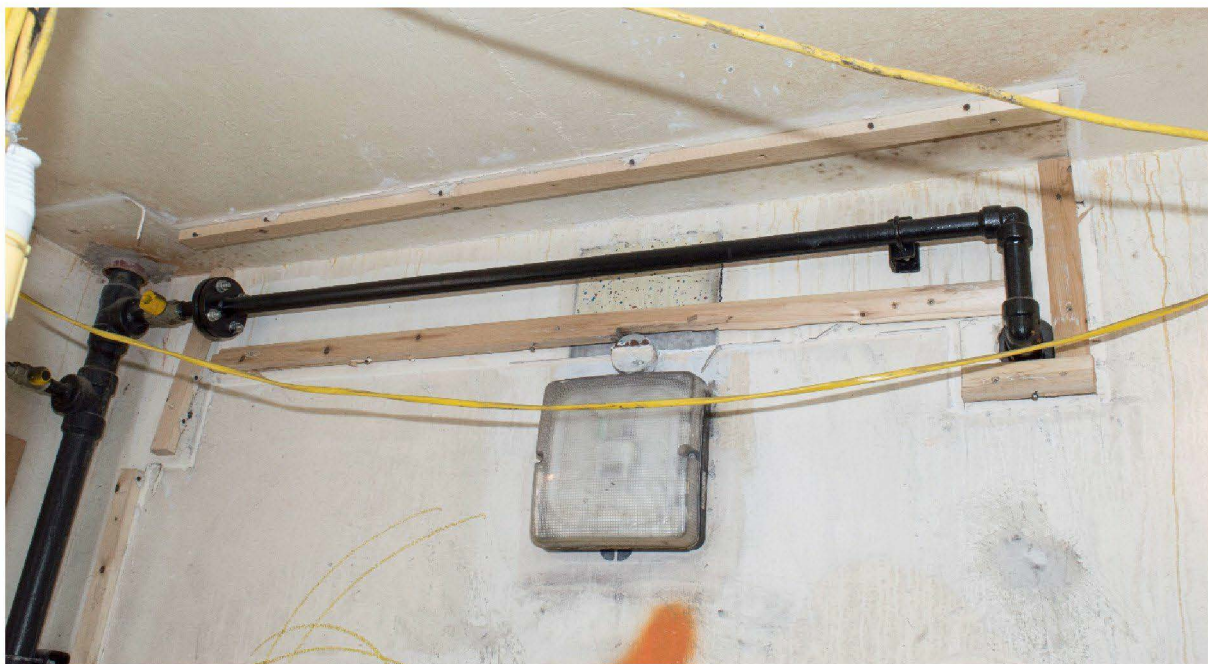
## 6<sup>th</sup> Floor

Boxing appears to have been intact at the time of the fire. Photograph {MET00016726} indicates that smoke did not enter the boxing and hence stairwell via the oversized penetration of the compartment wall through which the gas pipe passed.

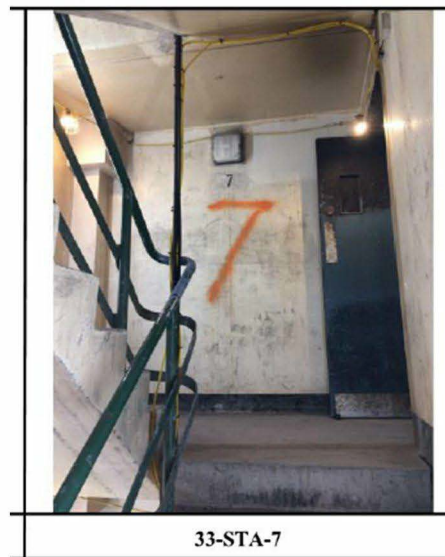
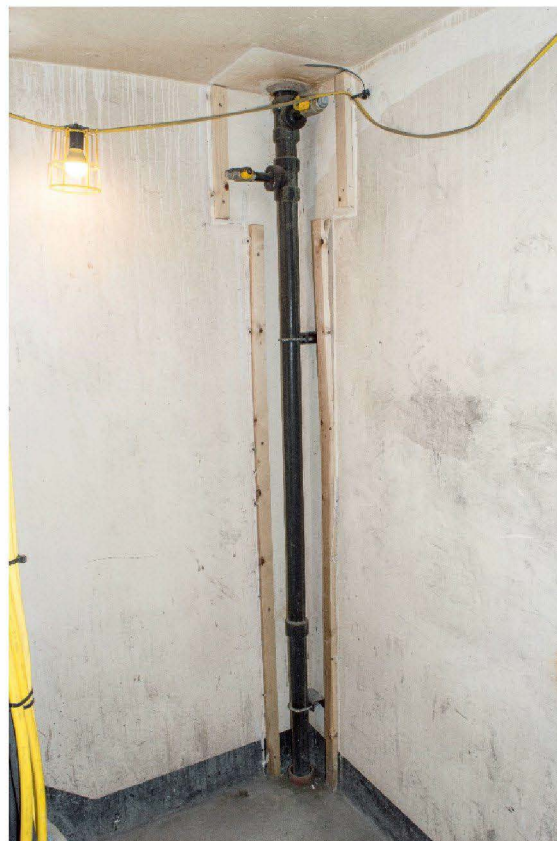
**Report of:**  
**Specialist Field:**  
**Prepared for:**  
**7<sup>th</sup> Floor**

Boxing appears to have been intact at the time of the fire. Photograph {MET00016619} indicates that there was no smoke present in the duct at this level at the time of the fire.

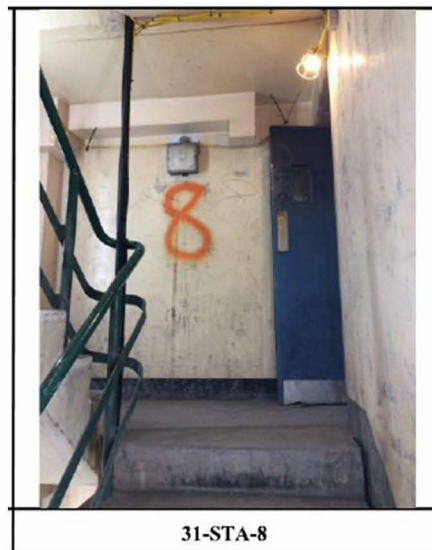
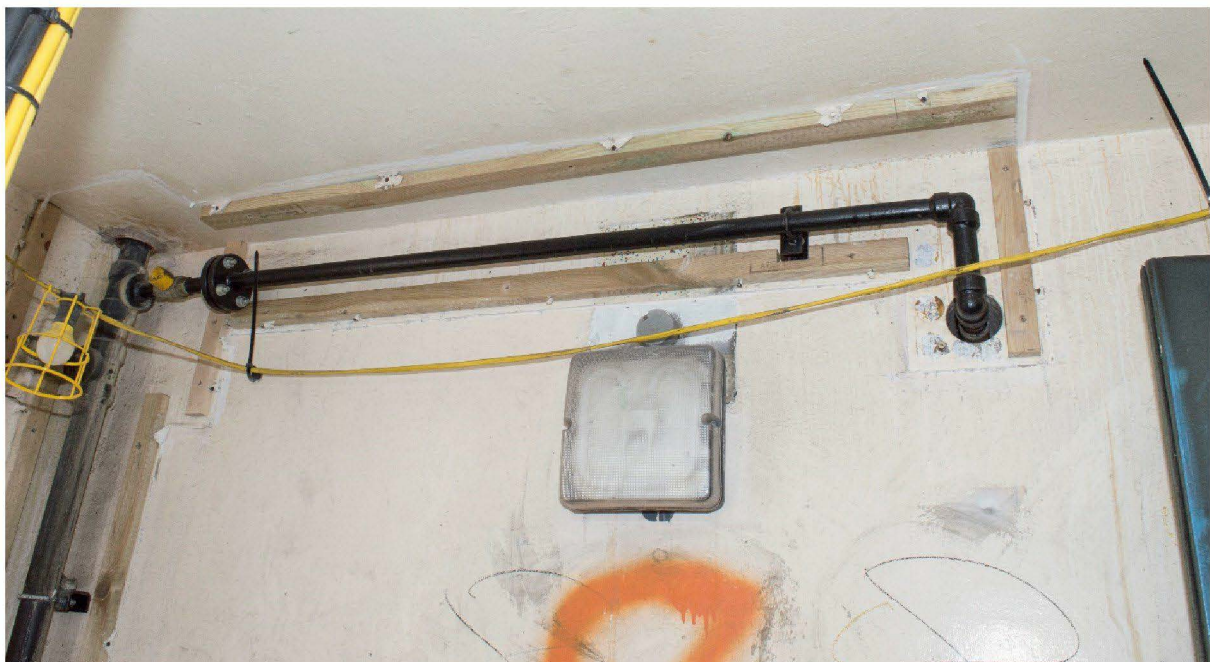
**Report of:** Rodney Hancox  
**Specialist Field:** Gas Engineering  
**Prepared for:** Grenfell Tower Inquiry  
**8<sup>th</sup> Floor**

Boxing appears to have been intact at the time of the fire. Photograph {MET00016685} indicates that smoke did not enter the boxing and hence stairwell via the oversized penetration of the compartment wall through which the gas pipe passed.

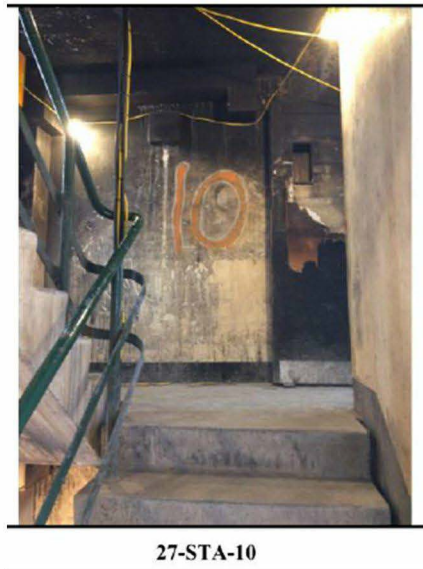
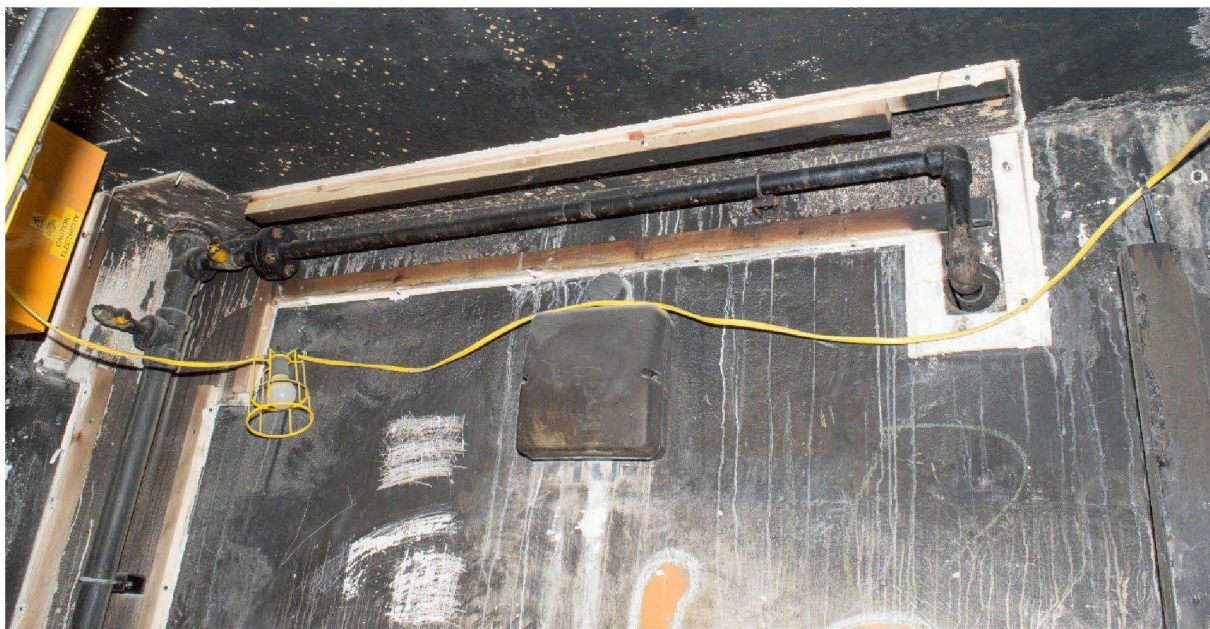
27-STA-10

Photograph {MET00016576} indicates that smoke entered into and/or exited from the boxing at this level via the oversized penetration of the compartment wall through which the gas pipe passed. Boxing appears to have been intact at the time of the fire. There is no reason to suspect that smoke was able to enter the stairwell at this level from the boxing.

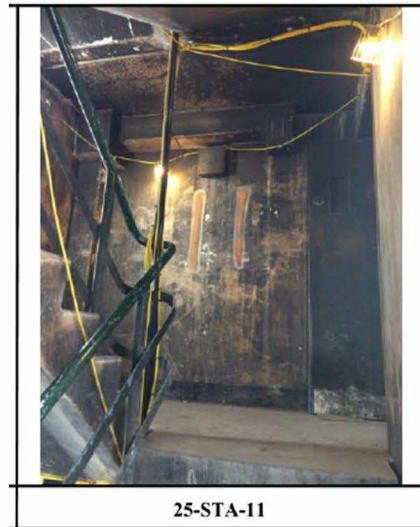
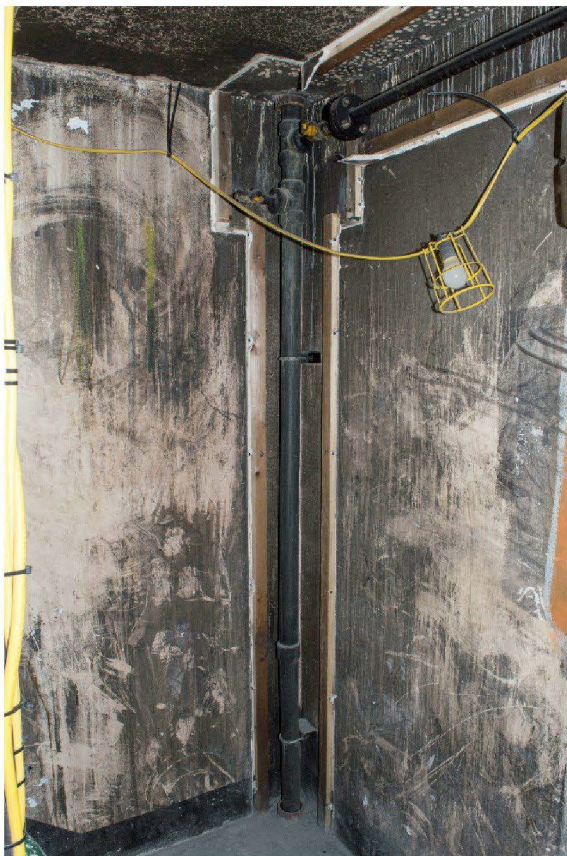
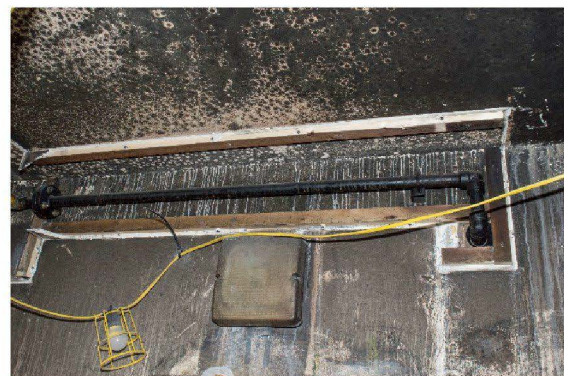
Photographs {MET00016747} and {MET00016559} indicate that smoke entered into and/or exited from the boxing at this level via the oversized penetration of the compartment wall through which the gas pipe passed. Boxing appears to have been intact at the time of the fire.

There is no reason to suspect that smoke was able to enter the stairwell at this level from the boxing.

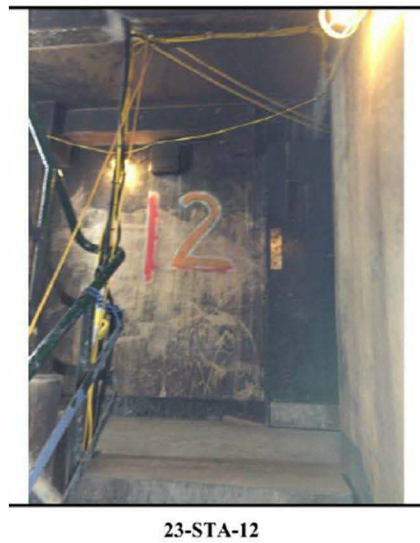
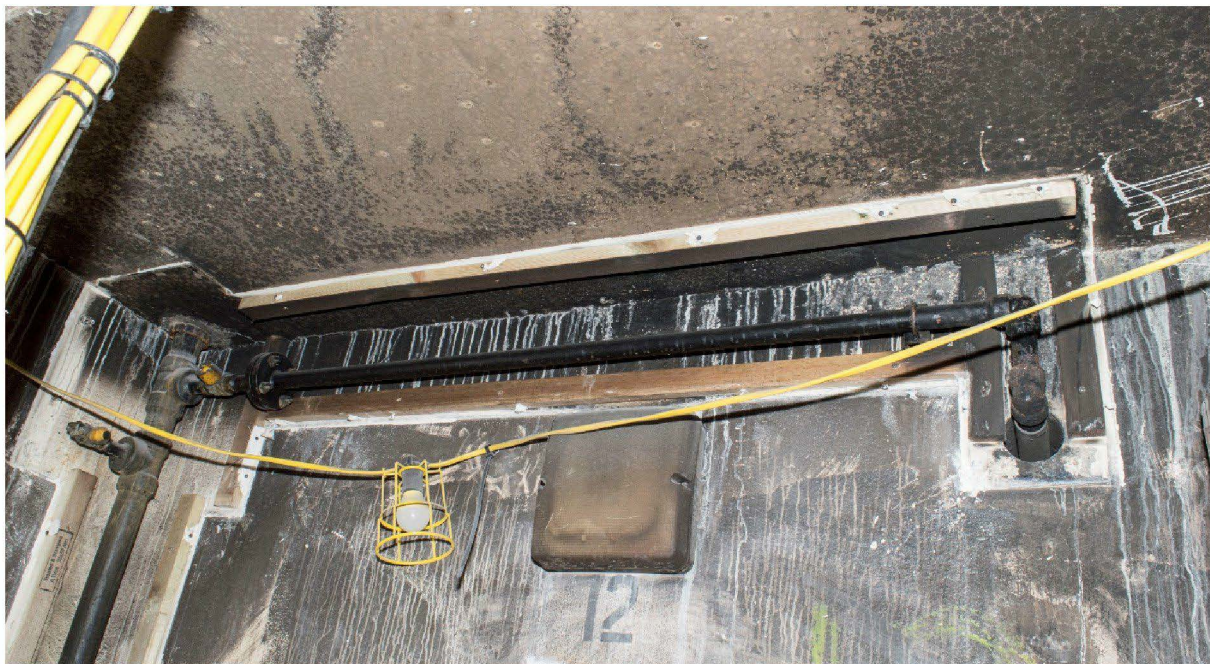
23-STA-12

Photograph {MET00016606} indicates that smoke entered into and/or exited from the boxing at this level via the oversized penetration of the compartment wall through which the gas pipe passed. Boxing appears to have been intact at the time of the fire. There is no reason to suspect that smoke was able to enter the stairwell at this level from the boxing.

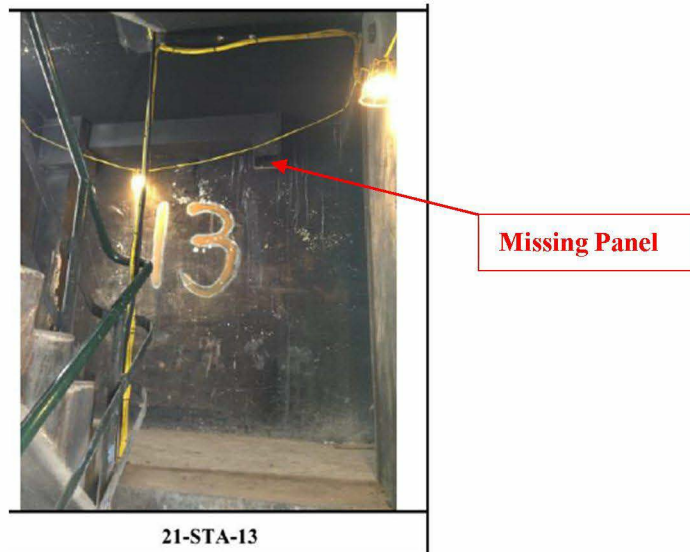
Photograph {MET00016560} indicates that smoke entered into and/or exited from the boxing at this level via the oversized penetration of the compartment wall through which the gas pipe passed.

As there was a missing panel at the time Dr Lane's team carried out its inspection, it is possible that the boxing may not have been intact at the time of the fire. If the panel had not been in place on 14<sup>th</sup> June then smoke would have been able to enter the stairwell via the oversized penetration of the compartment wall through which the gas pipe passed.

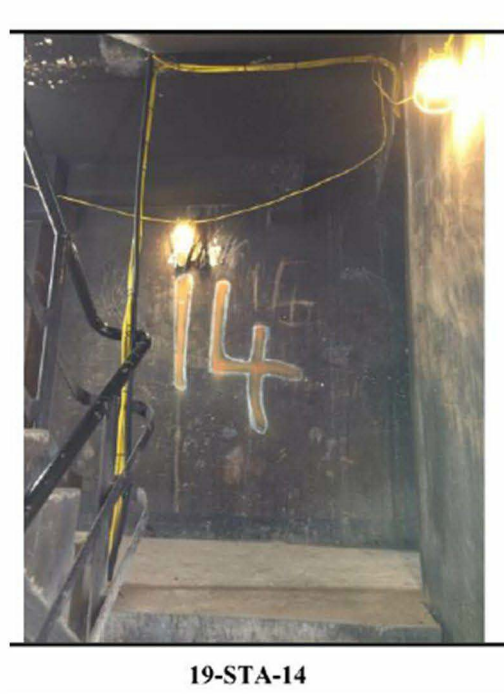
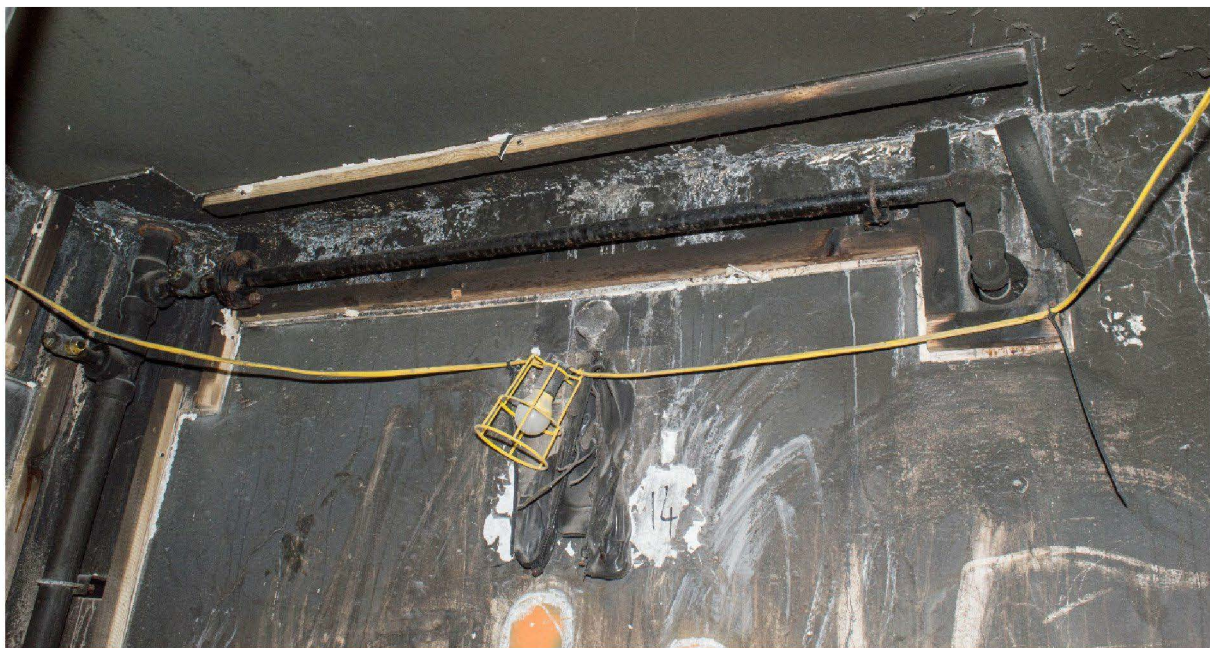
Photograph {MET00016580} indicates that smoke entered into and/or exited from the boxing at this level via the oversized penetration of the compartment wall through which the gas pipe passed. Boxing appears to have been intact at the time of the fire. There is no reason to suspect that smoke was able to enter the stairwell at this level from the boxing.

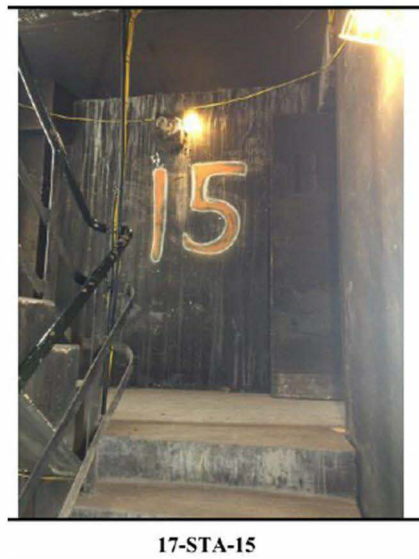
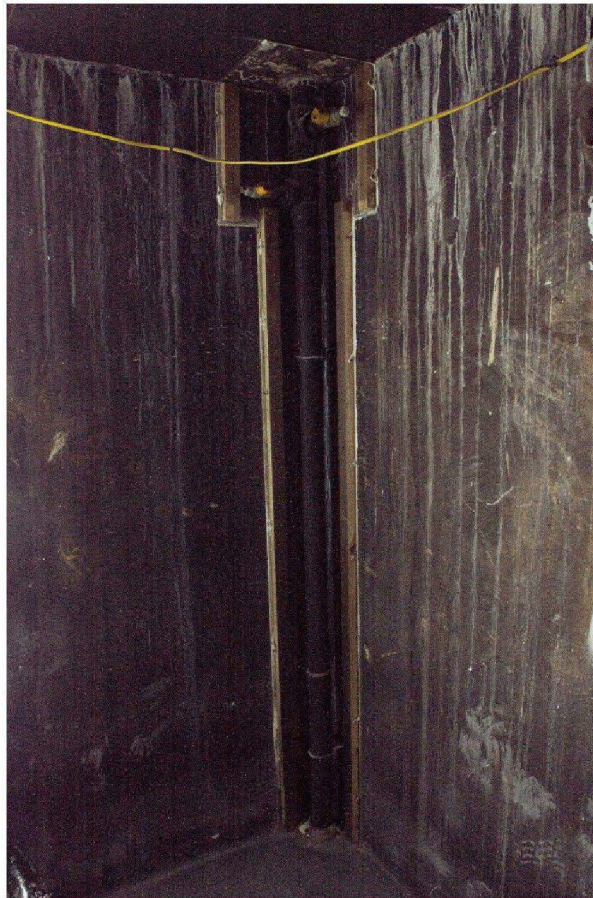
Boxing appears to have been intact at the time of the fire. Photograph {MET00016616} indicates that there was a significant amount of smoke present in the duct at this level at the time of the fire.

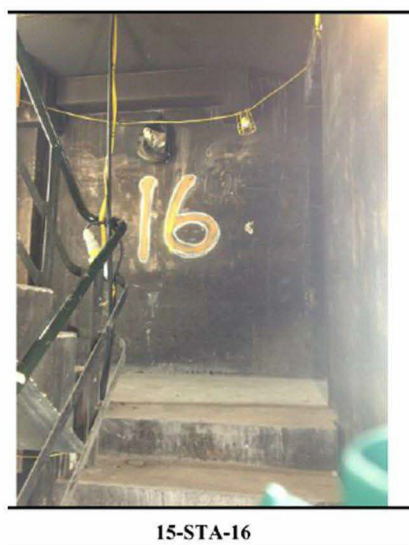
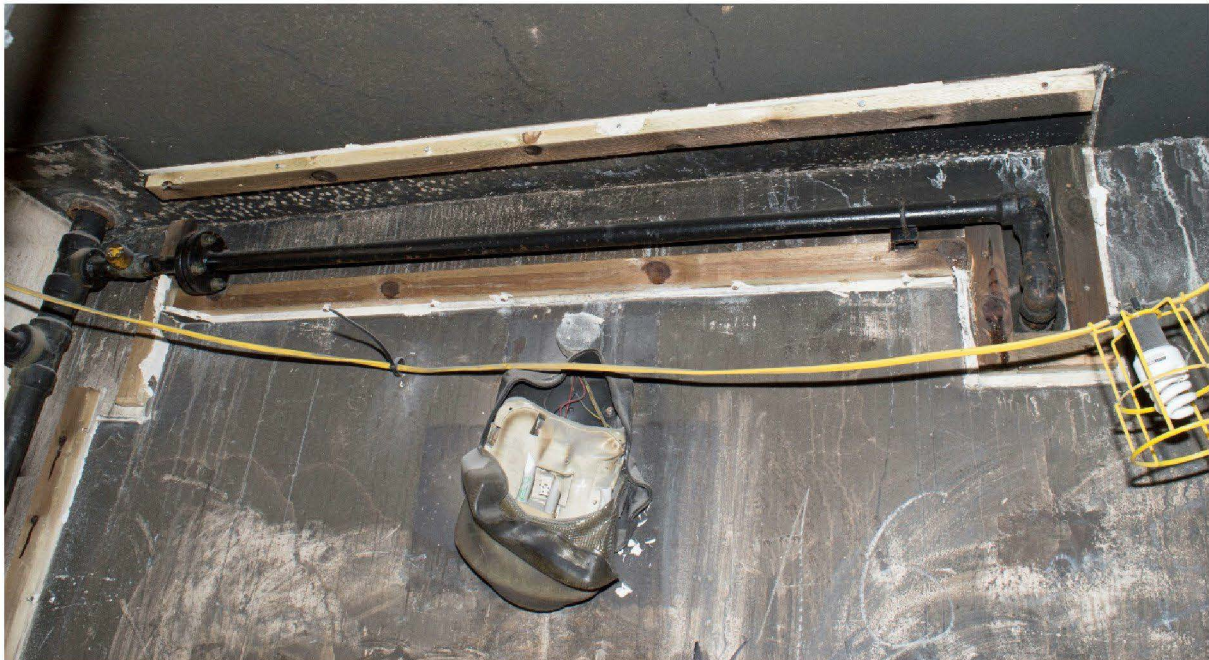
Photograph {MET00016518} indicates that smoke entered into and/or exited from the boxing at this level via the oversized penetration of the compartment wall through which the gas pipe passed. Boxing appears to have been intact at the time of the fire. There is no reason to suspect that smoke was able to enter the stairwell at this level from the boxing.

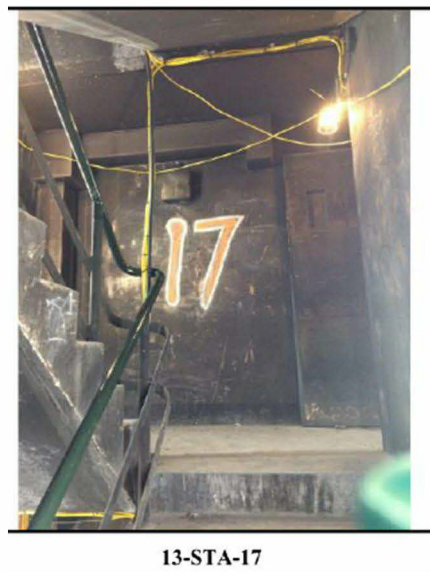
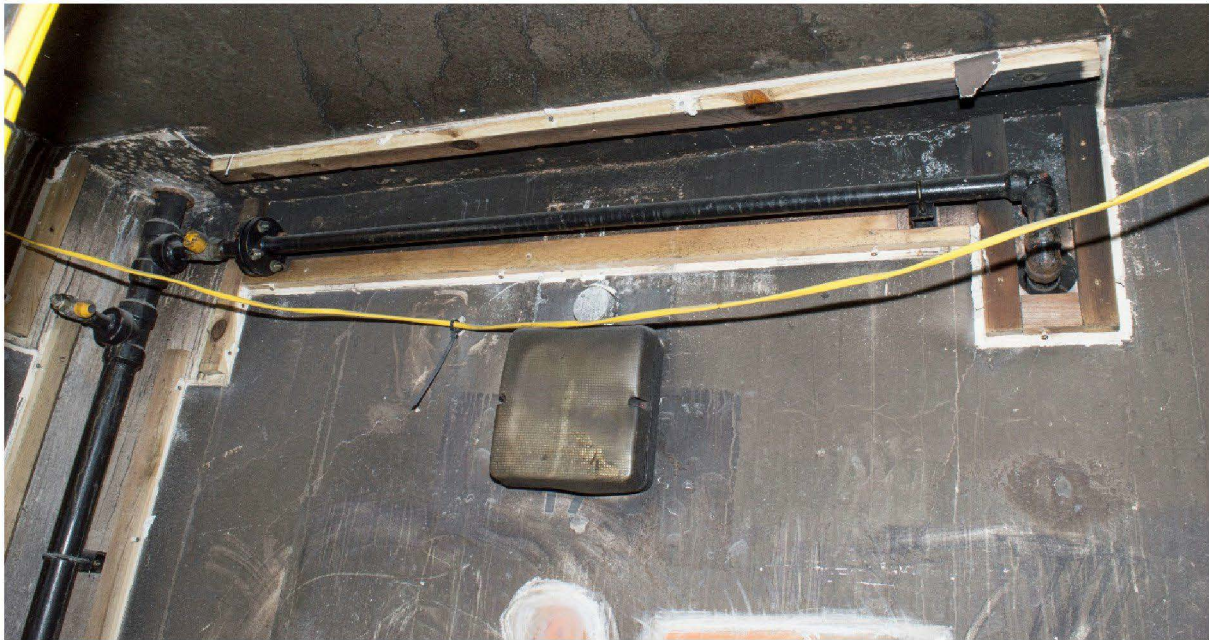
13-STA-17

Photograph {MET00016516} indicates that smoke entered into and/or exited from the boxing at this level via the oversized penetration of the compartment wall through which the gas pipe passed. Boxing appears to have been intact at the time of the fire. There is no reason to suspect that smoke was able to enter the stairwell at this level from the boxing.

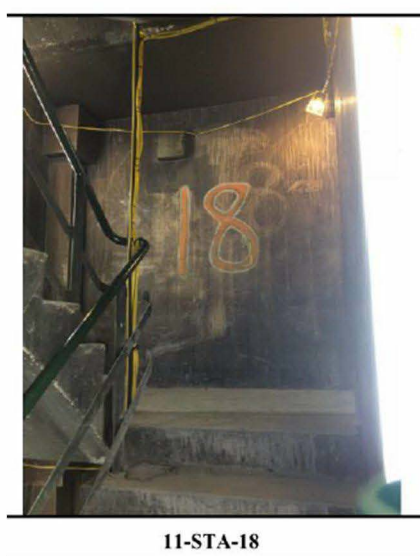
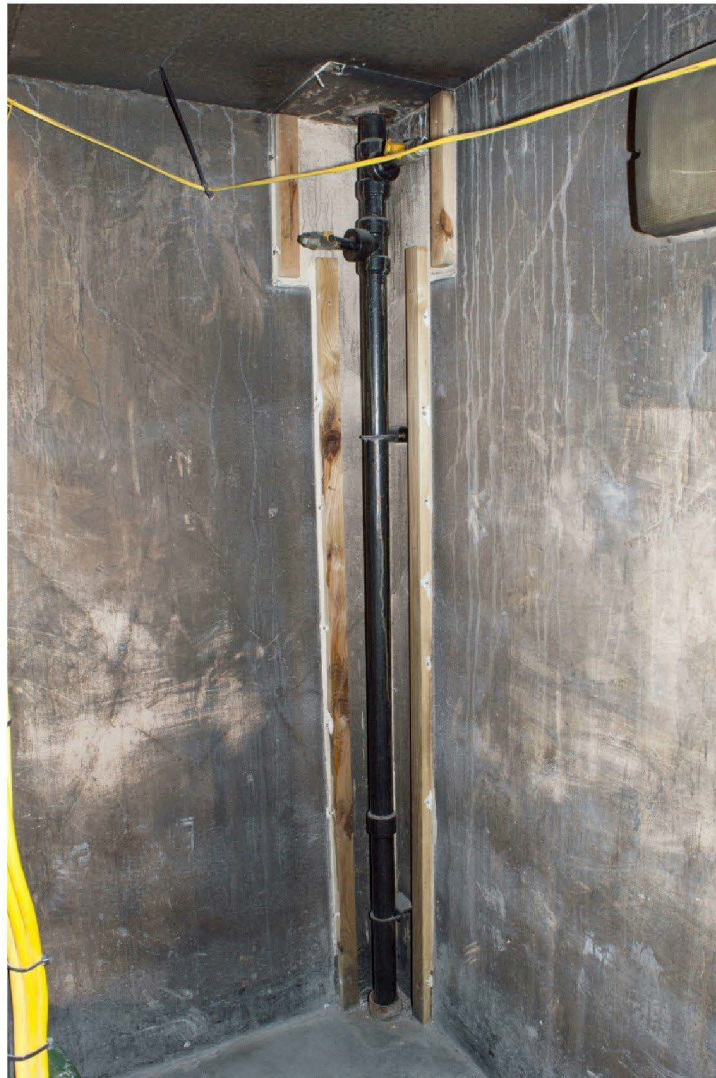
11-STA-18

Boxing appears to have been intact at the time of the fire. There was no penetration of the compartment wall at this level.

Photograph {MET00016533} indicates that there was some smoke present in the bottom half of the duct at this level at the time of the fire.

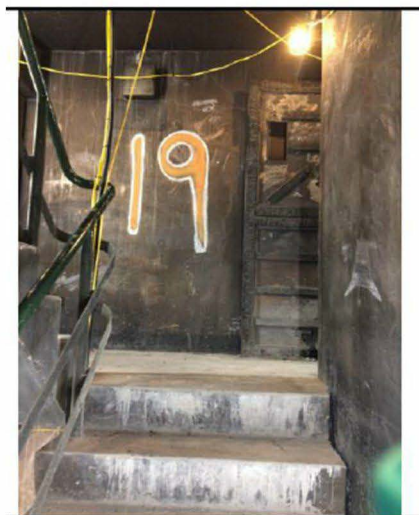
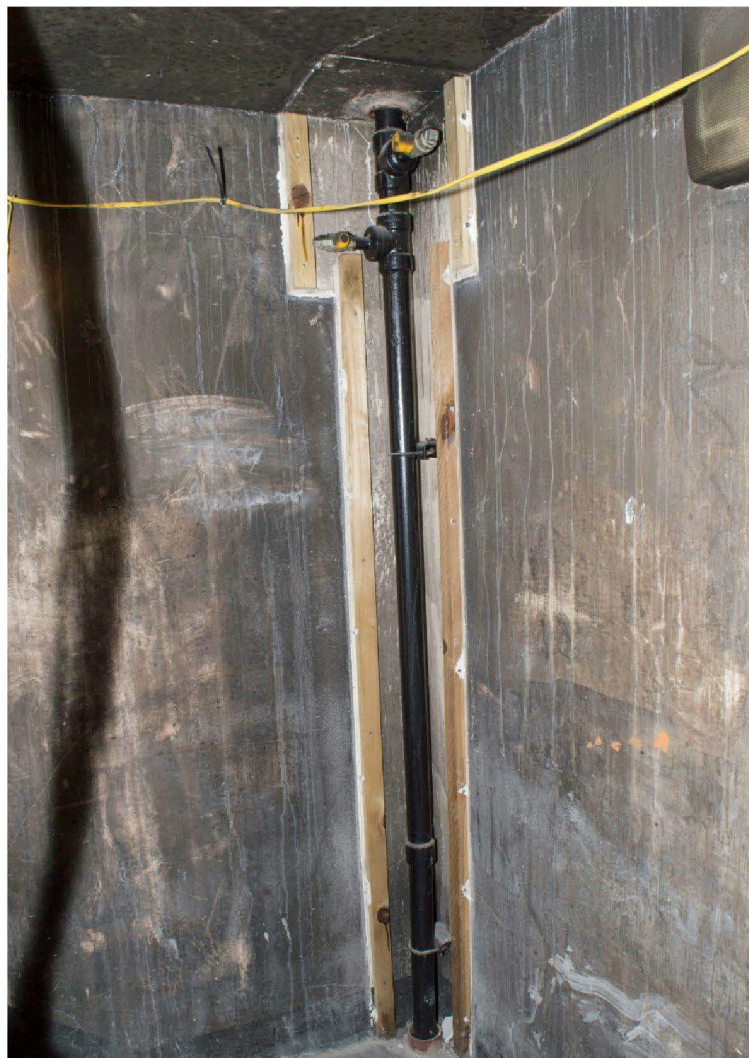
9-STA-19

Boxing appears to have been intact at the time of the fire. There was no penetration of the compartment wall at this level.

Photograph {MET00016729} indicates that there was a little smoke present in the bottom half of the duct at this level at the time of the fire.

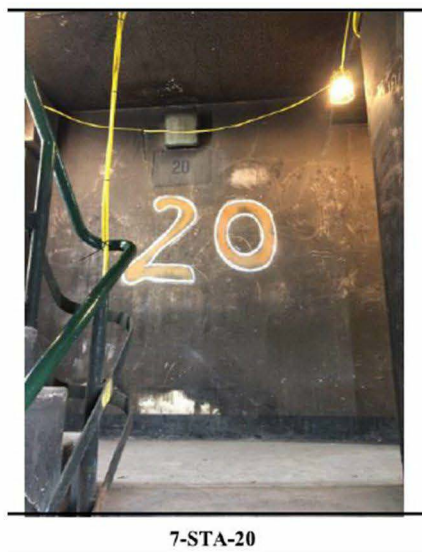
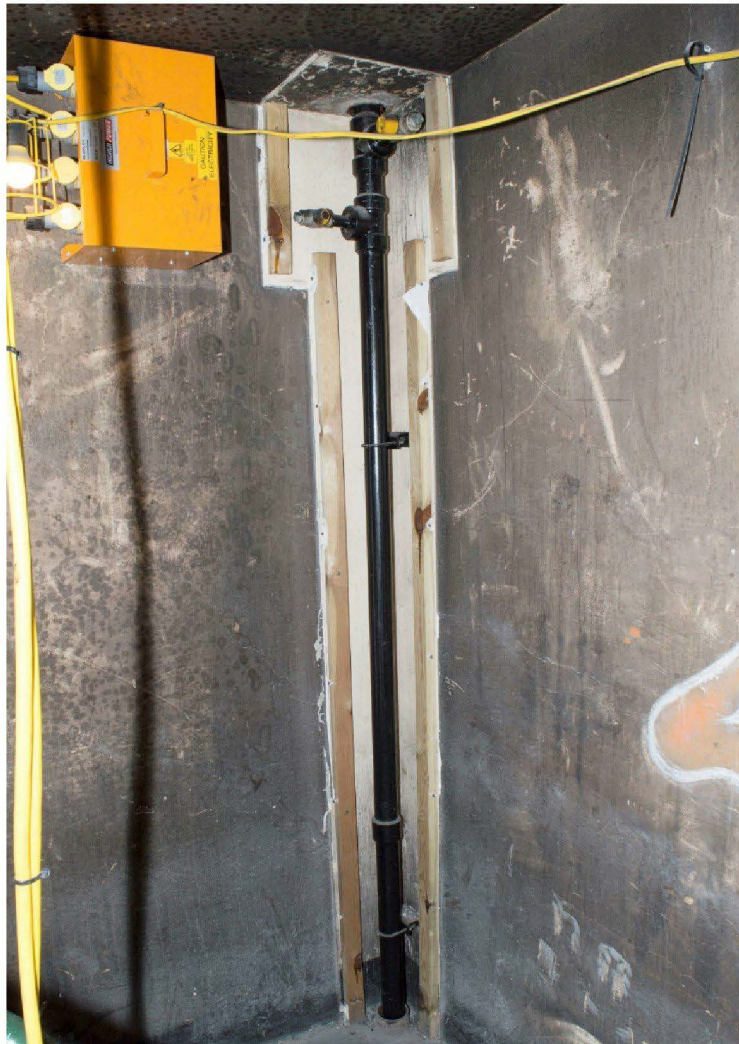
Boxing appears to have been intact at the time of the fire. There was no penetration of the compartment wall at this level.

Photograph {MET00016727} indicates that there was very little smoke present in the duct at this level at the time of the fire.

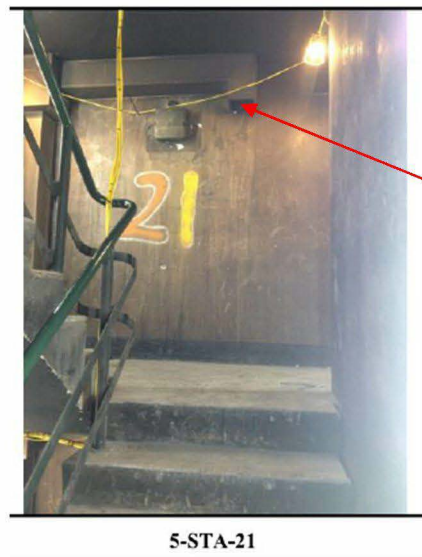
Photograph {MET00016549} indicates that smoke entered the boxing from the lobby at this level via the oversized penetration of the compartment wall through which the gas pipe passed. I note the vertical section appears to have been smoke free.

As there was a missing panel at the time Dr Lane's team carried out its inspection, it is possible that the boxing may not have been intact at the time of the fire. If the panel had not been in place on 14<sup>th</sup> June then smoke would have been able to enter the stairwell via the oversized penetration of the compartment wall through which the gas pipe passed.

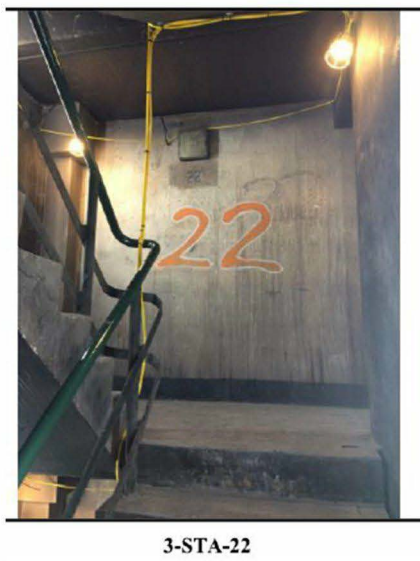
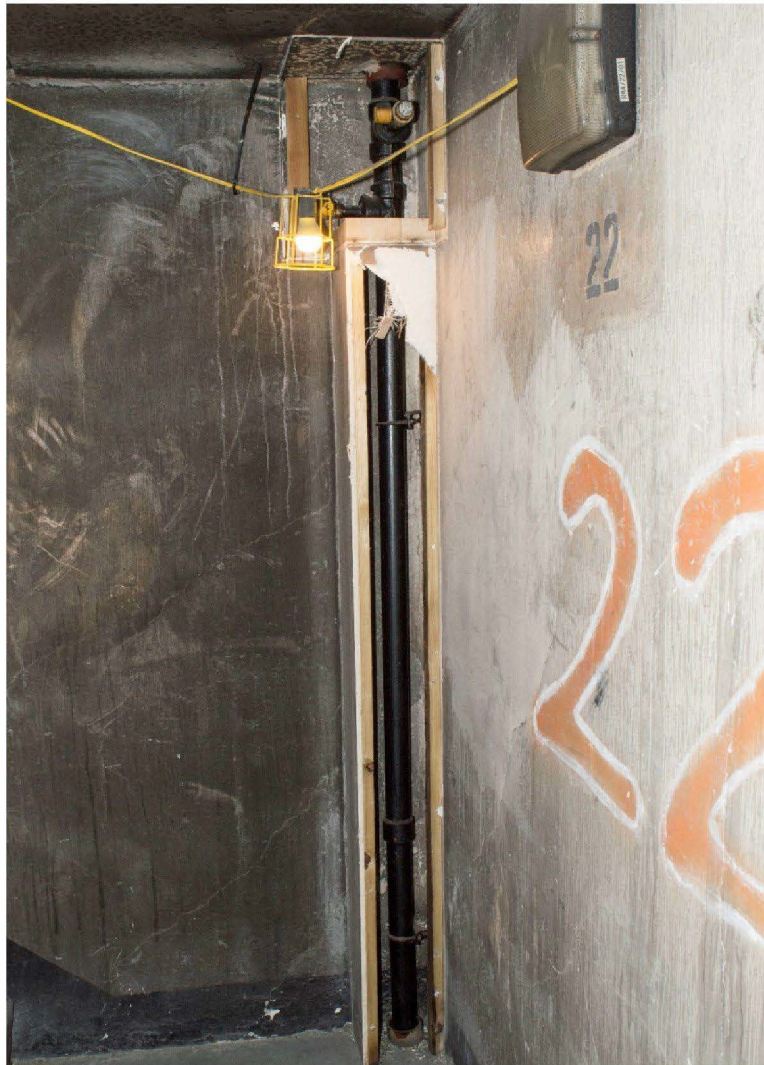
Boxing appears to have been intact at the time of the fire. There was no penetration of the compartment wall at this level.

Photograph {MET00016728} indicates that there was some smoke present in the duct at this level at the time of the fire.

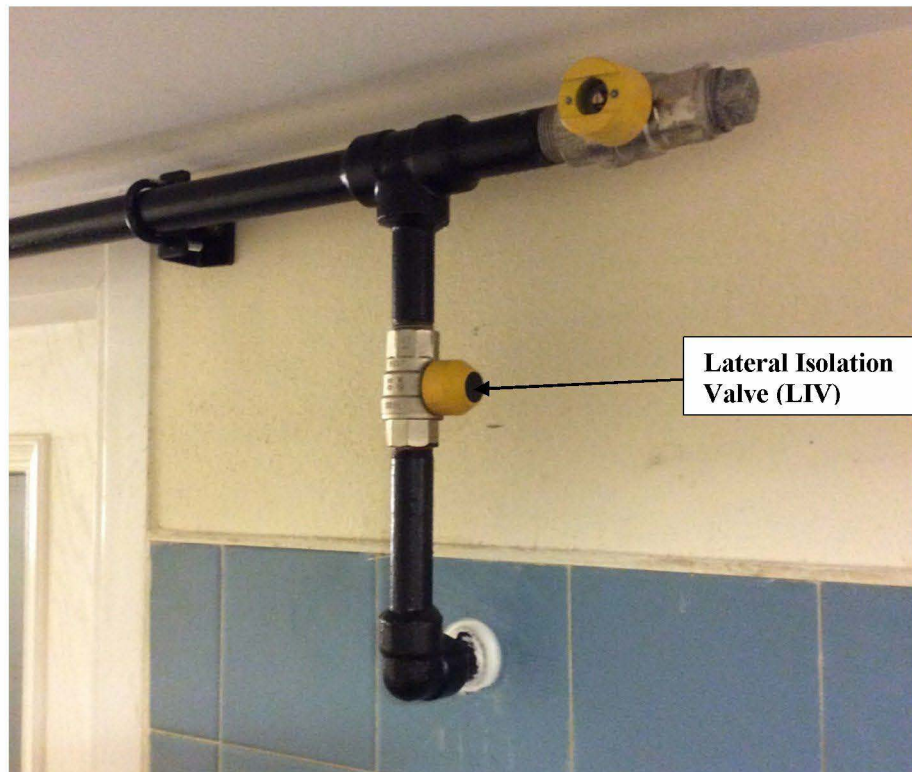
376. Each of the service entries into the flats from the lobbies were also breaches of a compartment wall. However, in each case which I observed, the service entry had been sleeved and sealed with what appeared to me to be fire stopping material.

**Fig. 87 – Service Entry into Flat ending in “2”. {CAD00001897}**

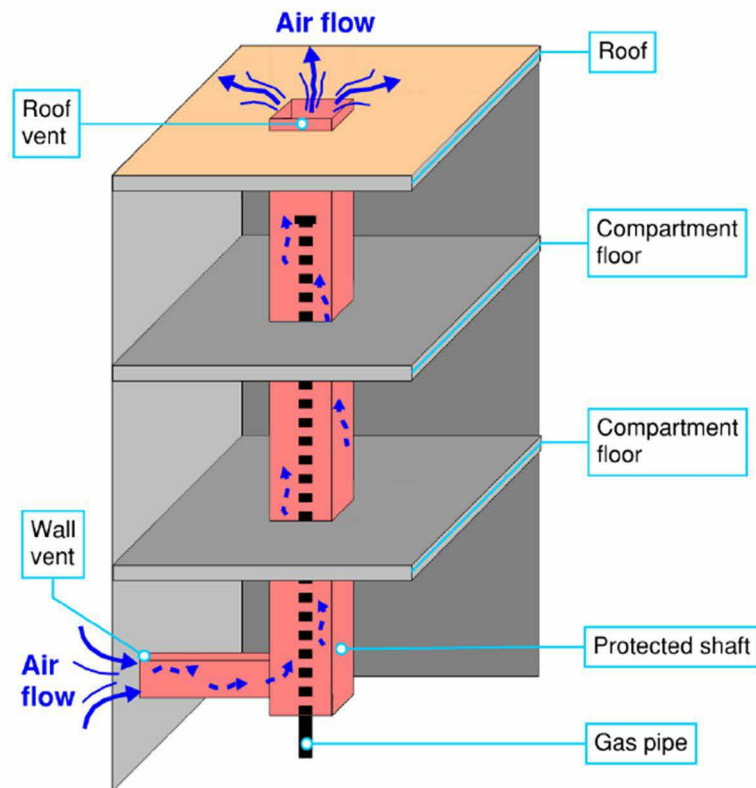
**Fig. 88 - Diagram of Ventilated Protected Shaft Containing a Gas Pipe**

381. Such a ventilated protected shaft as is depicted in Figure 88 above
- Requires sufficient air to be able to enter the bottom of the shaft from outside;

- Requires the air to be able to exit the shaft at the top to the outside;
  - Requires the air flow from bottom to top not to be impeded and to be sufficient to ensure that in the event of reasonably foreseeable gas leak the gas concentration within the shaft shall be no more than 25% of the Lower Flammable Limit;
