# **GRENFELL TOWER INQUIRY**

## **Final Report of**

**Rodney Denver Hancox B.Sc., C.Eng, MIGEM**

## **Gas Engineering**

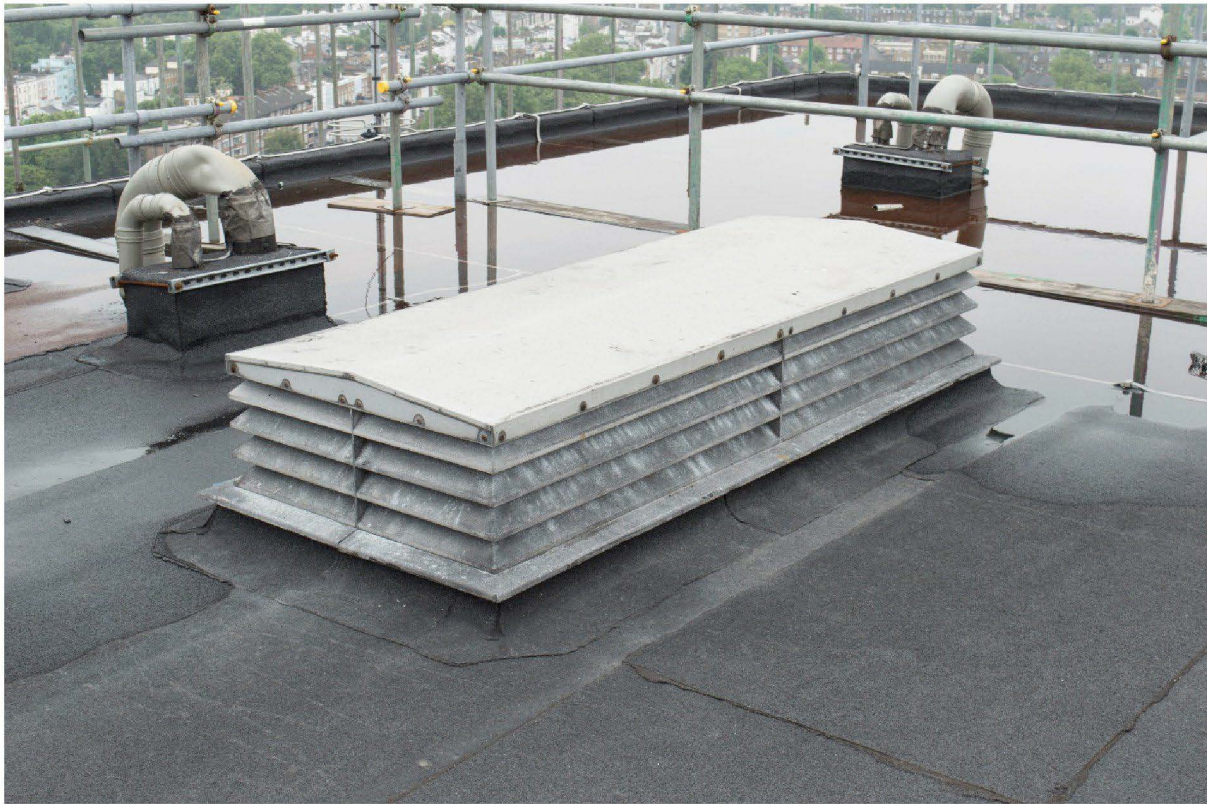
**Fig. 91 – Roof Vent**

391. Globe Scaffolding produced a design for the scaffolding. However, no design has been presented for the ventilation of the top of the boxing to the roof vent.
