## **Grenfell Tower**

### **Flat Sub-Main Rising and Lateral Supplies Report, 29<sup>th</sup> May 2013.**

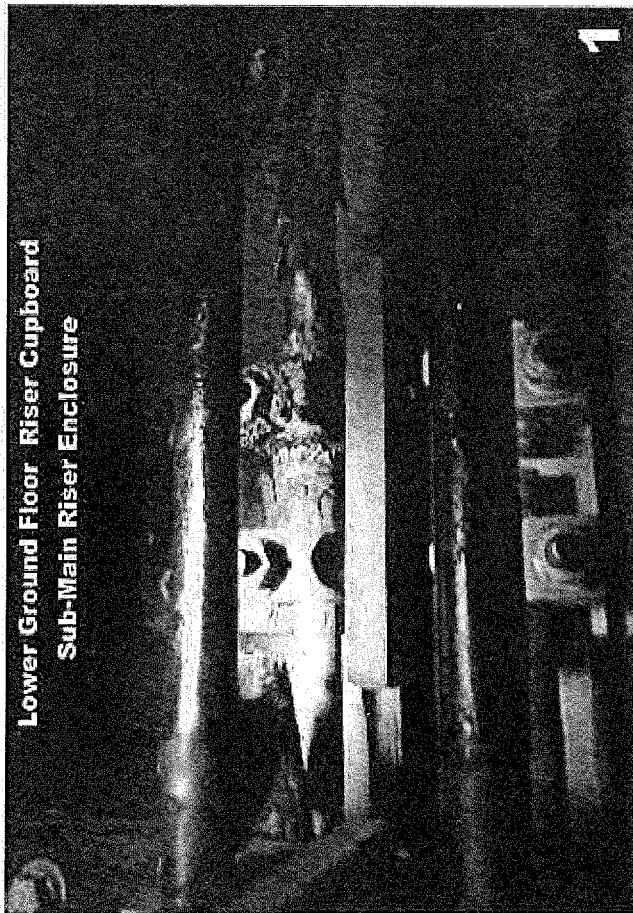
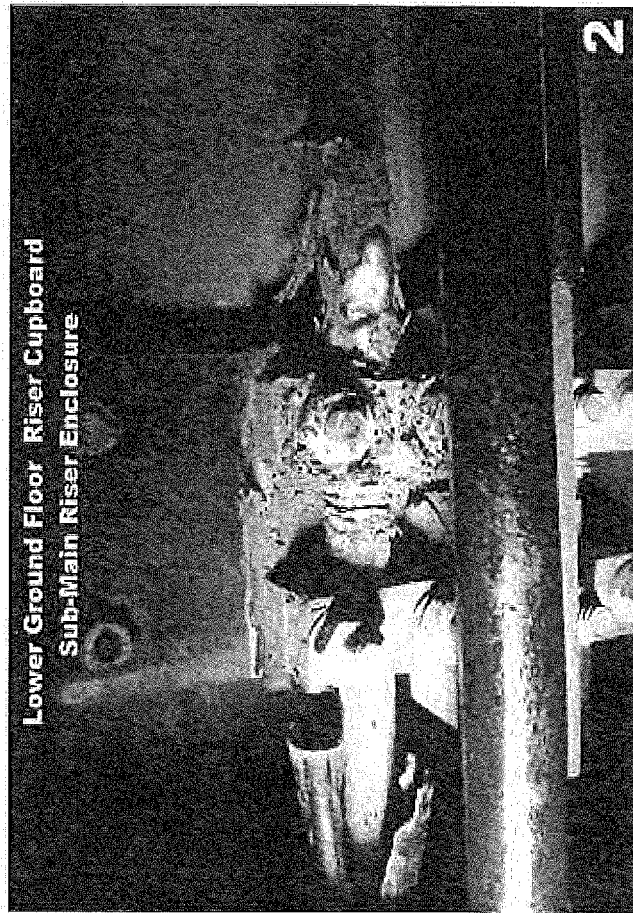
Further investigation found badly damaged enclosure and service cable in the lower ground floor riser cupboard where there is evidence of severe burn and arcing damage

This is concurrent with a Damaged/Broken cable on the sub-main supply side neutral. Connected to incoming service mains for Flats.

On inspection we found loose connections and the neutral cable had melted away from the clamp connections and could have caused a fire within the riser, please see attached photos on the following sheets.

As a result of our findings we recommend a overhaul of the existing equipment and replacing missing and faulty items. A new rising main supply will be required from the main service head and new terminations.
