Grenfell Tower – fire safety investigation:
The fire protection measures in place on the night of the fire, and conclusions as to:
the extent to which they failed to control the spread of fire and smoke;
the extent to which they contributed to the speed at which the fire spread.

Phase 1 Report – Appendix C

Excerpts from site inspection records

Dr Barbara Lane FREng CEng

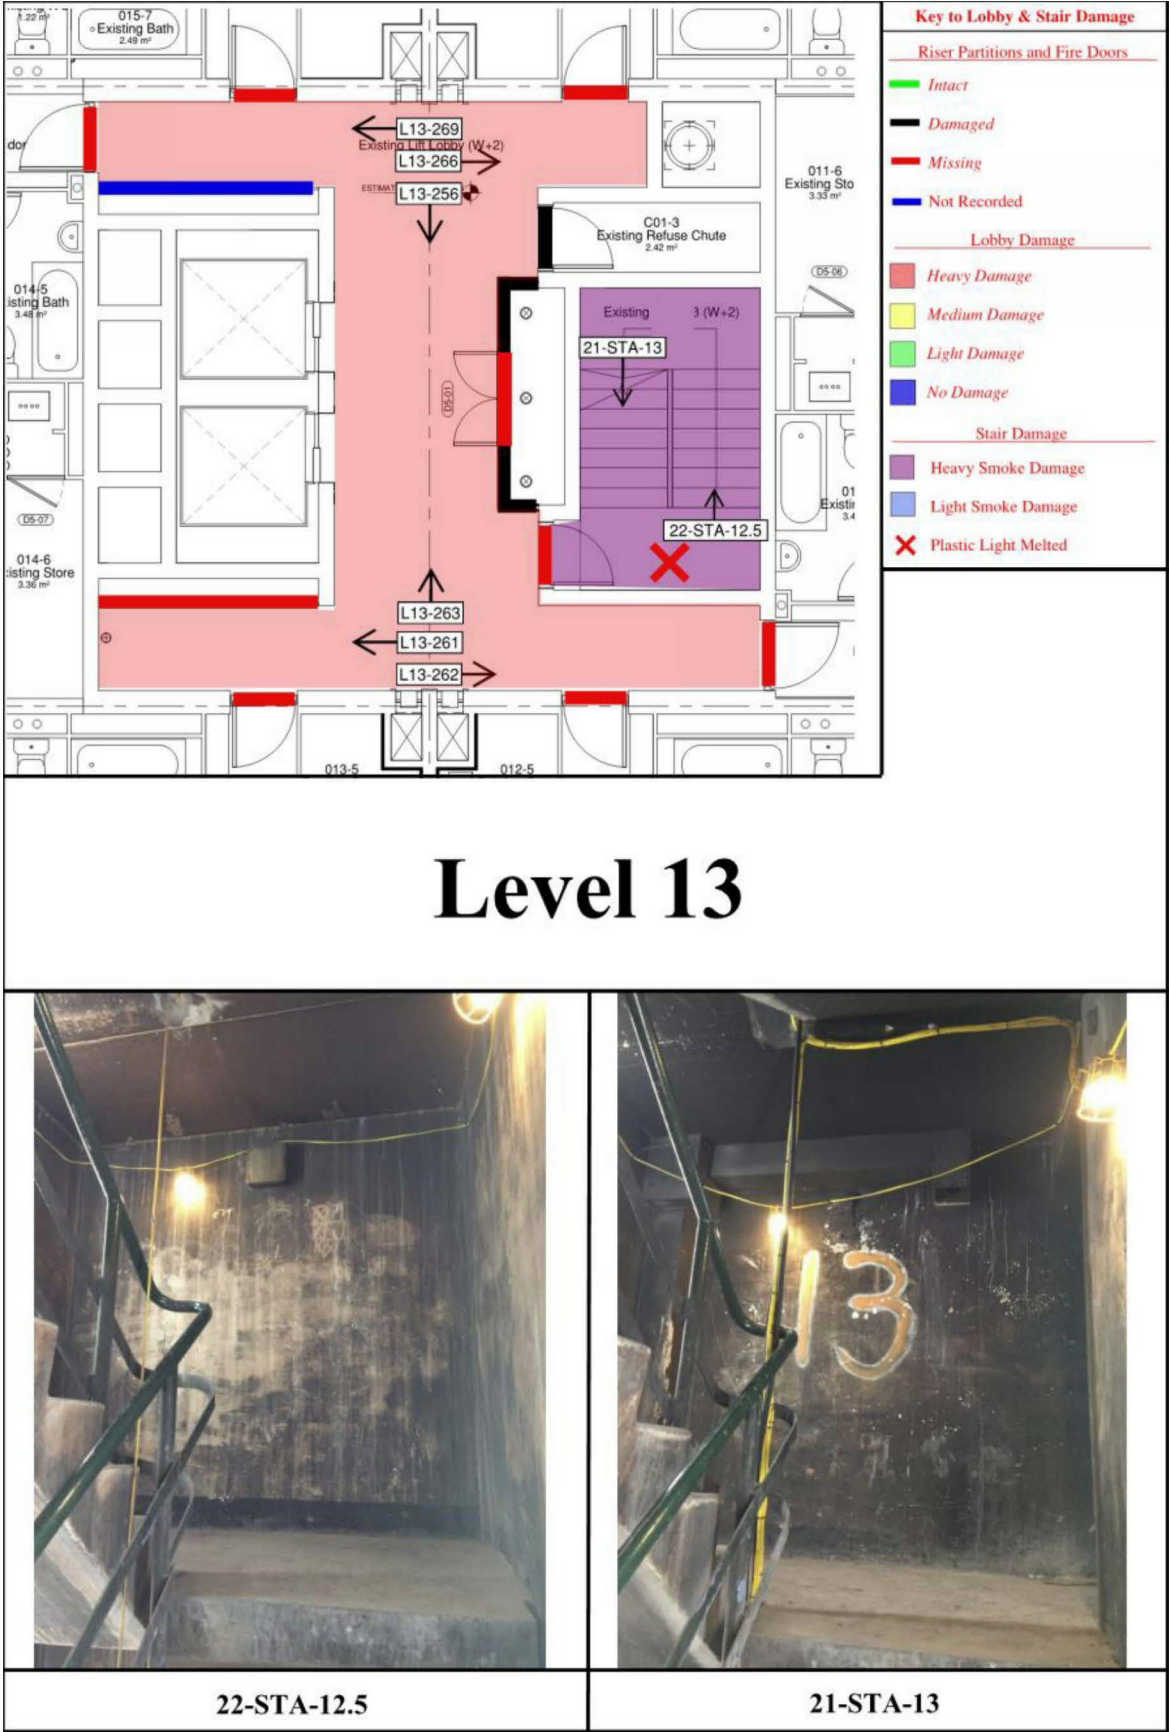
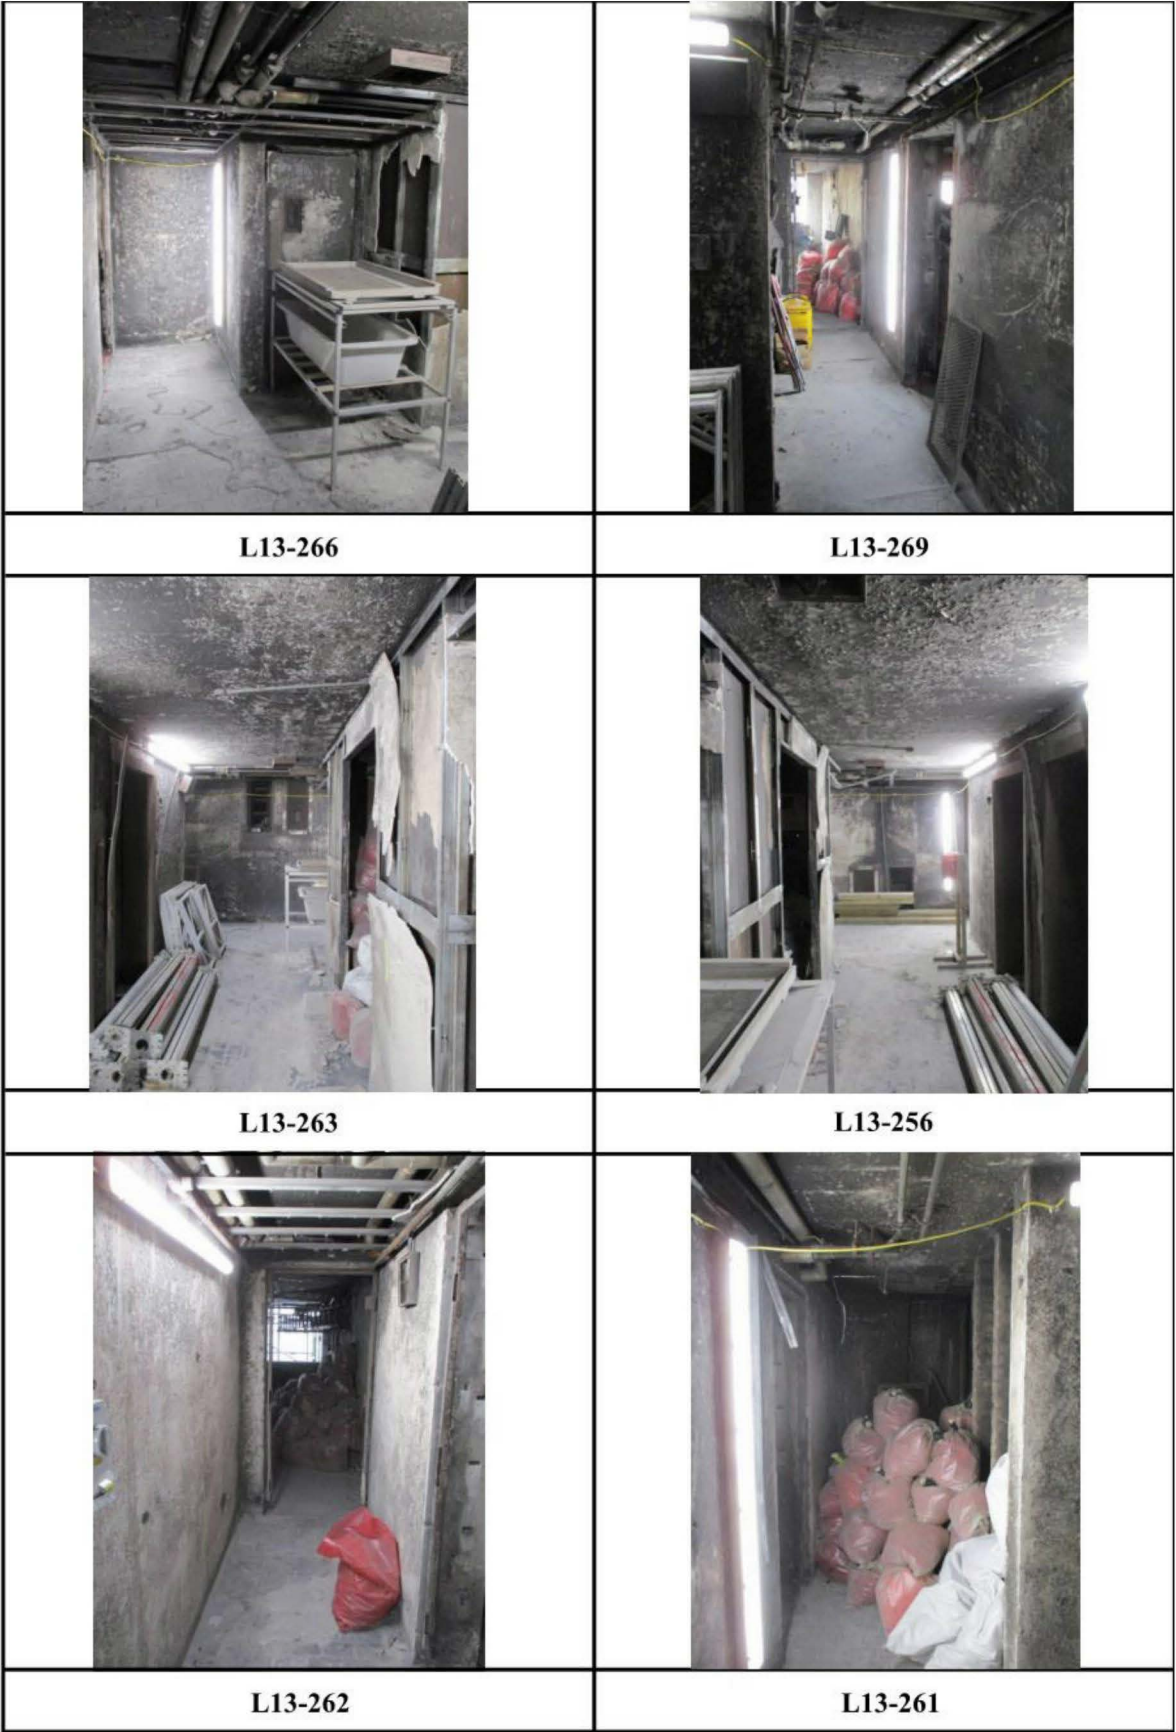
C2.1.17 Level 13

C3.1.1 During my November 2017 site inspections I observed stair doors were missing on Levels 13, 14, 16, 18, 20, 21, 22 and 23.

<p>L13-258</p>	<p>Site visit: door missing MPS photo: door missing Conclusion: Door missing</p>

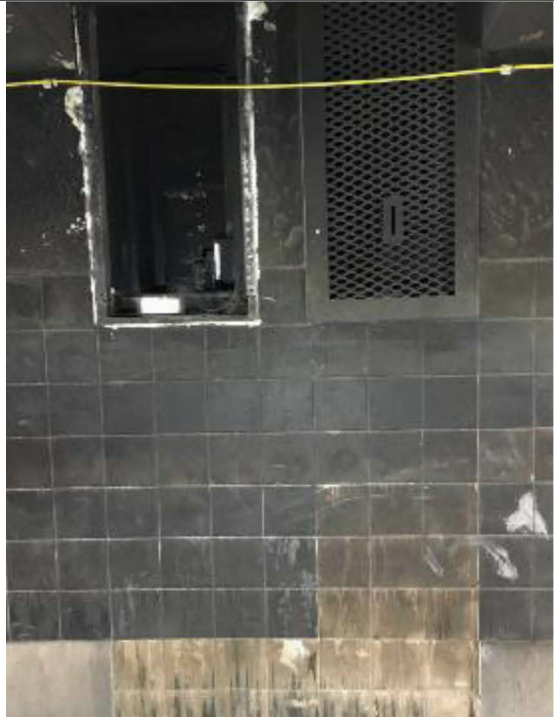
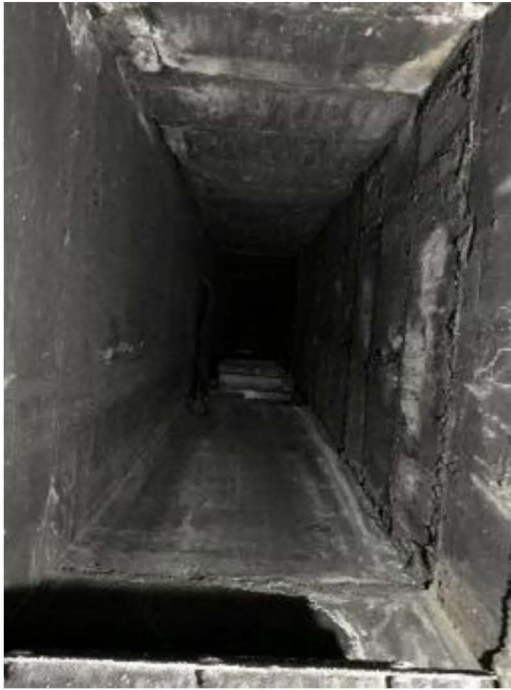
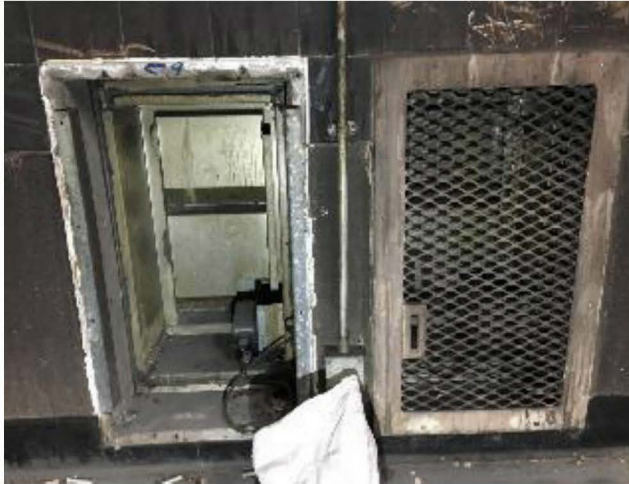
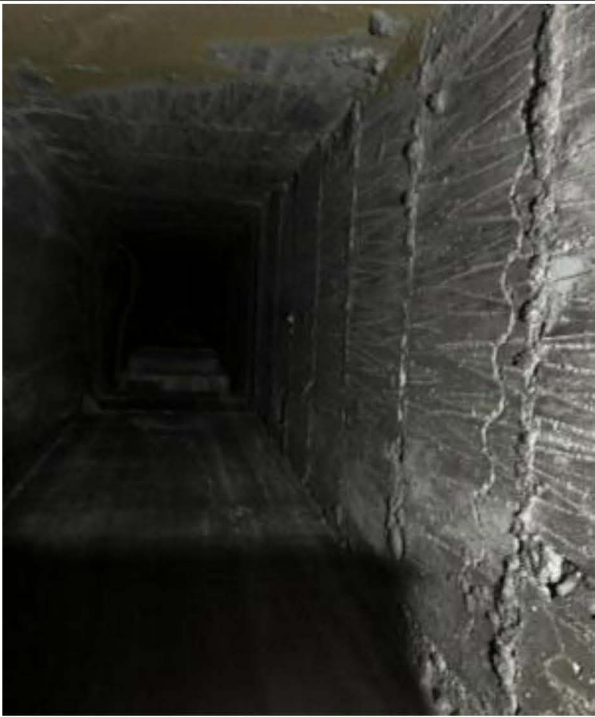
Level	North AOV		South AOV	
	AOV	Shaft	AOV	Shaft
9

9	Y	Y	Y	Y	Visible smoke damage in the shaft and on back of AOVs. Smoke markings on louvre frame indicate AOV was closed during fire.	Visible smoke damage in the shaft and on back of AOVs. Smoke markings on louvre frame indicate AOV was closed during fire.
10	Y	Y	Y	Y	Visible smoke damage in the shaft and on back of AOVs. Smoke markings on louvre frame indicate AOV was closed during fire.	Visible smoke damage in the shaft and on back of AOVs. Smoke markings on louvre frame indicate AOV was closed during fire.

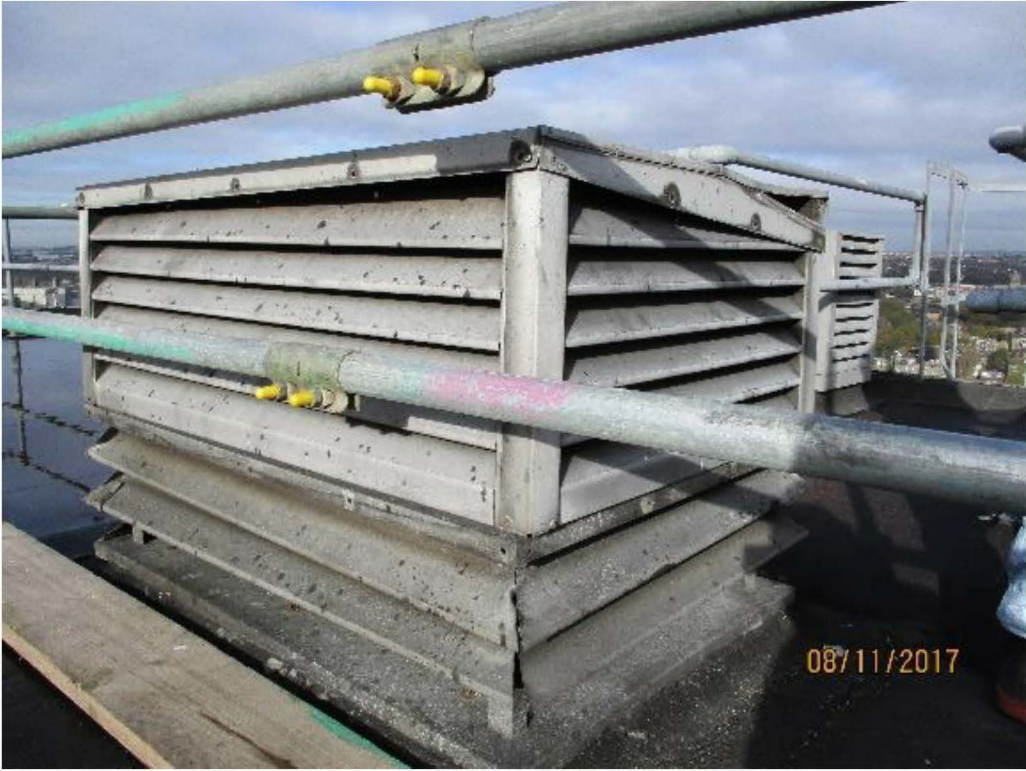
Roof cowl of lobby smoke extract North shaft looking North West Some particulate deposits on the louvres

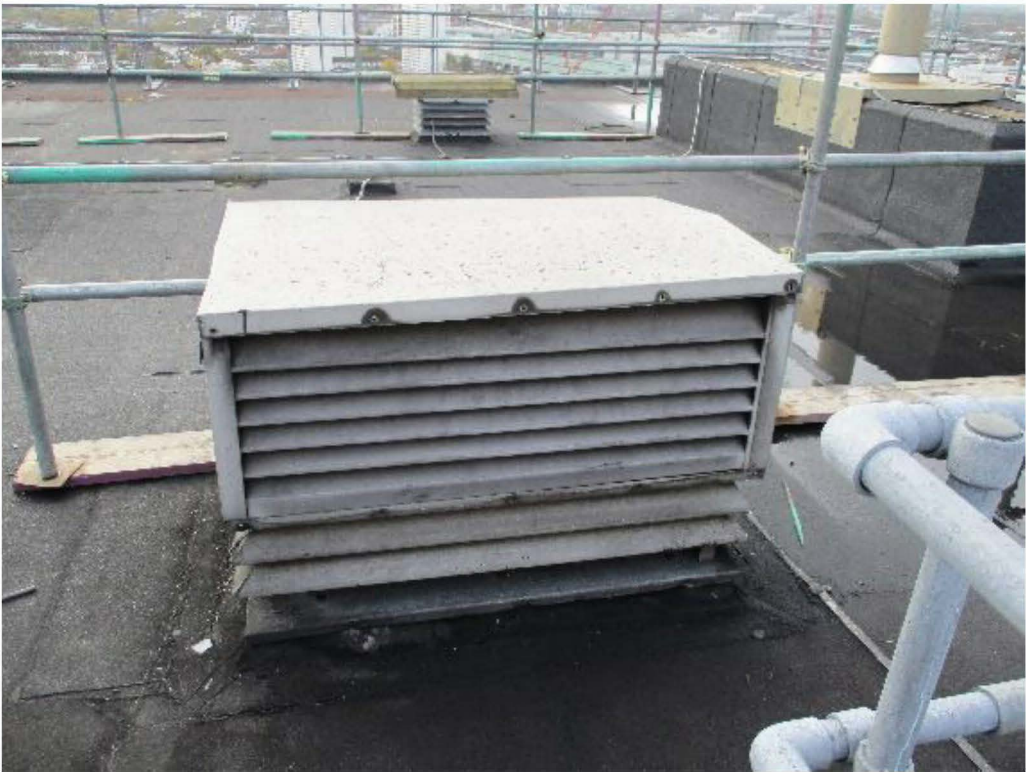
Roof cowl of lobby smoke extract North shaft looking South Some particulate deposits on the louvres

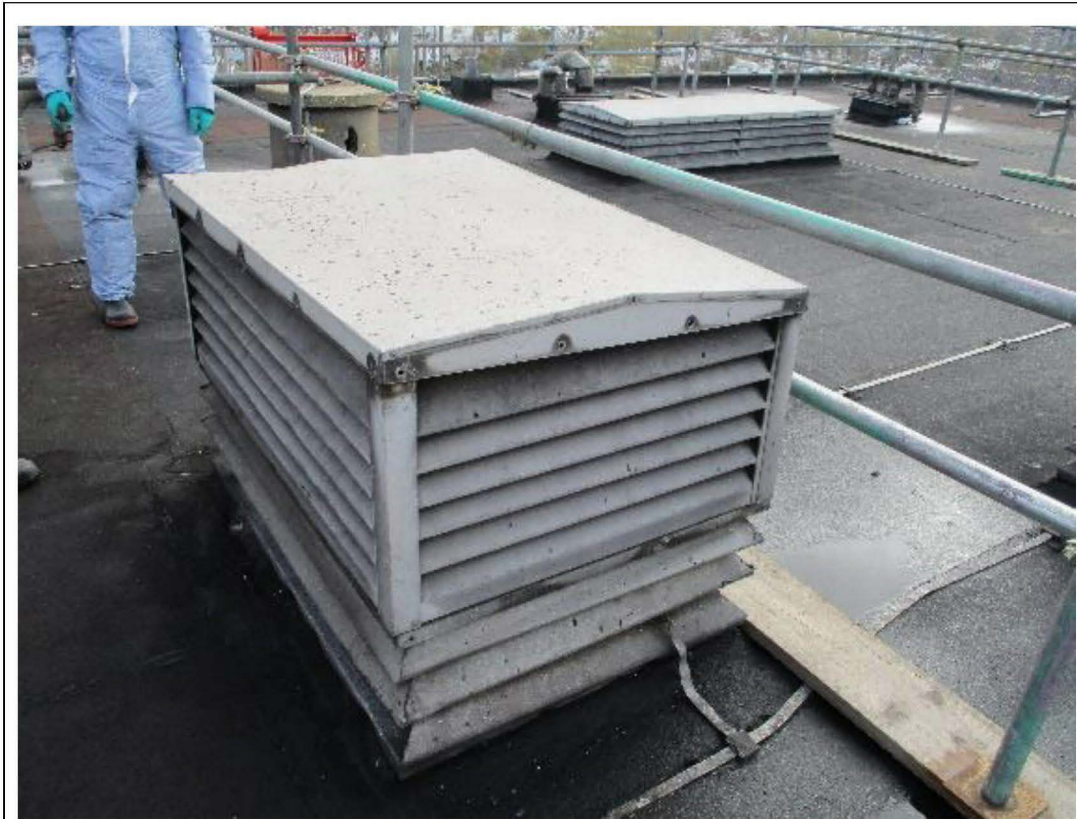
<p>Roof cowl of lobby smoke extract North shaft looking South-East Some particulate deposits on the louvres</p>

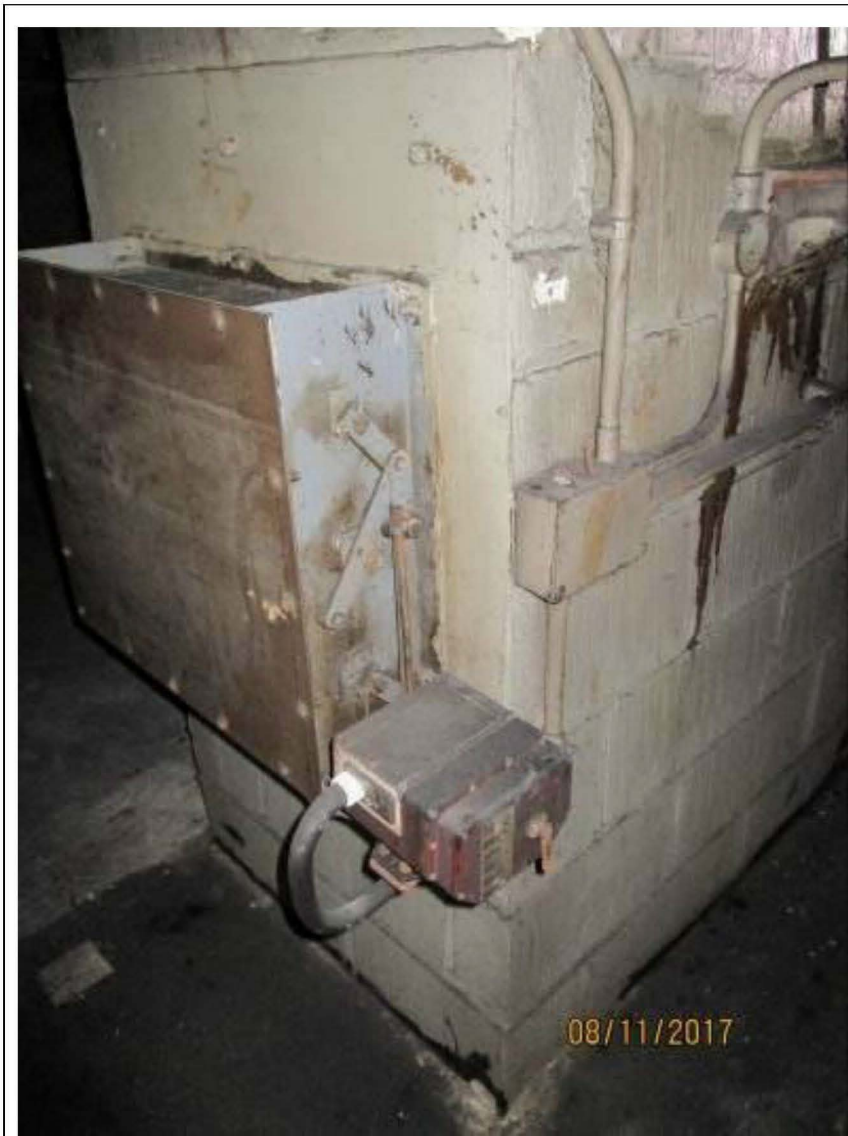
Motorised damper blanked off on smoke extract shaft

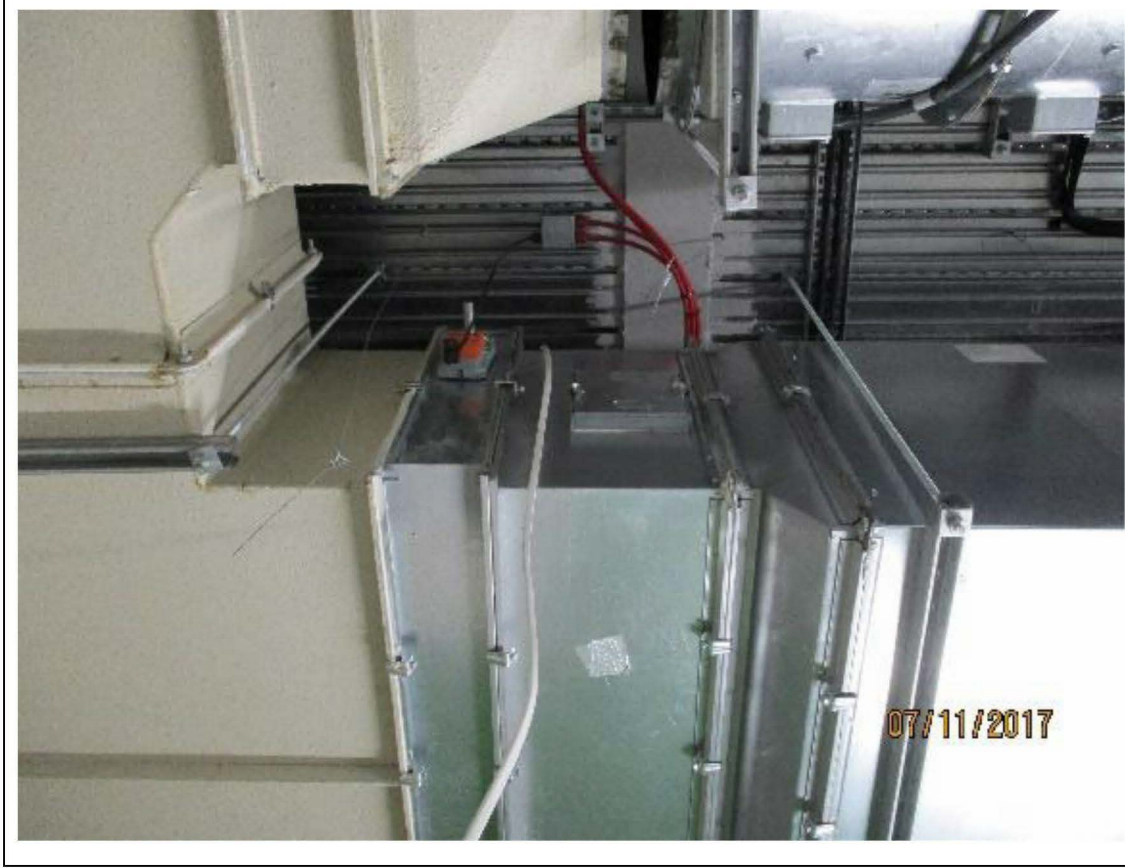
<p>Motorised damper for environmental supply fan branch cabling intact, and fire rated to junction box</p>

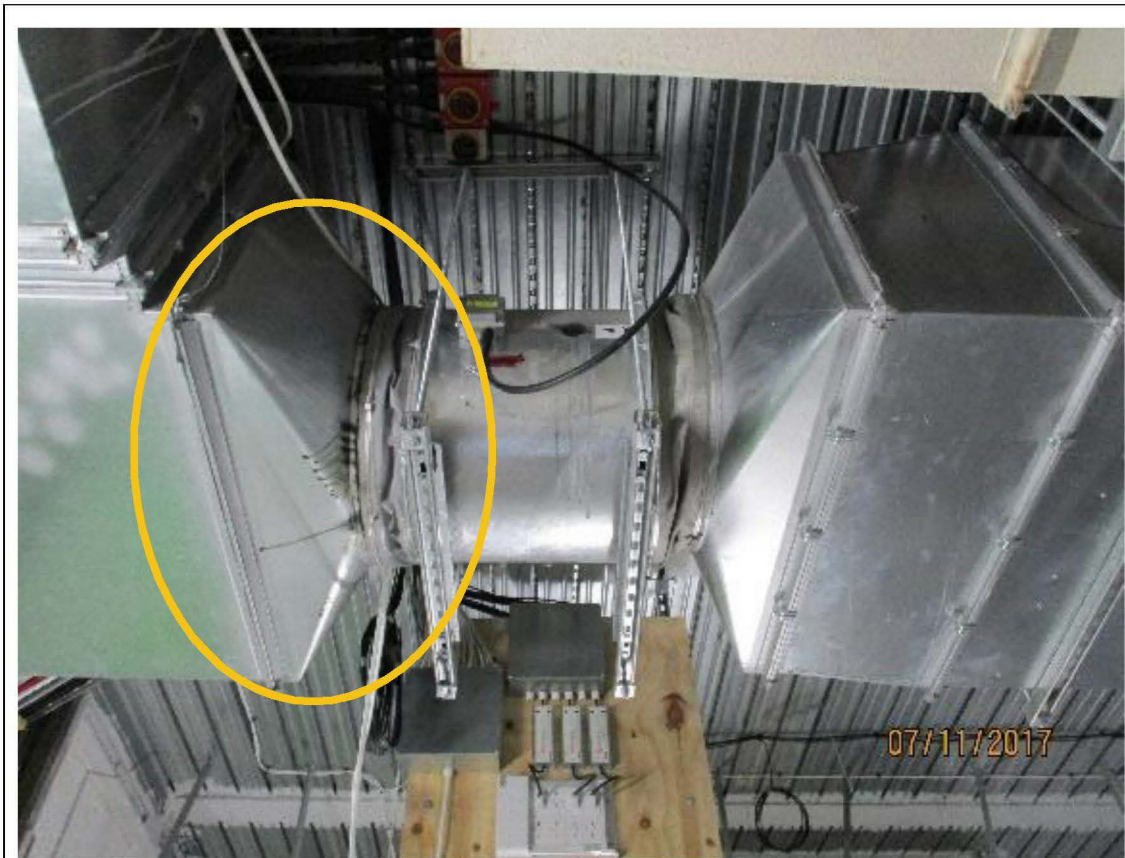
Environmental supply fan, evidence of soot at the flexible connection on discharge side of fan, would indicate fan was running

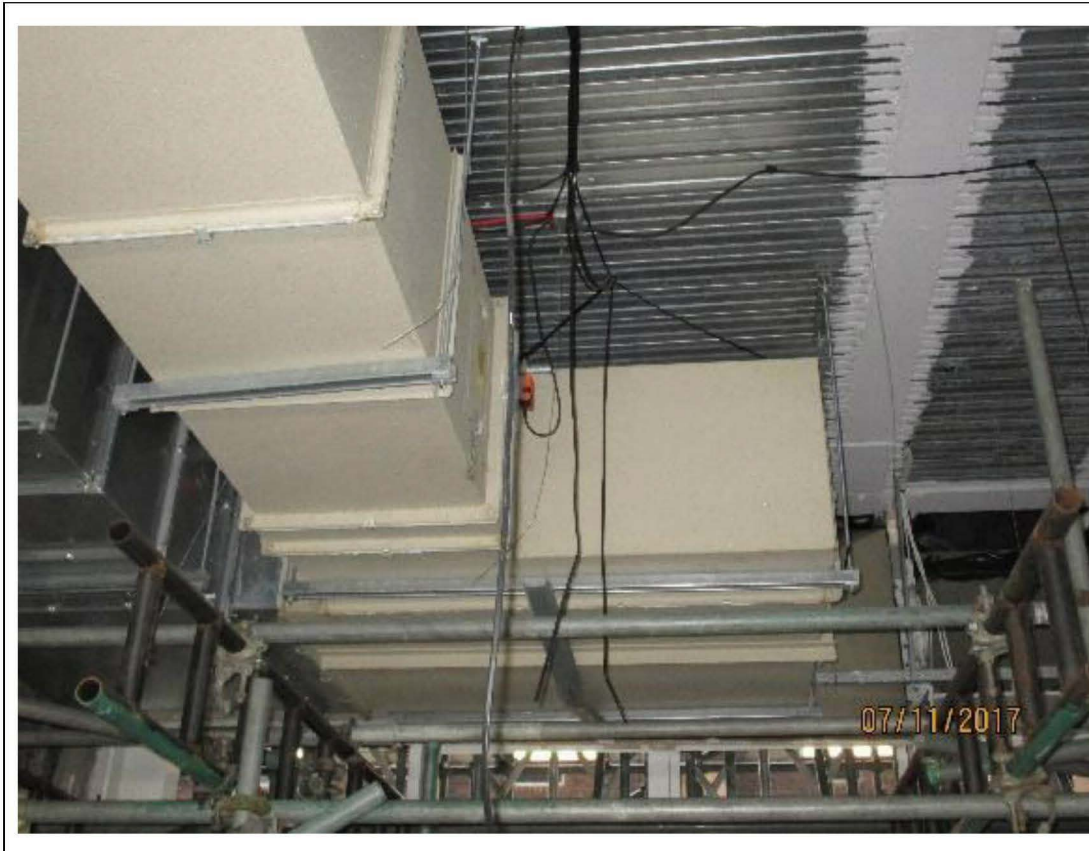
<p>Smoke extract ductwork discharges to external at high level on level 2</p>

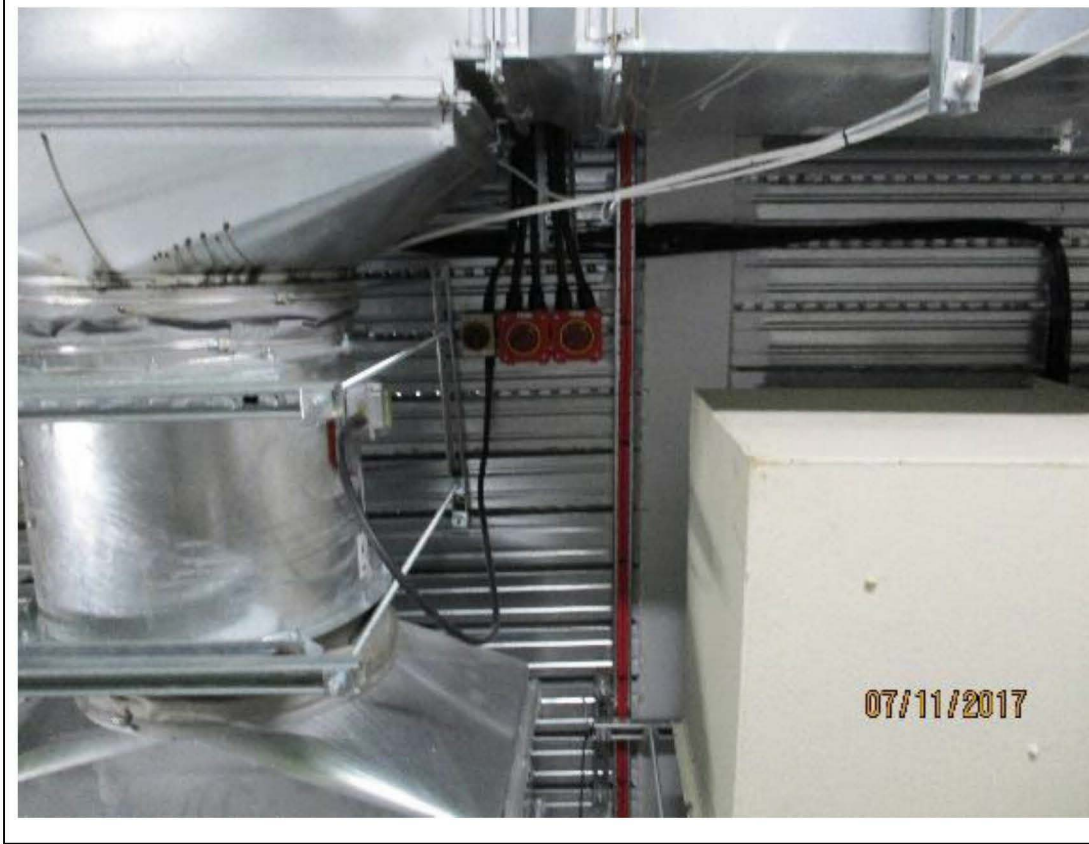
<p>Electrical isolators for the environmental supply fan and the smoke extract fans.</p>

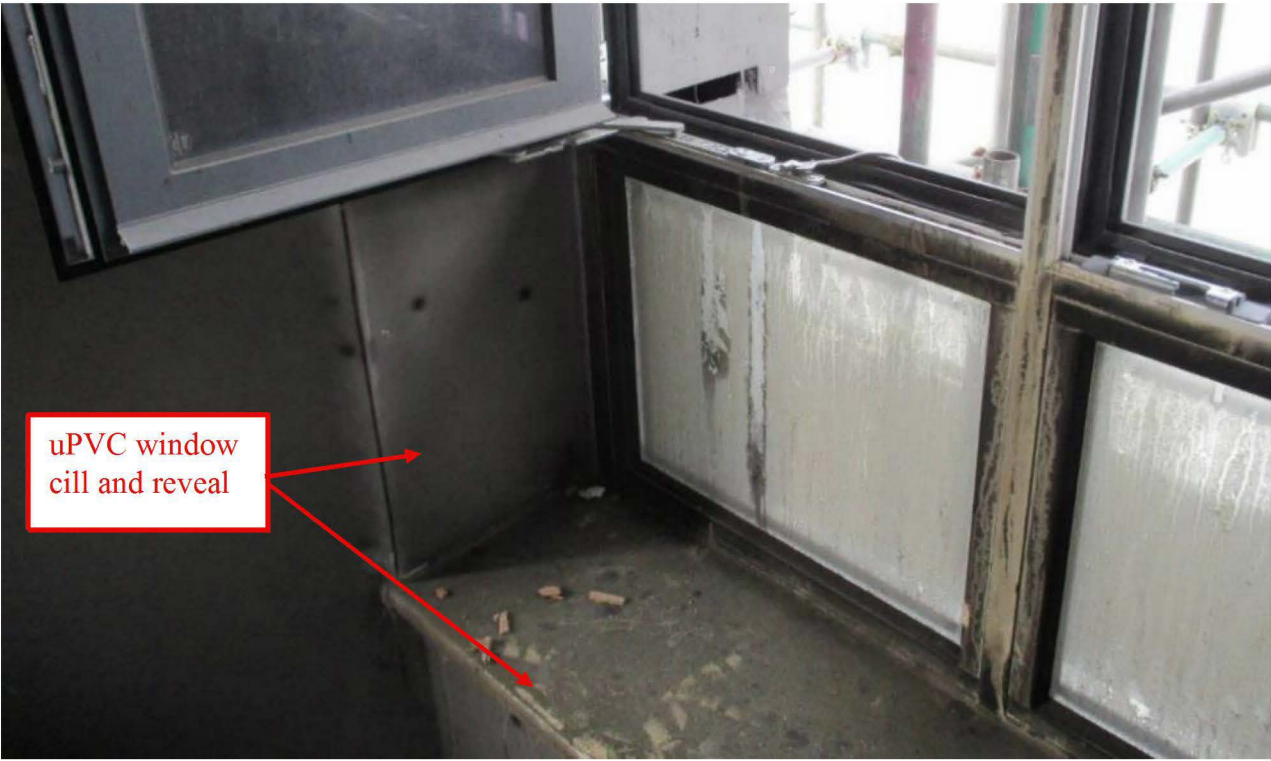
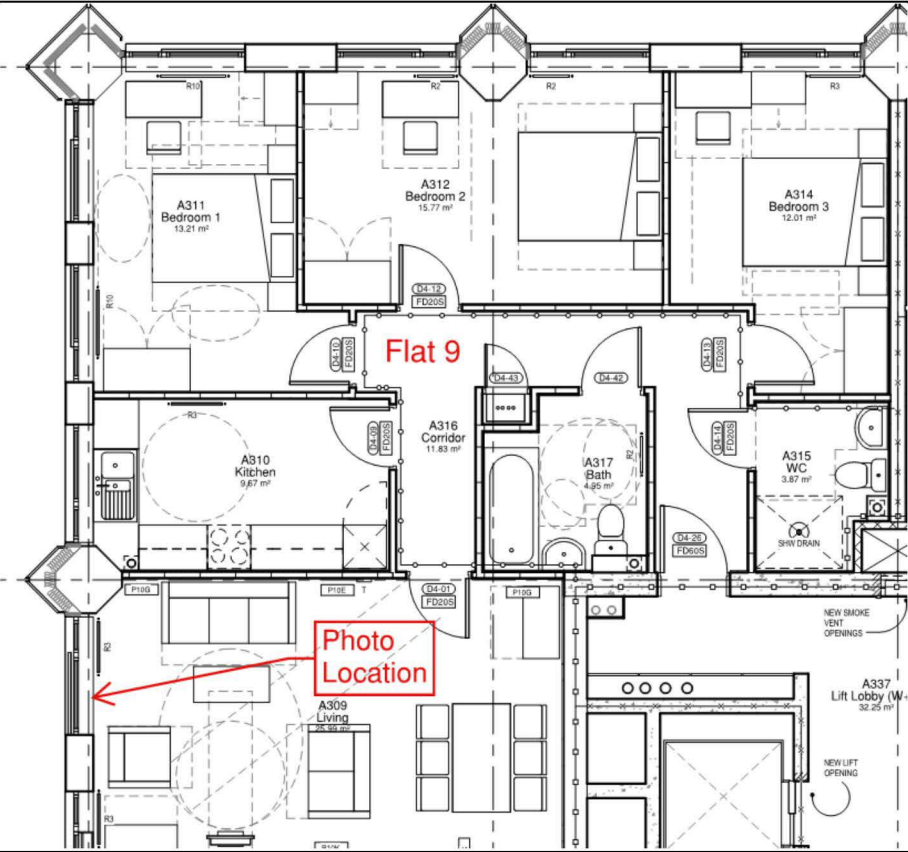
Floor	Flat	Window Linings in place	Thermal Insulation visible?	Photograph	Location
3	9	Yes	No - I was not able to inspect behind the window linings

<div>uPVC window cill and reveal</div>

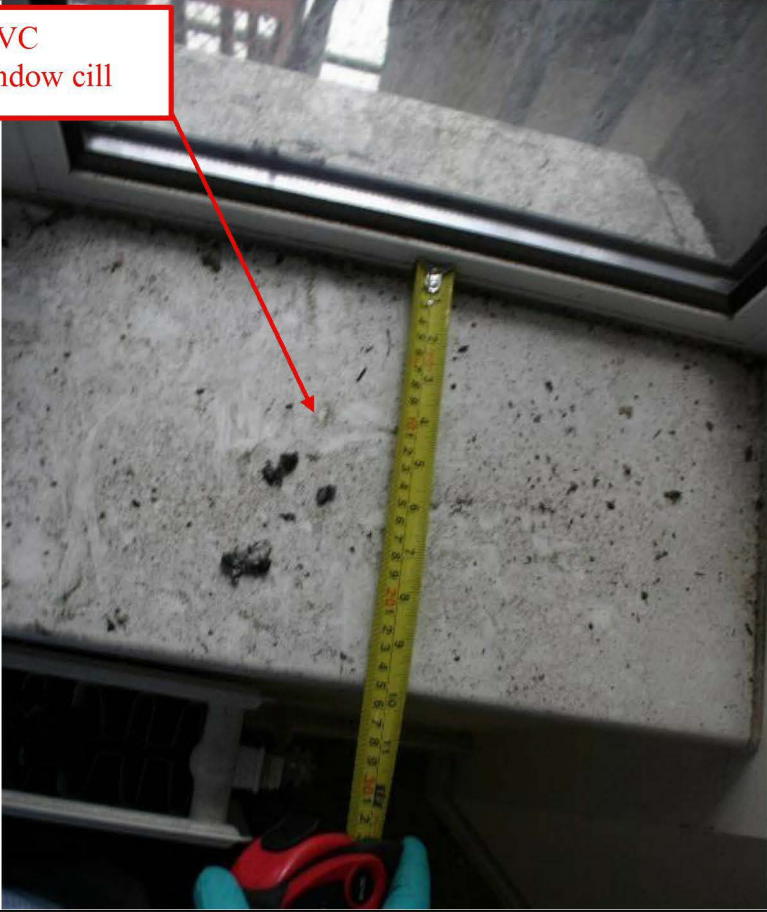
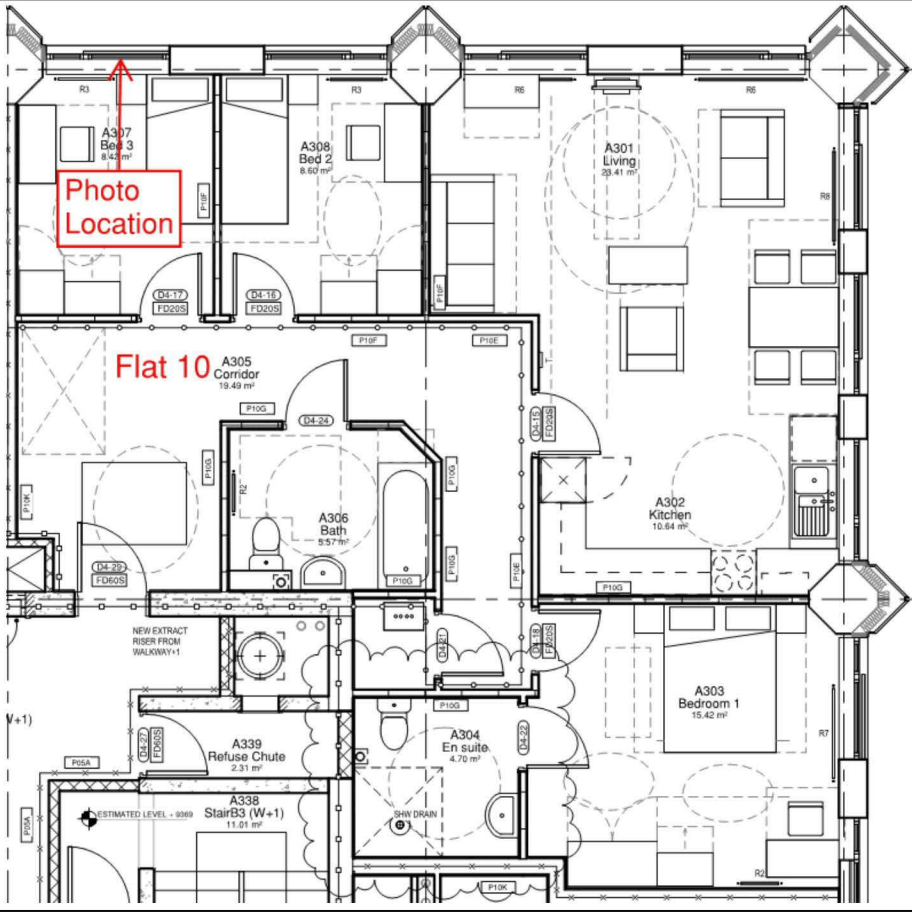
Floor	Flat	Window Linings in place	Thermal Insulation visible?	Photograph	Location
3	10	Yes	No - I was not able to inspect behind the window linings	<div><div>uPVC window cill</div>

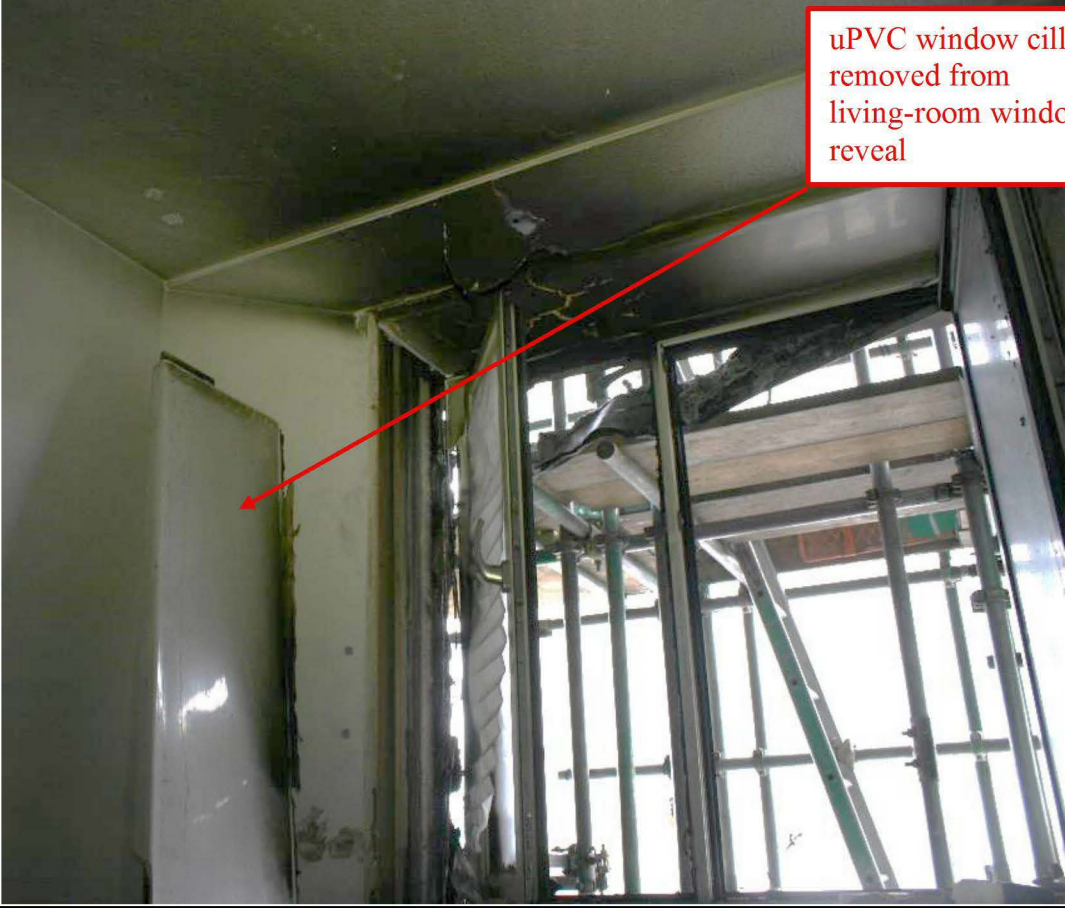
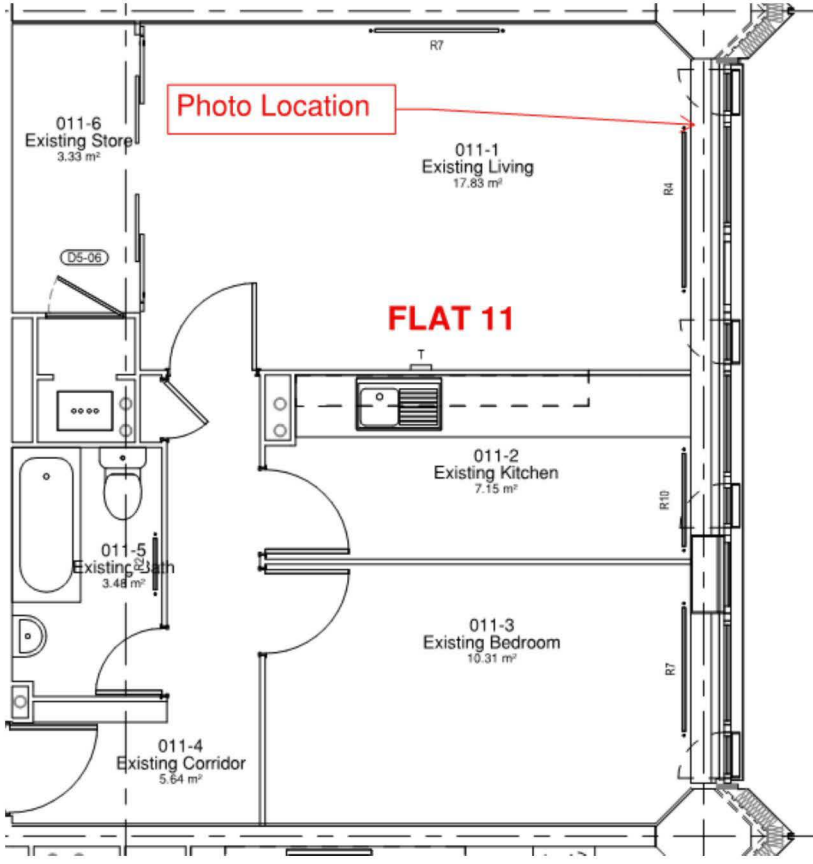
Floor	Flat	Window Linings in place	Thermal Insulation visible?	Photograph	Location
4	11	Yes. In place, except from the living room window reveal.	No - I was not able to inspect behind the window linings	<div>

<div>uPVC window cill removed from living-room window reveal</div></div>	<div>

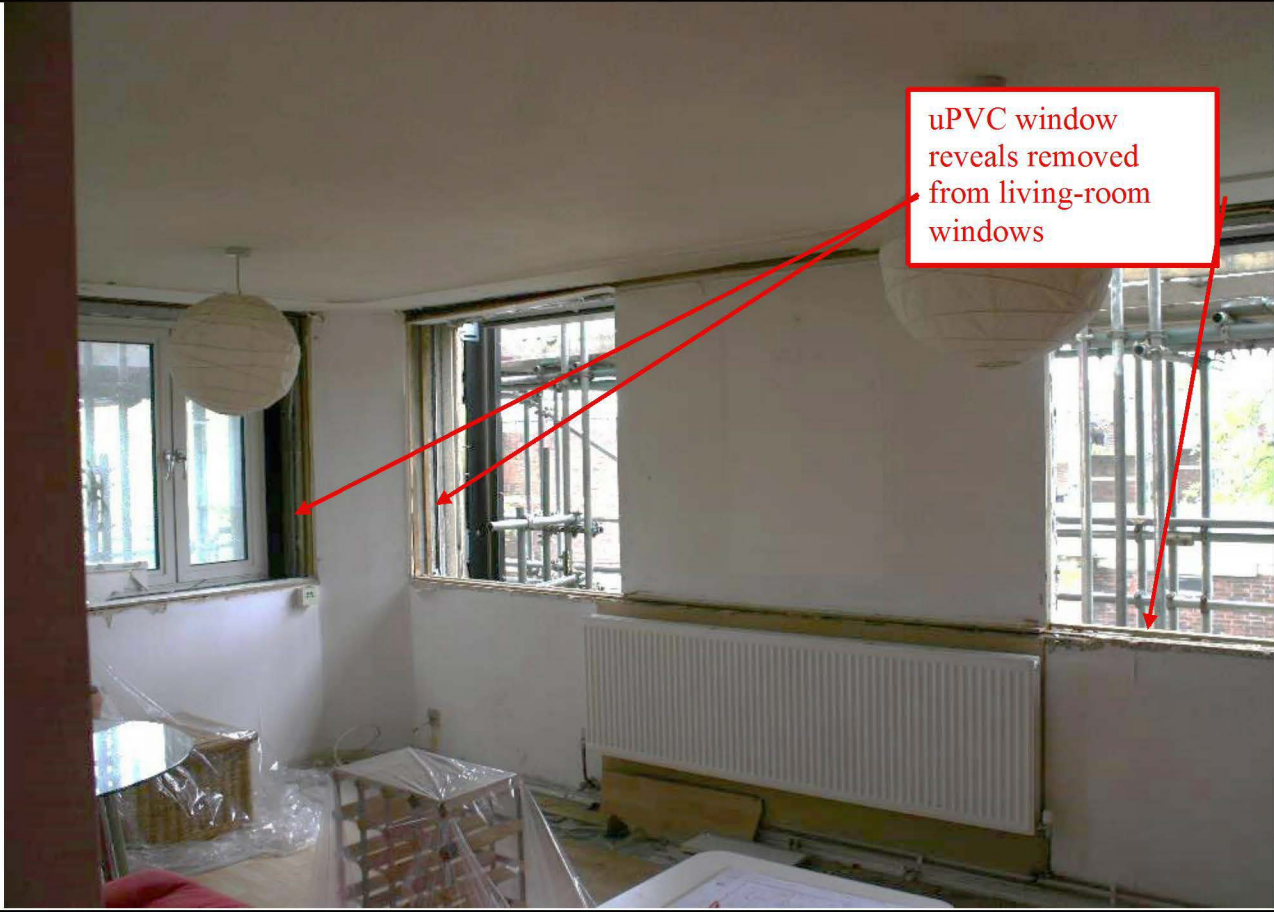
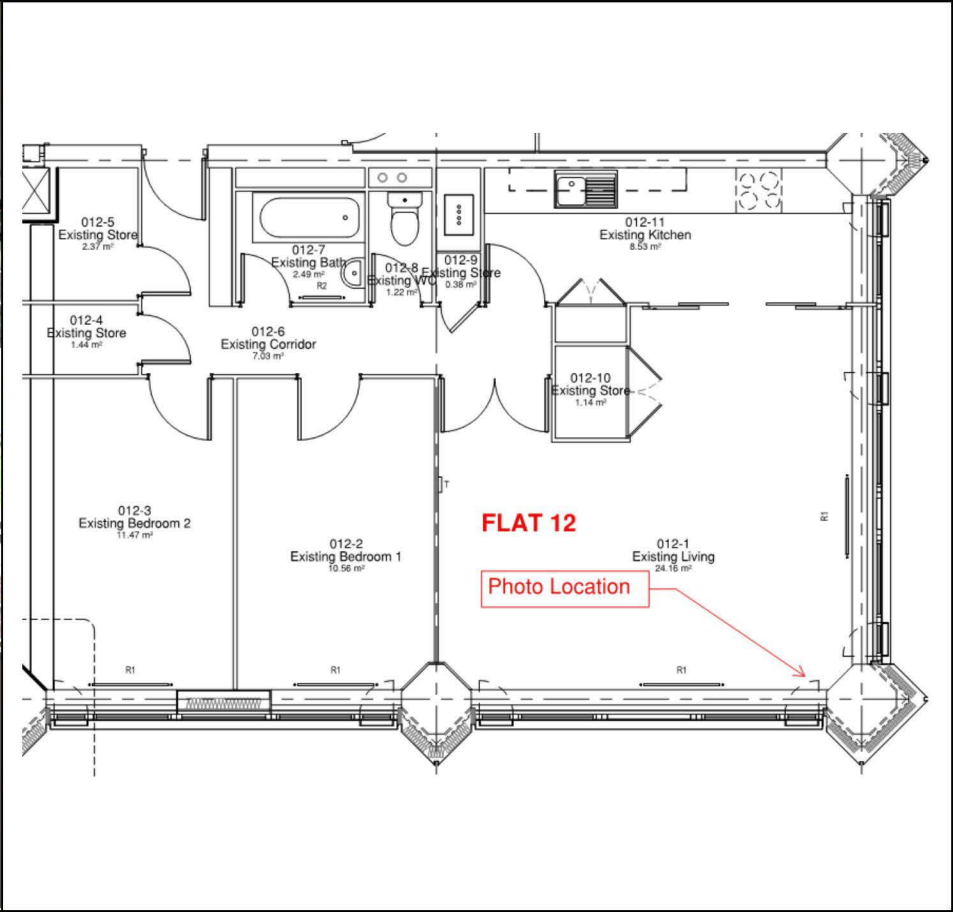
Floor	Flat	Window Linings in place	Thermal Insulation visible?	Photograph	Location
4	12	No. All finishes removed from windows and flat.	No – All window linings removed from windows and flat

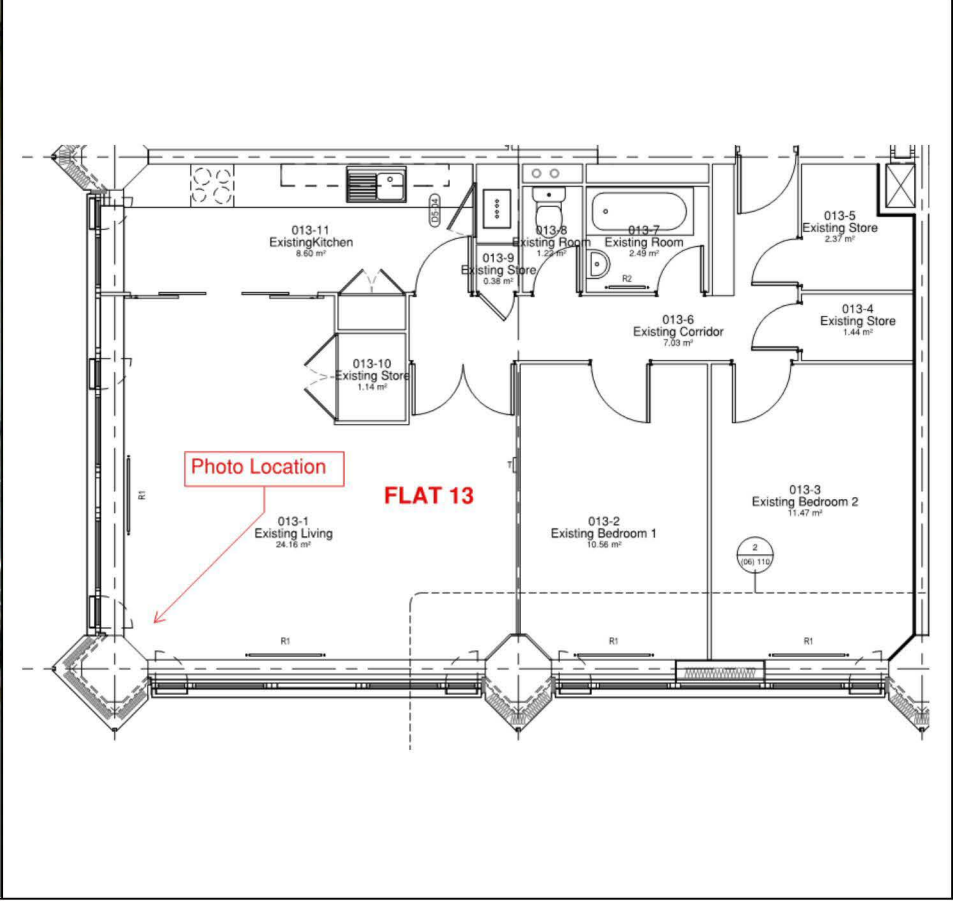
Floor	Flat	Window Linings in place	Thermal Insulation visible?	Photograph	Location
4	13	No. All finishes removed from windows and flat	No – All window linings removed from window and flat	  <div>uPVC window cills removed from living-room windows</div>

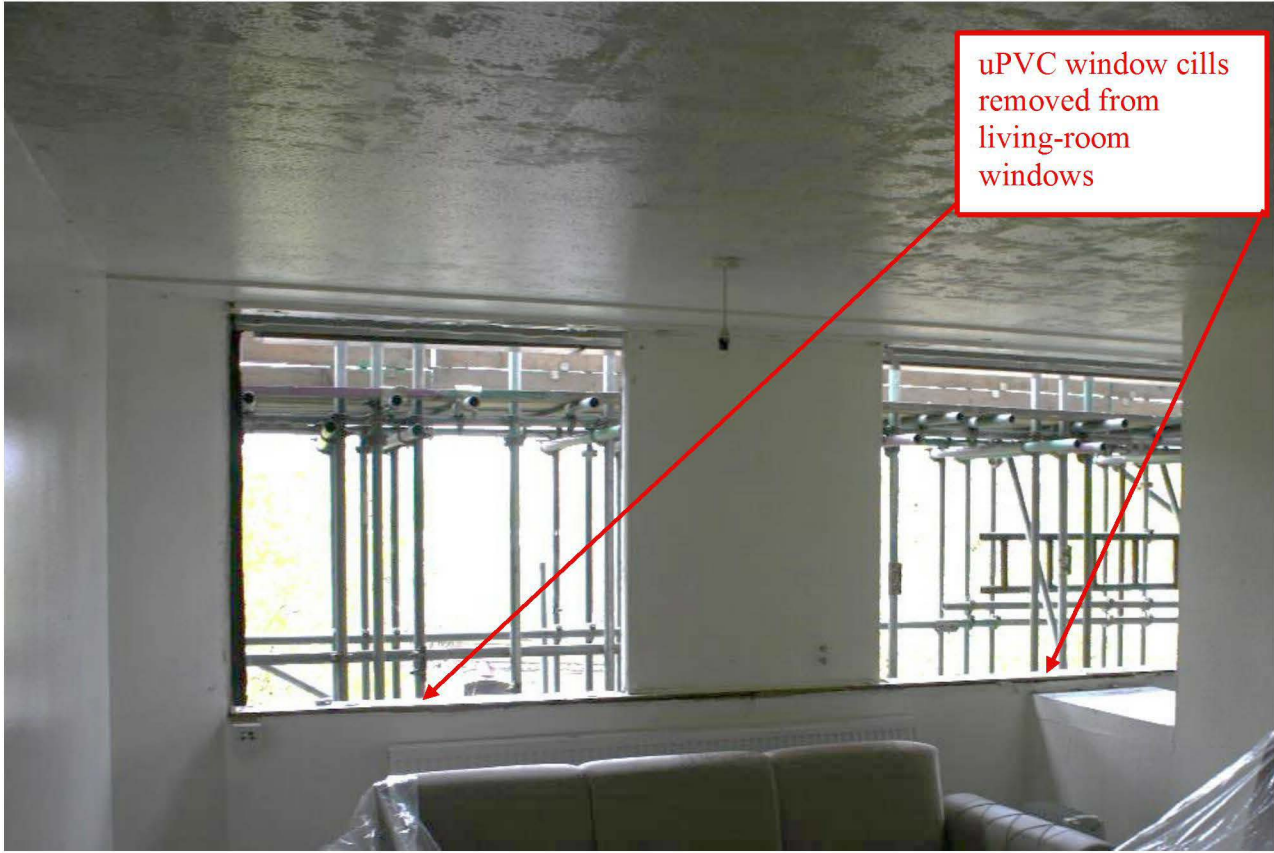
Floor	Flat	Window Linings in place	Thermal Insulation visible?	Photograph	Location
4	14	No. All finishes removed from windows and flat.	No – All window linings removed from window and flat

<div>uPVC window cills removed from living-room windows</div>	  <div>FLAT 14</div> <div>014-1 Existing Living 18.02 m²</div> <div>014-2 Existing Kitchen 7.15 m²</div> <div>014-3 Existing Bedroom 1 10.47 m²</div> <div>014-4 Existing Corridor 5.70 m²</div> <div>014-5 Existing Bath 3.46 m²</div> <div>014-6 Existing Store 3.36 m²</div> <div>Photo Location</div>
