Grenfell Tower – fire safety investigation:
The fire protection measures in place on the night of the fire, and conclusions as to:
the extent to which they failed to control the spread of fire and smoke;
the extent to which they contributed to the speed at which the fire spread.

Phase 1 Report – Appendix C

Excerpts from site inspection records

Dr Barbara Lane FREng CEng

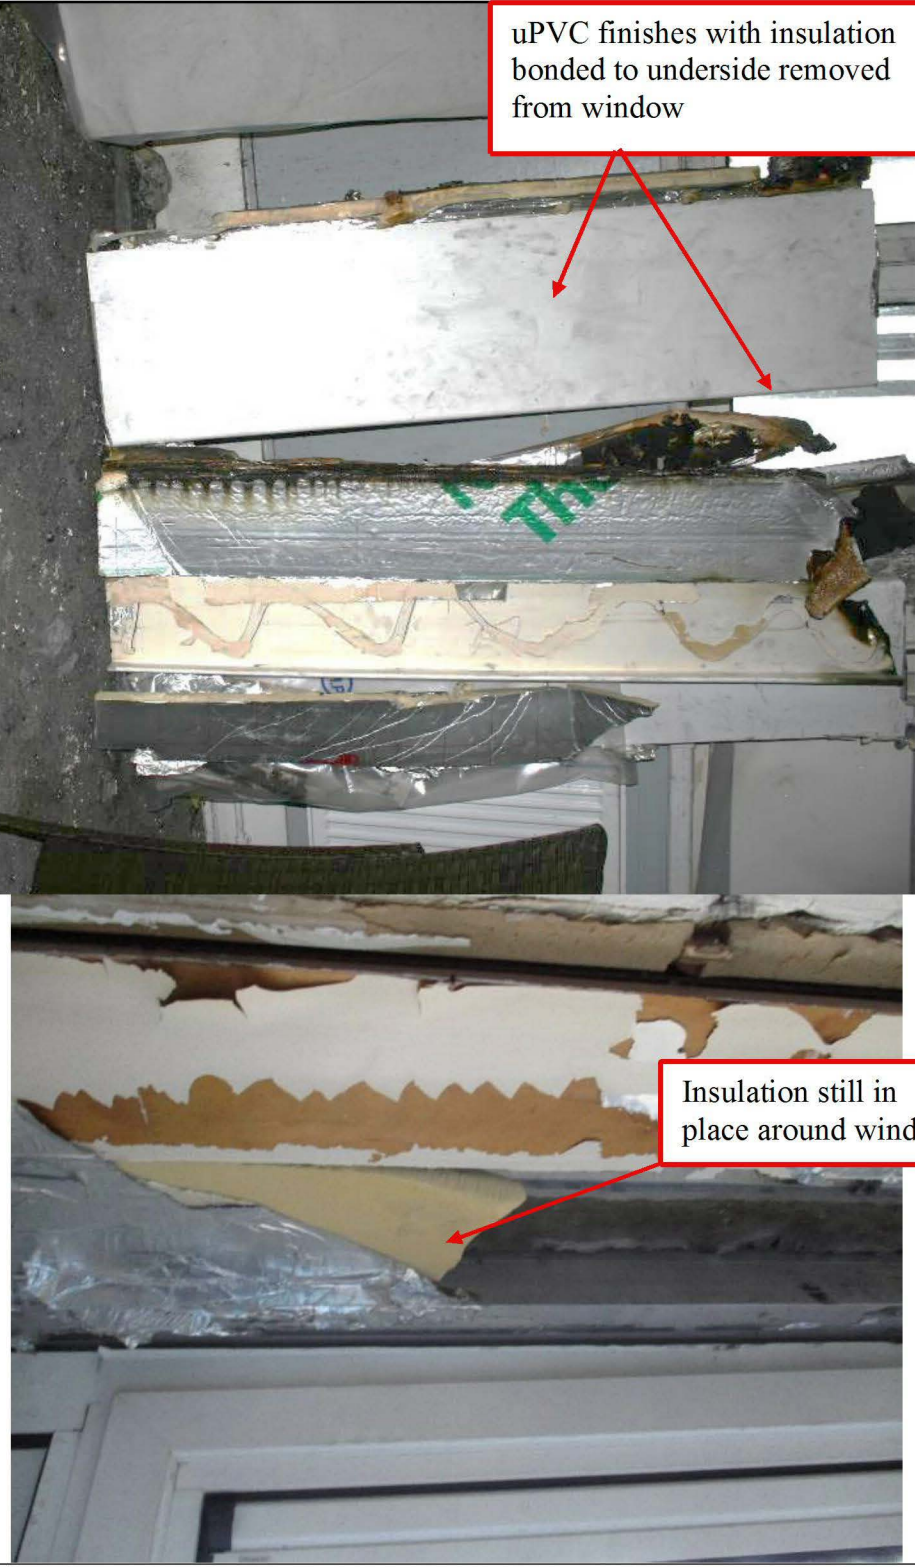
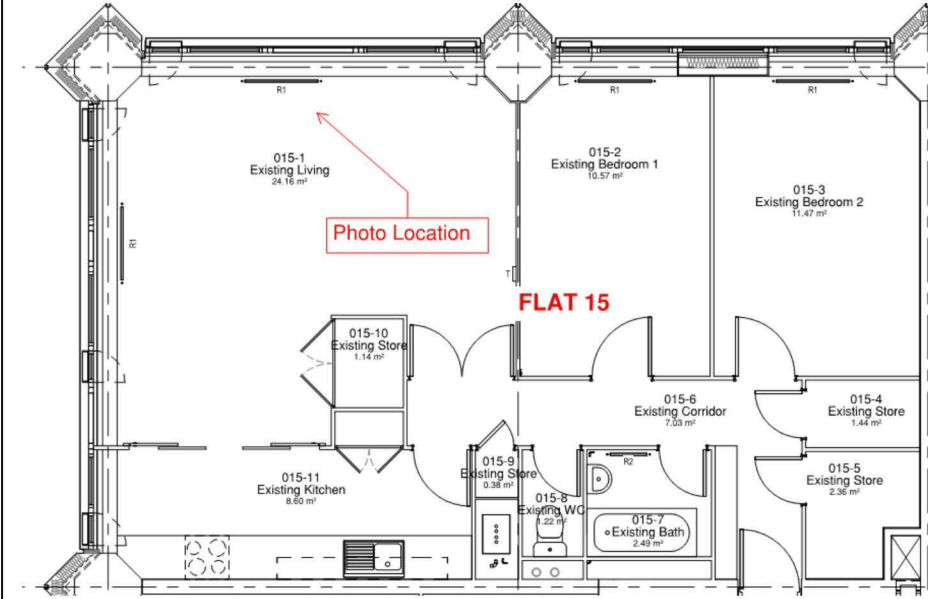
Floor	Flat	Window Linings in place	Thermal Insulation visible?	Photograph	Location
4	15	No. All finishes removed from around the window. Some insulation still in place.	Yes – linings removed and set next to Window	<div>

<p>uPVC finishes with insulation bonded to underside removed from window</p><p>Insulation still in place around window</p></div>	<div>

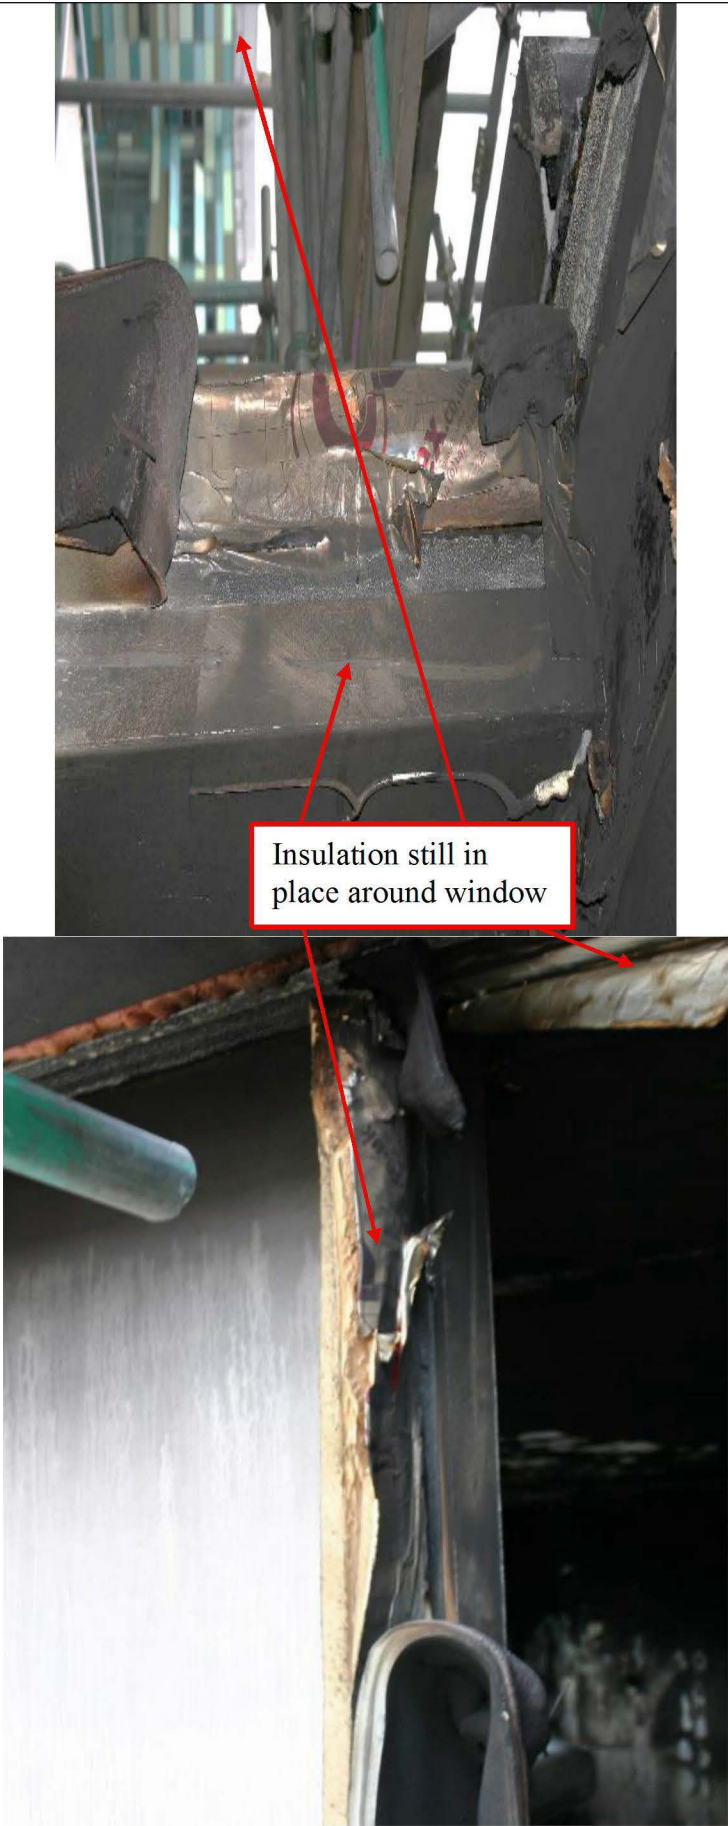
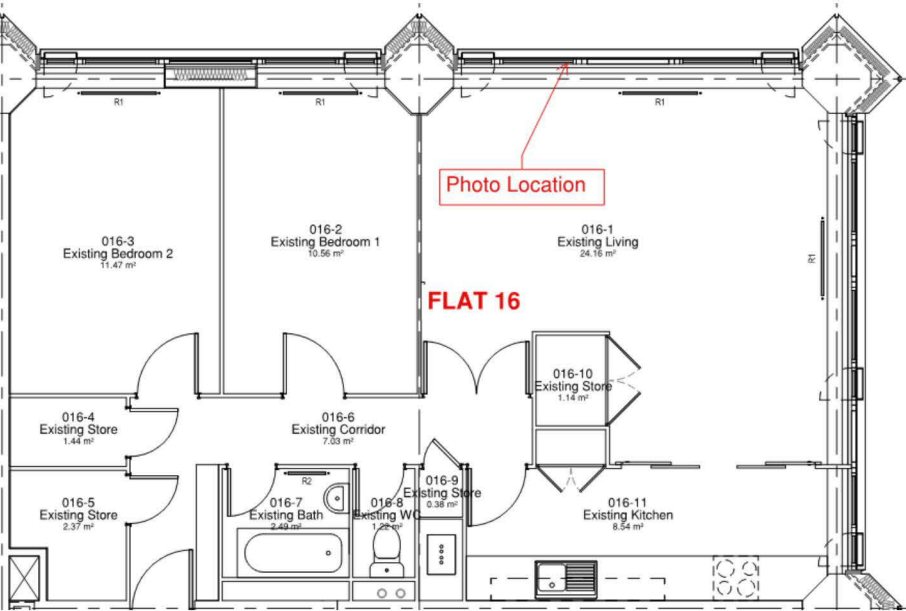
4	16	No. All finishes removed. Some insulation still in place.	Yes	<div>

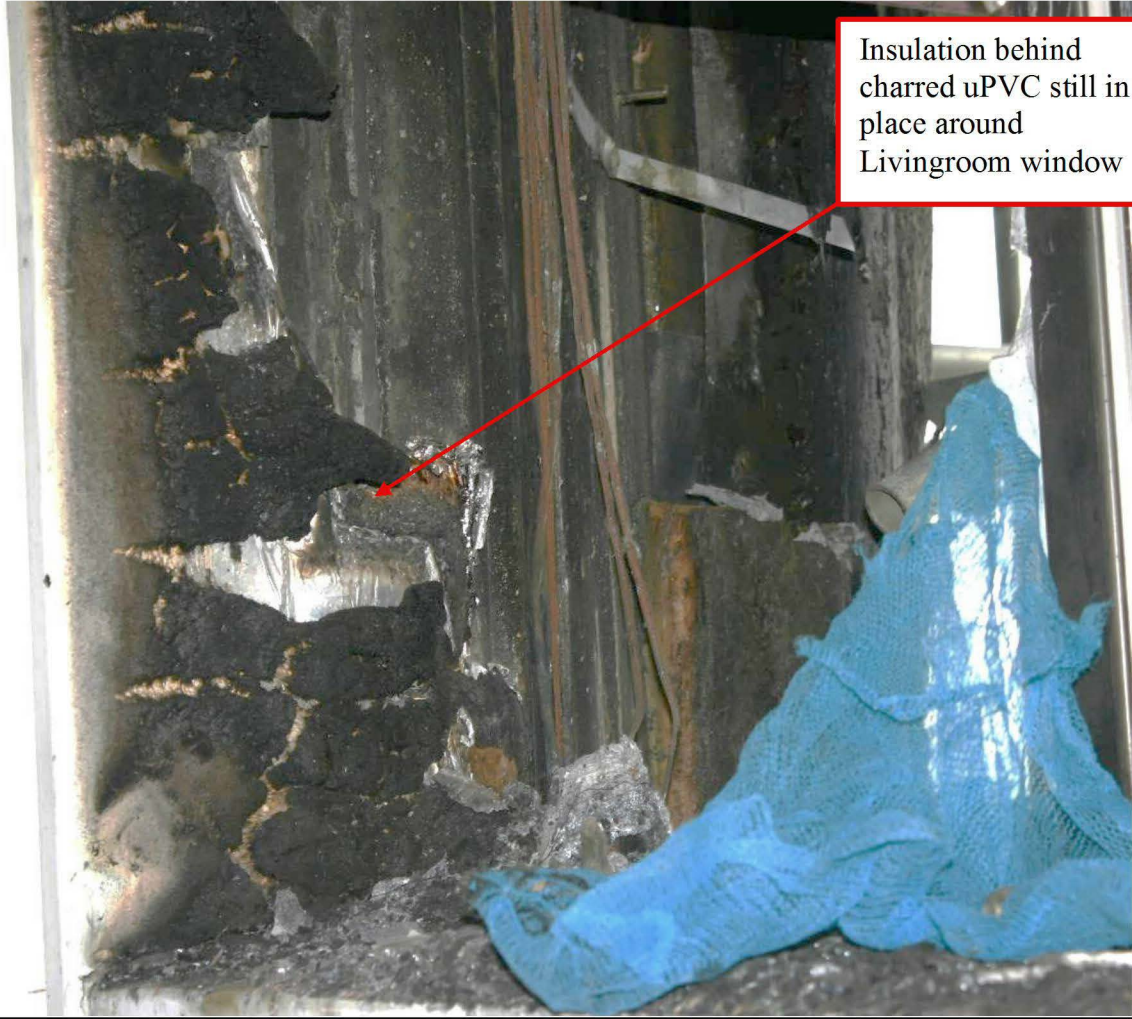
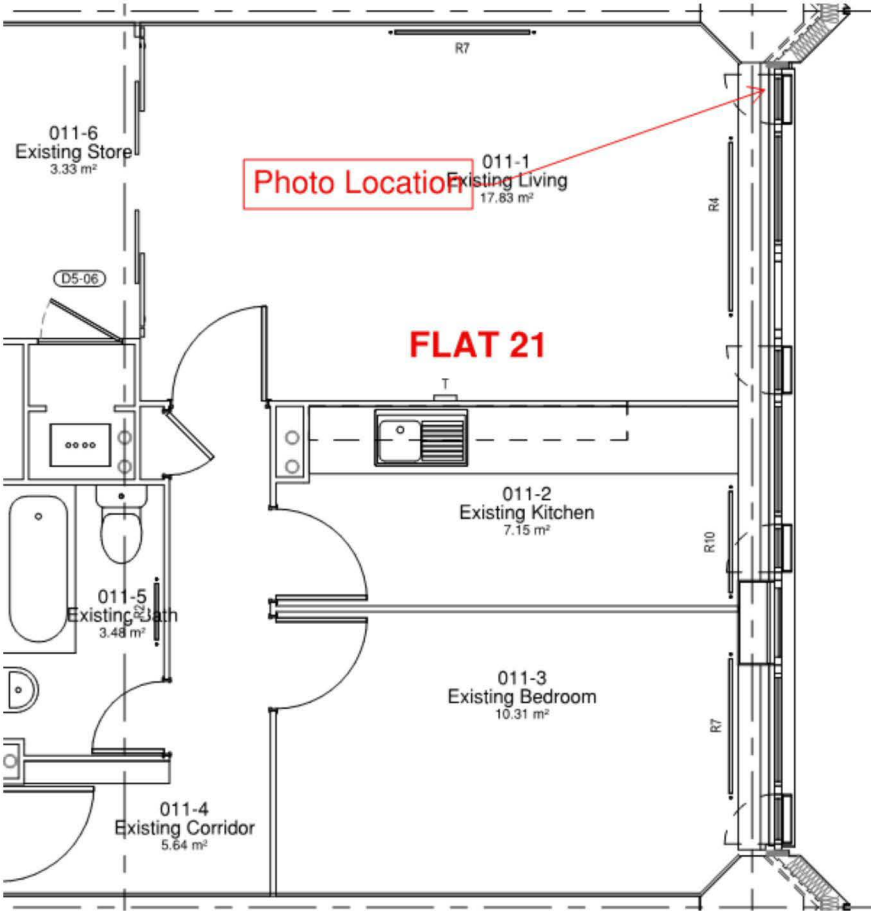
5	21	Yes. In place, though fire damage at Livingroom window reveals insulation around window.	Yes – Insulation visible behind charred uPVC

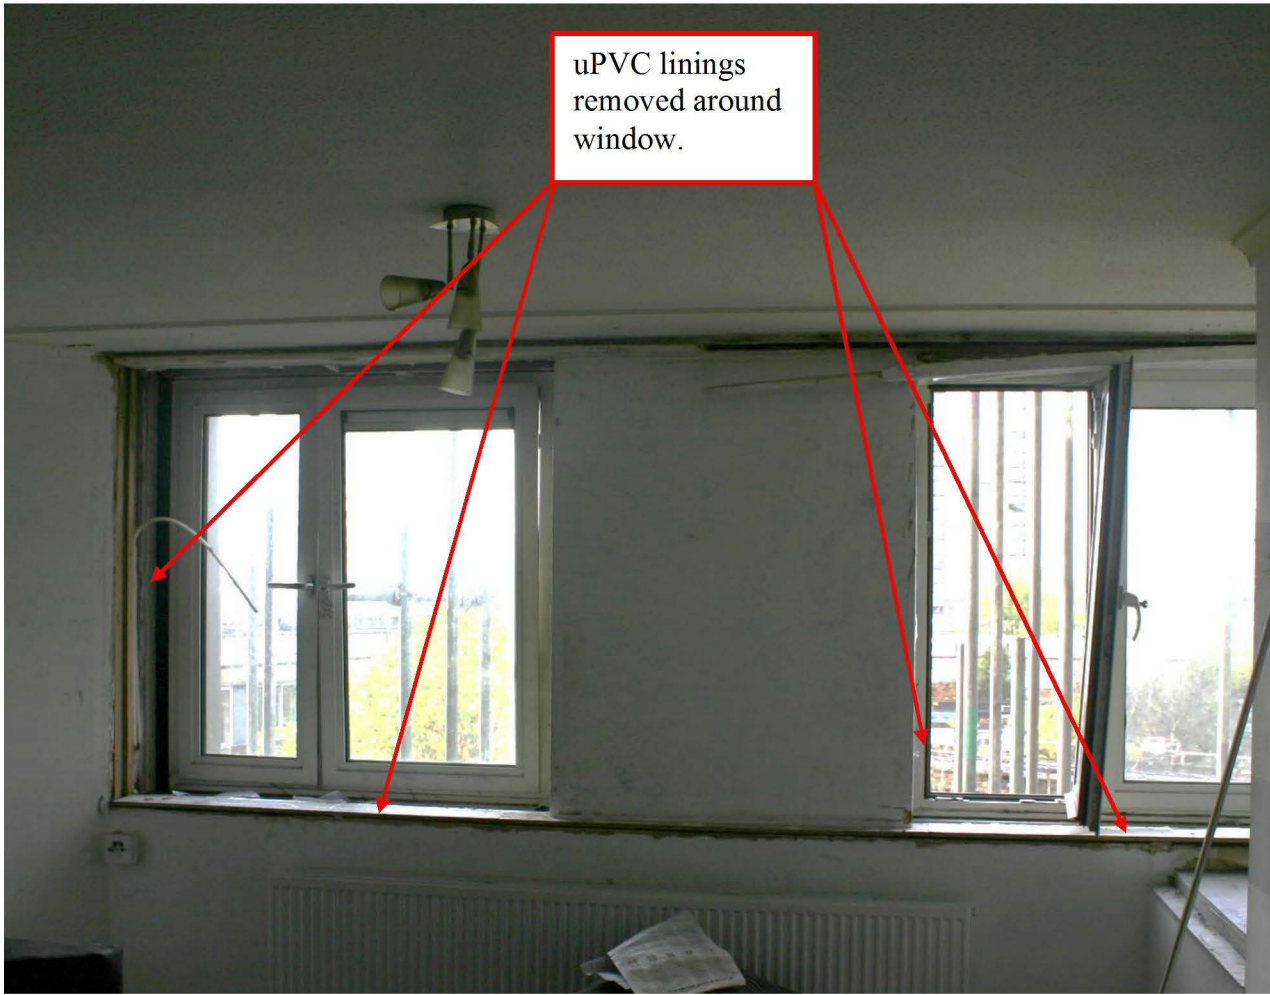
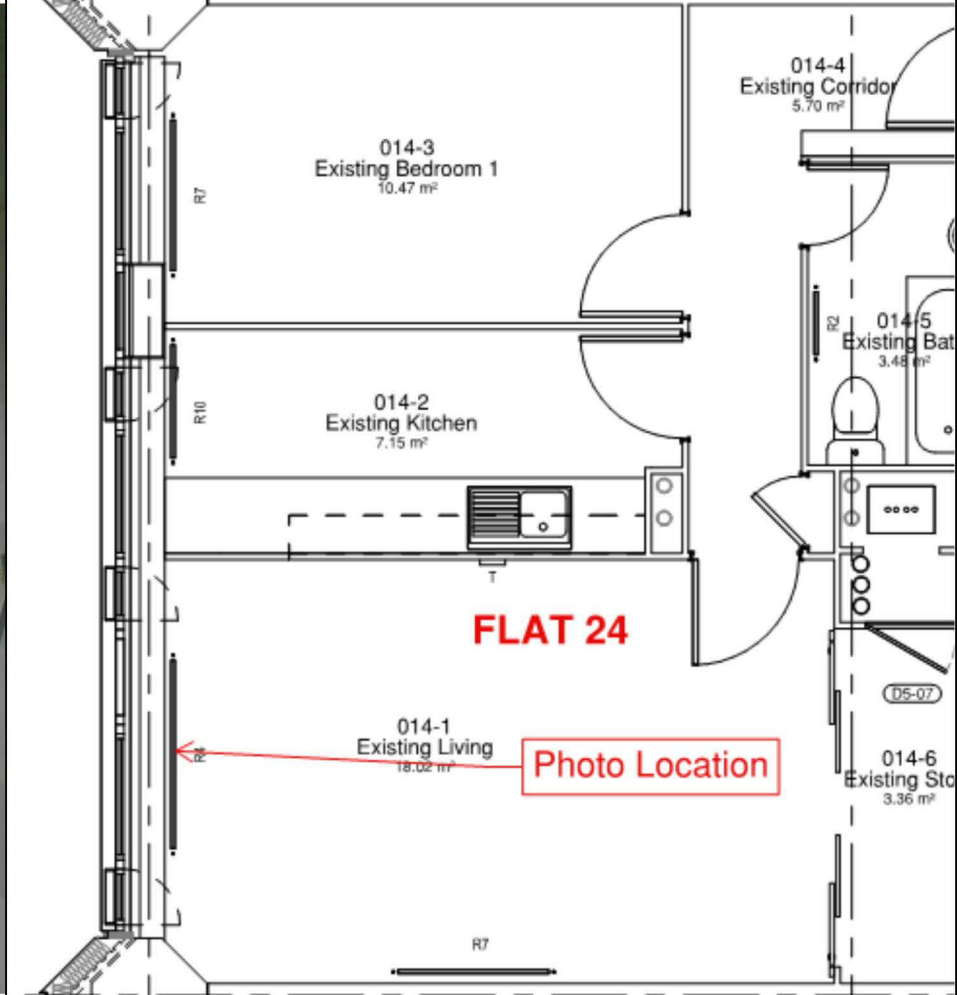
Floor	Flat	Window Linings in place	Thermal Insulation visible?	Photograph	Location
5	24	No. All finishes removed from windows and flat.	No – linings removed from flat

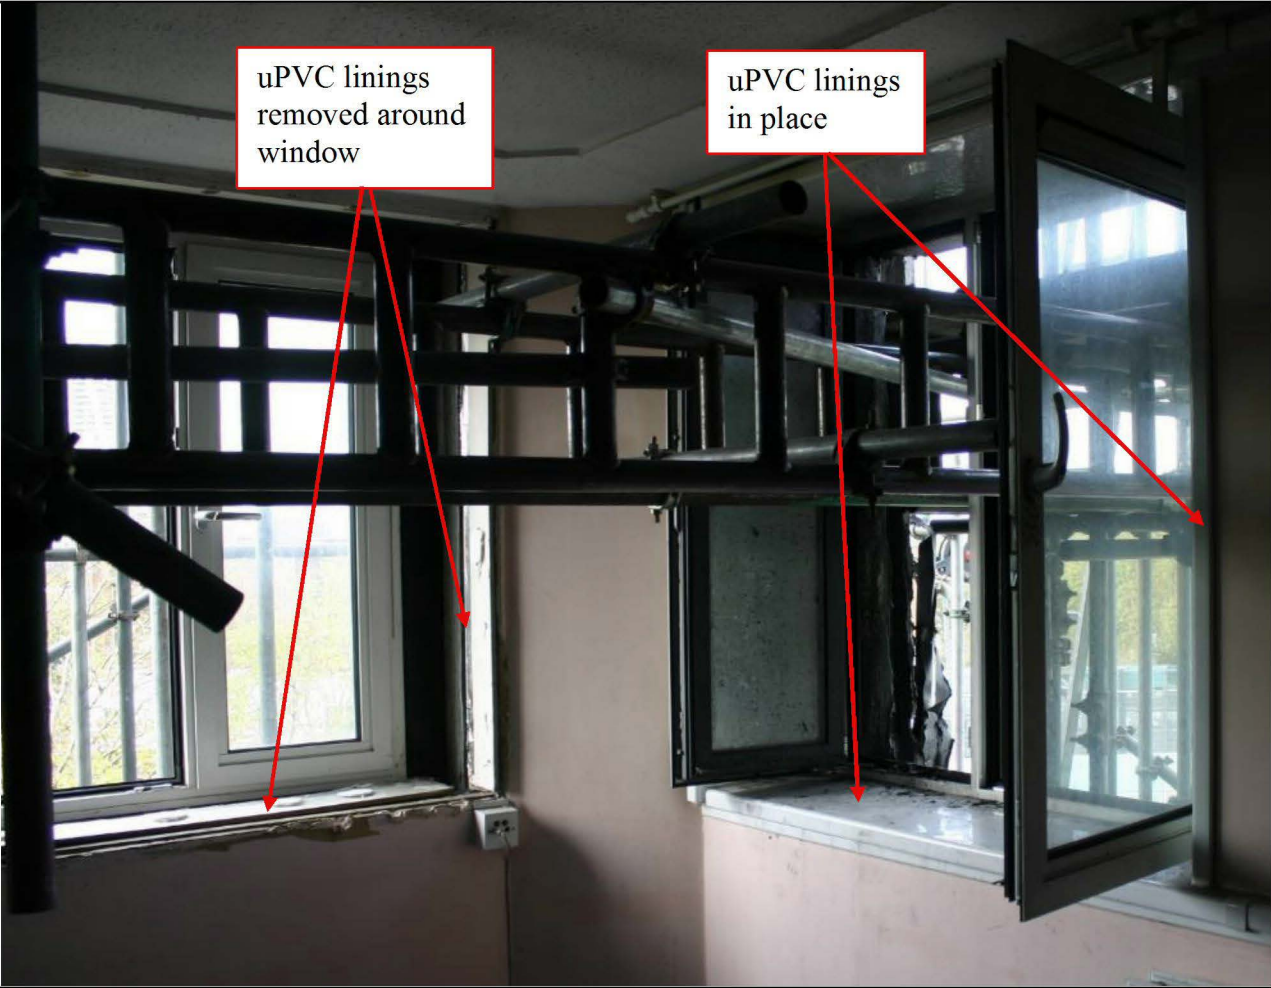
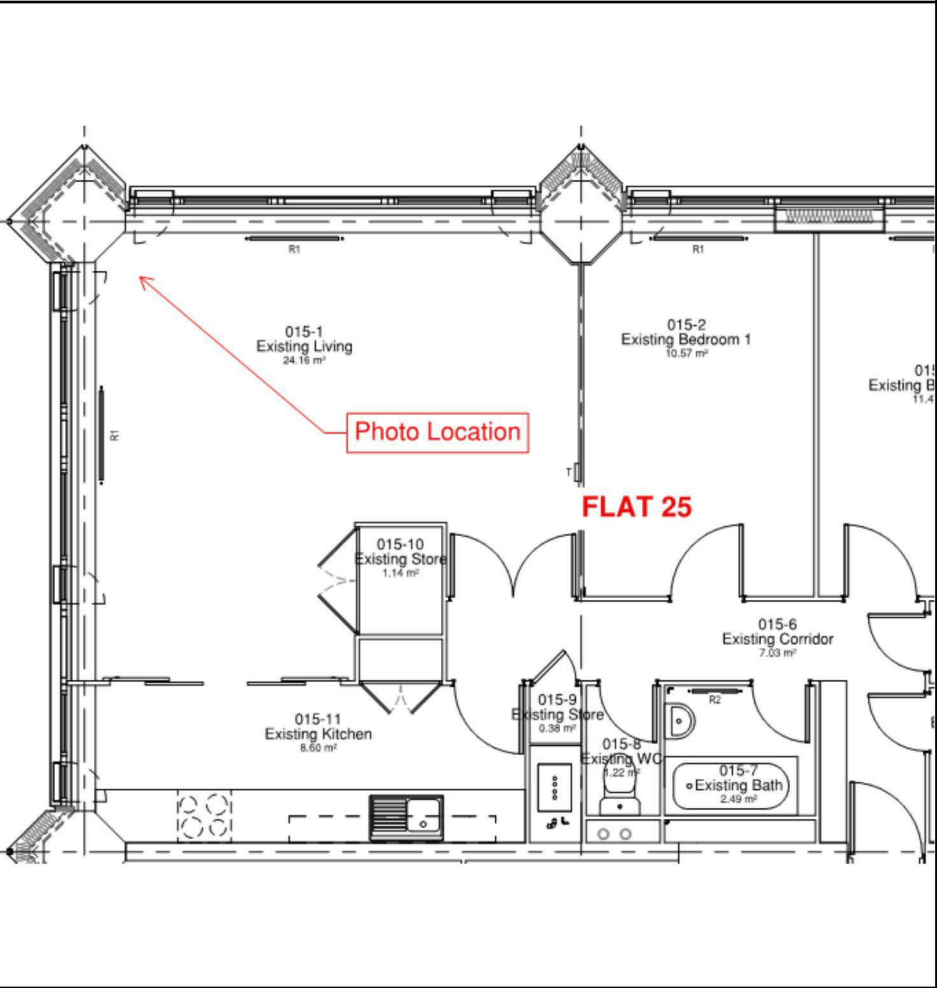
Floor	Flat	Window Linings in place	Thermal Insulation visible?	Photograph	Location
5	25	Partially - linings removed from the Livingroom window. Lining in place within bedrooms.	No – linings removed from flat.

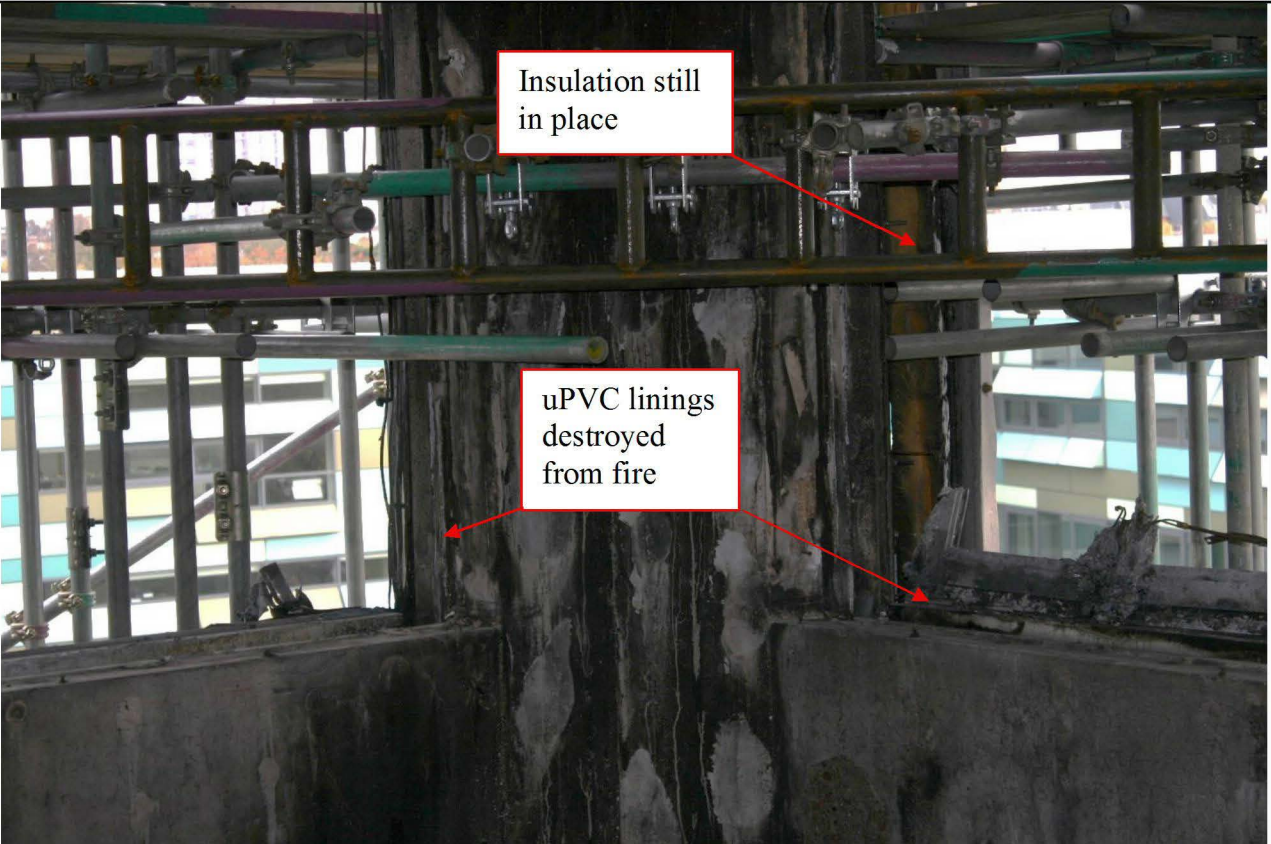
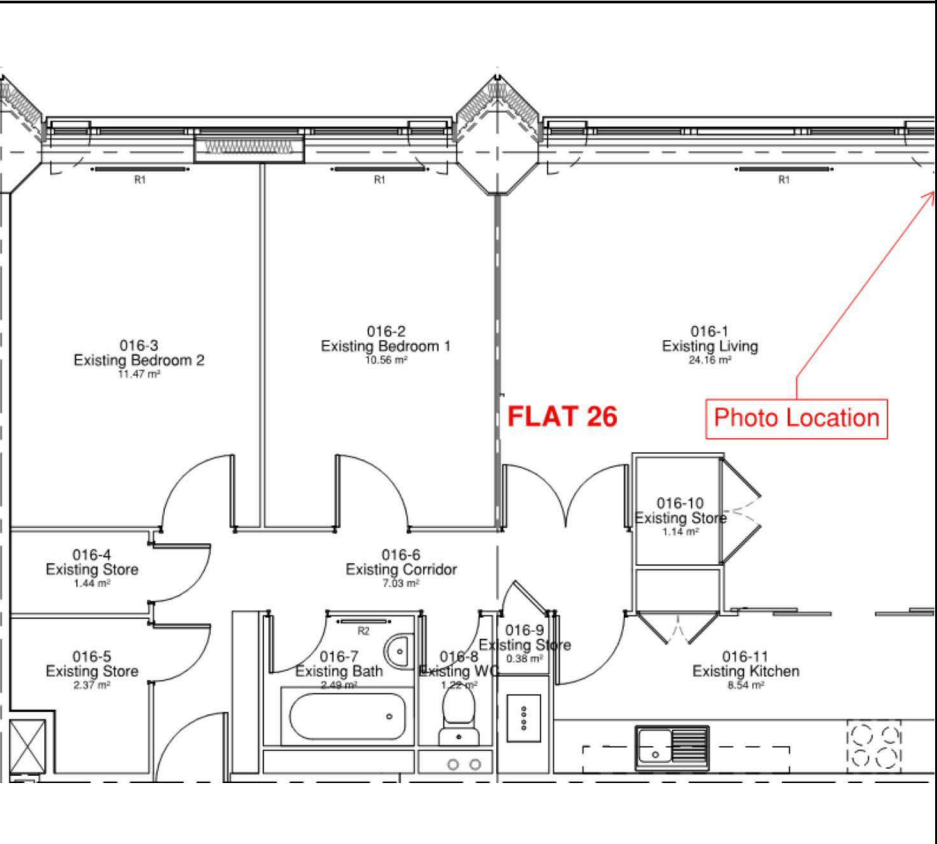
Floor	Flat	Window Linings in place	Thermal Insulation visible?	Photograph	Location
5	26	Finishes destroyed in fire	Yes

<p>Insulation still in place</p> <p>uPVC linings destroyed from fire</p>

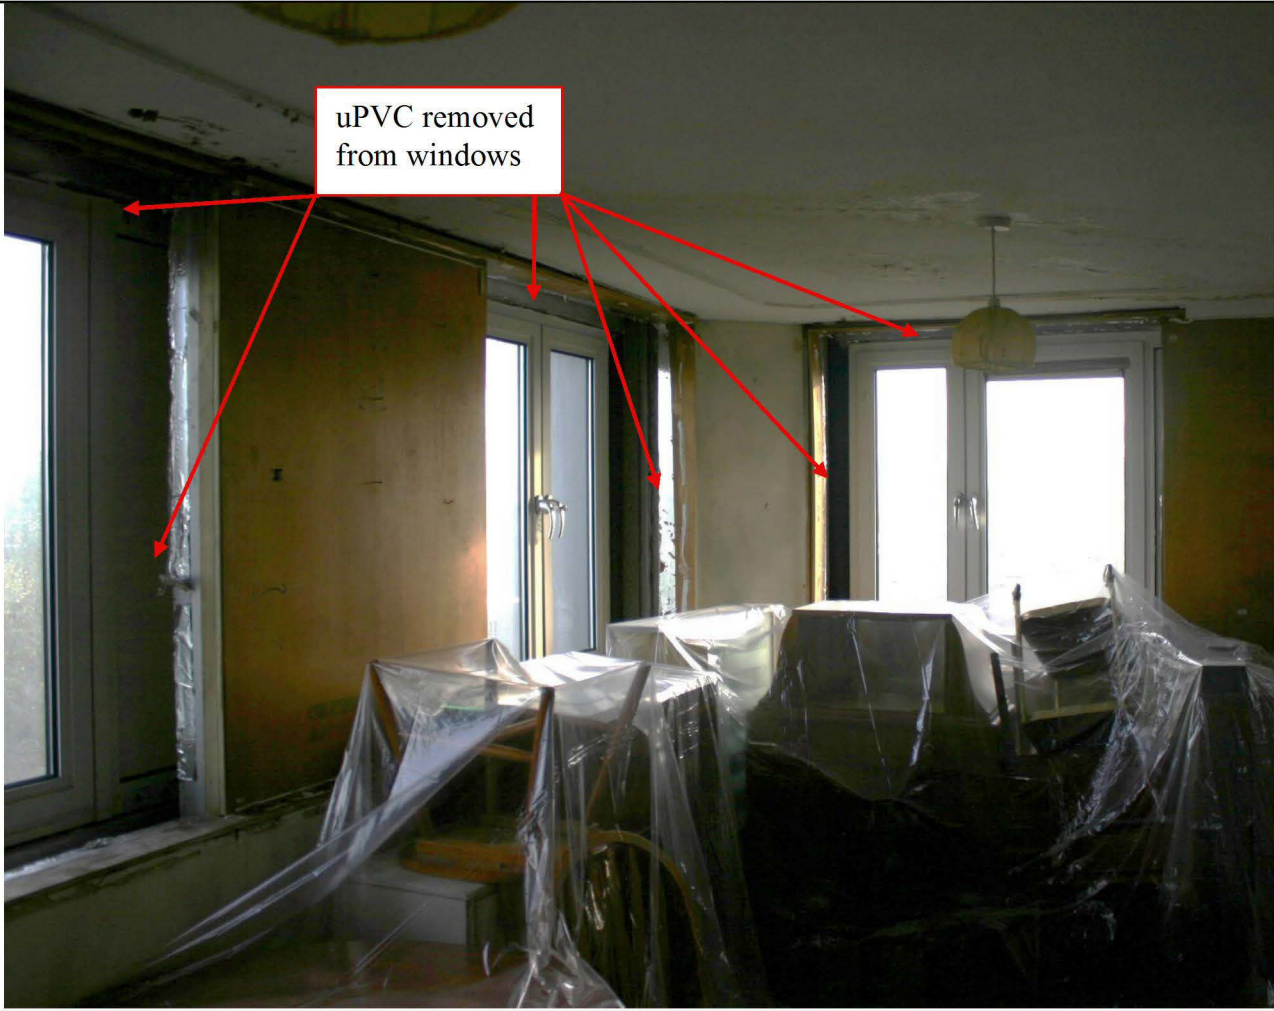
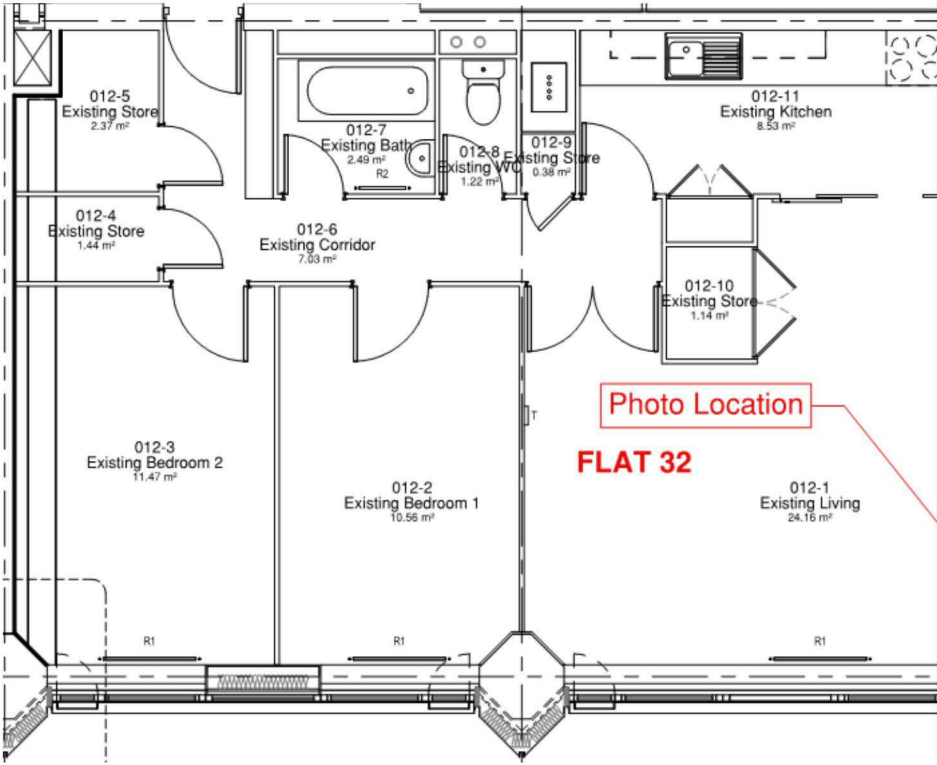
Floor	Flat	Window Linings in place	Thermal Insulation visible?	Photograph	Location
6	32	No. All finishes removed from windows and flat.	No. all finishing removed from flat.

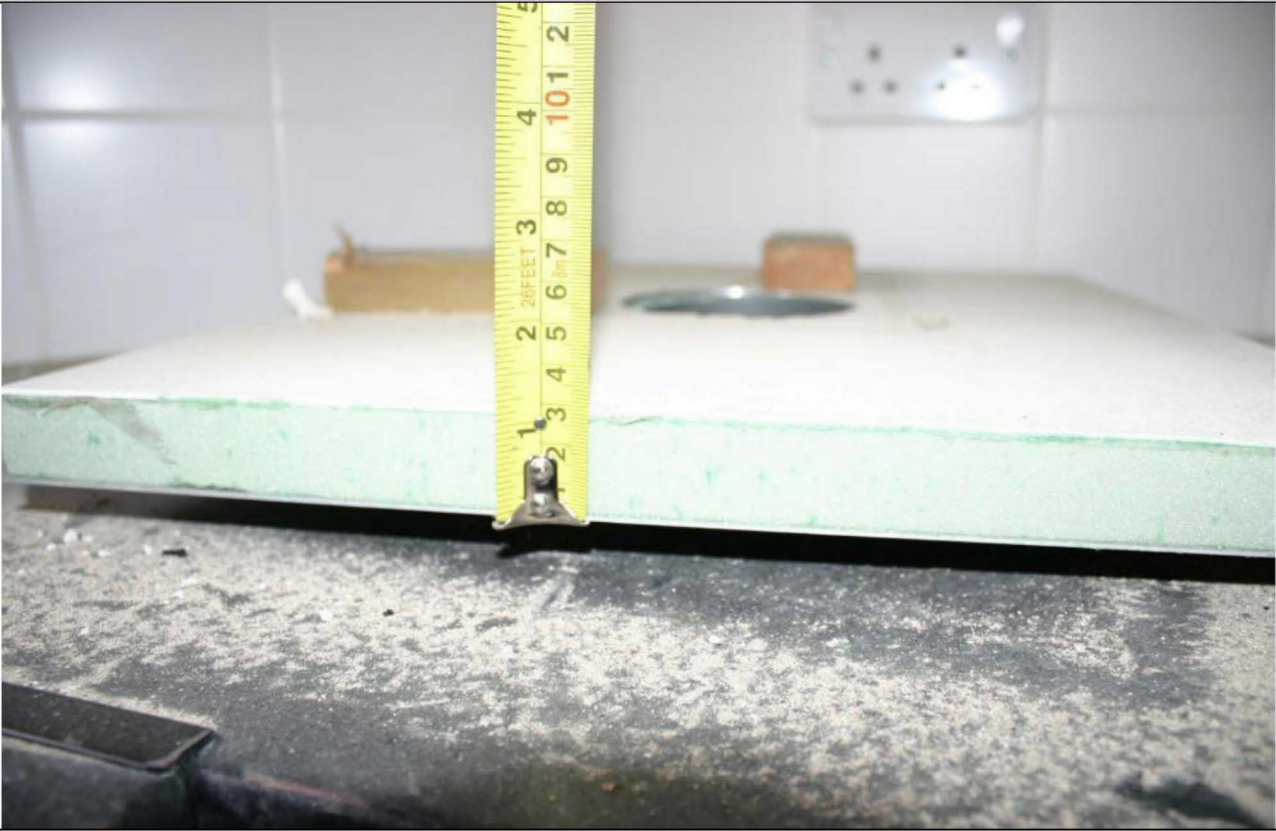
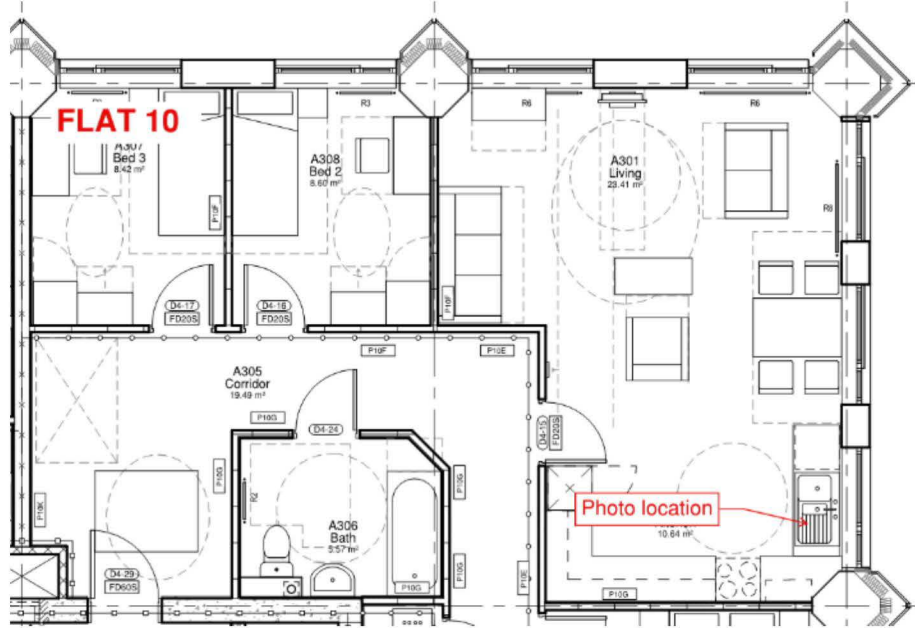
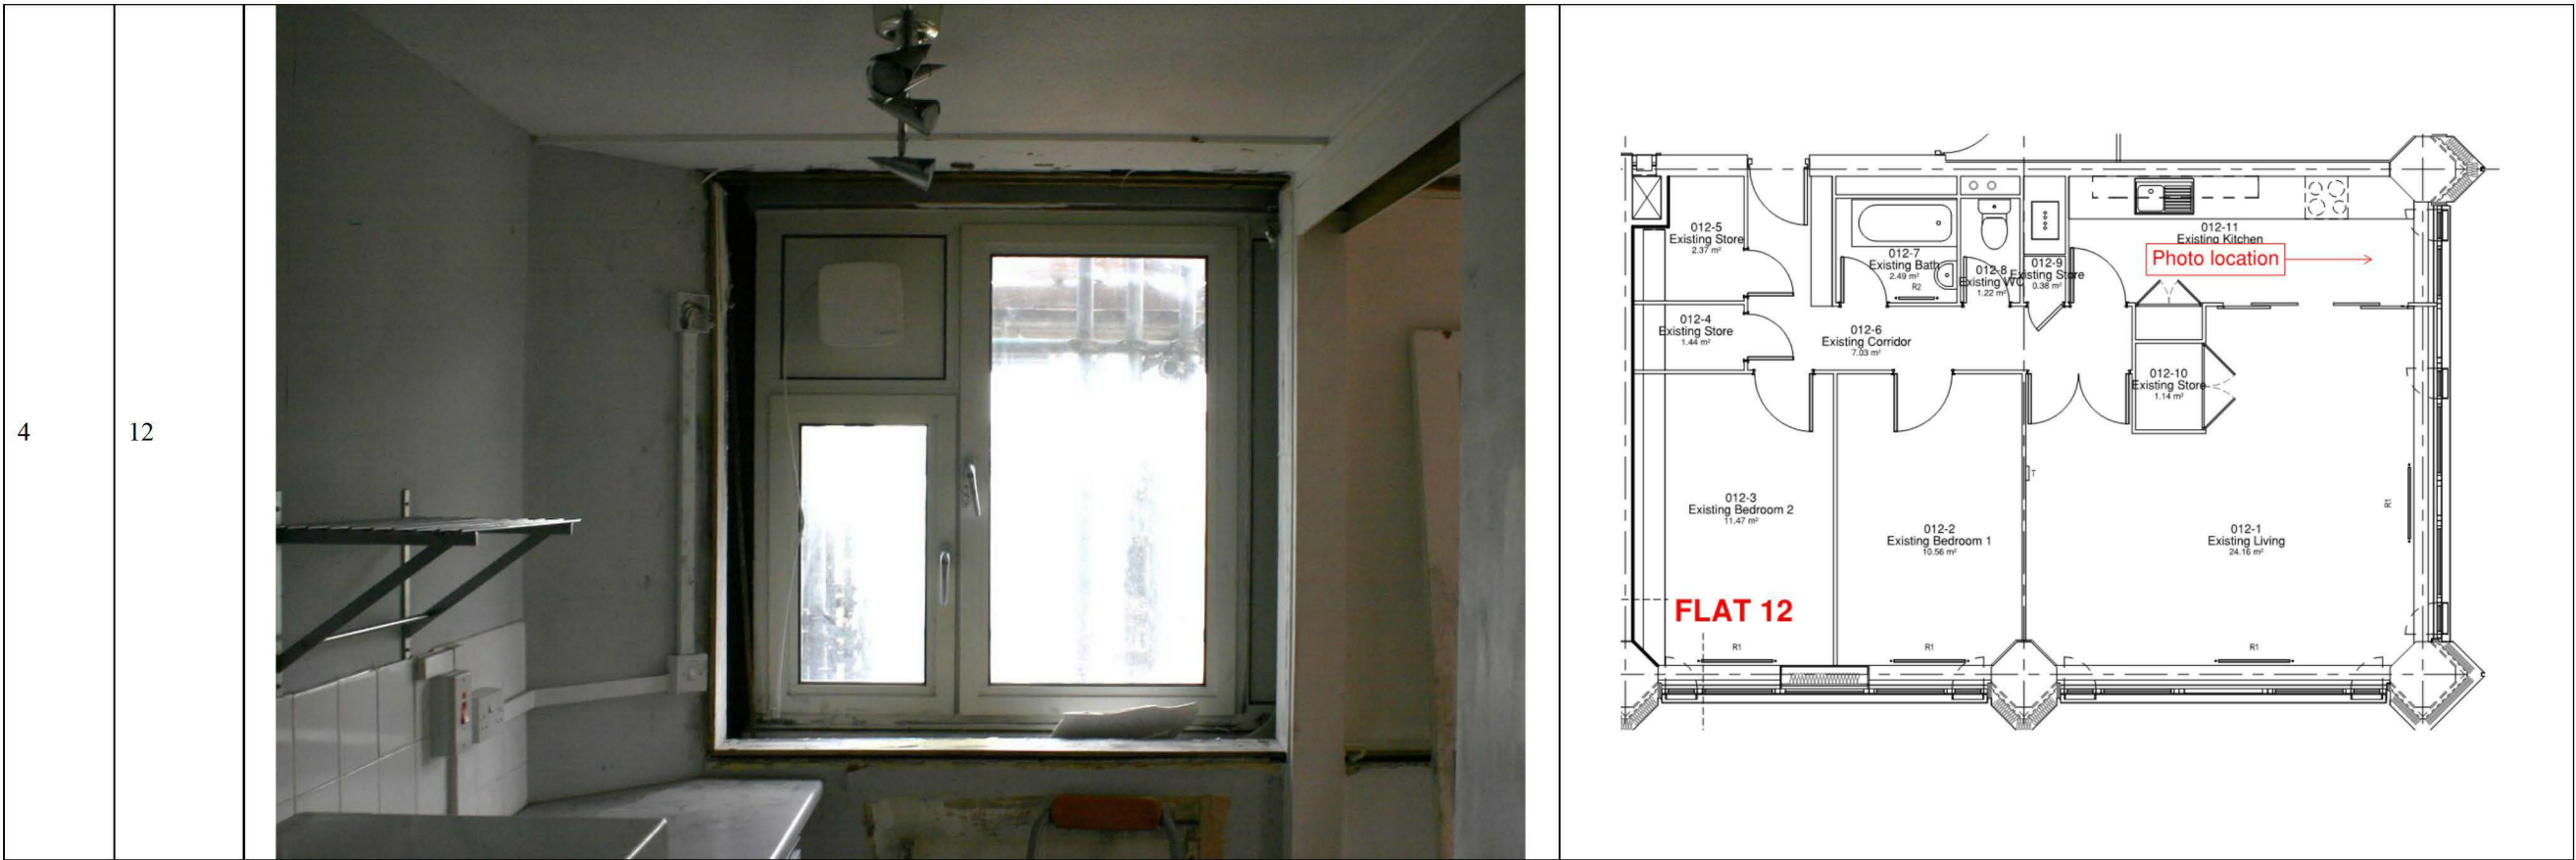
Level	Flat	Photograph	Plan location
3	10

Table C.10 Photographs of the insulating core panels I observed during my site inspection

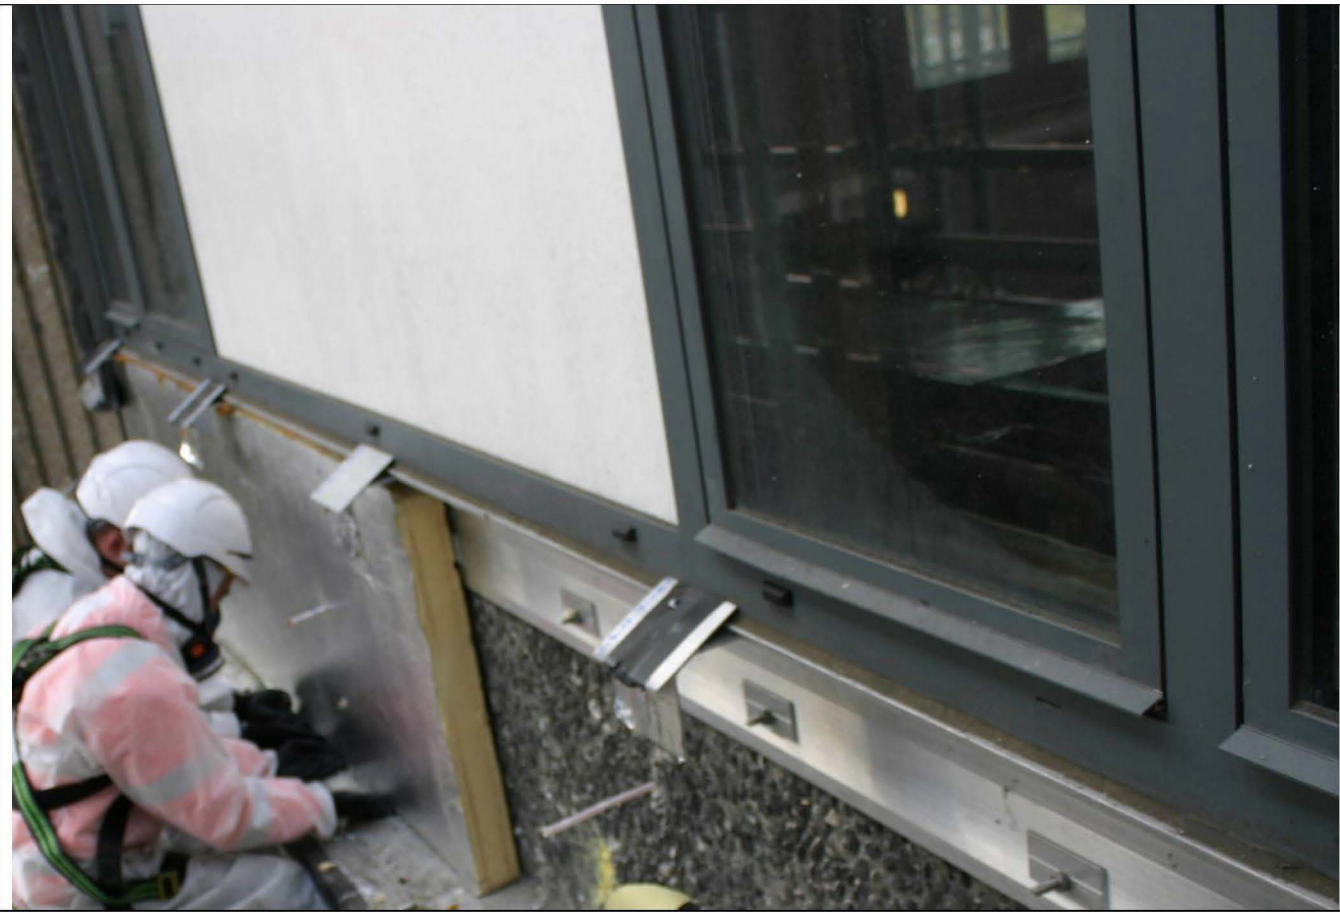
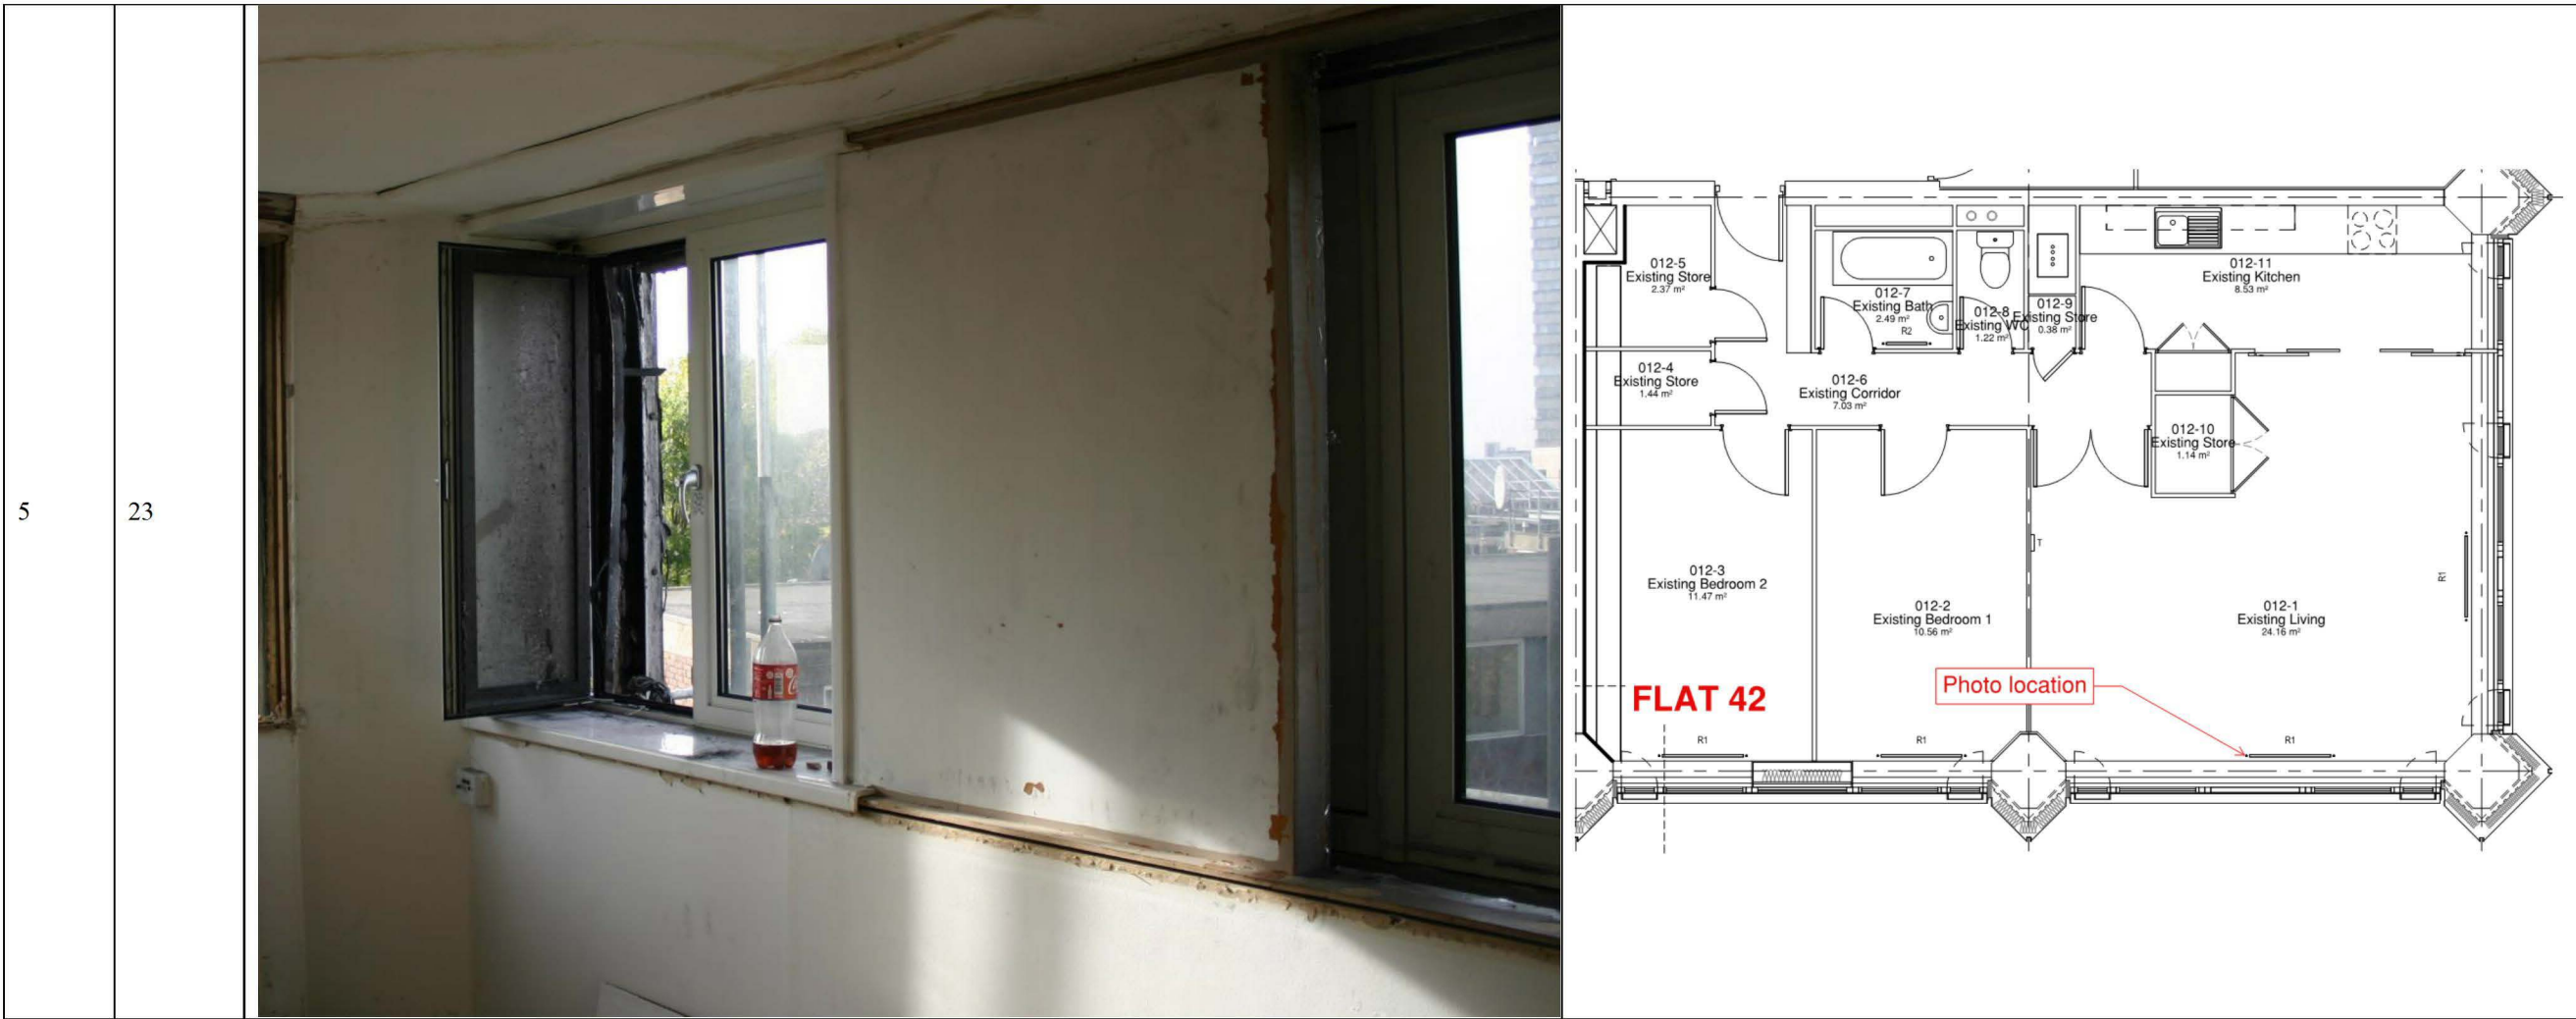
4	Exterior

Exterior – white infill insulating core panel shown between glazing
---	----------	---	---
