Grenfell Tower – fire safety investigation:
The fire protection measures in place on the night of the fire, and conclusions as to:
the extent to which they failed to control the spread of fire and smoke;
the extent to which they contributed to the speed at which the fire spread.

Phase 1 Report – Appendix C

Excerpts from site inspection records

Dr Barbara Lane FREng CEng

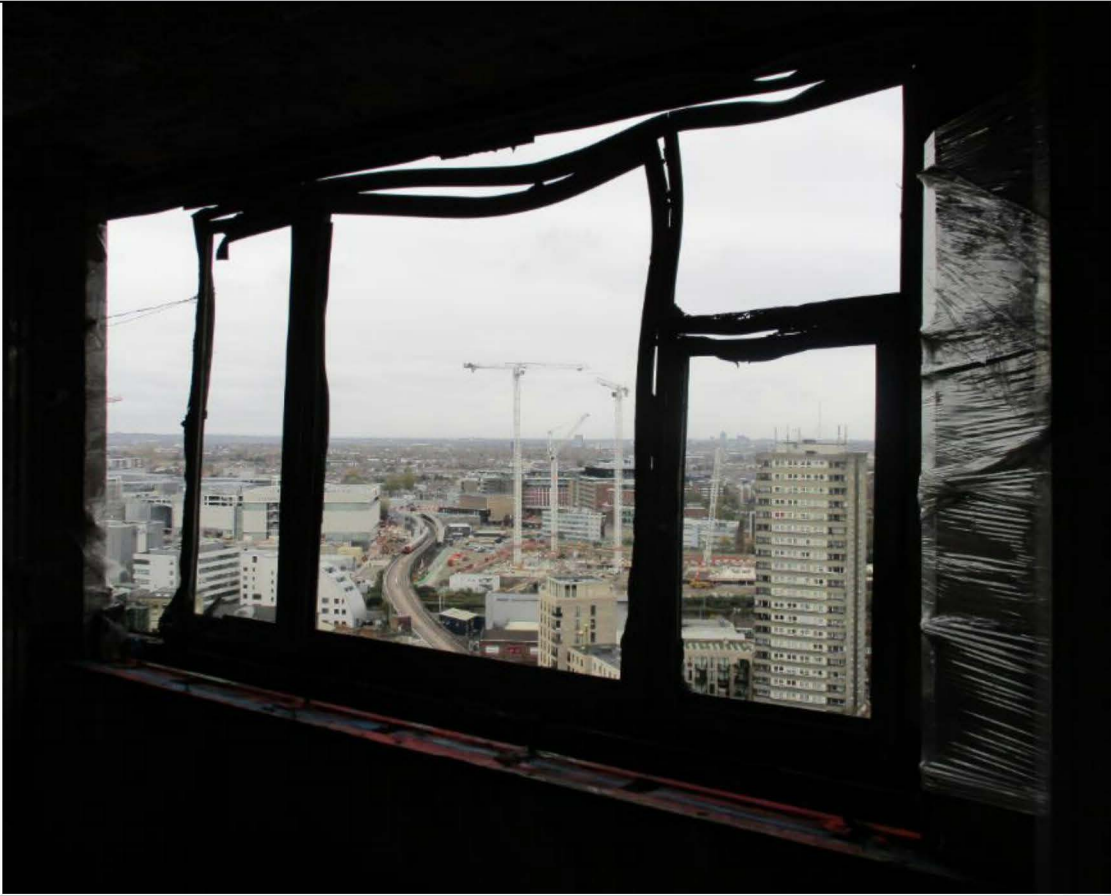
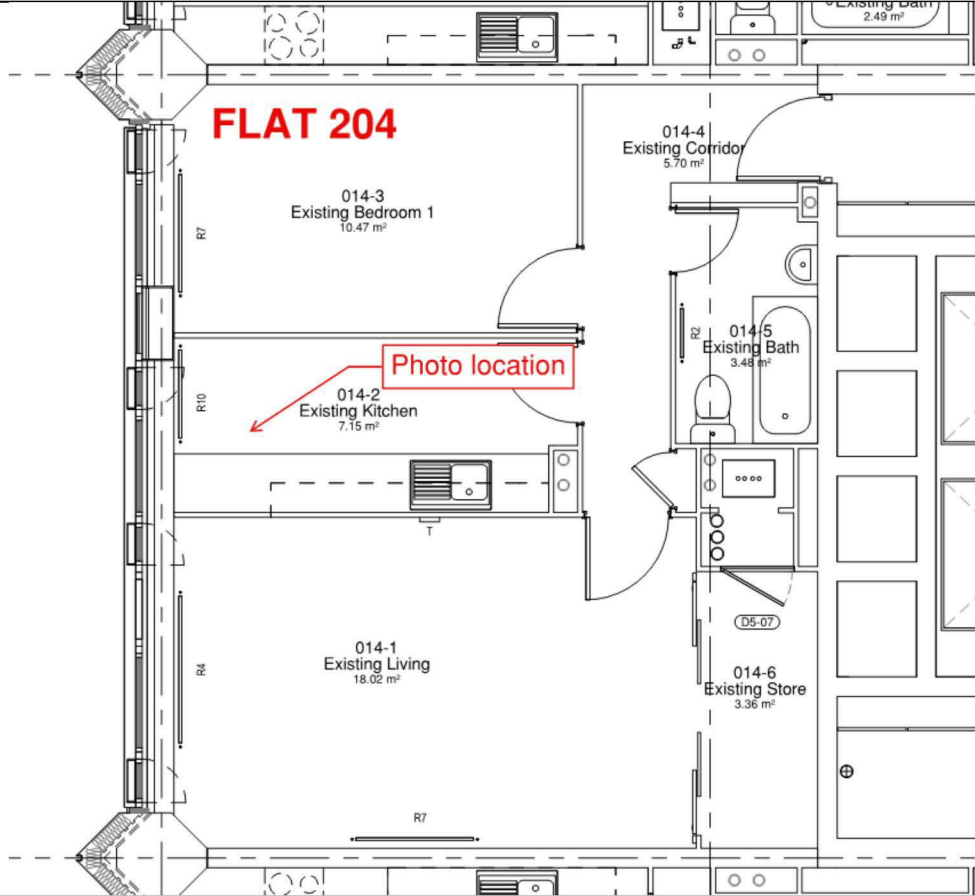
Level	Flat	Photograph	Plan location
23	204

- C8.1.1** In Table C.11 I have included a selection of photos from my site inspections on Levels 22 and 23 which show the extent of damage to the external walls window openings when viewed from the interior.

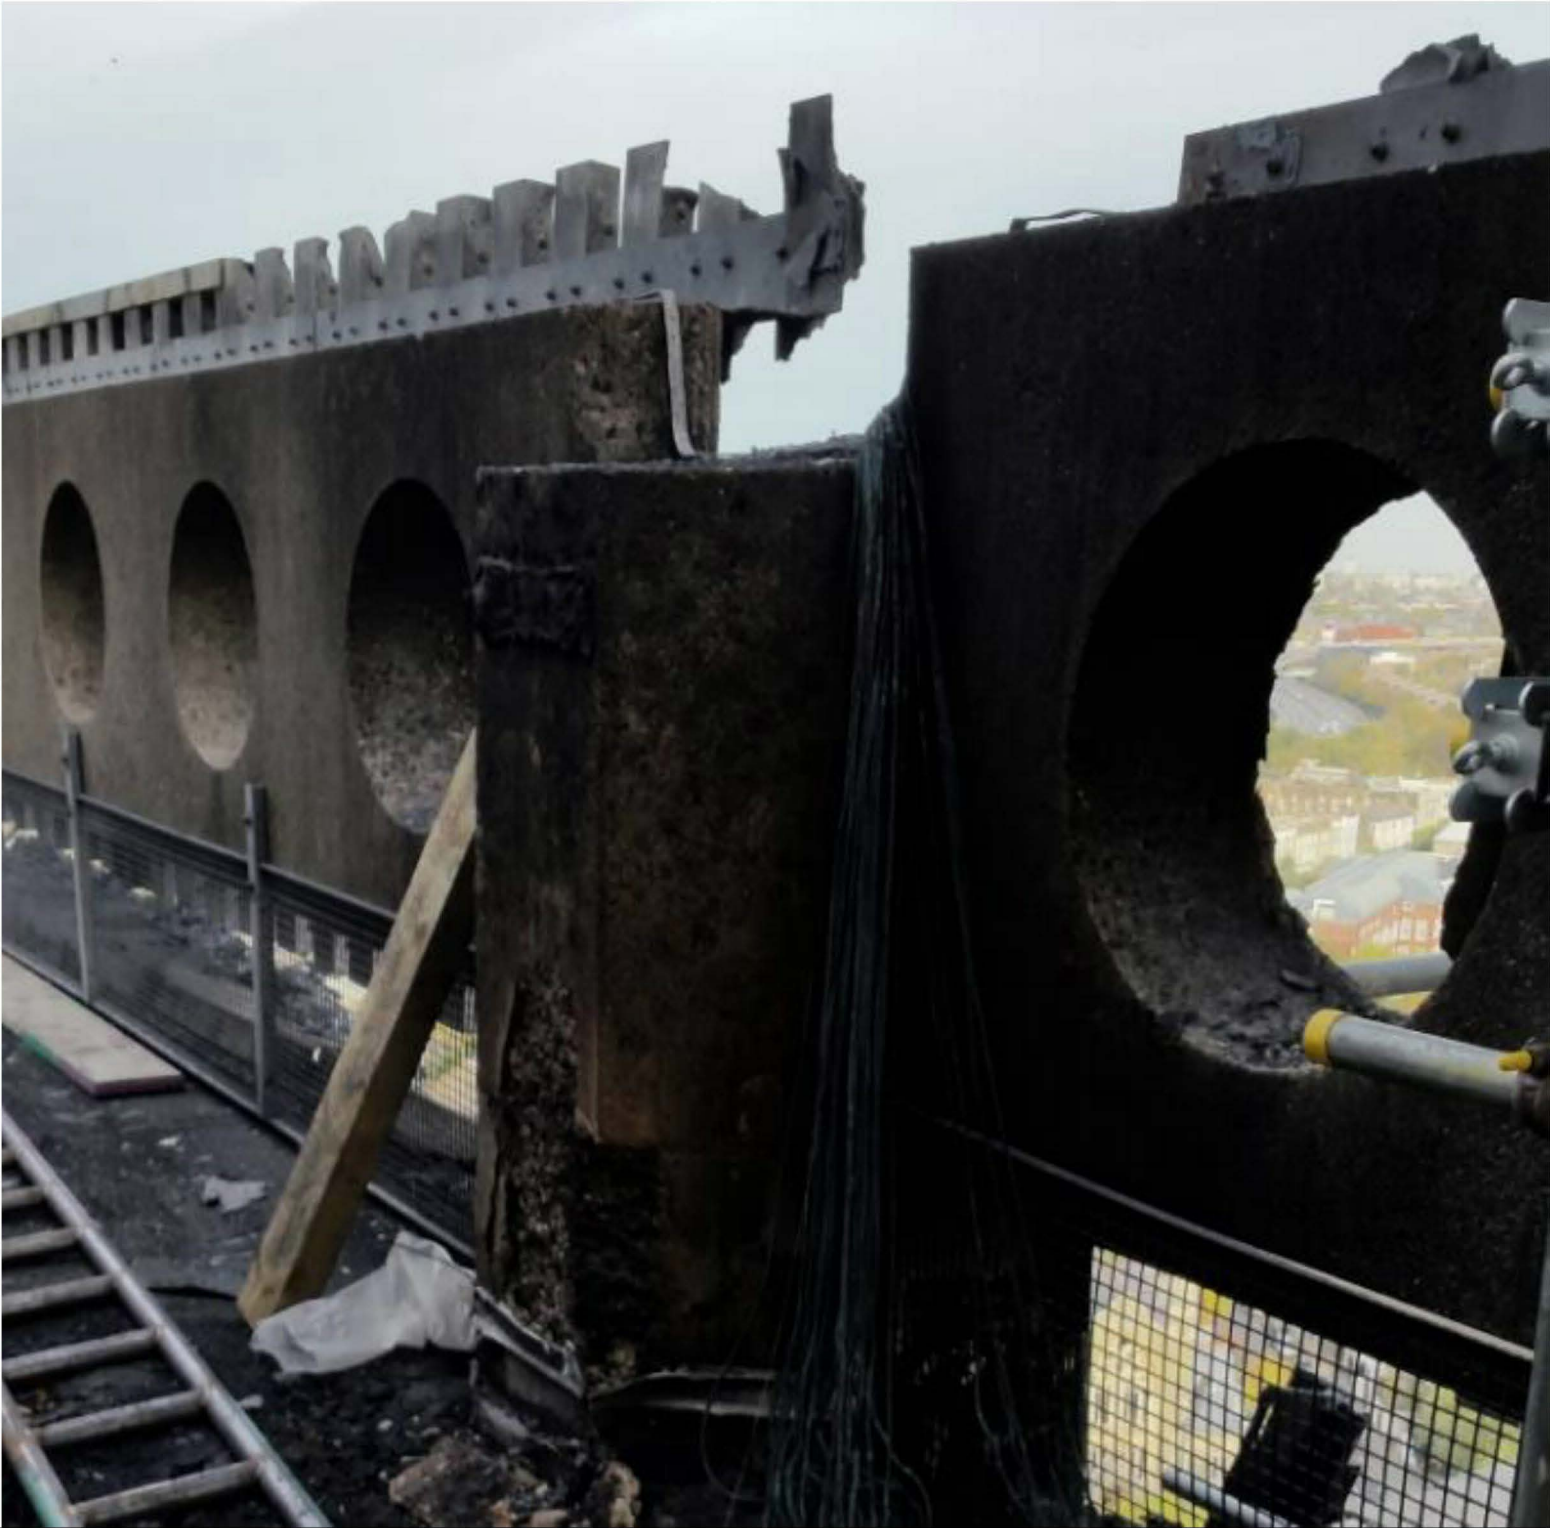
Location	Photograph
Roof

C9.1.1 In Table C.12 I have included a selection of photos from my site inspections at roof level which show the damage sustained to the façade ‘crown’.
