Grenfell Tower – fire safety investigation:
The fire protection measures in place on the night of the fire, and conclusions as to:
the extent to which they failed to control the spread of fire and smoke;
the extent to which they contributed to the speed at which the fire spread.

Phase 1 Report – Appendix I

Flat entrance and stair fire doors – requirements and provisions

Dr Barbara Lane FREng FRSE CEng

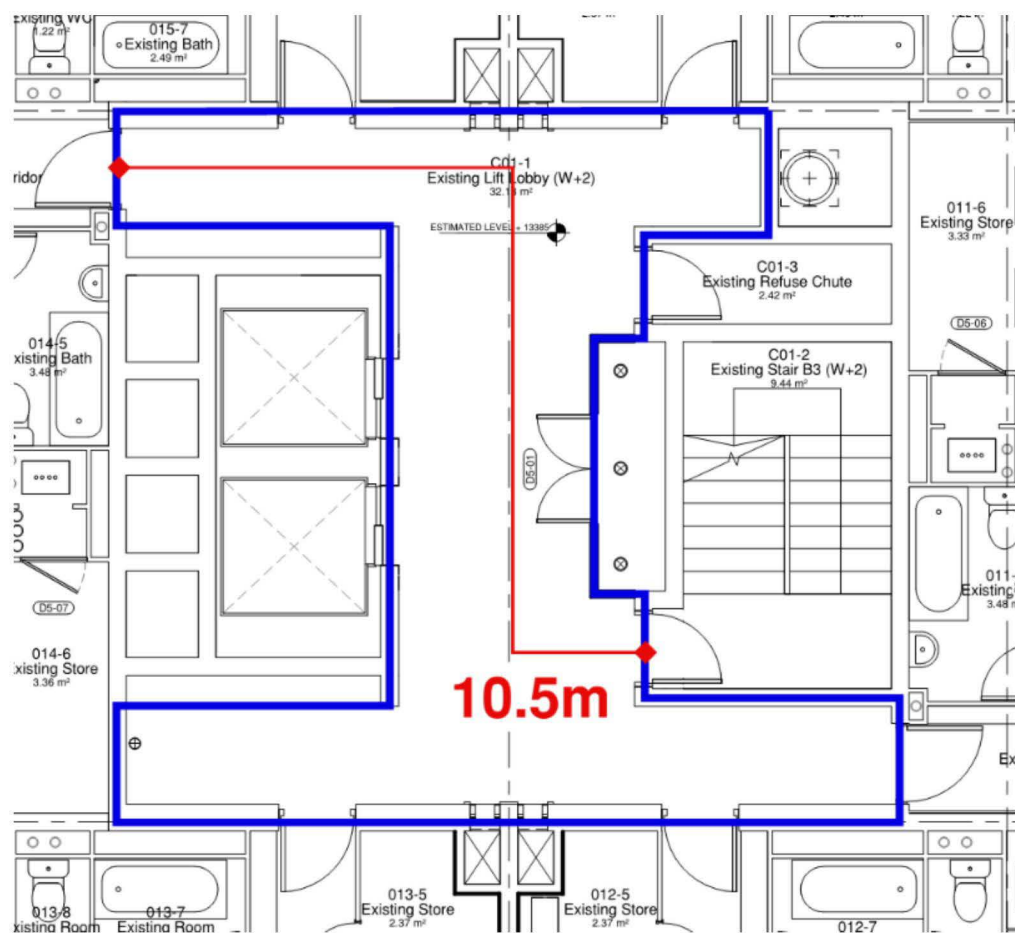
I4.3.34 During my post-fire site inspections, I measured the travel distances in the common corridors and found they exceed the limit of 10m set out above, and they were measured as 10.5m from flat ‘4’ on typical residential levels (shown in Figure I.7).

I4.3.35 As the measured travel distance in the common corridors is more than 10m, the LGA guidance would be that “***all doors** to the common corridor or lobby are at least ‘upgraded FD30S’ doors (see later) and the smoke ventilation comprises PVs or AOVs*”.

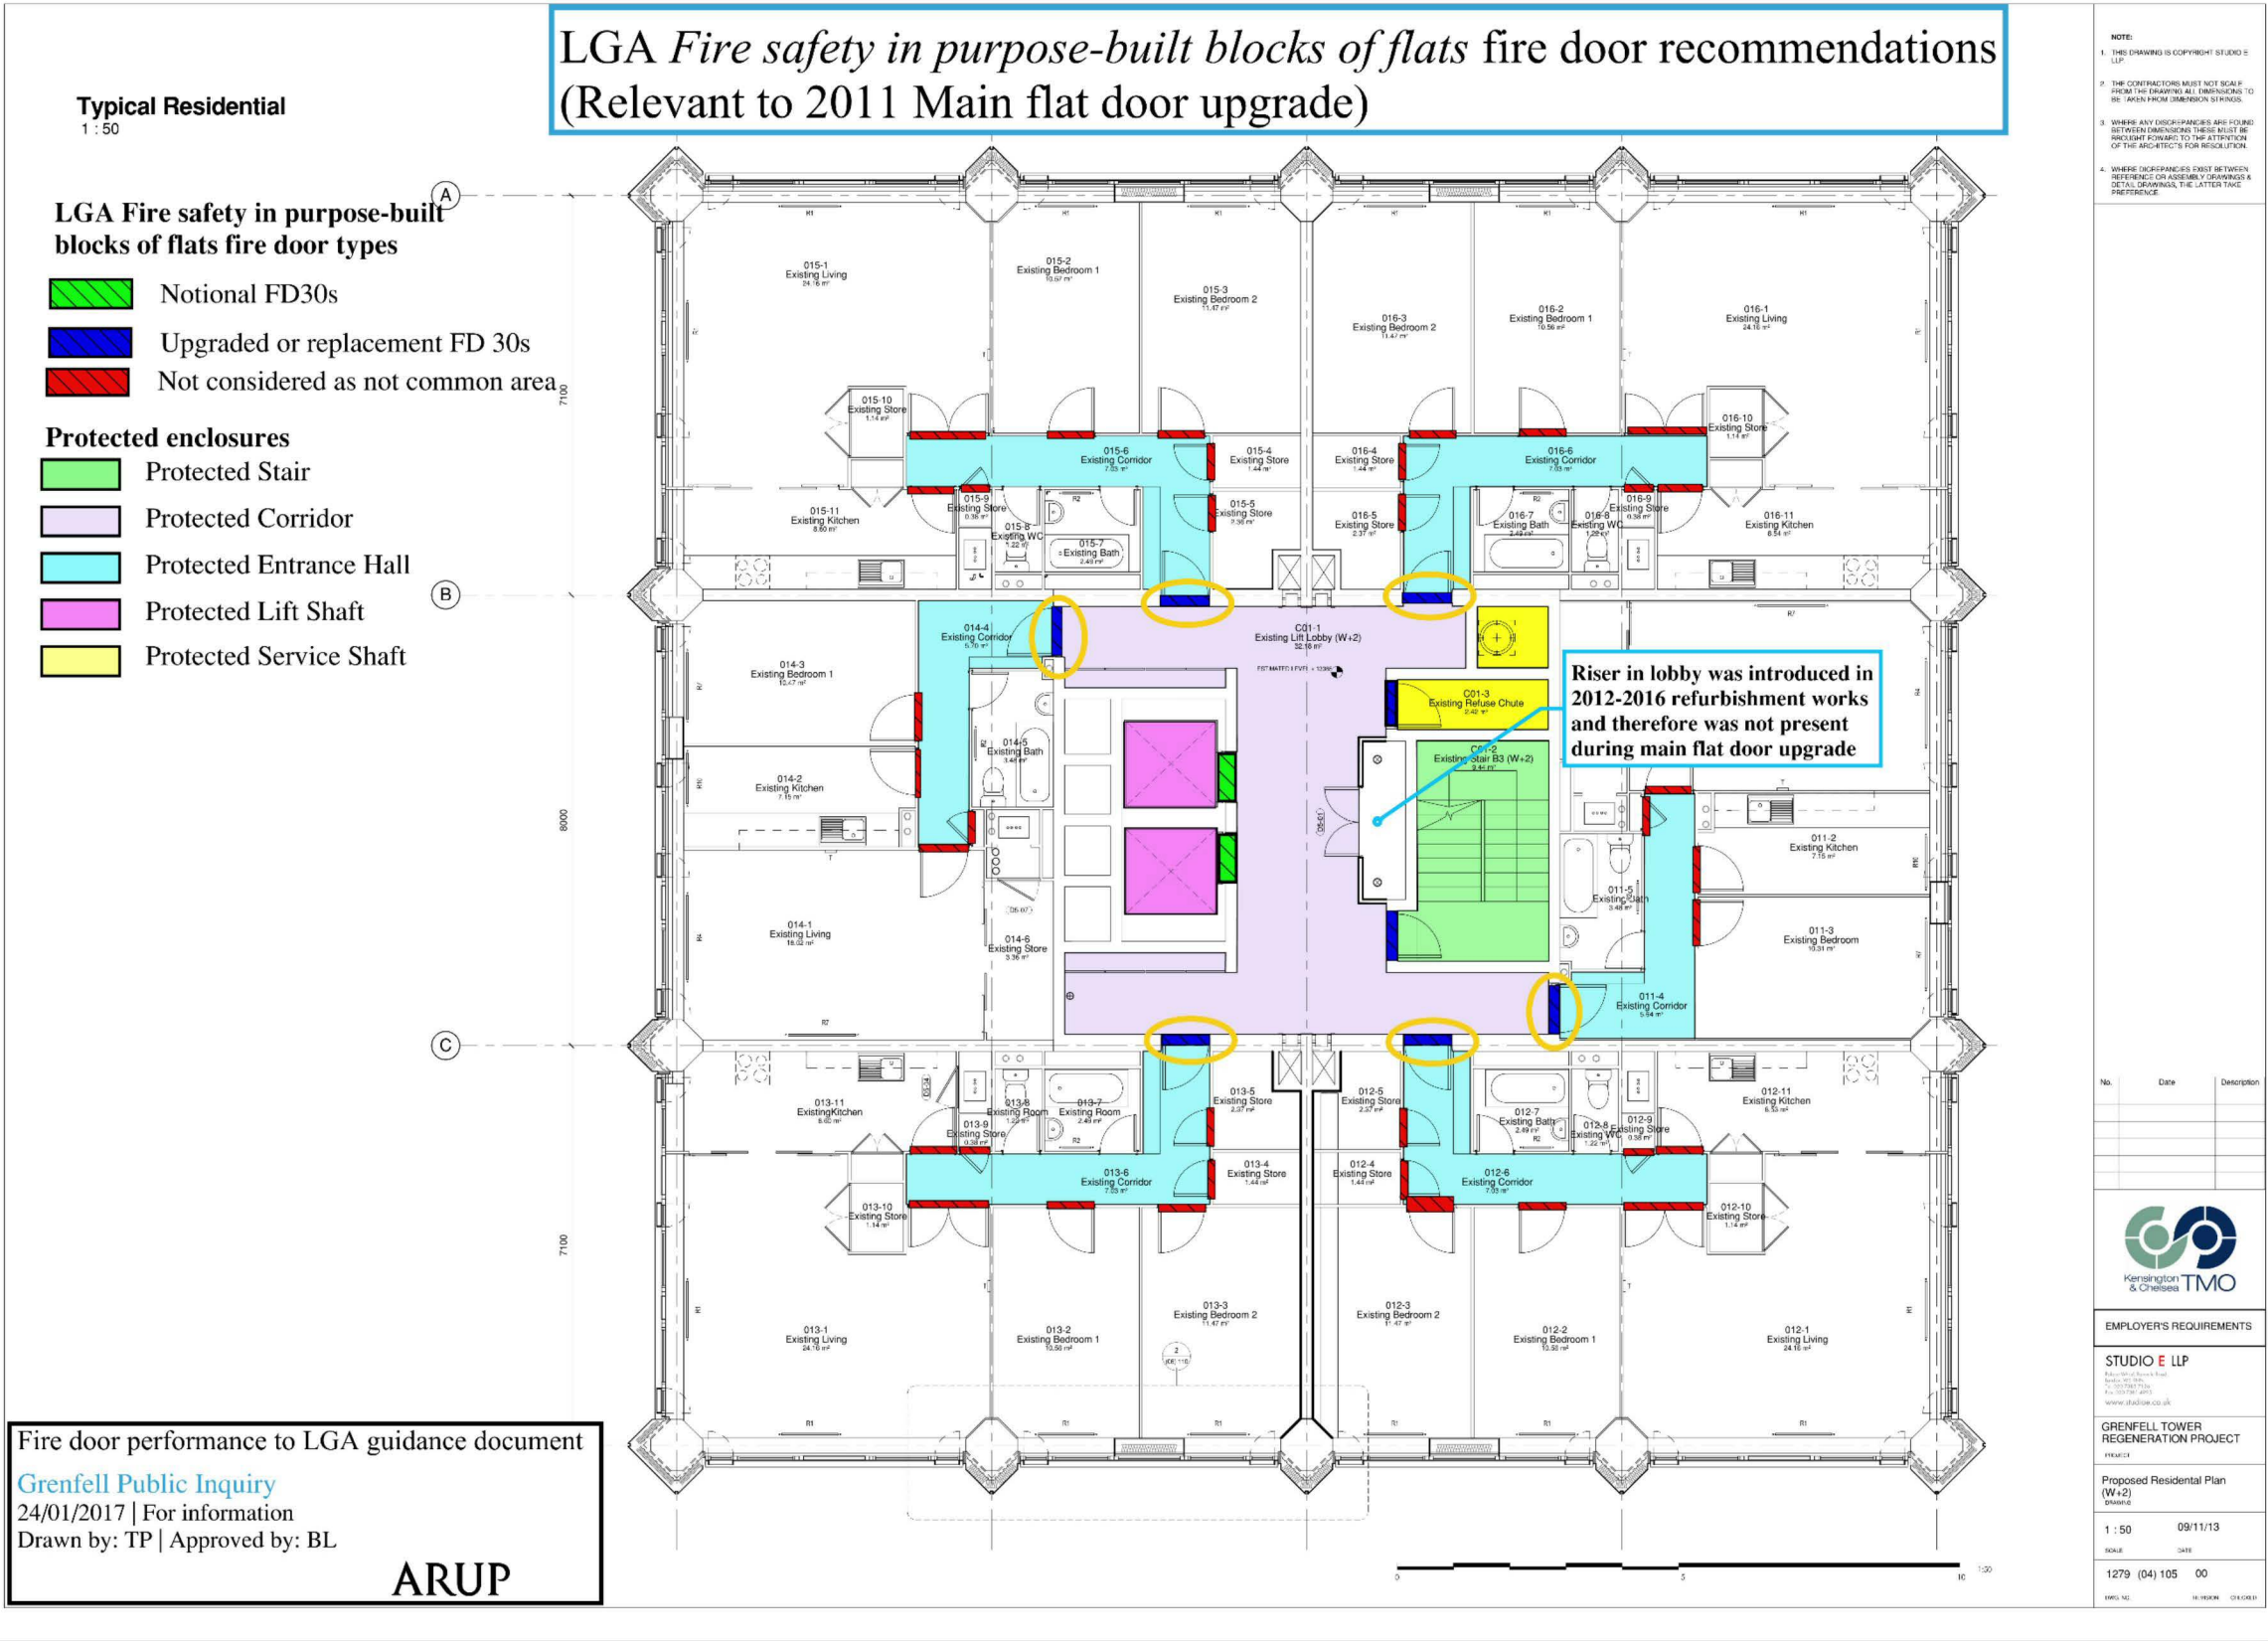
Figure I.8 LGA fire door – recommended performance (SEA00010474)

I4.3.44 Due to the travel distances within the common corridor of Grenfell Tower exceeding 10m, the LGA guide recommends all doors to the common corridor or lobby are at least ‘upgraded FD30S’. This performance standard from the LGA guidance has been indicatively marked up on the plan in Figure I.8 for all flat doors to the common lobby.

I4.3.45 The location of the main flat entrance fire doors which are the subject of this section are highlighted with orange circles.

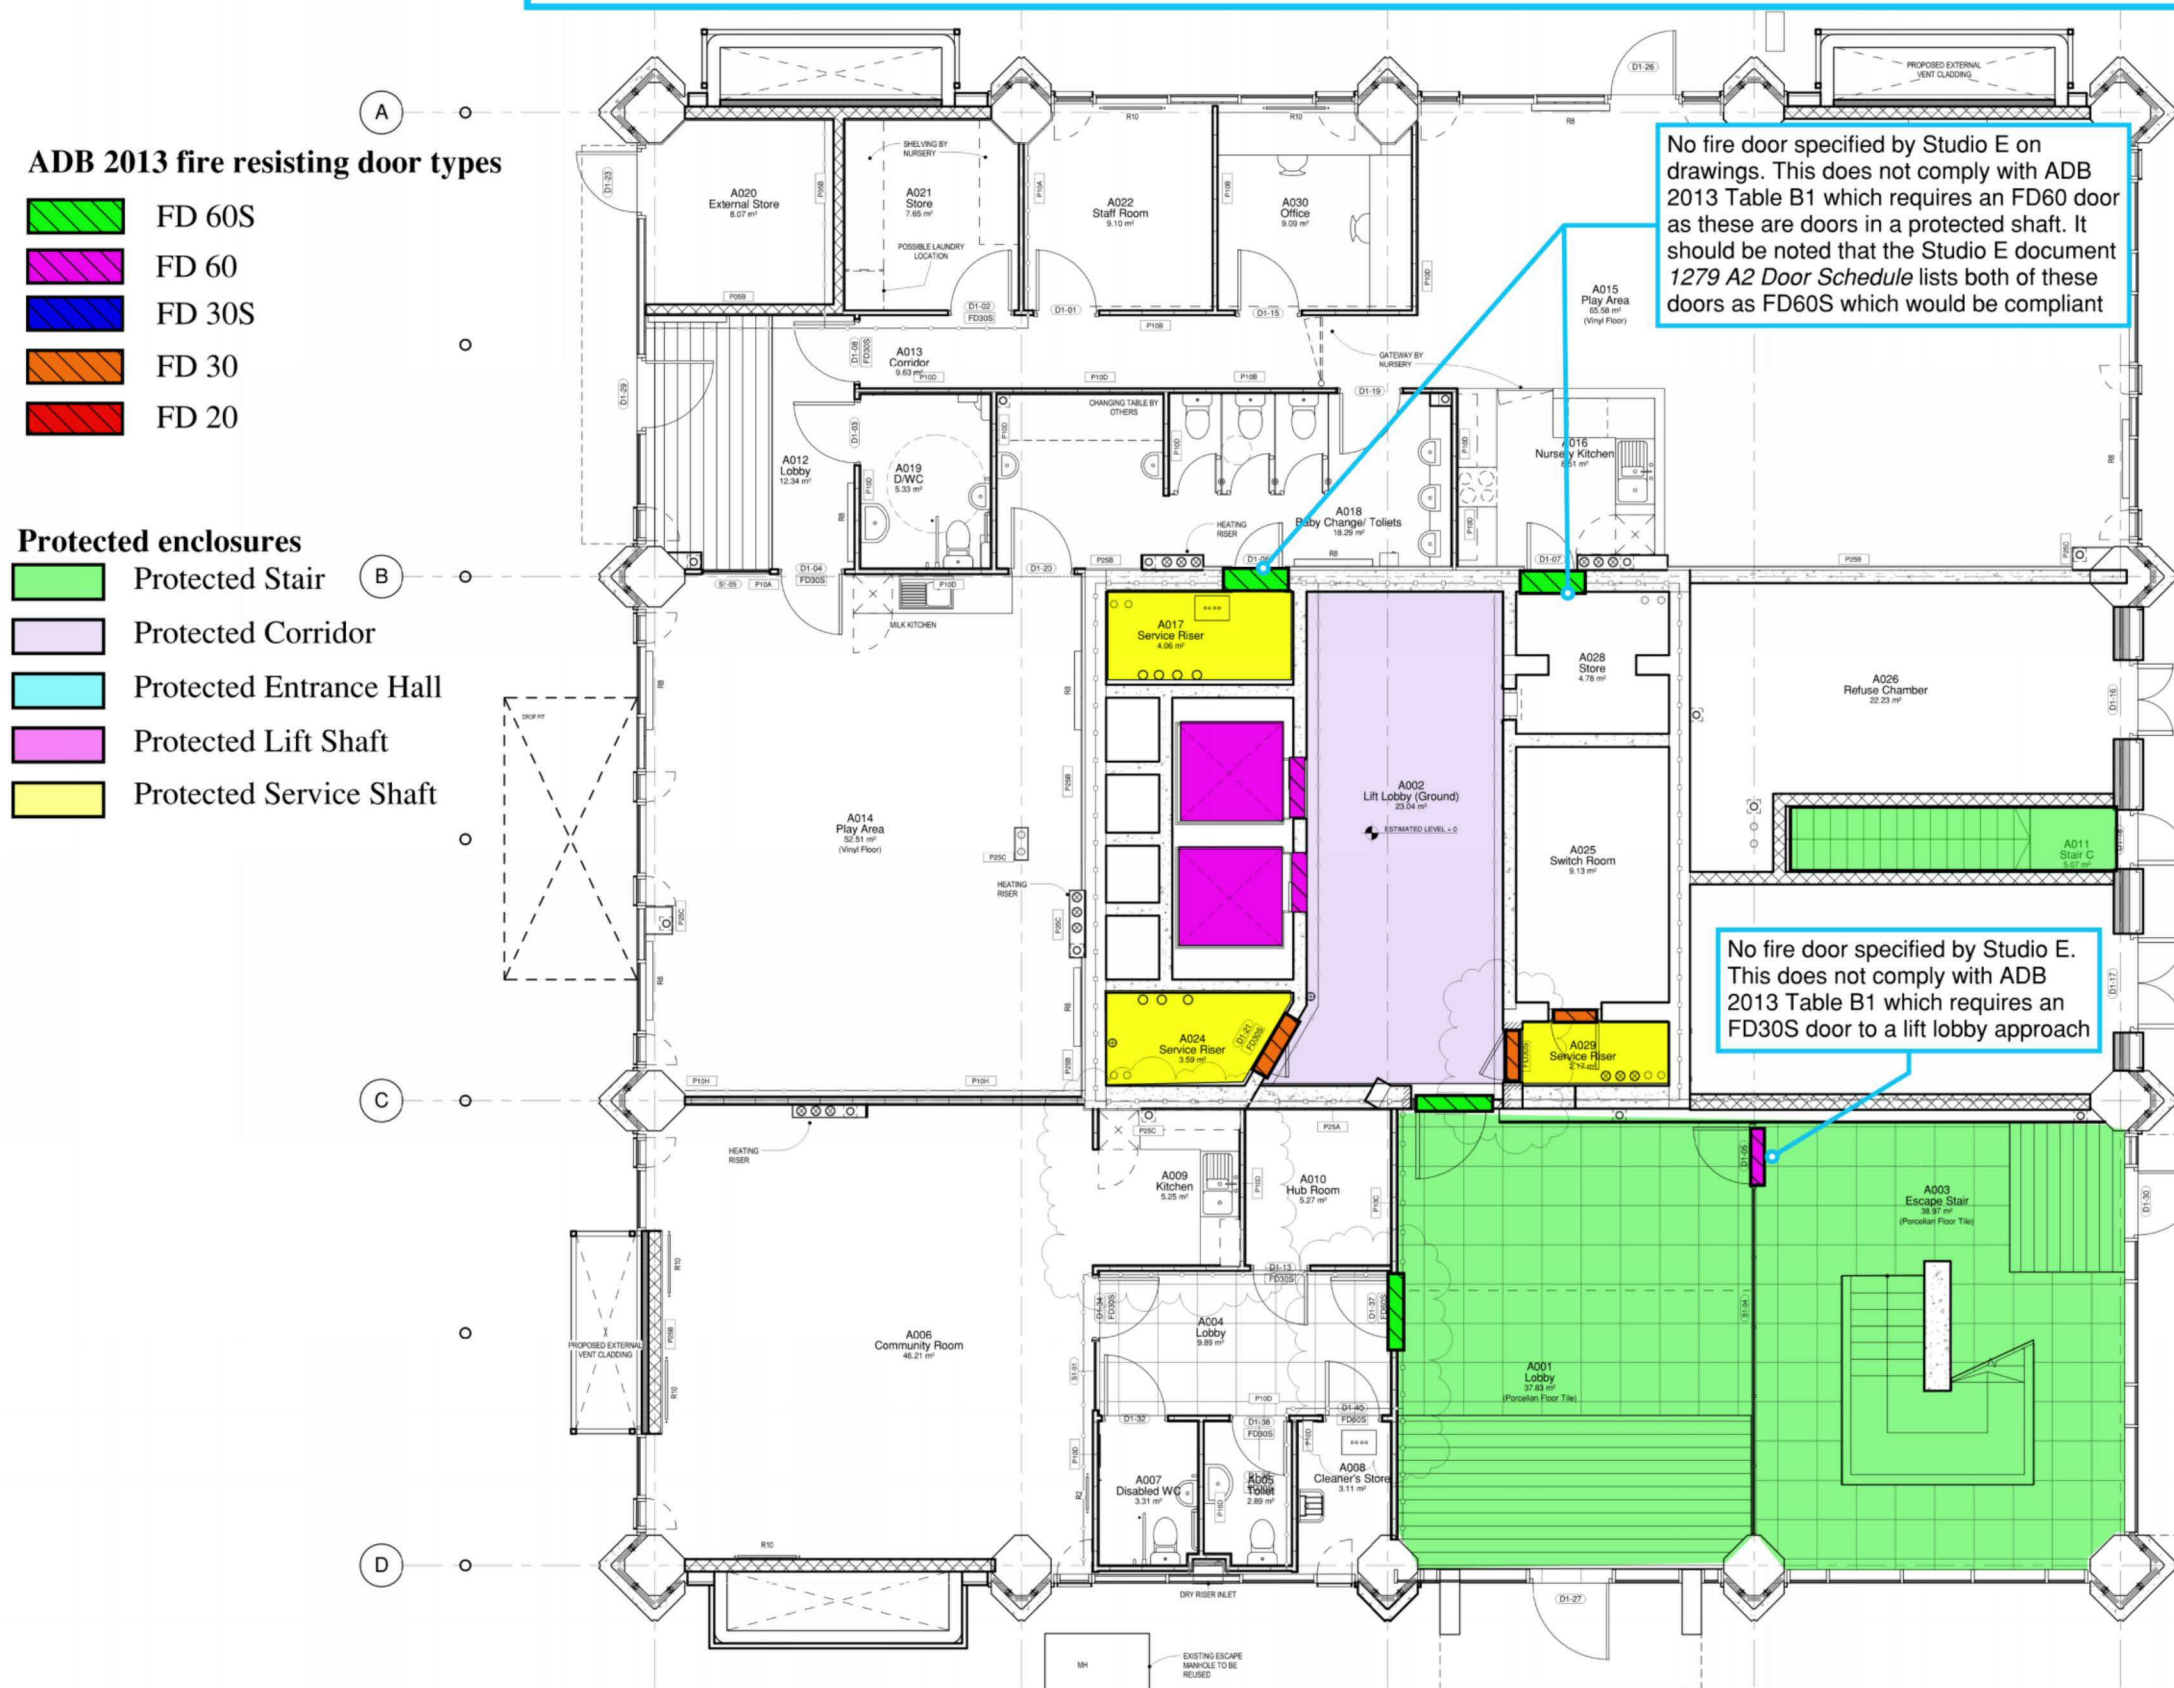
Figure I.31: Indicative over marking of ADB 2013 compliant fire doors on the Studio E as built ground floor plan (SEA00003232)

- I6.2.13** I have provided my indicative mark-ups of the fire performance required for compliance with ADB 2013 in the figures below. This represents my opinion regarding the non-compliance (or not) with the Studio E specification. These are shown in Figure I.31, Figure I.32, Figure I.33, Figure I.34.
- I6.2.14** The full list of non-compliances with the Studio E Door schedule (RYD00092648) is provided in Table I.13.
