Grenfell Tower – fire safety investigation:
The fire protection measures in place on the night of the fire, and conclusions as to:
the extent to which they failed to control the spread of fire and smoke;
the extent to which they contributed to the speed at which the fire spread.

Phase 1 Report – Section 10

Routes for vertical and horizontal fire spread throughout the building envelope

Dr Barbara Lane FREng FRSE CEng

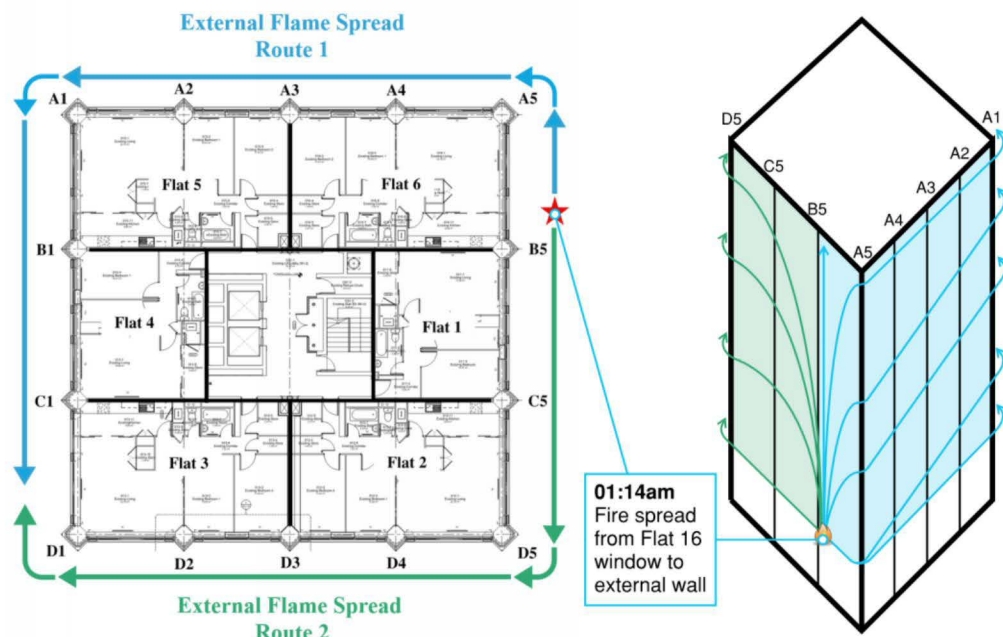
- 10.1.3** In Section 5 of this report I provided Figure 10.1 setting out on the plan drawing of the 4th floor, a diagram summarising the primary direction of the observed fire spread routes during the Grenfell Tower fire. Figure 10.1 also shows a schematic of the fire spread in 3 dimensions on an isometric representation of Grenfell Tower.

Figure 10.1: Plan (based on SEA00010474) and isometric views of Grenfell Tower showing fire spread observed and column references for orientation

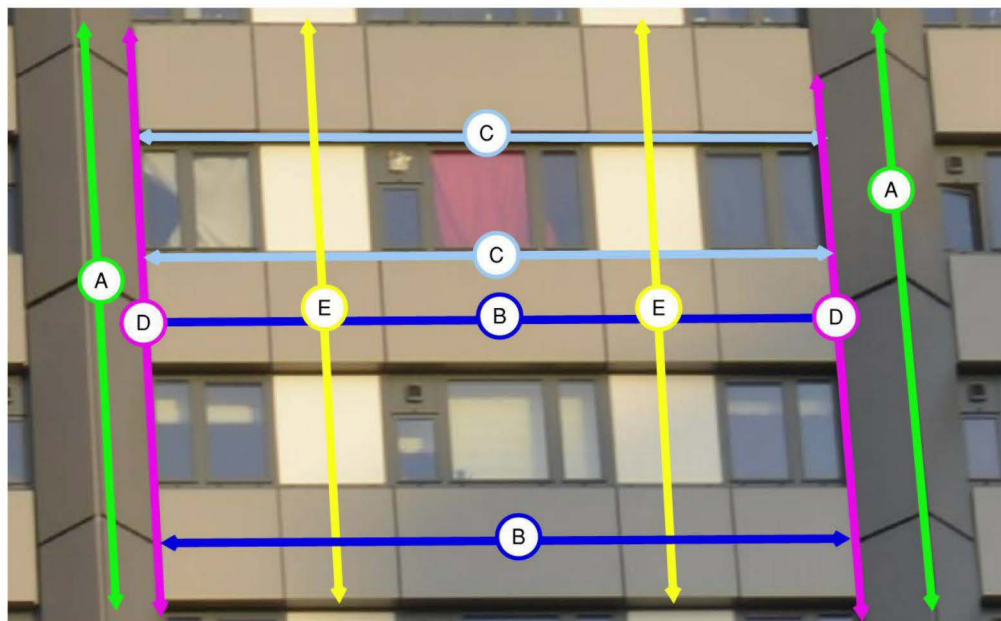
- Pathway E: Vertically by means of the insulating core panels which connect between spandrel panels;
 - Pathway F: Around the crown of the building.
- 10.1.7** Figure 10.2 identifies Pathways A to E on an undamaged portion of the façade of Grenfell Tower. These Pathways are also indicated on a rendered schematic of the building envelope in Figure 10.4.

Figure 10.2: Pathways A to E identified on undamaged façade (SEA00000350)

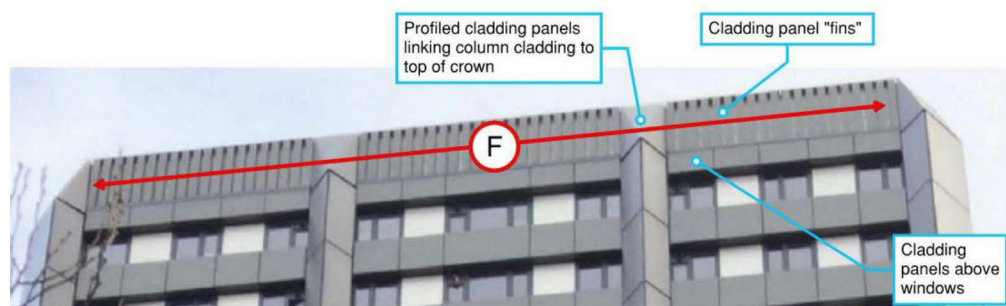
10.1.8 Figure 10.3 identifies Pathway F on an image of the façade from before the fire.

Figure 10.3: Pathway F identified on undamaged façade (SEA00000322)

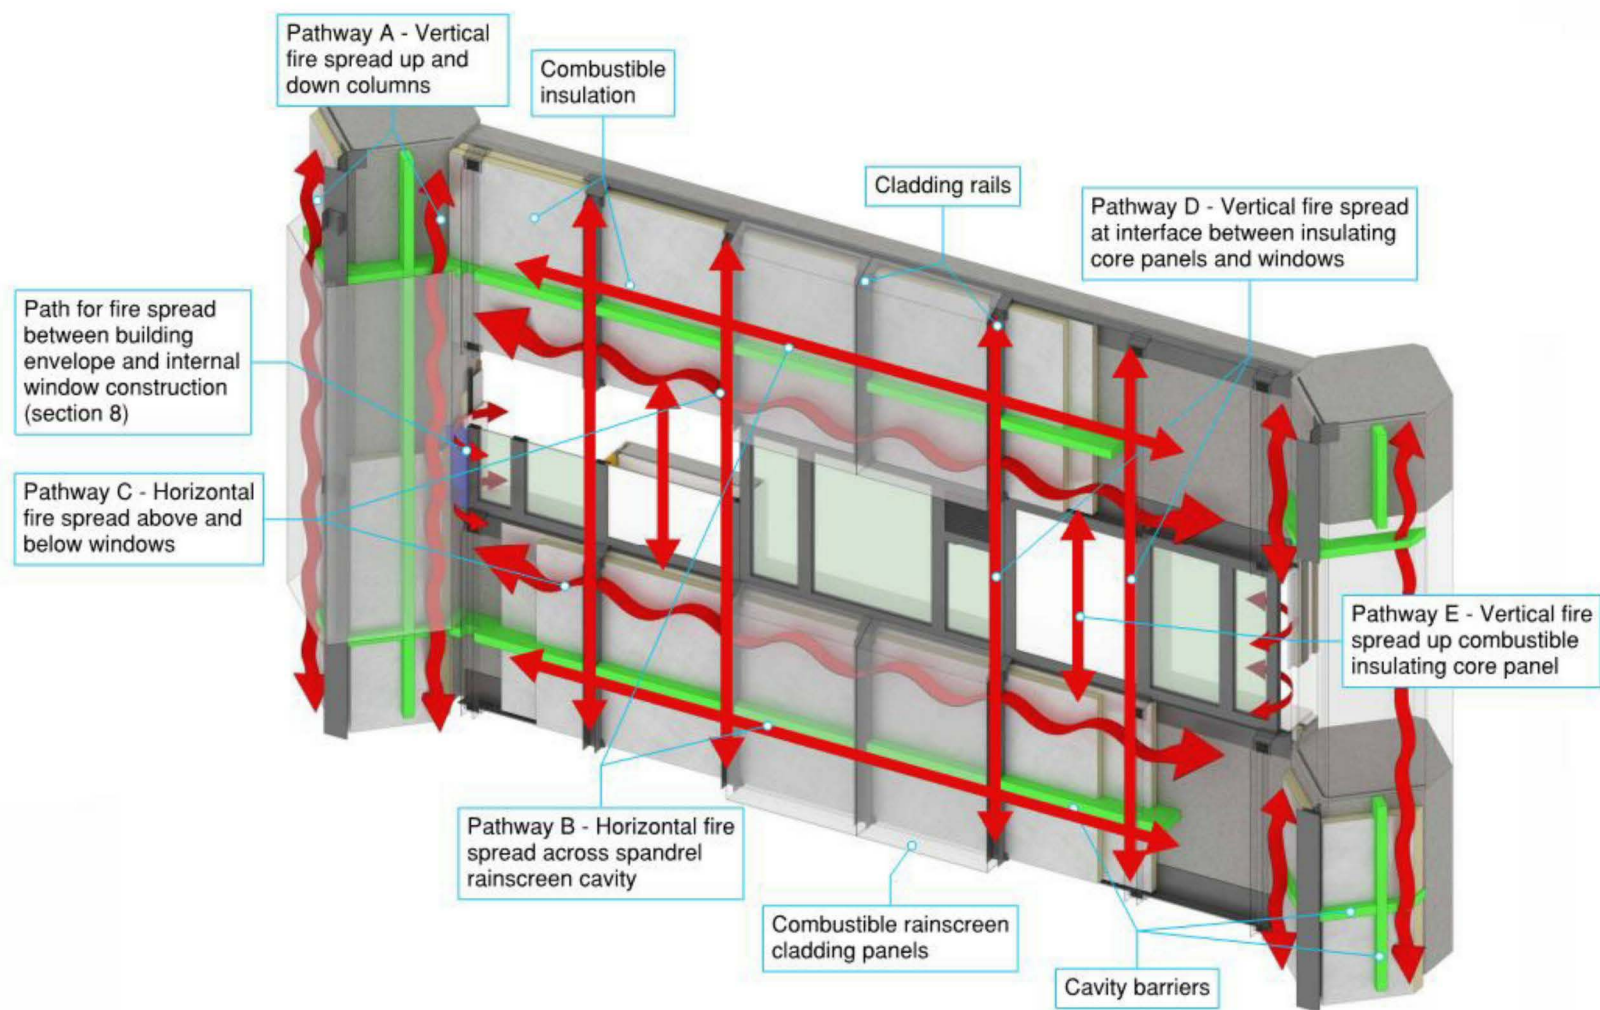
- 10.1.9** These pathways are shown on a rendered representation of the rainscreen cladding installation based on design drawings and observations from my post fire inspection in Figure 10.4.
- 10.1.10** These pathways are also demonstrated on photographs of external fire spread on the West elevation of Grenfell Tower in Figure 10.5.
- 10.1.11** In the following sections I will describe how the construction materials present at Grenfell Tower enable each of these Pathways, with reference to footage of the fire.
- 10.1.12** Please note it is not my intention to create a very detailed fire spread map in this part of my report. It is an analysis to understand general flame front routes, and importantly overall timescales where individual building elevations became fully involved in the fire. The very fine detail of the

Figure 10.4: Pathways A, B, C, D and E shown on a rendered representation of rainscreen cladding installation based on design drawings and observations from post fire inspection

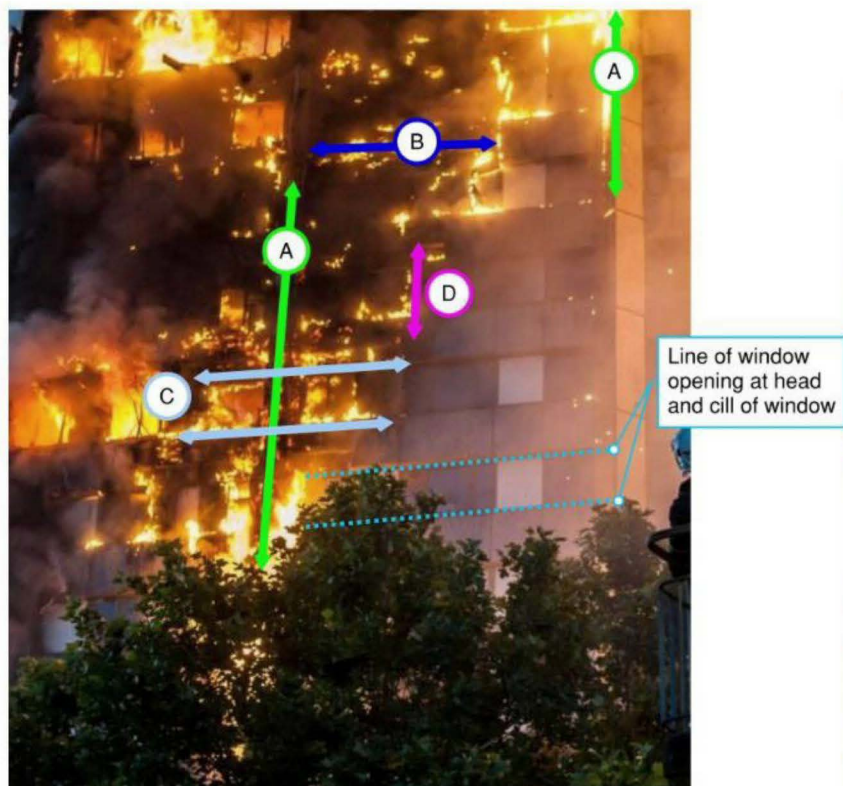
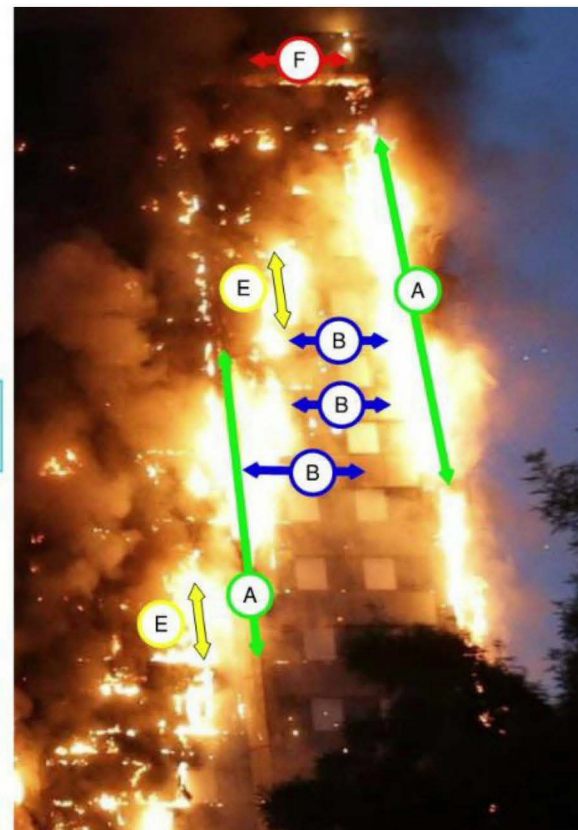
(a) Photographic evidence of Pathways A, B, C and D¹

(b) Photographic evidence of Pathways A, B and E²

Figure 10.5: Fire spread on West elevation of Grenfell Tower

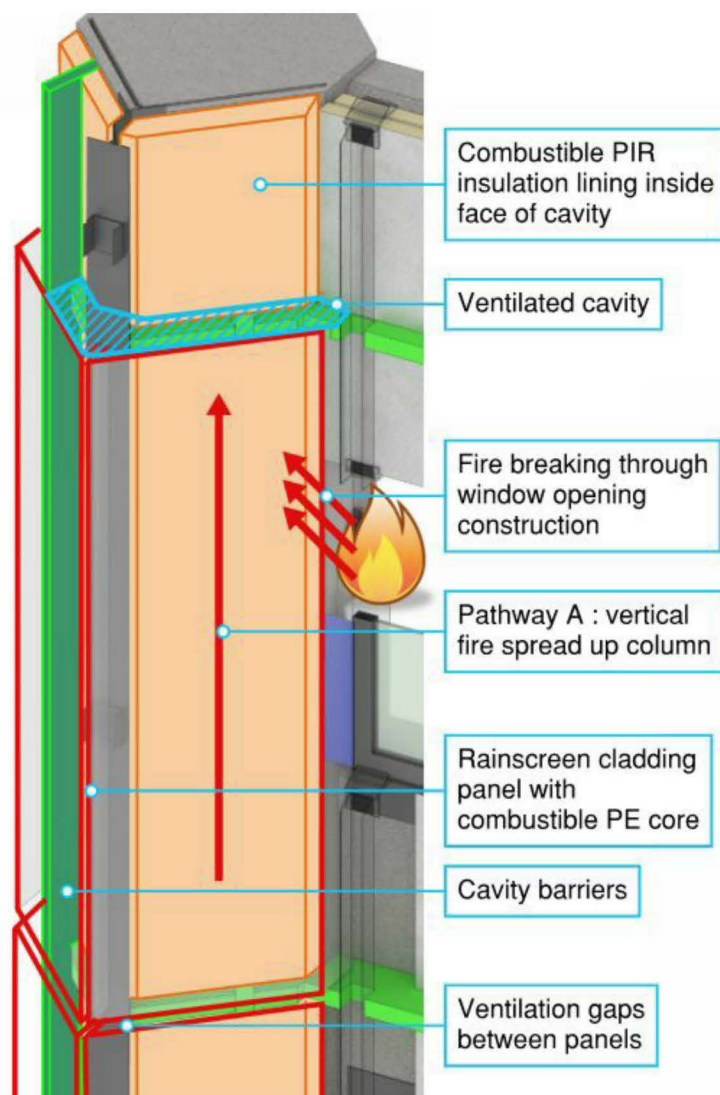
10.3.26 In summary, the vertical fire spread observed up and down the columns, was caused by:

- The presence of fuel (the combustible polyethylene core of the Reynobond panels, the combustible Celotex insulation and the combustible EPDM weather proof membrane);
- The presence of oxygen entering the rainscreen cavity through the specifically designed air gaps;
- Heat from a fire within a flat passing into the cavity via the window construction described in Section 9; and
- Polyethylene from the Reynobond panels melting and running down the building, while ignited.

Figure 10.13: 3D image of the fuel, ventilation and heat available within the column cavity of Grenfell Tower to support combustion

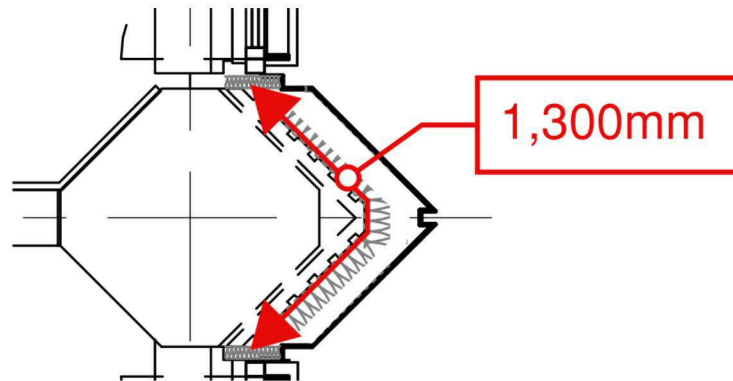
- 10.3.35** For the columns with no vertical fire stop this results in a cavity of 3.64m² in area over the face of the column, between each horizontal fire stop (Figure 10.16).

Figure 10.16: Horizontal extent of column cavity where no vertical cavity barrier is present (based on SEA00010474)

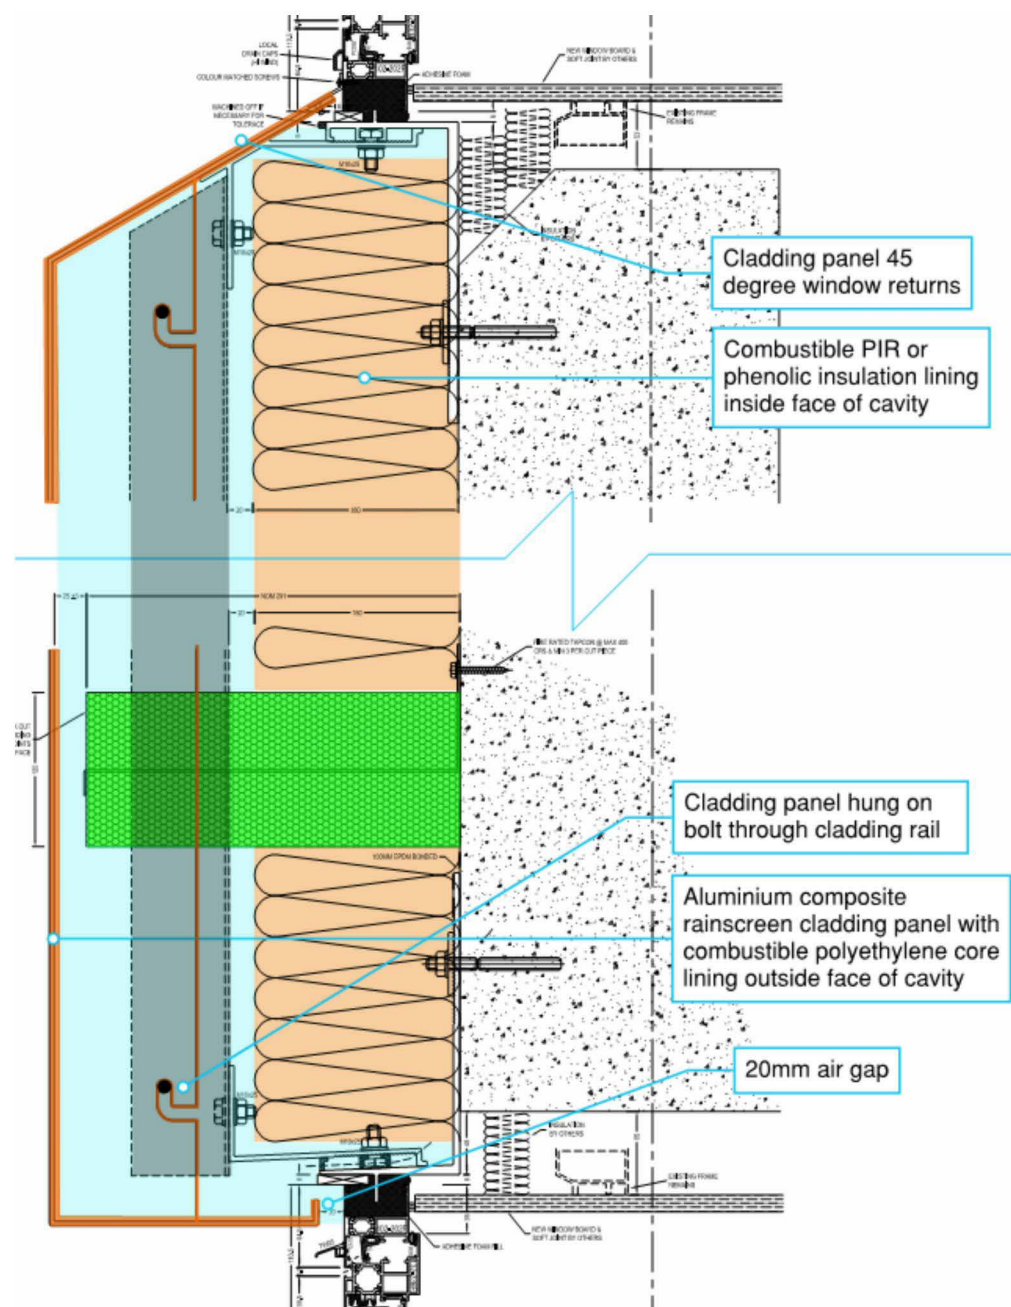
10.4.4 Figure 10.25 identifies the materials present in the building envelope on the outside of the concrete spandrels. These are: Reynobond rainscreen panels, with either Celotex PIR or Kingspan K15 phenolic foam (PF) combustible beneath; cavity barriers and metal support structure for the Reynobond panels.

Figure 10.25: Vertical section through building envelope at spandrel level (based on HAR00008879 & HAR00008901)

- 10.4.11** The flames and hot gasses within the spandrel cavity will be trapped in part, in the cavity, by the panel returning to meet the concrete spandrel at the window cill (Figure 10.25), allowing them to spread horizontally across the face of the building.

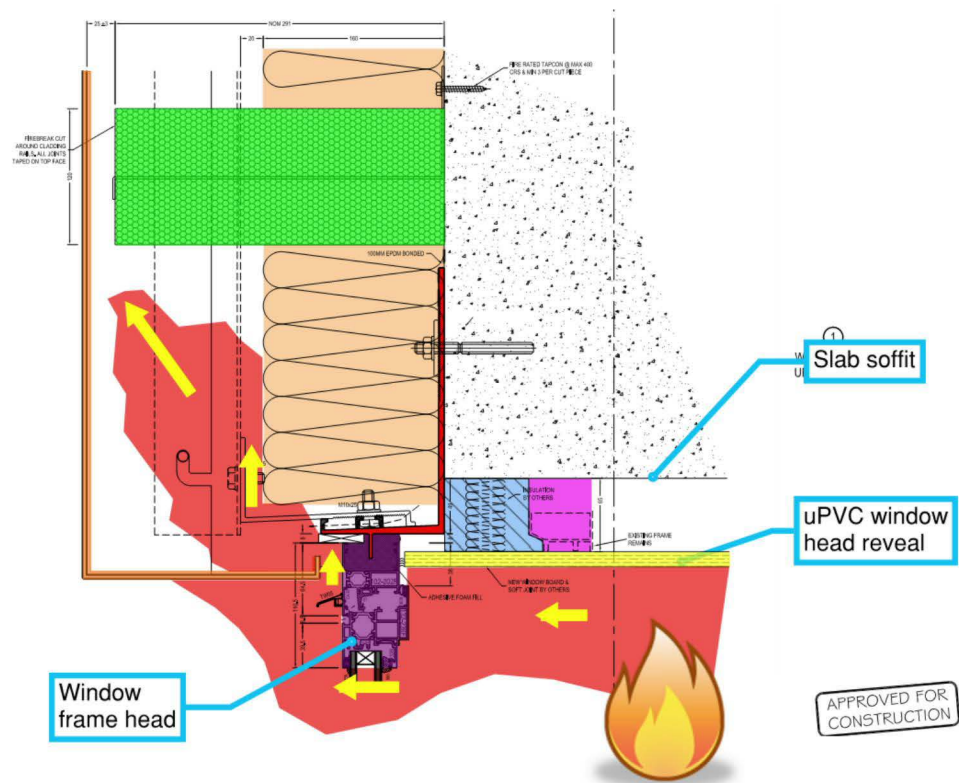
- 10.4.9** Fire can penetrate into the spandrel cavity either via Pathway A or by flames from internal fires breaking out of windows, passing into the cavity by the ventilation gap provided directly above the window head as identified in Figure 10.27.

Figure 10.27: Mechanism for fire to enter spandrel cavity at window head (replicated from Section 9) (HAR00008901)

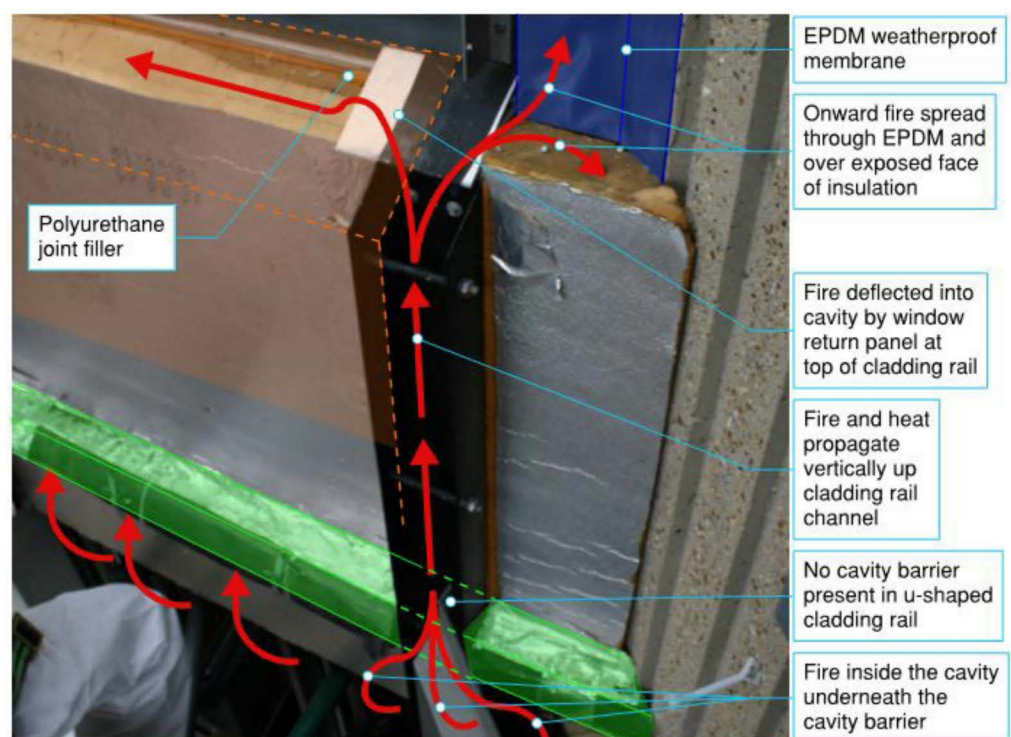
- 10.4.20** Additionally, the cladding rails installed on the spandrels as the supporting structure of the Reynobond cladding panels contribute to vertical fire spread by providing a route through the horizontal cavity barriers as shown in Figure 10.29. As can be seen in Figure 10.35 and in Figure 10.4, these cladding support rails are provided at the junction with the column, and directly below each end of the new combustible insulating core panel.

Figure 10.29: Schematic of possible fire spread via cladding support rail (External Flat 14)

10.7.7 As described in Section 8, one horizontal cavity barrier was positioned at approximately mid-height on the spandrel panels (Figure 10.29). There were no cavity barriers/firestops around the window openings, nor around the cavity formed by the Aluglaze infill.

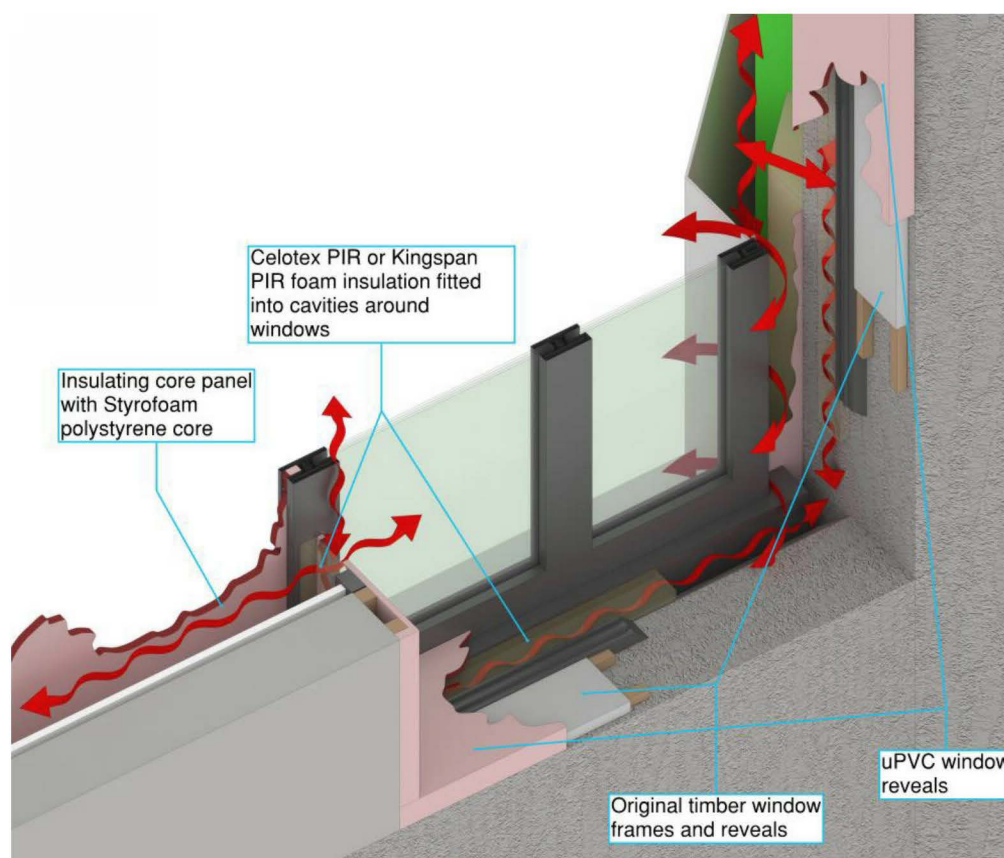
- 10.5.7** Please refer to Figure 10.31 for a diagram indicating the materials in the window surrounds.
- 10.5.8** This creates specific linear runs of combustible materials at the head and cill of each window.

Figure 10.31: Materials making up the window surround

- a) The presence of fuel (the combustible new uPVC window reveals, the original timber window frames and reveals, the combustible Celotex PIR or Kingspan therma PIR insulation behind the new uPVC cill and head reveals and the new Aluglaze extruded polystyrene insulating core panels) as shown in Figure 10.31 & Figure 10.32 ;
- b) The presence of oxygen from the outside atmosphere, or from within the flat; and
- c) Heat from a fire within a flat or in the external building envelope directly impacting the fuel identified in a) above.
- d) The presence of the Reynobond panel - either the cassette condition above a window or the cassette conditions below a window also provides a fire spread route (part of Route B).

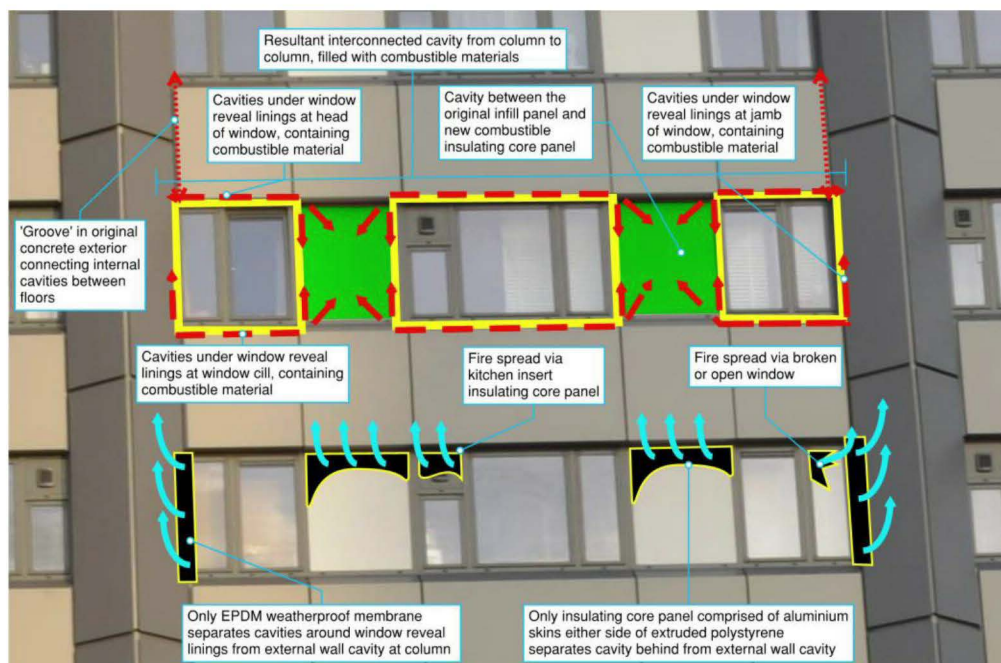
10.5.14 In Section 9 I found multiple pathways for fire to spread through the window construction and into the external rainscreen cavity. In Figure 10.33, I have replicated from Section 9 an external perspective showing how fire can spread from within flats to the external rainscreen.

Figure 10.33: Network of window cavities superimposed on exterior of the building and routes into external wall cavity (SEA00000350)

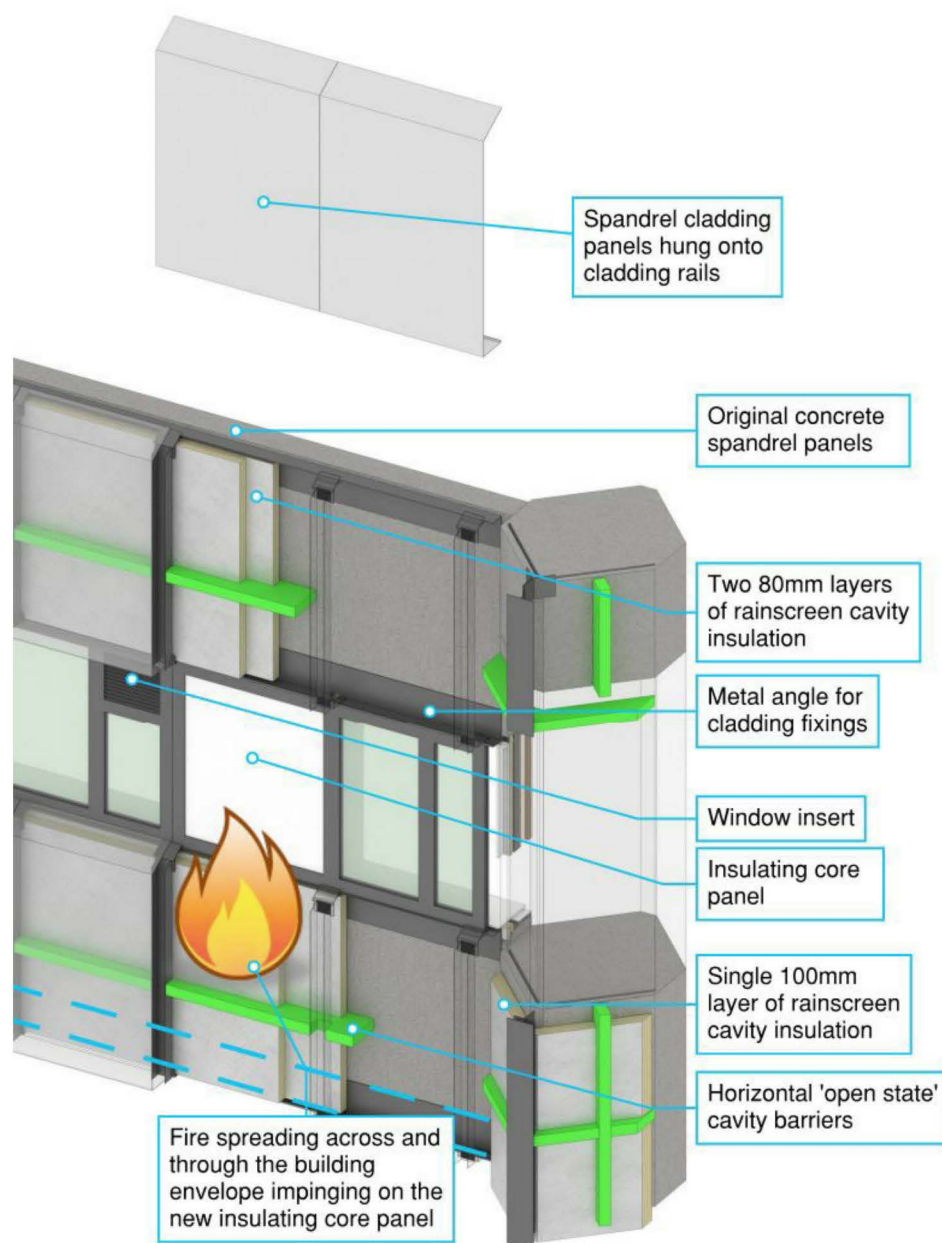
Styrofoam XPS core of the Aluglaze insulating core panels installed in between the windows, and the combustible Reynobond, Celotex and Kingspan materials fitted to the face of the spandrels. Please see Figure 10.38

Figure 10.38: Materials of the facade around the new combustible insulating core panels

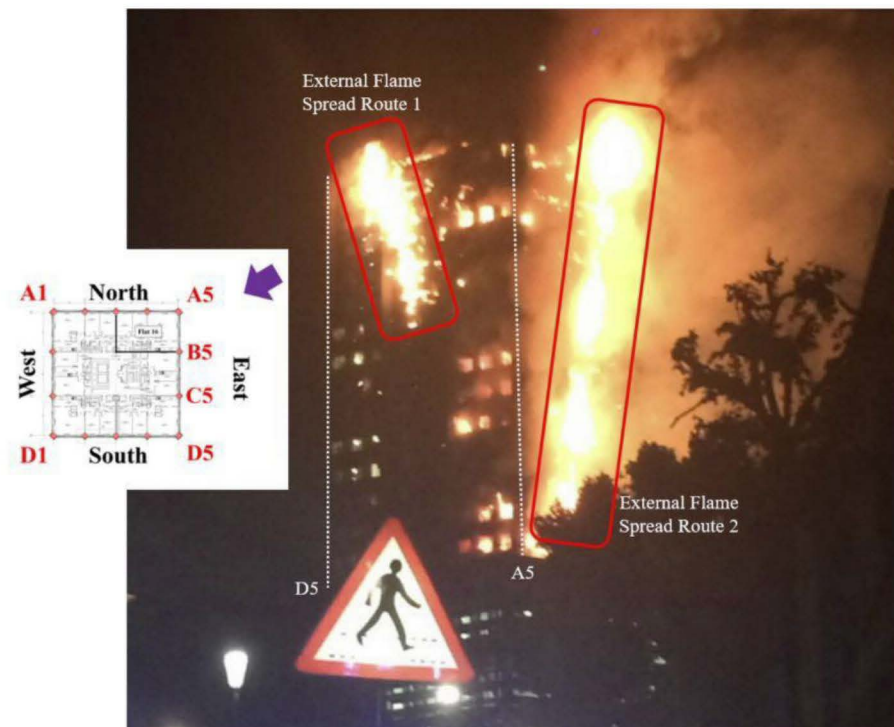
- 10.8.9** In most of the photographic and video evidence I reviewed of external fire spread after 02:08, I observed a consistent diagonal pattern of fire spread along both External Flame Spread Route 1 and 2, as shown in Figure 10.41, Figure 10.42 and Figure 10.43. The most advanced point of fire spread along the diagonal at any one time is located at the Crown.

Figure 10.41: Diagonal pattern for External Flame Spread Routes 1 and 2 at 02:08 on 14th June 2017 (MET00012593) (SEA00010474)

- 10.10.24** The diagonal pattern of flame spread I observed along both External Flame Spread Routes after 02:08 (refer to Figure 10.41) indicates that fire spread laterally across the crown on all elevations of Grenfell Tower (step 1 described in Section 10.10.22).

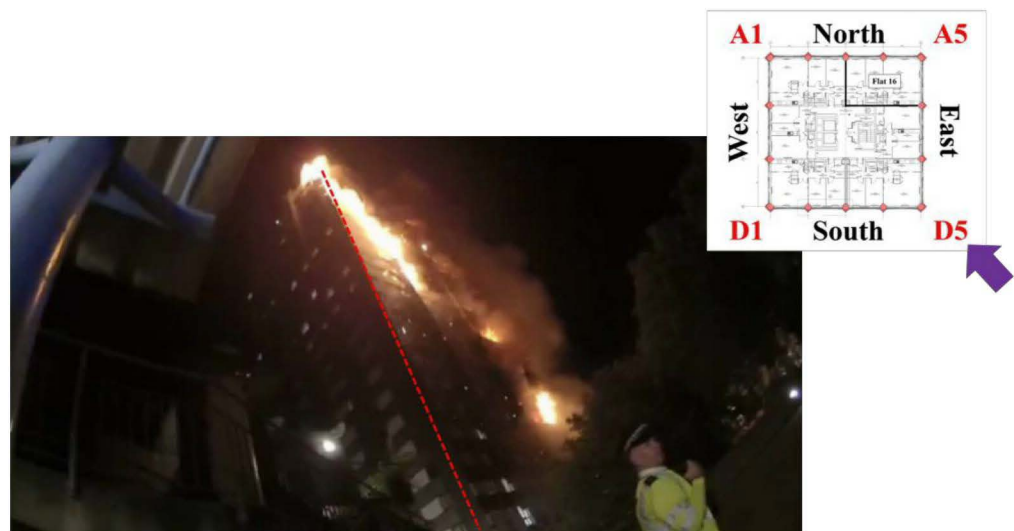
Figure 10.42: Diagonal flame front along External Flame Spread Route 2, that is, around column D5 (southeast corner of building), from East elevation to South elevation of the building envelope at 02:33 on 14 June 2017 (MET00012593) (SEA00010474)

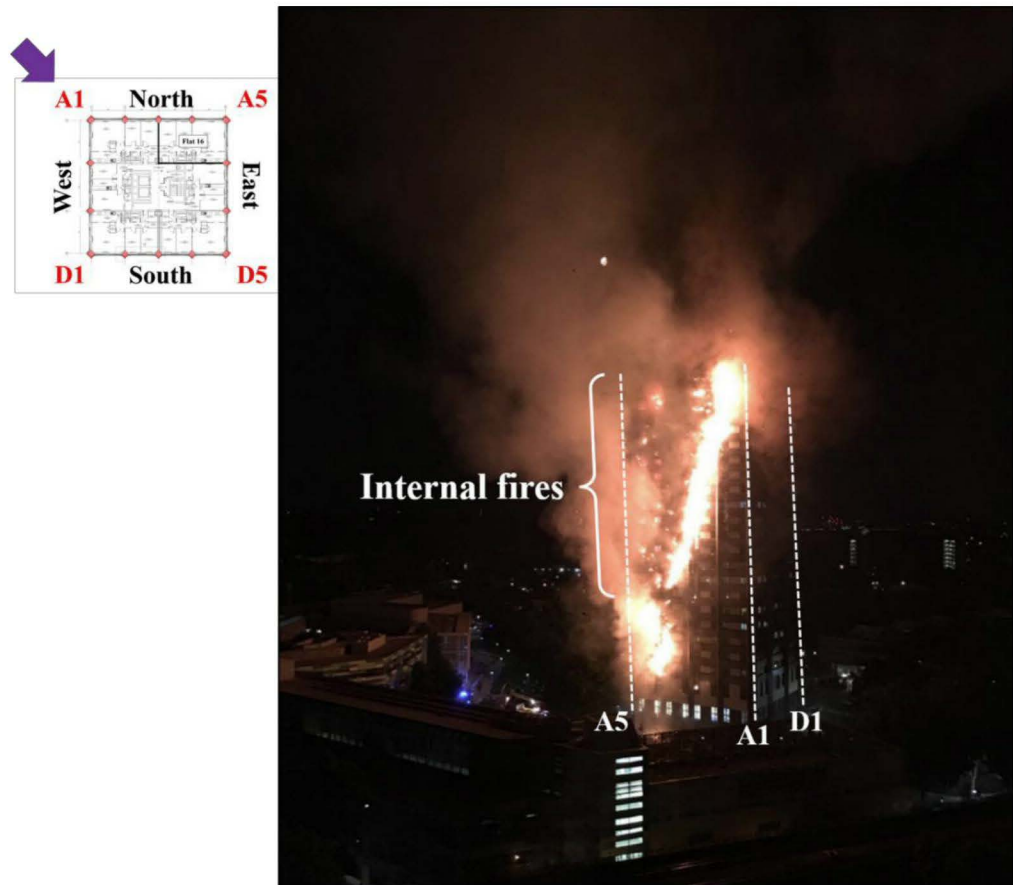
Figure 10.43: Diagonal flame front along External Flame Spread Route 1, that is, on the North elevation of the building envelope at 02:34 on 14 June 2017 (MET00012593) (SEA00010474)

- 10.8.10** This consistent diagonal pattern of flame spread indicates that fire advanced laterally along the crown before it spread to lower levels. In Section 10.10.14, I will describe the effect of the fire spreading at crown level before lower levels.
- 10.8.11** Behind the balustrade is the roof top plant room as well as a walking area; refer to Figure 10.45.
- 10.8.12** Figure 10.44 and Figure 10.45 identify that there is no evidence of fire spread over the surface of the roof. Damage and debris are largely present only at the perimeter of the roof.

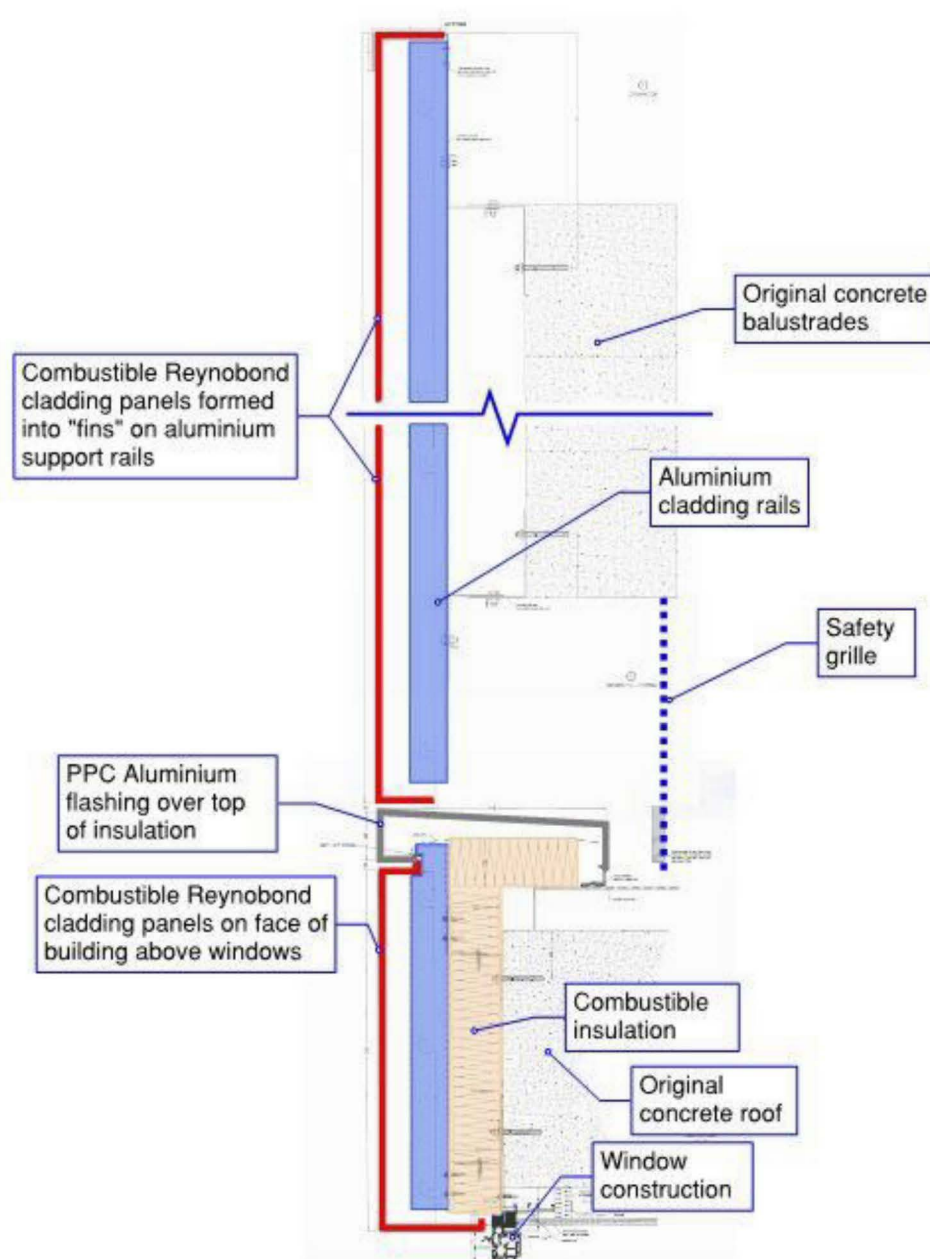
10.8.15 Figure 10.47 presents the specific materials used at the balustrade sections, based on Harley’s design drawings (excerpted from SEA0003242 and SEA00013263).

Figure 10.47: Materials used in balustrade sections of roof (excerpted from SEA00003242 and SEA00013263)

- 10.8.19 The safety grille indicated in Figure 10.47 was a steel mesh used to cover the gap between the bottom of the original concrete balustrade and the surface of the roof top, and was intended to be used as edge protection.

10.8.25 As indicated in Figure 10.47 and Figure 10.48, the Harley drawings did not appear to include a requirement for a horizontal cavity barrier/fire stop above the Level 23 windows. Therefore, no provision was made to prevent vertical fire spread from level 23 up to the roof area, including the Crown.

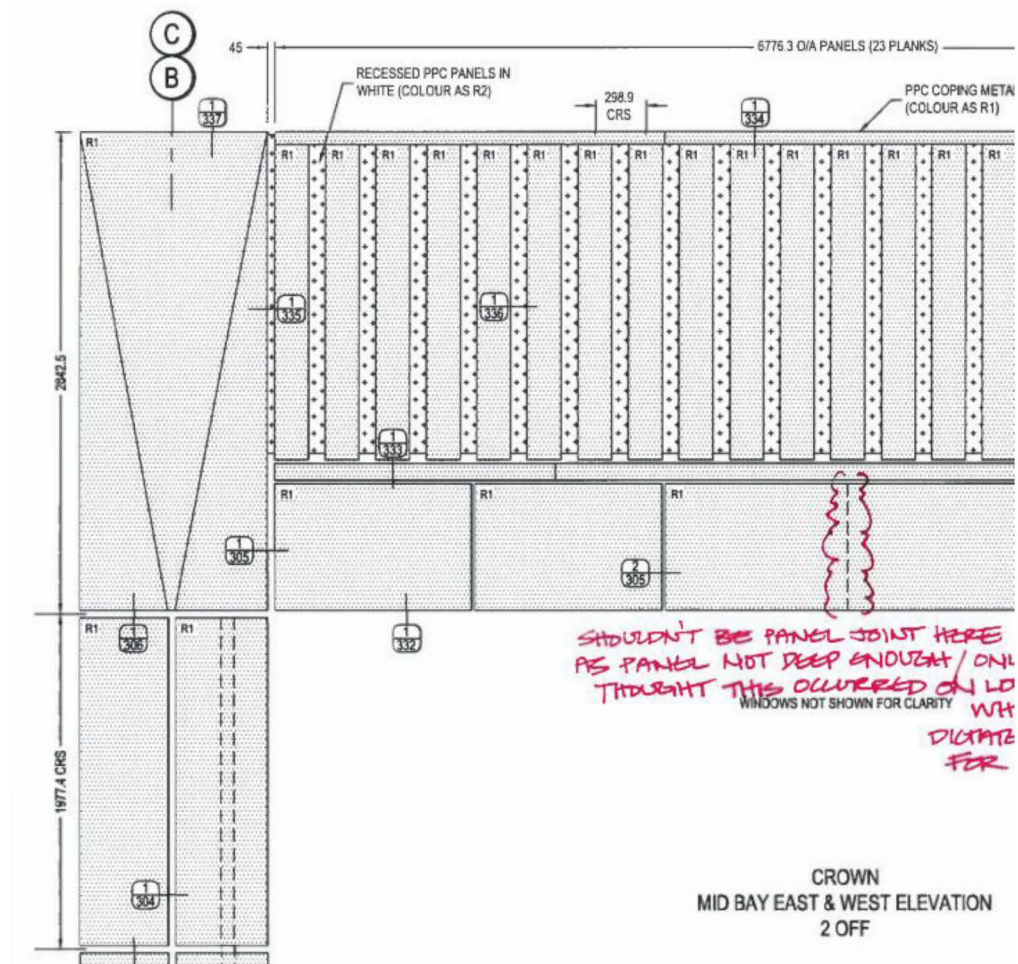
Figure 10.48: Excerpt from Harley drawing C1059-216 – red over-marks from original document (SEA00003242)

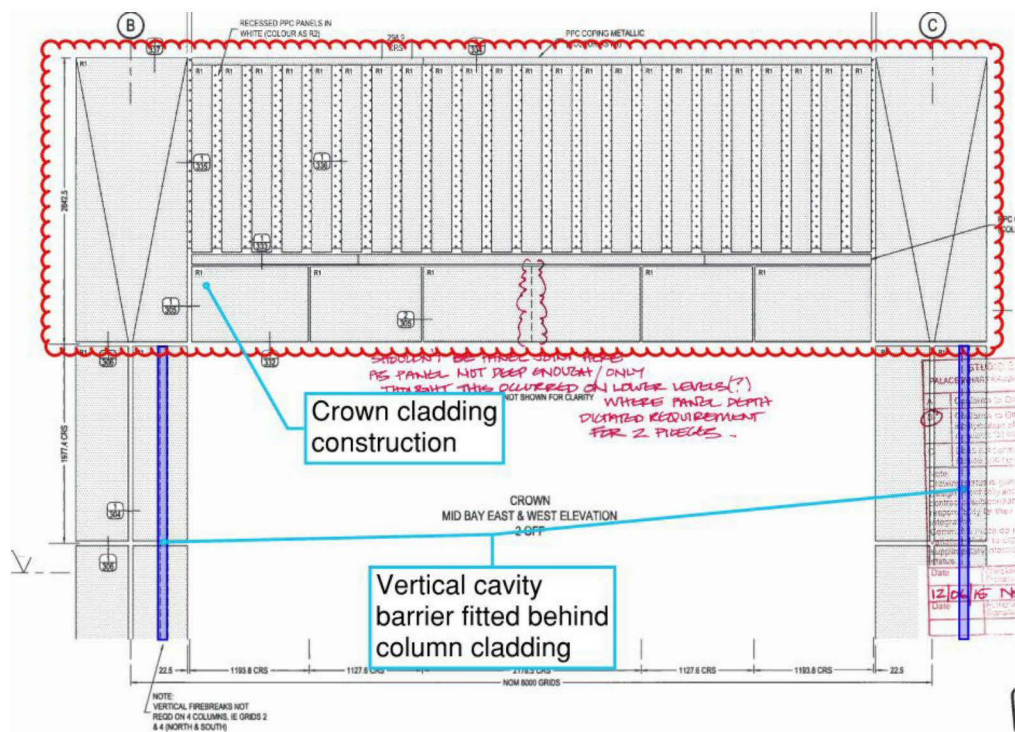
10.8.24 There is no evidence currently available that any provisions were made to prevent horizontal fire spread around the crown cladding. The Harley “approved for construction” drawings (Figure 10.49) indicate that the vertical cavity barriers provided behind the new column cladding were to terminate at the level of the top of the windows at Level 23. This would allow fire to spread over the top of the cavity barrier.

Figure 10.49: Harley “approved for construction” design drawings showing vertical cavity barrier extent (based on SEA00003242 red writing from original document)

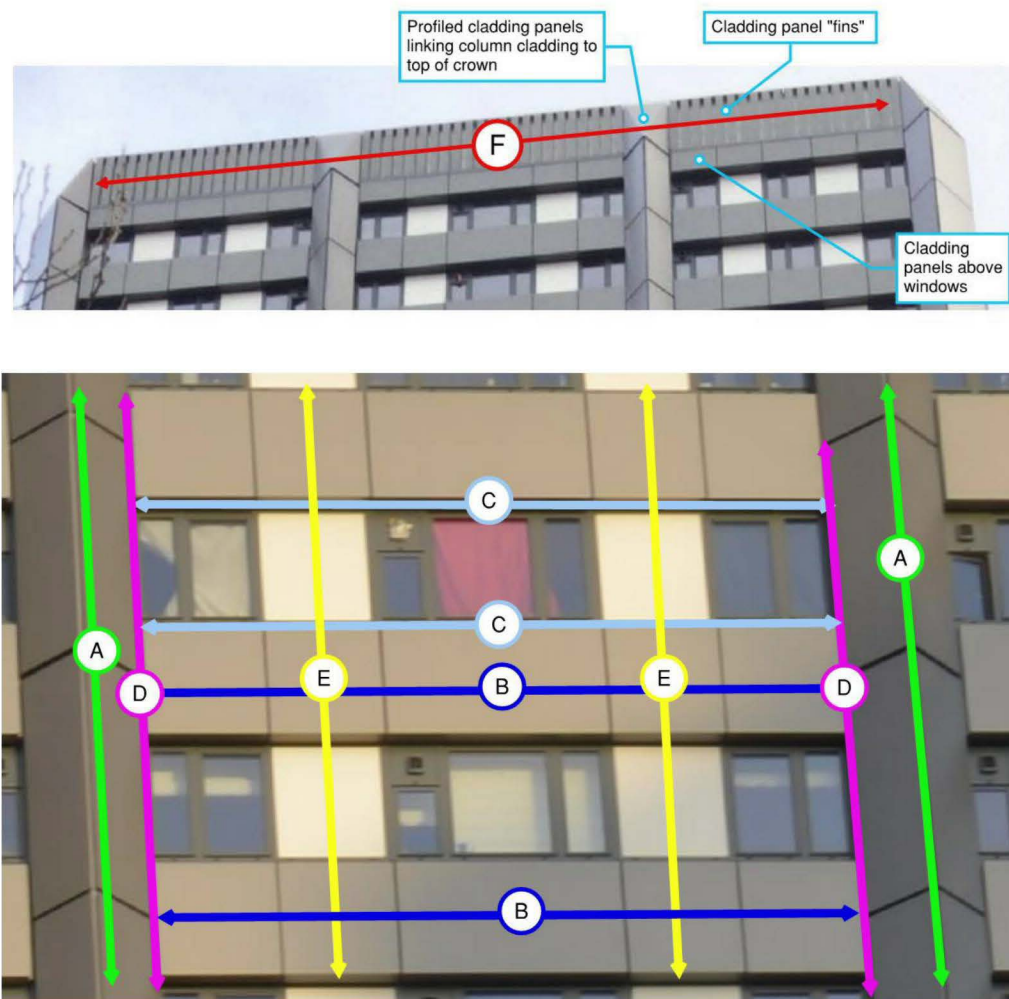
- 10.10.1** I have explained the 6 Pathways (A, B, C, D, E and F) shown in Figure 10.57 and how they permit vertical and horizontal fire spread along the building envelope.

Figure 10.57: Pathways A to E (lower image) and F (Crown) identified on undamaged façade (SEA00000350; SEA00000322)

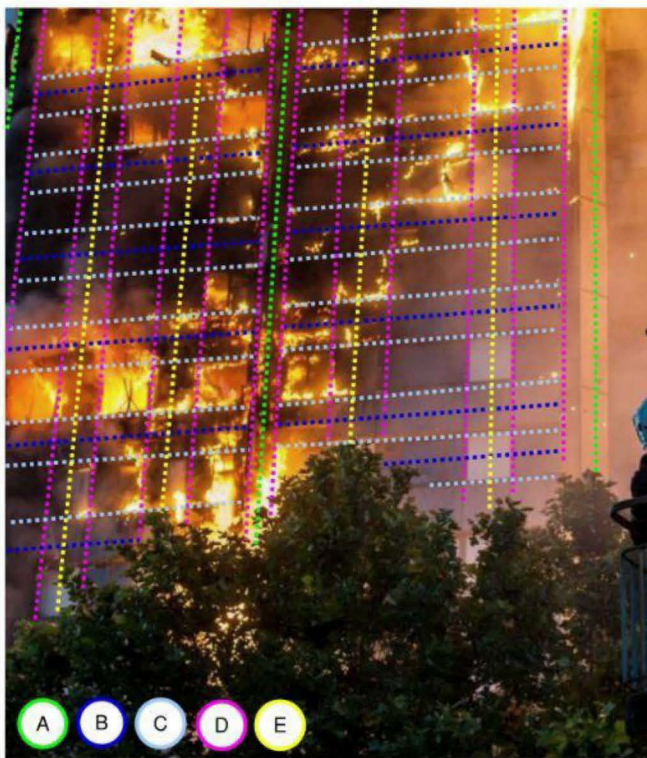
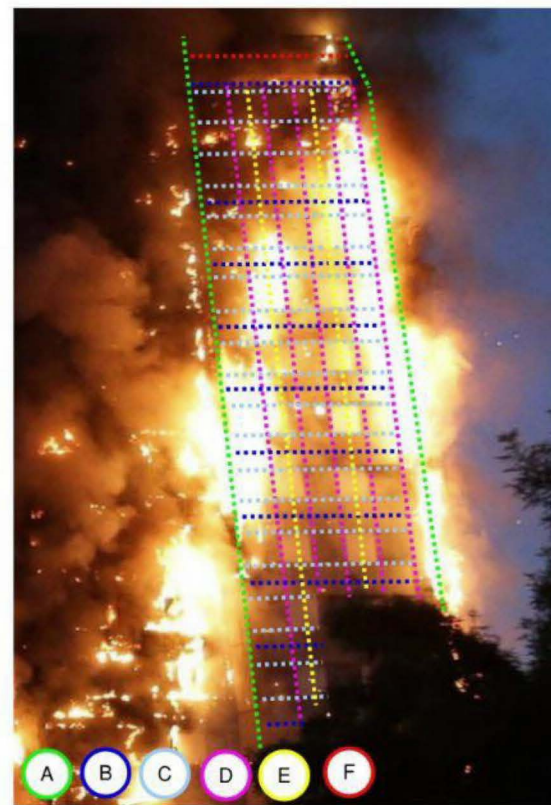
10.10.6 This fully connected grid facilitated fire spread in both the vertical and horizontal directions on all elevations of the building and between elevations, connecting the entire building envelope of Grenfell Tower. Figure 10.58 shows photographic evidence of fire spread via each of the six pathways on the West elevation of Grenfell Tower.

(b) Photographic evidence of Pathways A, B, C and D¹²

(b) Photographic evidence of Pathways A, B and E¹³

Figure 10.58: Fire spread on West elevation of Grenfell Tower

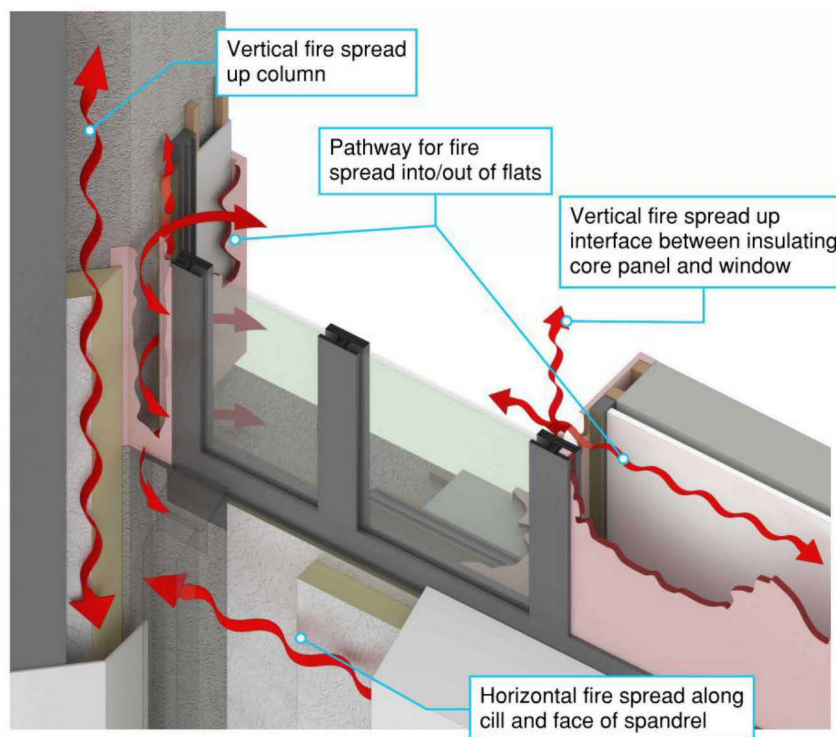
10.10.7 These six pathways and their connections permitted the fire to encompass the whole of the façade and penetrate inwards to the majority of the flats. I have presented in Section 9 the specific routes that I have identified that could permit fire to spread from inside a flat into the building cladding, but importantly fire could spread from the outside of the building back inside, as shown in Figure 10.59.

Figure 10.59: Pathway between external wall cavity and inside of flats

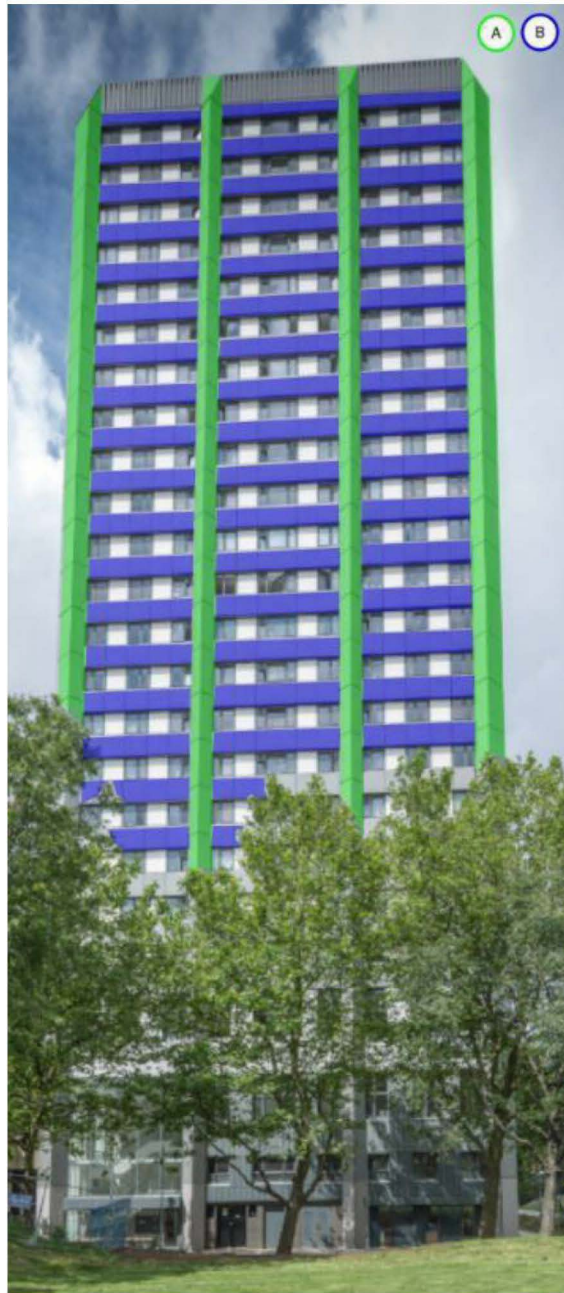
10.10.11 In this section I have considered the two pathways relevant to the external rainscreen cladding system only (Figure 10.61), that is:

- a) Pathway A: Vertically via the Reynobond 55 PE and Celotex RS5000 insulation attached to the columns; and
- b) Pathway B: horizontally via the Reynobond 55PE and Celotex RS5000 or Kingspan K15 thermal insulation attached to the spandrels.

Figure 10.61 Pathways for external fire spread: pathway A and B (SEA00000387)

- 10.10.12** In Figure 10.61 I have over-marked a photograph of Grenfell Tower before the fire on 14th June 2017. The vertical and horizontal connection between the columns and spandrels creates a grid and therefore resultant pathway for fire to spread over the full extent of the exterior of Grenfell Tower.
- 10.10.13** Figure 10.62 shows photographic evidence of fire spread via Pathways A and B on the West elevation of Grenfell Tower. The installation of Reynobond 55PE ACM panels and Celotex RS5000 or Kingspan K15 thermal insulation along the columns and spandrel panels in the rainscreen system created a grid covering all parts of the external wall in isolation.
