Grenfell Tower – fire safety investigation:
The fire protection measures in place on the night of the fire, and conclusions as to:
the extent to which they failed to control the spread of fire and smoke;
the extent to which they contributed to the speed at which the fire spread.

Phase 1 Report – Section 10

Routes for vertical and horizontal fire spread throughout the building envelope

Dr Barbara Lane FREng FRSE CEng

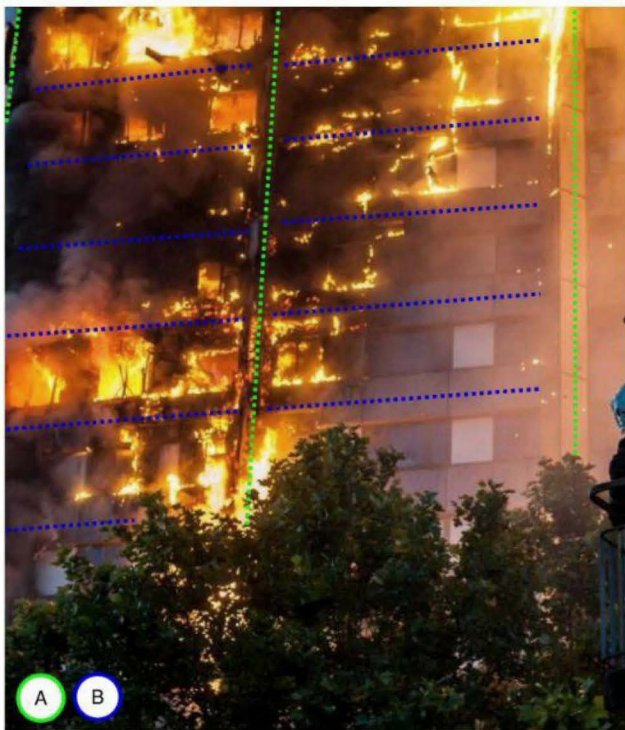
(a) Photographic evidence of Pathways A, B, C and D¹⁴

Figure 10.62: Fire spread on West elevation of Grenfell Tower

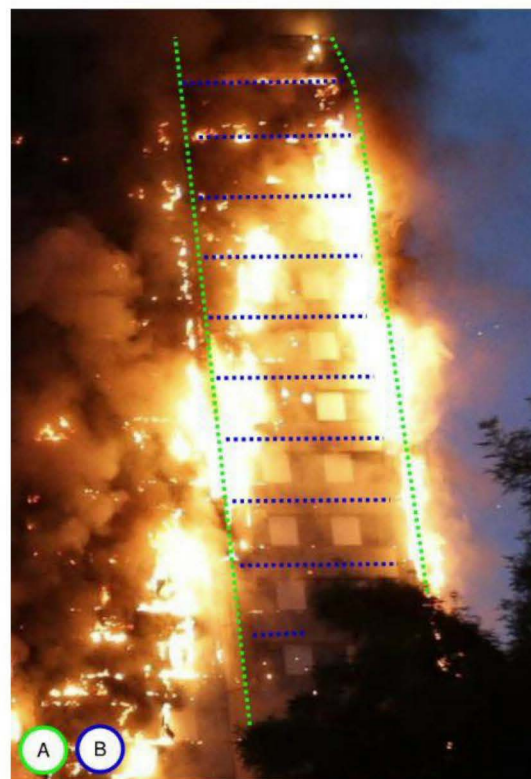
(b) Photographic evidence of Pathways A, B and E¹⁵

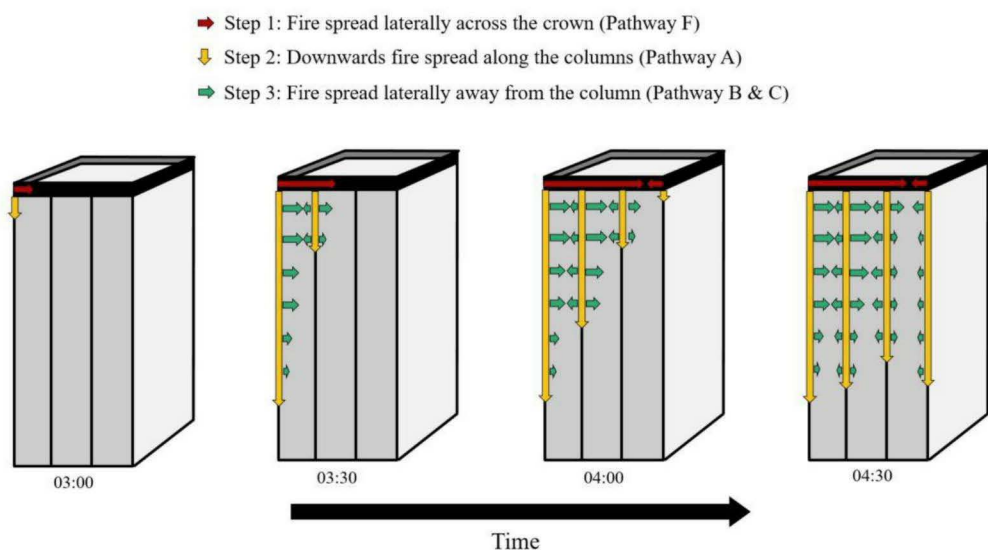
10.10.26 In Figure 10.72, I provide a schematic of these three steps of external fire spread caused by the crown, as I observe them to be, to demonstrate the effect of fire spread along the architectural crown on lower levels of the building over time.

10.10.27 This schematic is based on photographic and video evidence of external fire spread on the West elevation of Grenfell Tower.

Figure 10.72: Schematic demonstrating the effect of fire spread along the architectural crown on lower levels of the building over time, on the West elevation of Grenfell Tower (MET00012593) (see Videos 2-5 accompanying Prof. Bisby's supplemental Phase 1 report.)

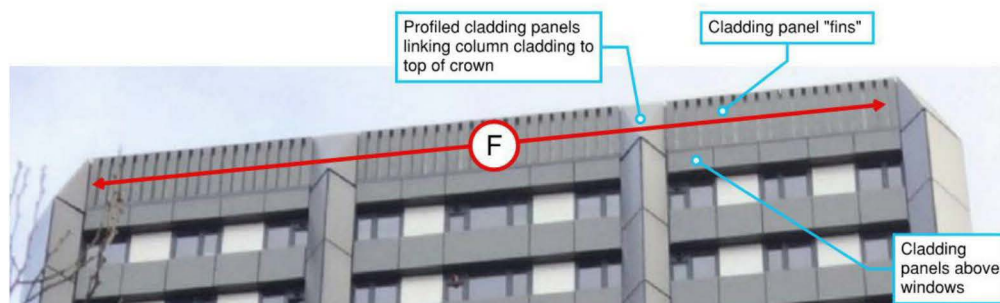
- a) Fire spread from combustible cladding panel “fins” on the architectural crown to the combustible cladding panels, insulation and cavity above the Level 23 windows (refer to Figure 10.73) – see photographic evidence in Figure 10.74; and
- b) Polyethylene from the Reynobond 55 PE panels on the crown melting and running down the building, while ignited – see photographic evidence in Figure 10.75.

Figure 10.73: Pathway F (Crown) identified on undamaged façade (SEA00000322)
