**Grenfell Tower – fire safety investigation:  
The fire protection measures in place on the night of the fire, and conclusions as to:**

**Phase 1 Report – Section 14**

**The performance of the protected stair and lobbies**

**Dr Barbara Lane FREng FRSE CEng**

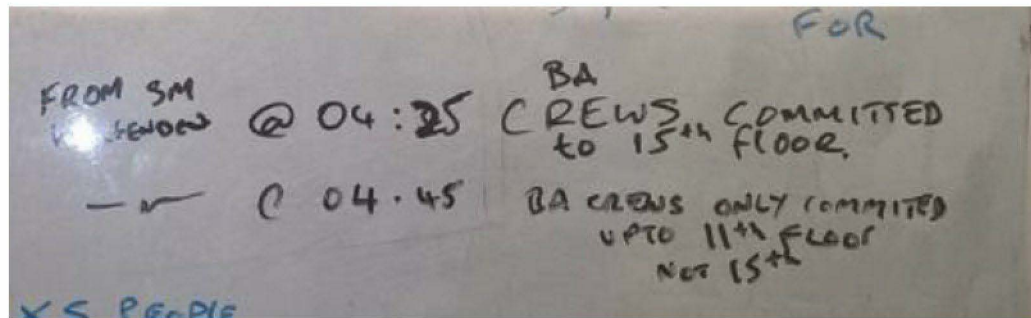
Figure 14.16: Excerpt from MET00015925 recording the times at which restrictions on crew movements were imposed

- a) Approximately 04:25 – Wolfenden and Welch have a discussion resulting in agreement to try to get firefighters up to Level 15. The result of this discussion is recorded on a white board in CU7 (MET00015925, excerpted below). By this time there had been 58 FSG calls recorded from floors between Ground and Level 15. After 04:25 only 5 of the residents still in the tower were rescued, all from Level 10 or 11. However, as I describe in Table 14.10, there were only 7 fatalities of residents who lived between Ground and Level 15, and therefore the majority of residents who made FSG calls from Level 15 or below were able to escape the building.
- b) Approximately 04:45 – In his oral evidence, Egan records a communication from Wolfenden that crews will not be committed above Level 11 (MET00015925, excerpted below). There were no FSG calls from above Level 11 at that time.

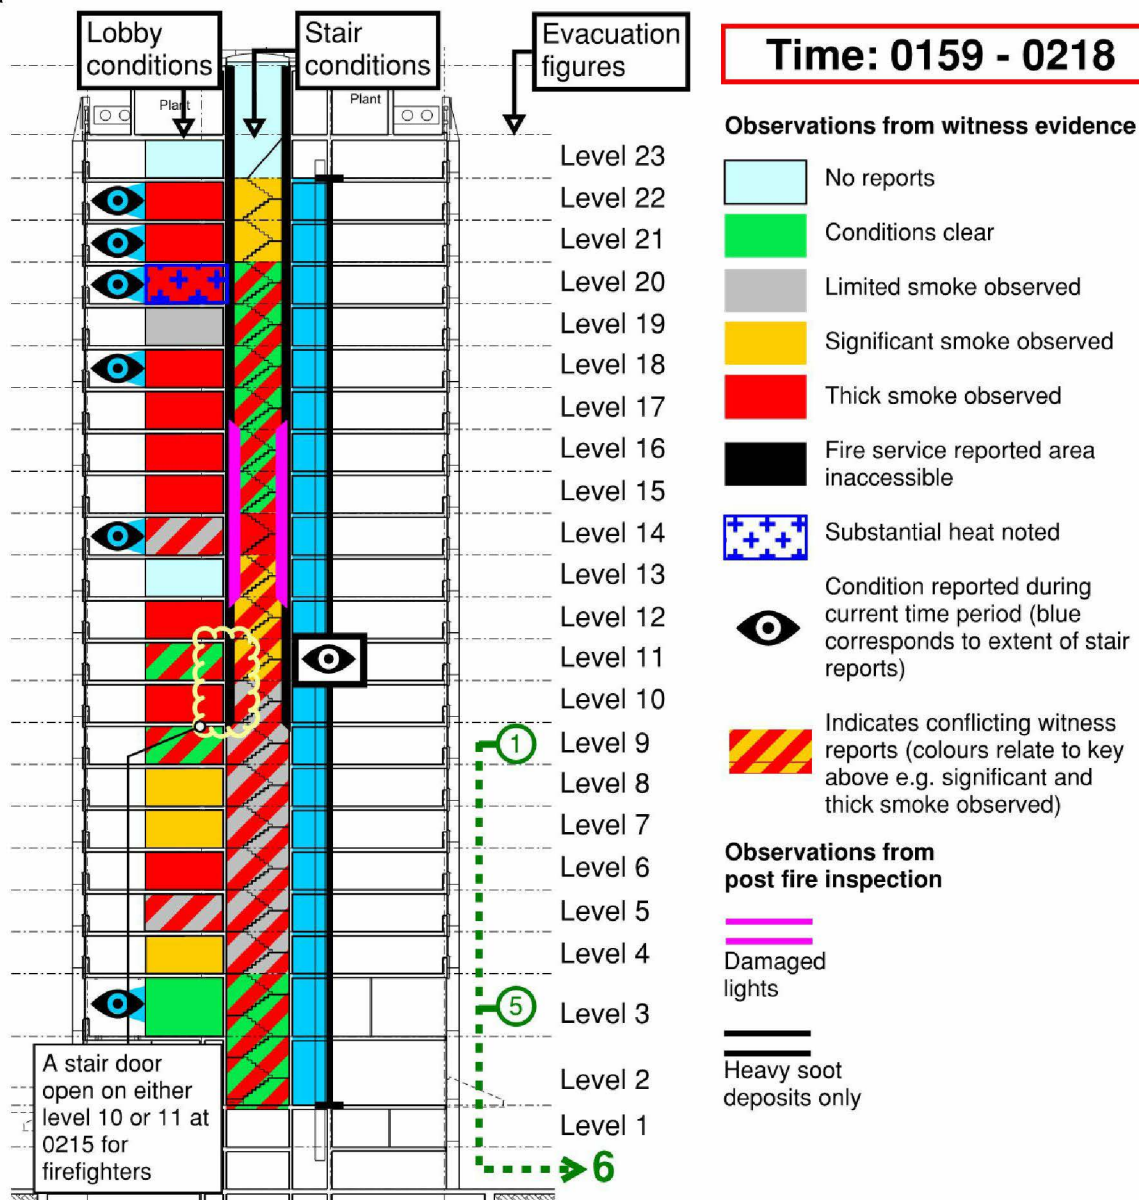
Figure 14.22: Condition of the stair and lobbies between 01:59 and 02:18

**14.4.80** Based on the evidence available, smoke began to enter the lobbies on floors above Level 4 from approximately 01:18. Additionally, the stairs became significantly affected by smoke with visibility decreasing from approximately 01:40, and particularly after 02:00 (as seen in Figure 14.22).

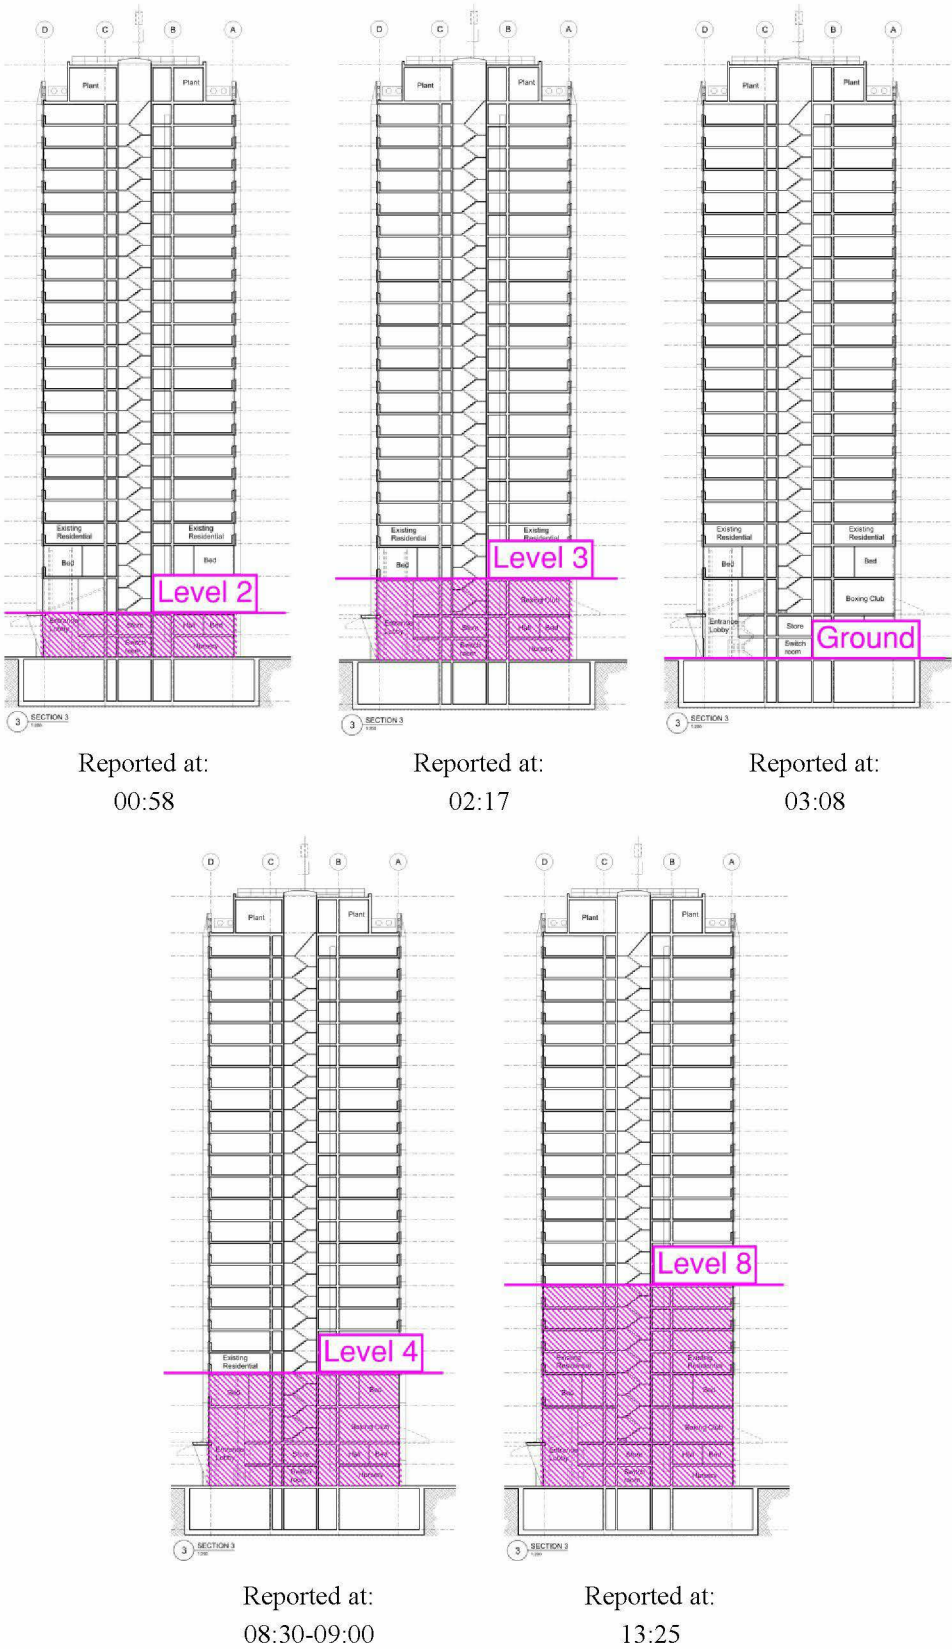
Figure 14.31: Location of Bridgehead relative to conditions reported in stairs purple shading indicates the floors below the level of the Bridgehead (SEA00009461).

**14.4.132** In Figure 14.31 I have overlaid the Bridgehead position over the relevant conditions reported in the stair at these times.

**14.4.133** The pink hatching in Figure 14.31 indicates the floors below the Bridgehead - the so-called lobby sector.

- 14.4.138** Figure 14.31 indicates that firefighters in Grenfell Tower were required to use their breathing apparatus from the Bridgehead. From Figure 14.31 I have shown this was not the standard two floors below the fire floor. In the worst case between 3:08 and 6:31 when the Bridgehead was at ground floor, there were 23 floors between the Bridgehead and the top fire floor (Level 23).

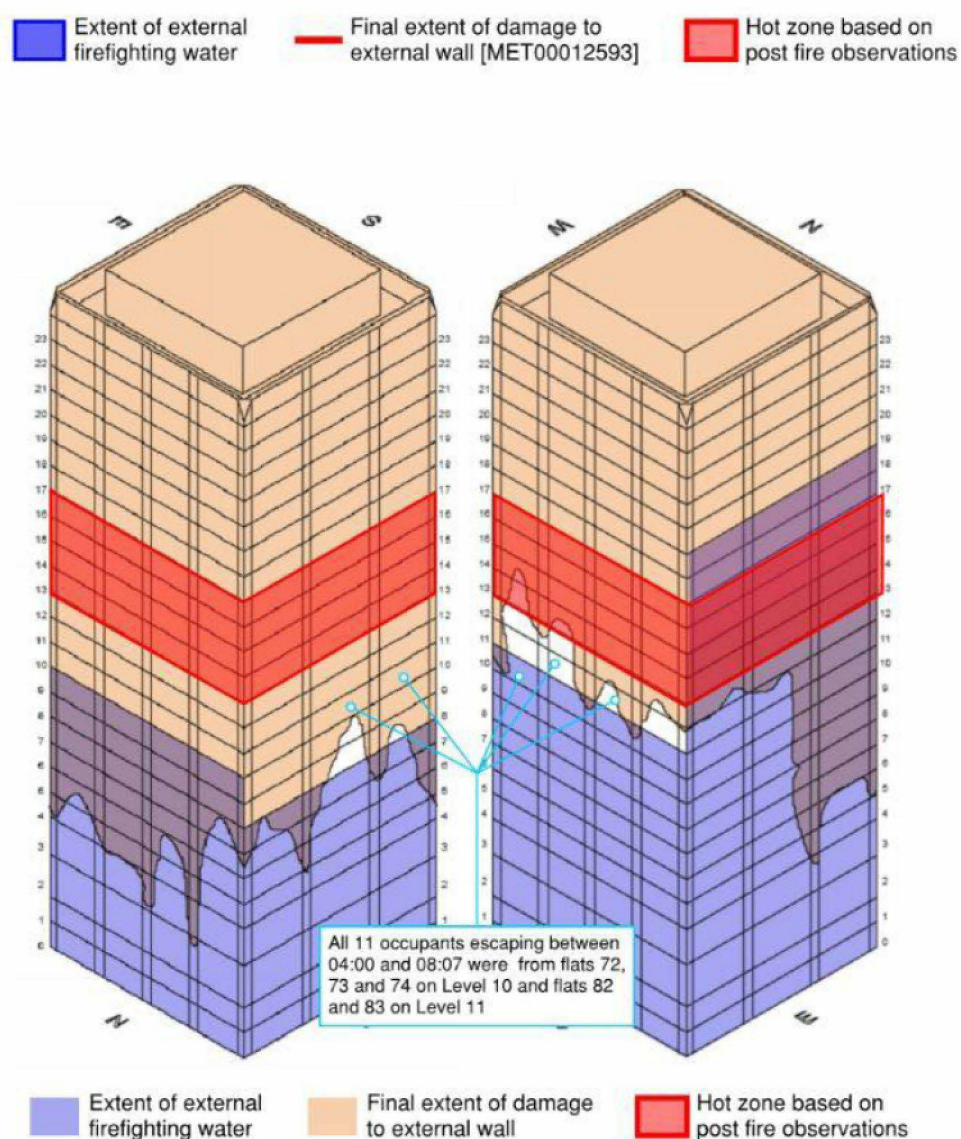
**14.4.150** I have compared the approximate reach of the four confirmed sustained external firefighting positions, with the damage to the building envelope observed post-fire on each elevation; refer to Figure 14.32 and Section 17. There appears to be a strong correlation between the levels to which external water was applied and the lack of external fire damage on these levels.

**14.4.151** On Figure 14.32 I have also marked Levels 13 – 16, where my post fire inspection has identified the conditions within the stair as being particularly severe. I have overlaid this location to compare it with the extent of external damage and also external fire-fighting water application.

- 14.4.155** Finally, I have also over-marked in Figure 14.32, showing the location I believe the last 11 residents to evacuate from Grenfell Tower originated from. This is in Flats 72, 73 and 74 on the South and West elevations of Level 10, and Flats 82 and 83 on the South elevation of Level 11 (MET00016072).

Figure 14.32: Estimated extent of external firefighting water coverage prior to 04:40am (Section 17), extent of external fire spread (Section 5, 12) and the hot zone within the protected stair as described in this Section 14 from post fire inspections.

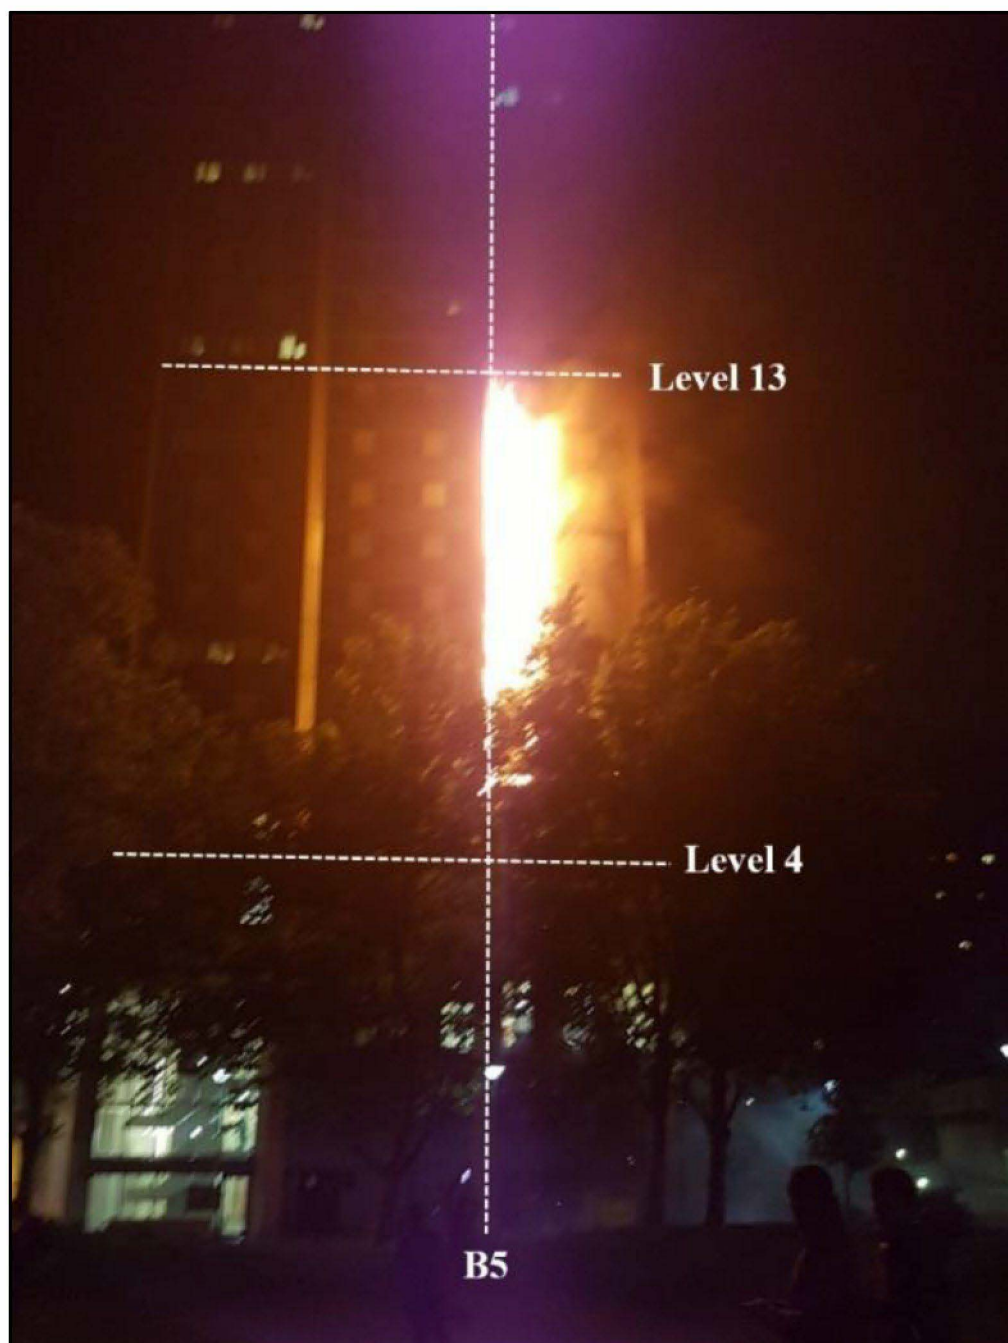
**14.4.165** Figure 14.33 and Figure 14.34 shows the fire observed in the cladding at approximately 01:20 and 01:40, to coincide with the end of the first and second 20 minute periods respectively.

Figure 14.33: Fire on East elevation of the building envelope at 01:22 on 14<sup>th</sup> June 2017 (MET00012593)

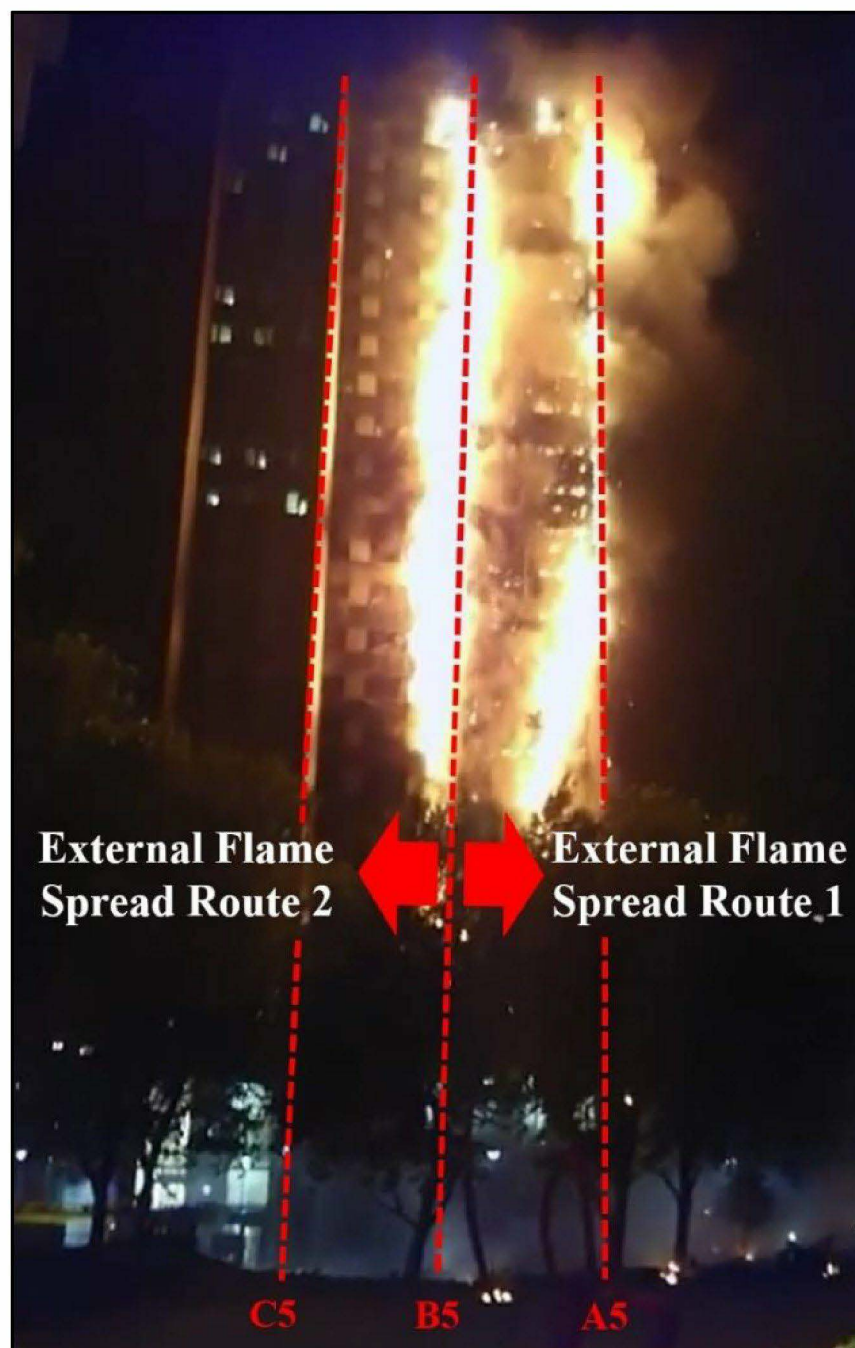
Figure 14.34: Fire on East elevation of the building envelope on 14<sup>th</sup> June 2017, estimated time 01:36

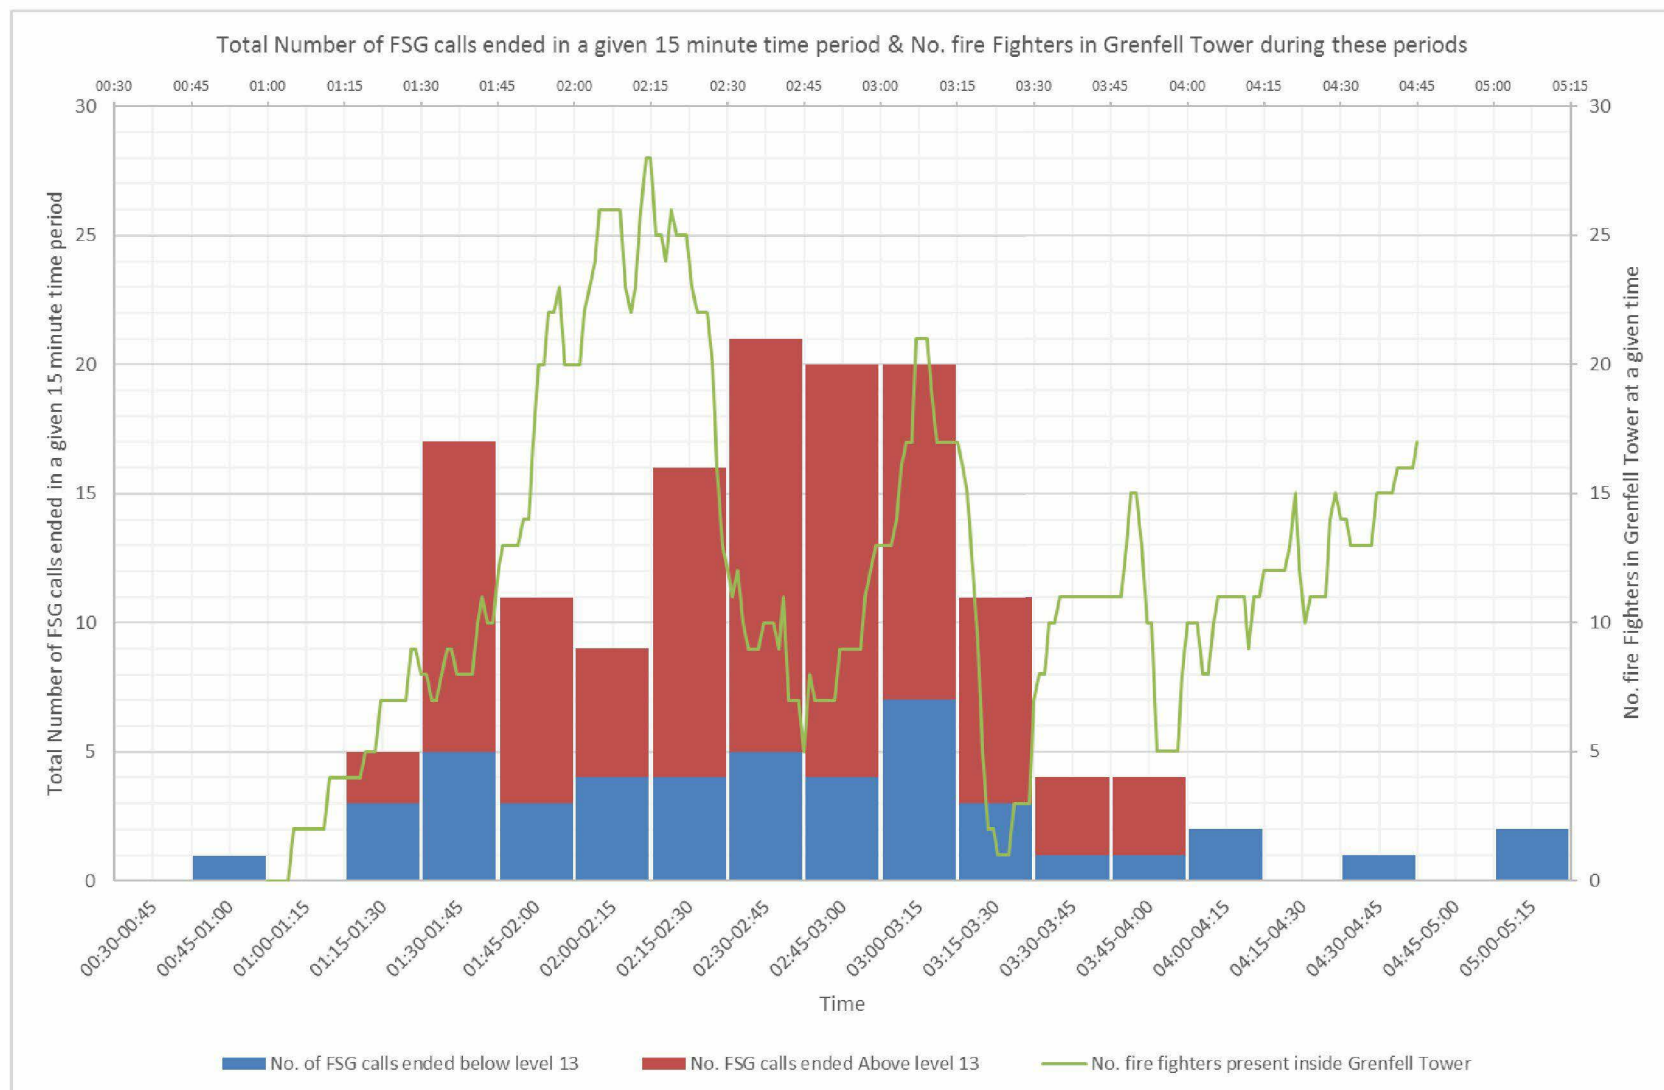
Figure 14.35 Frequency of FSG calls vs time & No. Firefighters in Grenfell Tower at start of time interval

- 14.4.178** It can be seen in Figure 14.35 that there was an initial surge of FSG calls between 0130 and 0145 (23 calls in total).
- 14.4.179** The number of firefighters beyond the bridgehead in Grenfell Tower increased from 5 at 0115 to 28 at 0215.

- 14.4.180** Between 02:15 and 02:45 the number of firefighters beyond the bridgehead in Grenfell Tower reduced from 28 to 5. During this period the number of FSG calls recorded as finishing increased from 12 between 02:15 and 02:30, to 23 between 02:45 and 03:00. Note that my Figure 14.35 does not record the duration of calls, but only indicates the number of calls that completed within each time period.

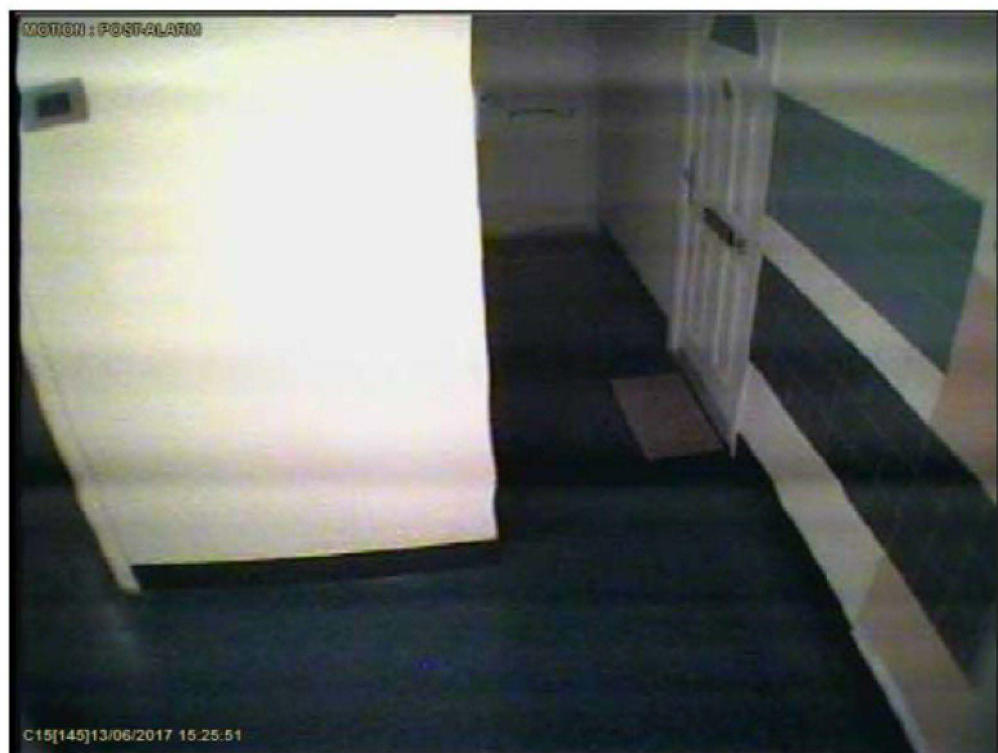
**14.6.54** Stills taken from CCTV footage (MET00012593), reproduced in Figure 14.39 to Figure 14.42, identify the changing conditions in the lobby of Level 7 at 01:40, 03:00 and 03:36. The conditions at 03:36 (Figure 14.42) indicate that the lighting has either failed, the CCTV camera has malfunctioned or complete obscuration of the light has occurred due to thick black smoke.

Figure 14.39: Level 7 lobby - Before the fire (MET00012593)

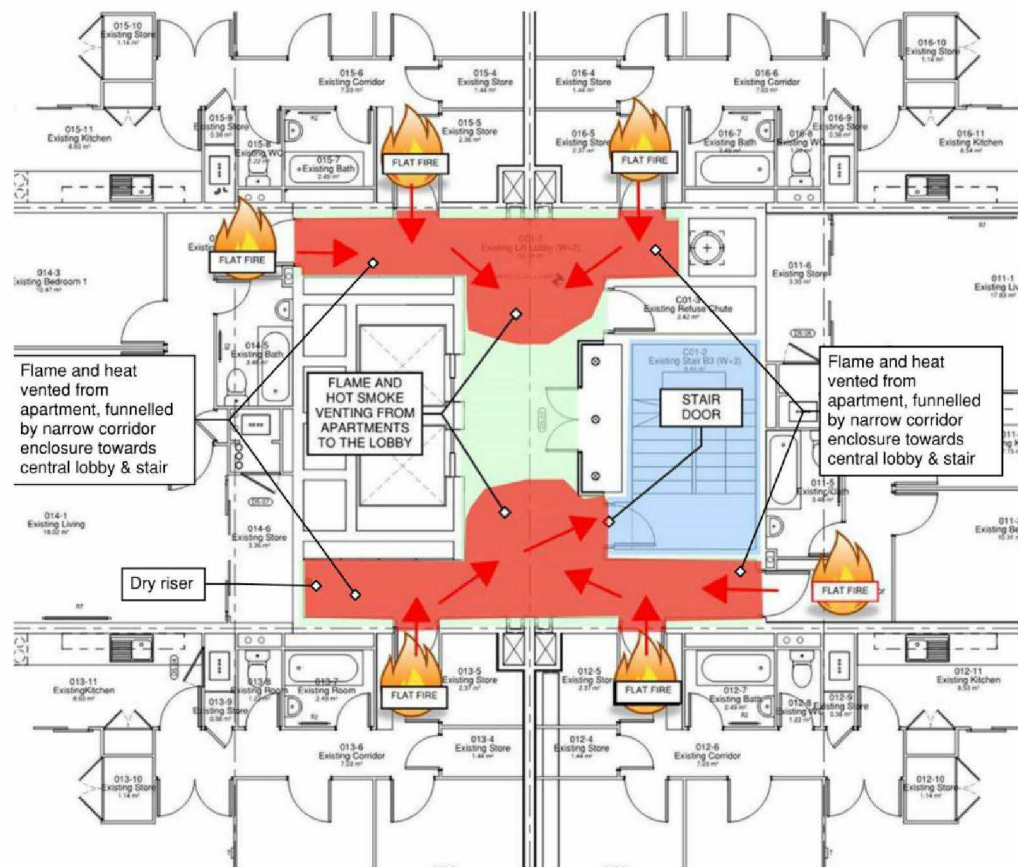
- 14.6.71** Hot gases could enter the lobby from flats through flat entrance doors that were either left open or failed during the fire; I have illustrated this schematically in Figure 14.48.

Figure 14.48 Illustration of heat and smoke venting from apartments to the lobby (based on SEA00010474)

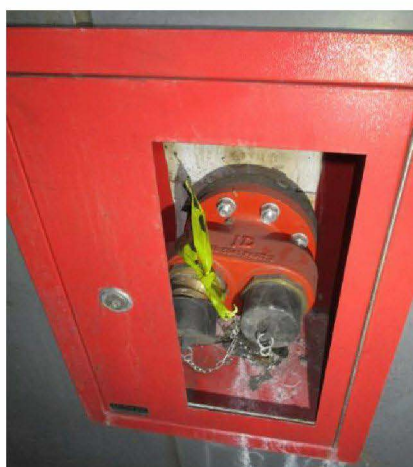
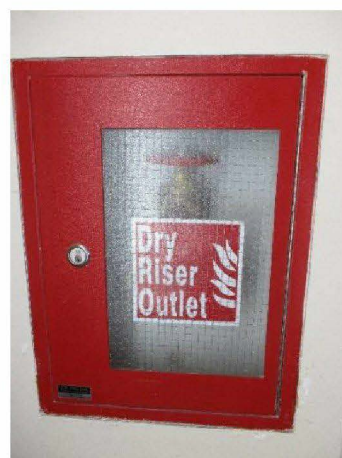
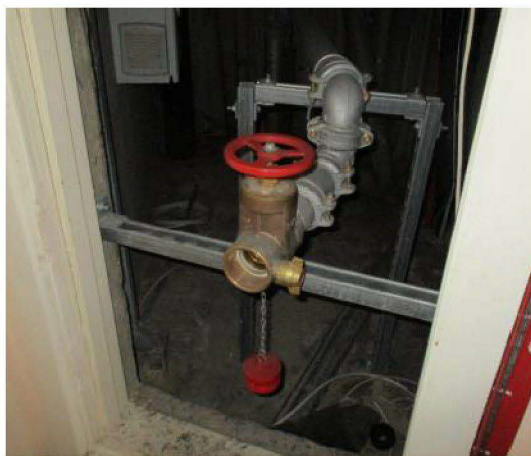
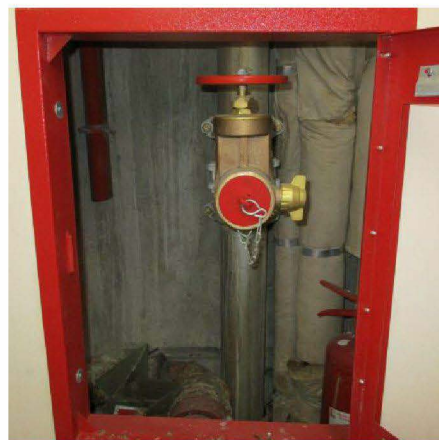
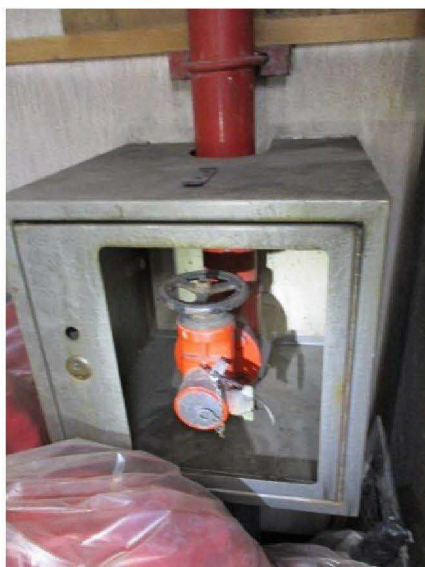
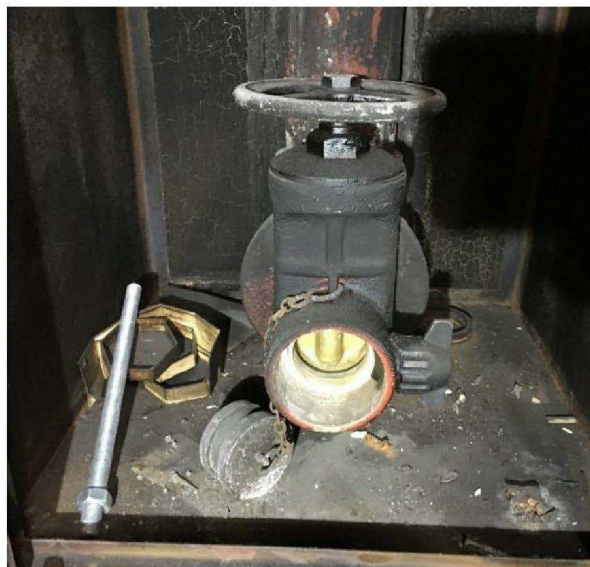
Figure 14.56: Example photos of the dry fire main

- 14.7.3 Evidence from the post fire site inspection**
- 14.7.4** During my site inspection I observed a fire main outlet at every level of Grenfell Tower, I have included photographs of a number of levels as an example in Figure 14.56; please refer to Appendix C for further details.

- 14.7.5** It is not possible to identify from these post-fire inspections which fire main outlets were used during the fire.
- 14.7.6** The only evidence of hose connection to the fire main I found during my post fire inspection was on Level 14 (see Figure 14.57). It is not possible to determine at what time this was connected or if the hose was used on 14 June 2017.

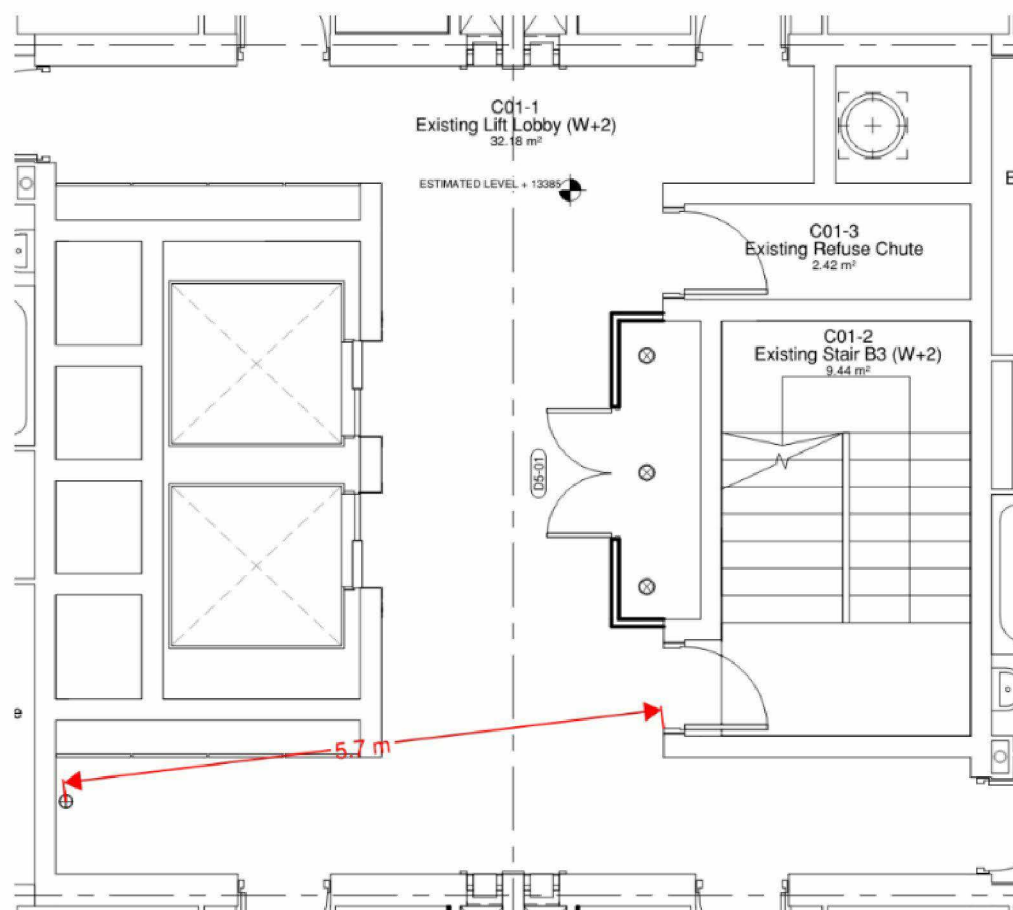
- l) The fire main was located within the narrow enclosure, 5.7m from the stair door (refer to Figure 14.58 Position of fire main relative to stair door on Levels 04 – 23), and directly outside the entrance door of Flat 3 on each level. Therefore, smoke and heat venting from a flat entrance door because of a flat fire, vented directly in front of the fire main. I have recorded severe damage around the fire mains on multiple levels.

**14.7.10** I have shown in the preceding sections that a fire main outlet was provided on every floor of Grenfell Tower. This fire main outlet was located in the Southwest corner of each lobby, immediately adjacent to the entry door to one of the flats (Figure 14.58).

**14.7.11** As I have explained earlier in this section, fires adjacent to flat entrance doors in this location caused venting of fire and smoke into the lobby, resulting in severe damage. I observed this damage on site and there is also support for this in the firefighter witness statements.

Figure 14.58 Position of fire main relative to stair door on Levels 04 – 23

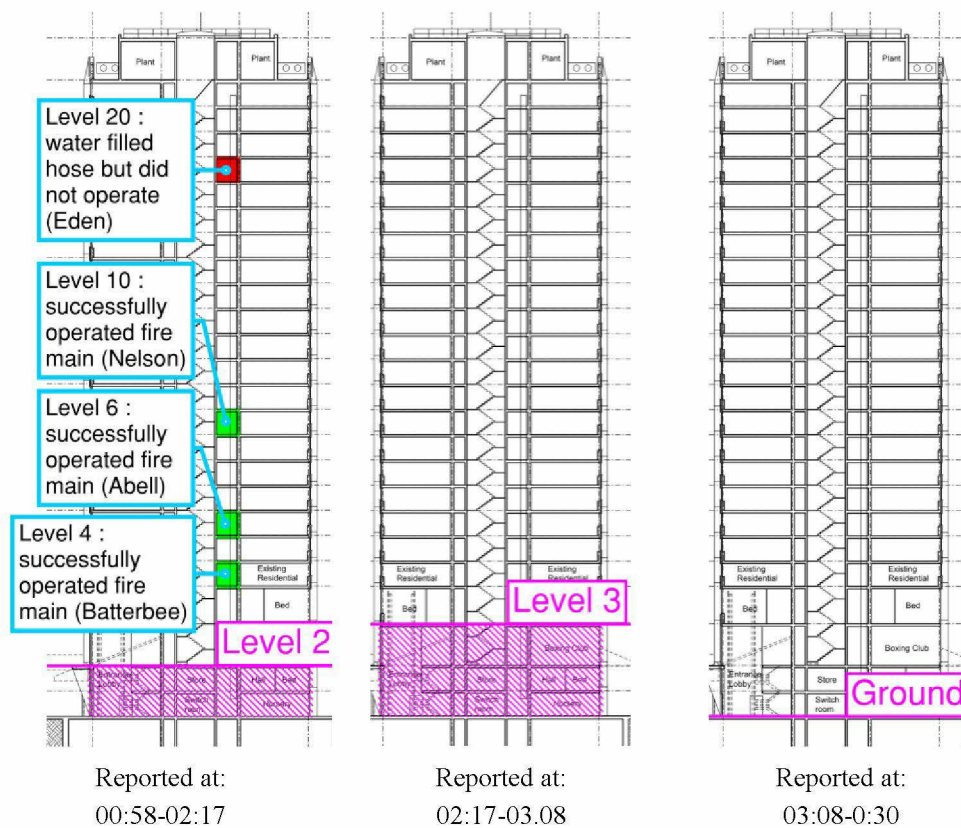
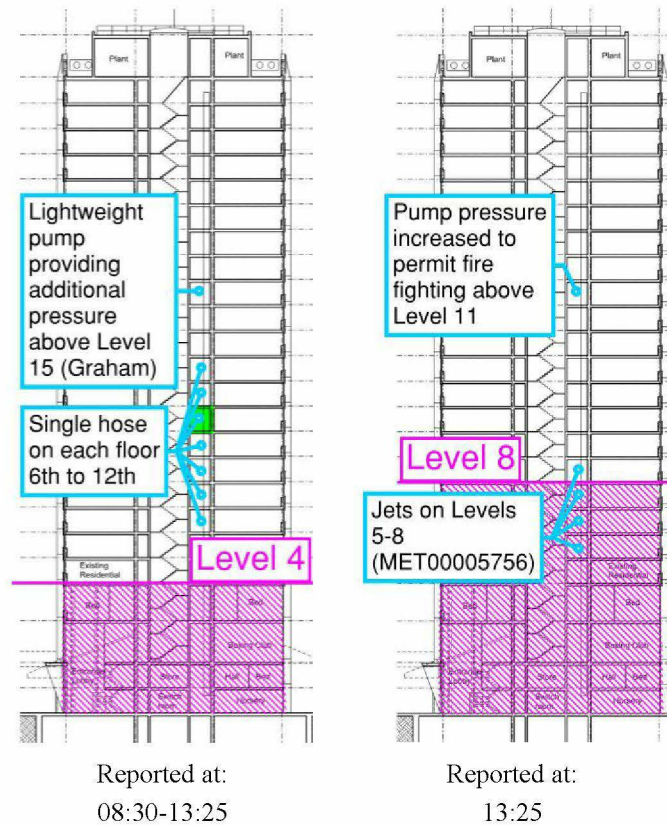
- 14.7.37** Figure 14.59 summarises the levels on which successful or unsuccessful fire main operation was recorded over the course of the 14 June 2017. It also illustrates the recorded level of the Bridgehead (Section 14.4.110) at that time.
- 14.7.38** Figure 14.59 also illustrates that crews were attempting to operate the fire main up to 18 stories above the Bridgehead location. This is significantly greater than the typical 2 stories I described in Section 14.2.

Figure 14.59 Evidence related to dry main operation during 14 June 2017 relative to the Bridgehead location (SEA00009461)
