Grenfell Tower – fire safety investigation: The fire protection measures in place on the night of the fire, and conclusions as to:

Phase 1 Report – Section 17

External access for the fire and rescue services – the provisions available at Grenfell Tower

24th October 2018

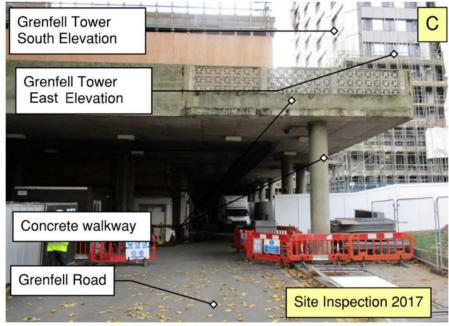
- Grenfell Road is a public road (Figure 17.5(a) and (b)) which I measured to be between 7.68m and 8.72m wide along its length.
- 17.2.15 The minimum measured width of 7.82m between kerbs is greater than the minimum 3.7m recommended by ADB 2013 Table 20 therefore, the width of Grenfell Road between kerbs is compliant.
- As Grenfell Road approaches Grenfell Tower, it runs underneath an elevated concrete walkway (Figure 17.5(c)) which I measured to be 4.4m above the roadway.
- 17.2.17 The minimum measured height of 4.4m is greater than the minimum 4m clearance required for access by high reach appliances in ADB 2013 Table 20. Therefore, the overhead clearance of Grenfell Road is compliant.

- (a) Measurement of 8.72m between kerbs on Grenfell Road Location 'A' Figure 17.4
- (b) View of back down Grenfell Road Location 'B' Figure 17.4

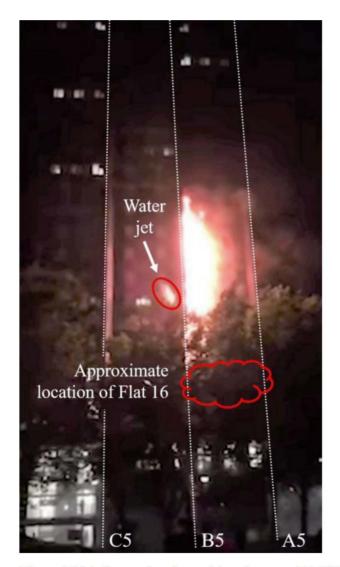
- During FF O'Hanlon's evidence (Day 16, 4 July 2018, p. 111-112), he was shown a video clip of external fire spread on the East elevation of Grenfell Tower at 01:22. He was asked if he "saw something coming up through the flames from the bottom-right to top-left" in the video, which showed the East elevation of Grenfell Tower at 01:22:20; refer to Figure 17.14. When asked if

Overall, it was not clear to me if FF O'Hanlon thought the video showed the water jet he sprayed from the Flat 16 kitchen window onto the East elevation of the building envelope or not.

Figure 17.14: Screenshot from video shown to FF O'Hanlon during his evidence (Day 16, 4 July 2018, p. 111-112) of East elevation of Grenfell Tower at 01:22 (LBY00000002)

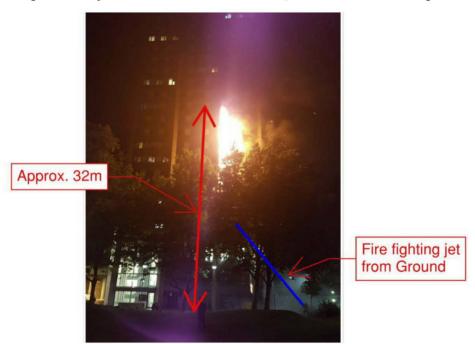
- 17.3.49 Ultimately, this initial external firefighting was not successful. As shown in Figure 17.15, the fire spread beyond Level 7 and up to Level 11 (32m above ground level) by 01:21.

- 17.3.52 It appears therefore that before 01:21 the fire brigade lacked sufficient access at height, to apply water in a way that could prevent the full extent of fire spread over the East elevation of the building.

Figure 17.15 Evidence of external firefighting at 01:21 14 June 2017 (MET00012593)

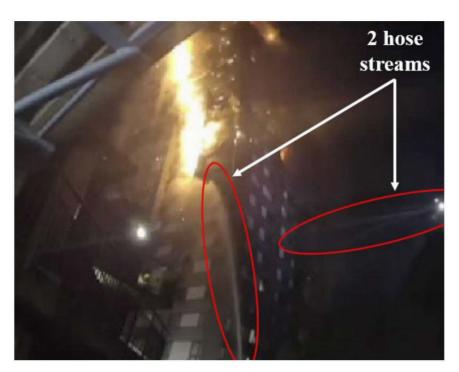
- I do not know the time when Alpha 245 was first in operational position and began to apply a hose stream to Grenfell Tower. The earliest evidence I have of its operation is at 03:29. By this time, it was providing a jet onto the East elevation of the building, as shown in Figure 17.23. I observed a jet on the East elevation in several photographs between 03:29 and 11:03.

Figure 17.23: External firefighting at 03:29 – jet on the East elevation of building (aerial appliance) and jet on the South elevation of the building (MET00012593)

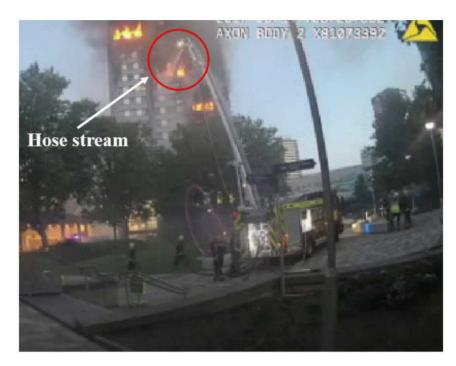
Figure 17.25 shows an aerial appliance positioned on the pedestrian path at 04:26. I have not been able to confirm if this is the same aerial appliance as shown in Figure 17.24. If it is, I do not know when it was moved from the grass verge to the pedestrian path and why it was moved.

Figure 17.25: Aerial appliance providing a jet on East elevation at 04:26 (MET00012593)

- b) I do not know whether the paved area was designed with sufficient load carrying capacity to meet ADB 2013 Table 20. However, it is apparent that an appliance was driven on this area in (Figure 17.25).

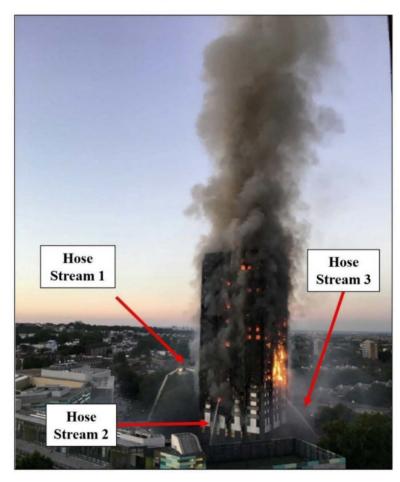
- a) Hose Stream 1 High reach vehicle appliance located in front of the East elevation (Figure 17.25 and Figure 17.26).
 - b) Hose Stream 2 Hose jet position located on the roof of the Kensington Aldridge Academy, applied to the North elevation (Figure 17.26 and Figure 17.28); a high reach appliance replaced this hose jet on the North elevation by 17:47 (Figure 17.34)

- c) Hose Stream 3 Hose jet position located at ground level in the playground and applied to the West elevation (Figure 17.26 and Figure 17.29).
- d) Hose Stream 4 Hose jet position located on the Lancaster Estate raised walkway applied to the South elevation (Figure 17.27).

Figure 17.26: Firefighting jets on building envelope - East, North, and West elevations - at 04:43 on 14^{th} June 2017 (MET00012593)

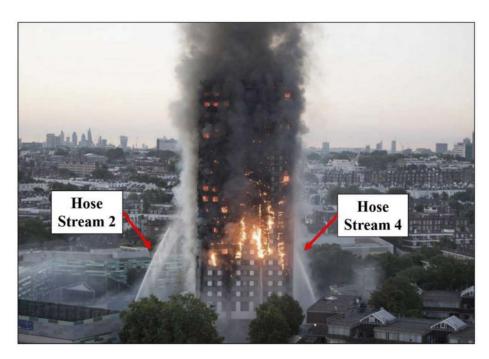
Figure 17.27: Firefighting jets on building envelope - North and South elevations, on 14 June 2017 (https://www.standard.co.uk/news/london/individuals-may-face-criminal-grenfell-charges-says-prosecutor-a3605581.html)

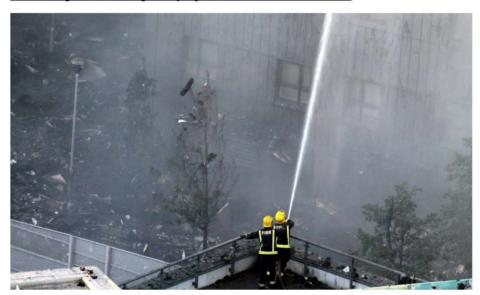
Figure 17.28: External firefighting via handheld hose from roof of the Kensington Aldridge Academy, applied to the North building elevation at unknown time (https://www.theguardian.com/uk-news/gallery/2017/jun/14/tower-block-blaze-in-london-in-pictures)

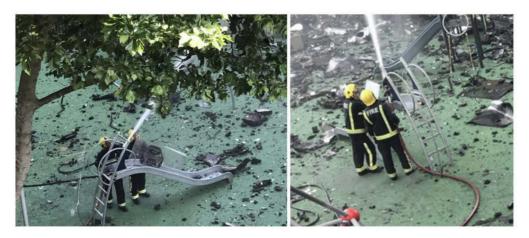
Figure 17.29: External firefighting via handheld hose from playground on the West elevation of the building; exact time after 04:42 unknown (https://www.theguardian.com/uk-news/gallery/2017/jun/14/tower-block-blaze-in-london-in-pictures)

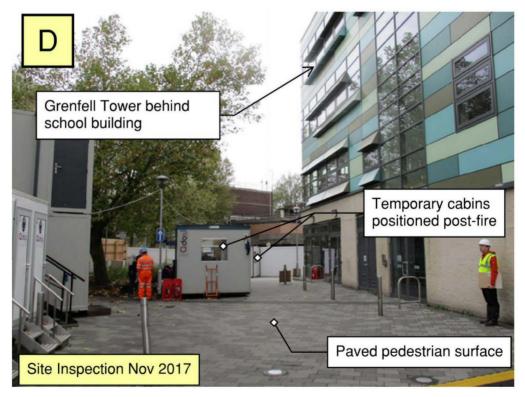
Additionally, Figure 17.40 is a photograph along the access road, taken during my site inspection. When the photograph was taken, the area was being used by the MPS to locate facilities for their site investigations and therefore contains security hoarding and temporary cabins which were not present on 14th June 2017.

Figure 17.40: Image of secondary vehicle access route from Silchester Road (facing south towards Grenfell Tower, which is located behind the school building on the right side) – Location 'D' Figure 17.38.

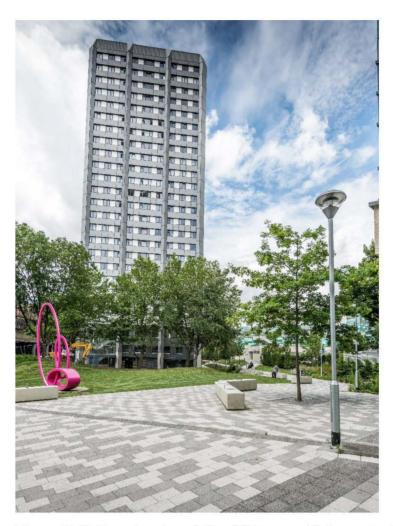
Figure 17.43: East elevation of Grenfell Tower with Lancaster Green in front of it (SEA00000385)

- Figure 17.43 shows the pedestrian path to access the North elevation of Grenfell Tower (on the right side of the photograph) from the East elevation. Figure 17.46 shows the pedestrian path to access the North elevation of Grenfell Tower (on the left side of the photograph) from the West elevation. Based on these photographs, there was no vehicle access possible to the North elevation of Grenfell Tower. Therefore, I have not assessed the North elevation against ADB Diagram 49.

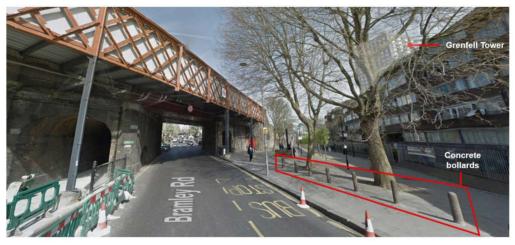
c) There is a set of concrete bollards between Bramley Road and Station Walk, which restricts, but does not fully prevent, vehicle access to Station Walk, as shown in Figure 17.45.

Figure 17.45: Photograph of Bramley Road (looking towards Latimer Road Station) with Station Walk to the right (Google Images)

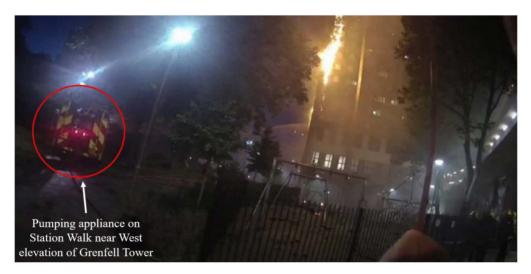
- Therefore, unrestricted vehicle access was available to the South elevation only by Grenfell Road. Some vehicle access may have been possible by Secondary Access Road 1, from Silchester Road, which also accesses the South elevation. Hardstanding next to the East elevation was accessible from the Grenfell Road Access Road (Figure 17.6)
- Access to the North, and West elevations was pedestrianised, although I have seen evidence LFB were able to position a fire appliance on Station Walk leading to the West elevation, as shown in Figure 17.46

Figure 17.46: Pumping appliance on Station Walk near West elevation of Grenfell Tower at 03:28 on 14th June 2017 (MET00012593)

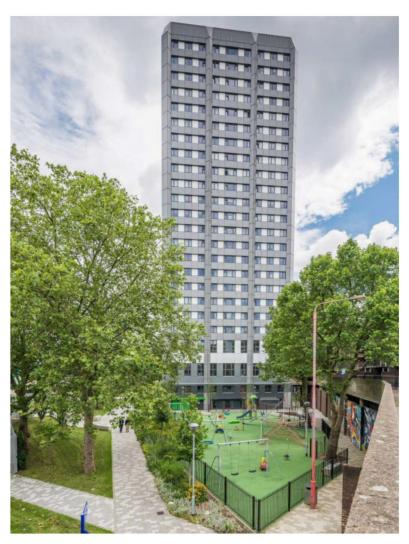
- As shown in Figure 17.47, there was no vehicle access possible for the area immediately adjoining the West elevation of Grenfell Tower. Therefore, I have not assessed the West elevation against ADB Diagram 49.

Figure 17.47: West elevation of Grenfell Tower with playground in front of it (SEA00000374)

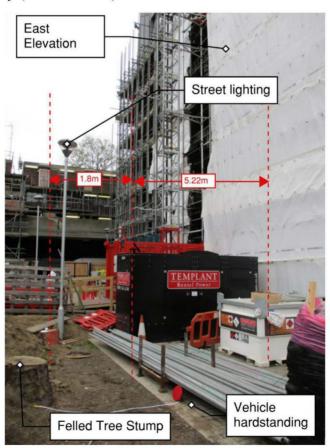
- In Figure 17.49 I have included a photograph of the East Elevation, over marked with my measurements from my site inspection. I was able to measure the width of the hardstanding beyond the scaffolding as 5.22m, which is less than the required 7.5m for a hydraulic platform.

- I also observed the stumps of three trees and a street light next to the hardstanding (these appear to have been felled after the fire). These are all within the 2.2m zone required to be kept clear to allow manoeuvring of high reach and aerial appliances. Both the trees and street light would also have presented an overhead obstruction reducing the ability of a high reach appliance to work next to the building on the East elevation. The East elevation is where the fire from Flat 16 is first observed to have broken out externally (See Section 5).

Figure 17.49 Width of East elevation hardstanding and position of overhead obstructions (trees and lights). Measurements made by my site inspection team.

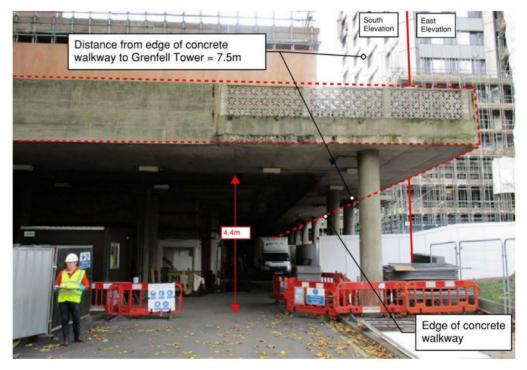
- In Figure 17.50 I have included a photograph from my site inspection of the position of the overhead concrete walkway relative to the South elevation of Grenfell Tower. I have over-marked this with the measurements I made onsite of its position relative to Grenfell Tower.

- 17.5.35 Therefore, the concrete walkway would have affected the ability of LFB to work with high reach and aerial appliances very close to the South elevation of Grenfell Tower.

Figure 17.50 Position of concrete walkway and South elevation of Grenfell Tower. Measurements made by my site inspection team.

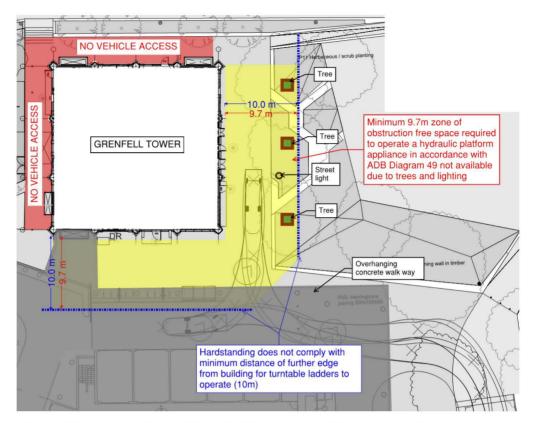
Figure 17.51: Comparison of Grenfell Tower against high reach appliance requirements of ADB 2013 (SEA00003480)

17.5.37 I have summarised this assessment, as well as my conclusions with regards to the vehicle access achieved on 14th June 2018, in Table 17.1 and Figure 17.51.

Elevation	Provisions for high reach appliances	Vehicle access achieved on 14 th June 2018
North	Pedestrian access only - Inaccessible to any fire appliance vehicle (Section 17.2)	Aerial appliance near Northeast corner of Grenfell Tower (Figure 17.34); no apparent vehicle access achieved directly in front of North elevation.
East	Minimum clear zone of 10m for turntable ladders or 9.7m for hydraulic platforms from building to edge of hardstanding not available (trees and street lighting obstructions)	Aerial appliance positioned on road adjacent to East elevation (Figure 17.19). Aerial appliance positioned on grass verge (Figure 17.24) and the paved pathway (Figure 17.25) to the East of Grenfell Tower.
South	Minimum clear zone of 10m for turntable ladders or 9.7m for hydraulic platforms from building to edge of hardstanding not available (concrete walkway obstruction)	No vehicle access achieved.

West	Pedestrian access only - Inaccessible to any fire appliance vehicle (Section 17.2)	Vehicle access to Station Walk achieved, behind playground. (Figure 17.46).

- 17.5.38 In summary, there was no vehicle access to the North and West elevations therefore reducing the ability of the fire brigade to use any type of appliance on these elevations.
