Grenfell Tower – fire safety investigation:
The fire protection measures in place on the night of the fire, and conclusions as to:
the extent to which they failed to control the spread of fire and smoke;
the extent to which they contributed to the speed at which the fire spread.

Phase 1 Report – Section 19

How the protected stairs and lobbies failed for the residents and firefighters

24th October 2018

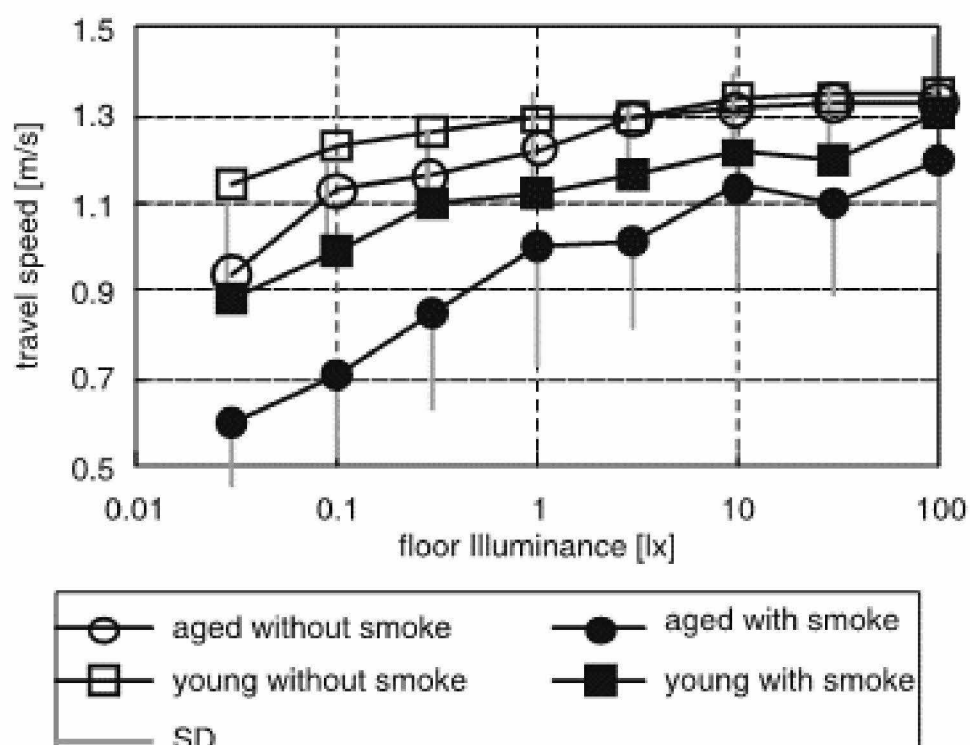
Figure 19.1 Illuminance and travel speed in smoke (Excerpt from SFPE Handbook Fig 61.20)

19.3.11 Specifically, as indicated in Figure 19.1 below, when poor visibility is caused by smoke, people will move even more slowly when compared with poor visibility not caused by smoke. For example, for the same illumination (1 Lux) walking speed of the elderly would reduce from 1.3m/s without smoke to

19.3.13 In addition to the above, PD 7974-6:2004 Section 6.3 describes the effect of poor visibility as causing a proportion of people, approximately 30%, to turn back rather than continue through smoke-logged areas. Therefore, the presence of visible smoke impacts people's willingness to evacuate.

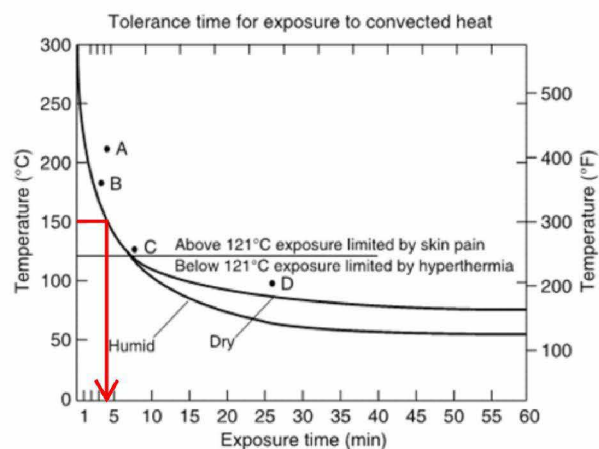
Figure 19.2: Thermal tolerance for humans at rest, naked skin exposed, with low air movement reproduced from SFPE Handbook 5th edition (Figure 63.28)

- 19.3.30** I have extracted in Figure 19.2 and Figure 19.3 data on human tolerance of heat as a function of time. The human tolerance time of temperatures below 121°C is limited by hyperthermia, that is where the core body temperature > 40°C. Above 121°C the tolerance time is limited by skin pain.

- 19.3.31** Therefore, for temperatures in excess of 150°C persons at rest can tolerate these temperatures on unprotected skin for no more than 4 minutes. I have over-marked this in Figure 19.2. It should be noted this is not a time to lower pain threshold. Under these conditions skin pain and potential skin and respiratory tract burns would be experienced.

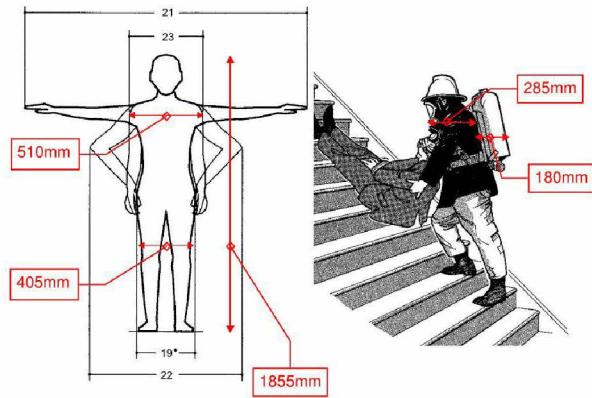
(a) Typical dimensions for a person using Metric Handbook and standard BA dimensions

19.6.81 Despite the Grenfell Tower stair being perceived to be narrow I have so far seen no evidence that the stairs actually became blocked at any stage or that its width in and of itself significantly impacted on escape by the residents or access by fire fighters.
