Grenfell Tower – fire safety investigation:
The fire protection measures in place on the night of the fire, and conclusions as to:
the extent to which they failed to control the spread of fire and smoke;
the extent to which they contributed to the speed at which the fire spread.

Phase 1 Report – Section 4

**Overview of building works at Grenfell Tower,
including recent refurbishment 2012-2016**

Dr Barbara Lane FREng FRSE CEng

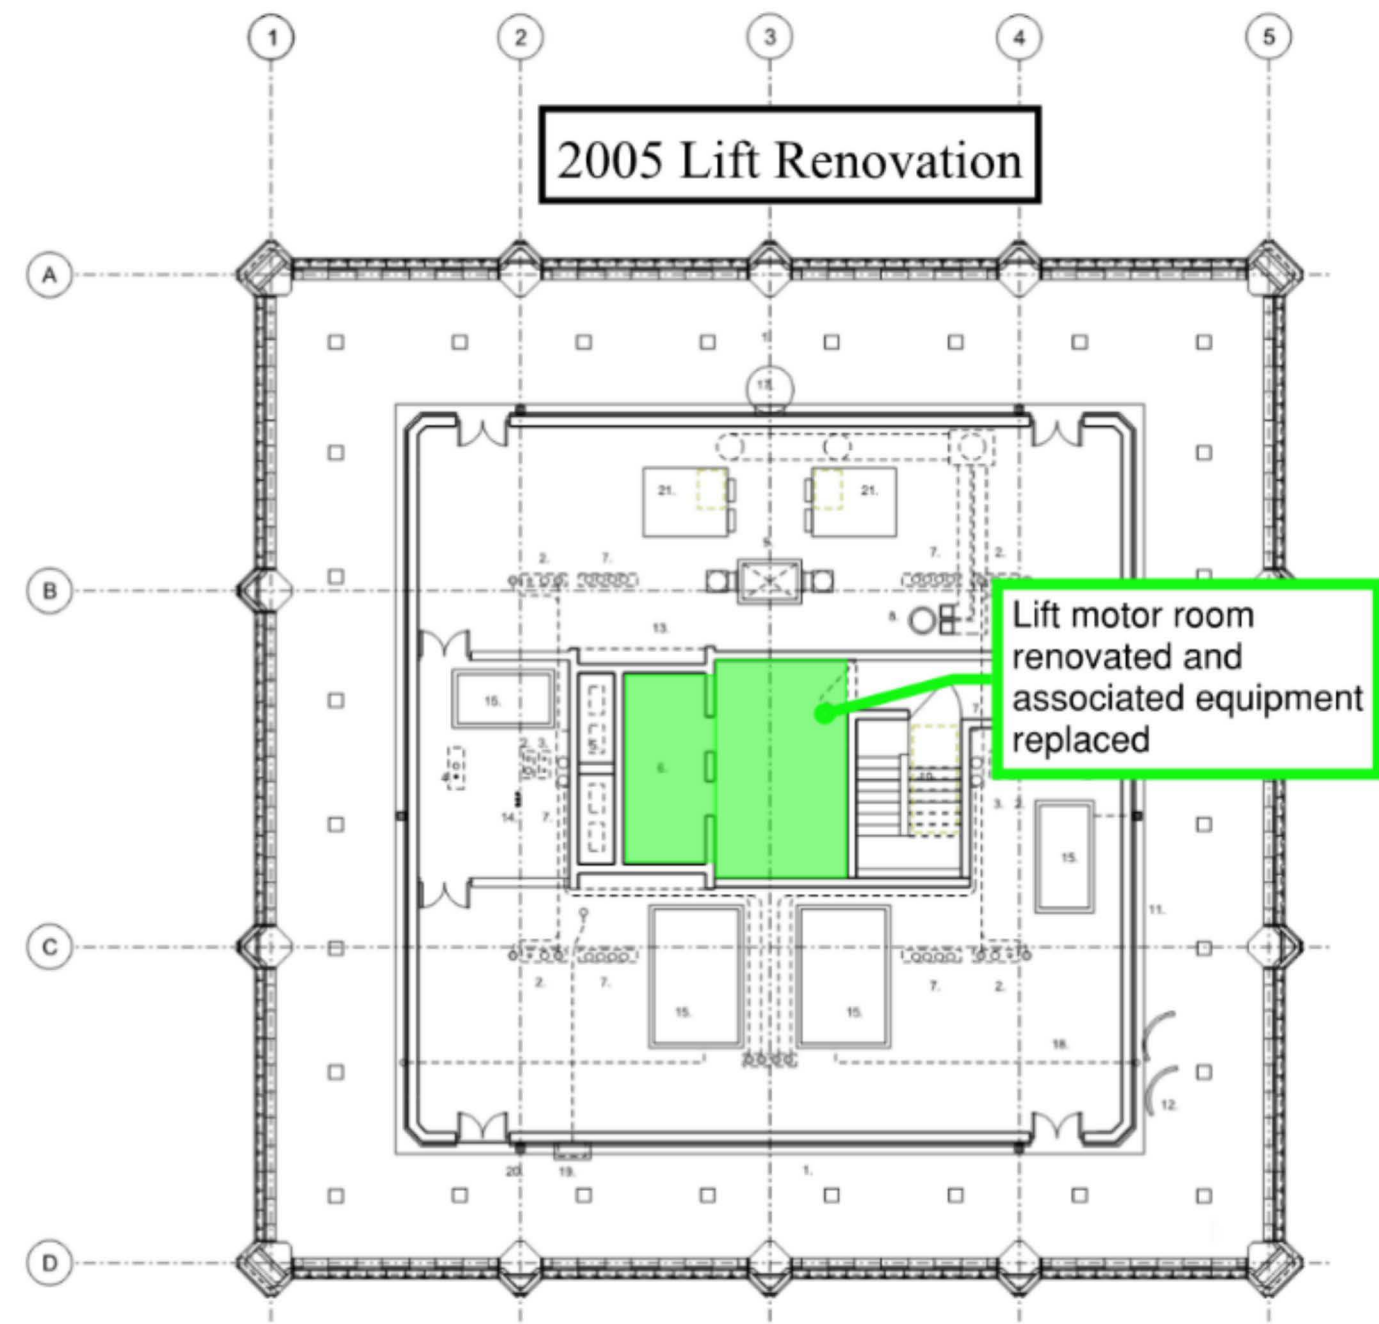
Figure 4.18: 2005 lift replacement on plant level. (CCL00000028)

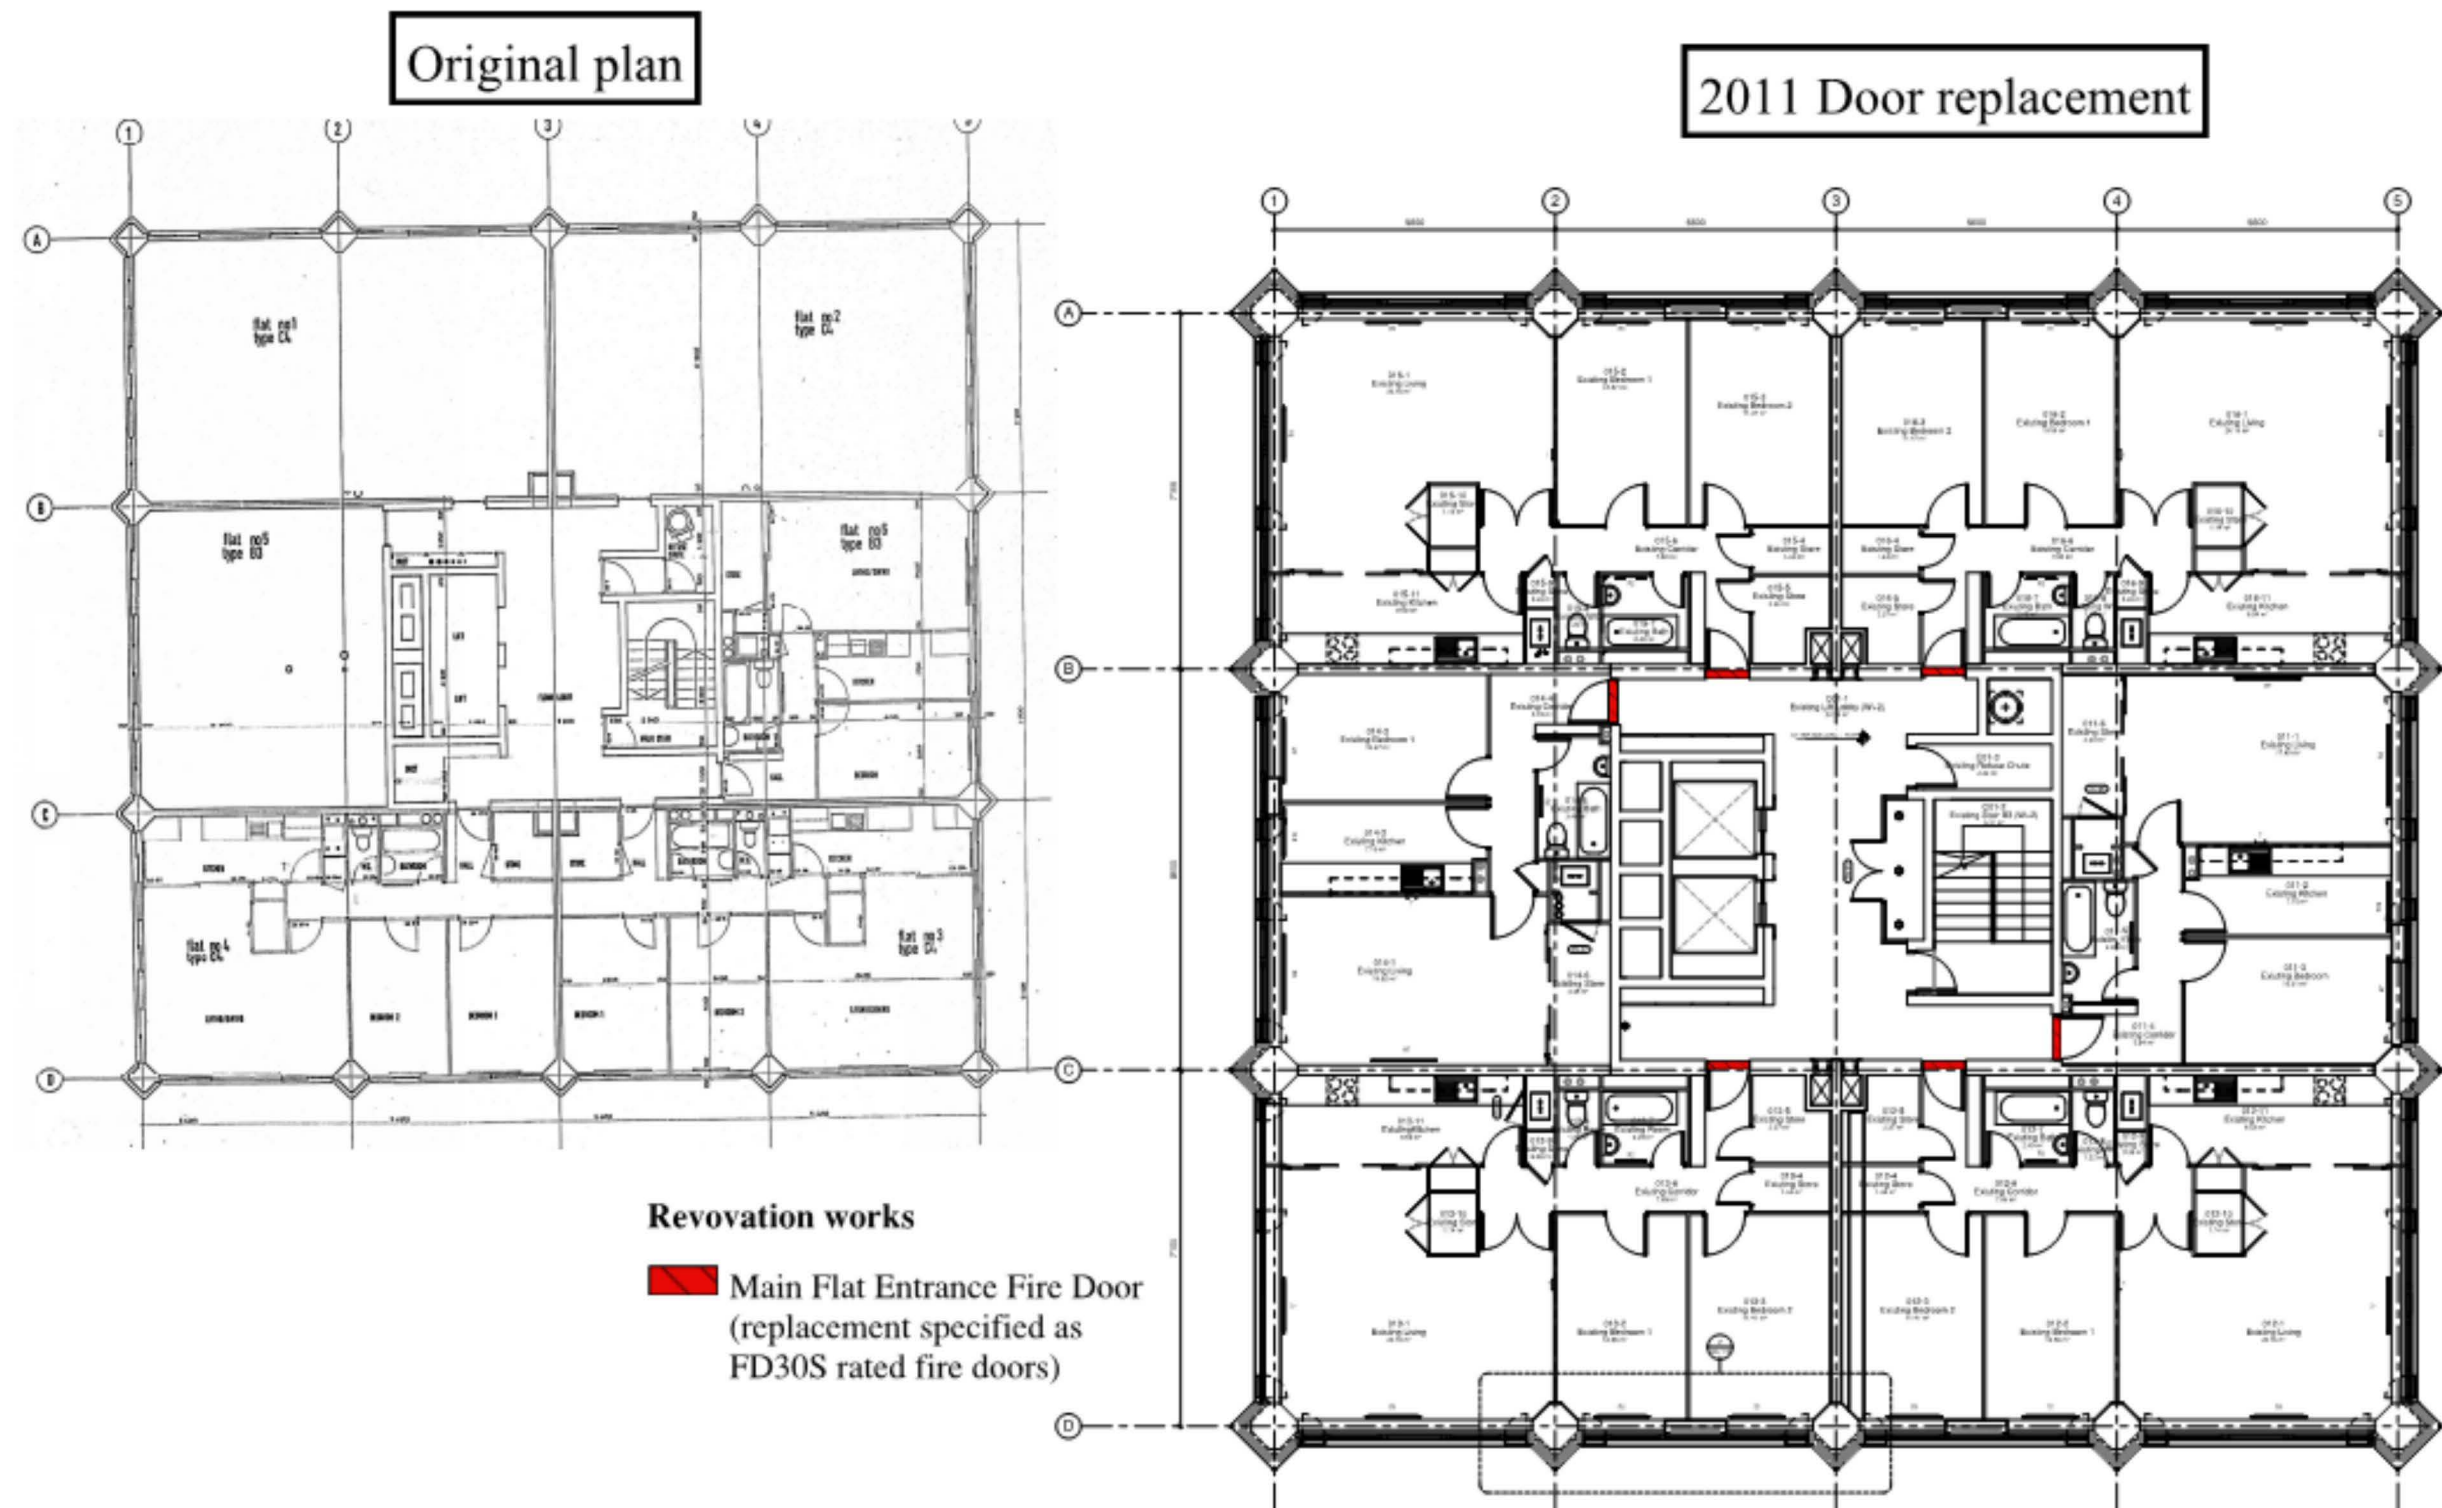
4.6.9 109 No. Main flat entrance fire doors are listed on the 2011 door replacement specification spreadsheet written by Masterdor (MAS00000003). Three of the doors listed are duplicates (Flats 106, 114, 202). The reasons why there are duplicate doors on the list is unknown.

4.6.10 Discounting the duplicate doors, 106 No. fire doors appear therefore to have been supplied and installed by Manse Masterdor Ltd to replace main flat entrance fire doors in Grenfell Tower in May/June 2011. From the flat doors listed by Manse Masterdor the door replacement included 104 tenanted flat doors and 2 leaseholder flat doors.

Figure 4.20: 2011 TMO tenant main flat entrance fire door replacement on levels 4 – 23. (RBK00018837; SEA00010474)

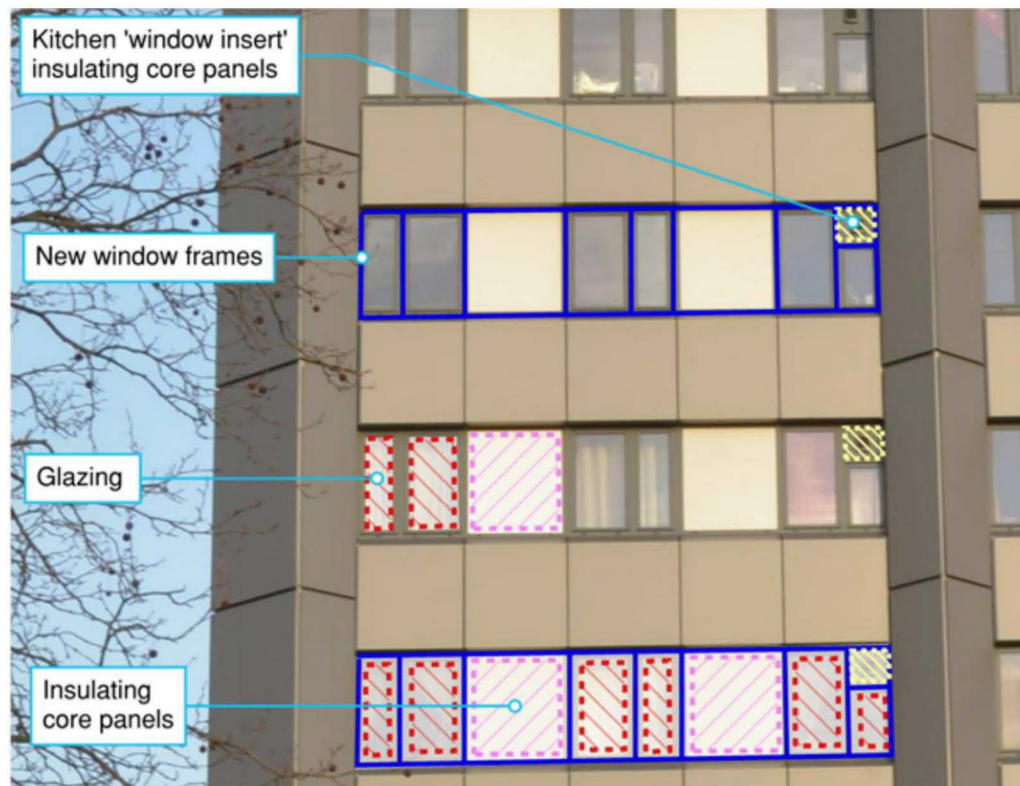
- b) Insulating core panels as infill between windows, formed of combustible Styrofoam supplied by Panel Systems Ltd;
- c) Window fan inserts specified as the combustible Kingspan TP10 insulation;
- d) 100mm thick Celotex RS5100 combustible PIR insulation board applied to columns;
- e) 80mm thick Celotex RS5080 combustible PIR insulation board (two layers) applied to the spandrels between floors;
- f) Kingspan K15 combustible phenolic foam insulation (two layers) applied to the spandrels between floors;
- g) Arconic Reynobond 55 PE Cassette system ACP (smoked silver metallic);
- h) Arconic Reynobond 55 PE Cassette system ACP (pure white);
- i) EPDM weatherproof membrane between the new windows and the existing concrete structure;
- j) Vertical cavity barriers on the columns;
- k) Horizontal cavity barriers;

Figure 4.22: Summary photograph of externally visible cladding components (SEA00000350)

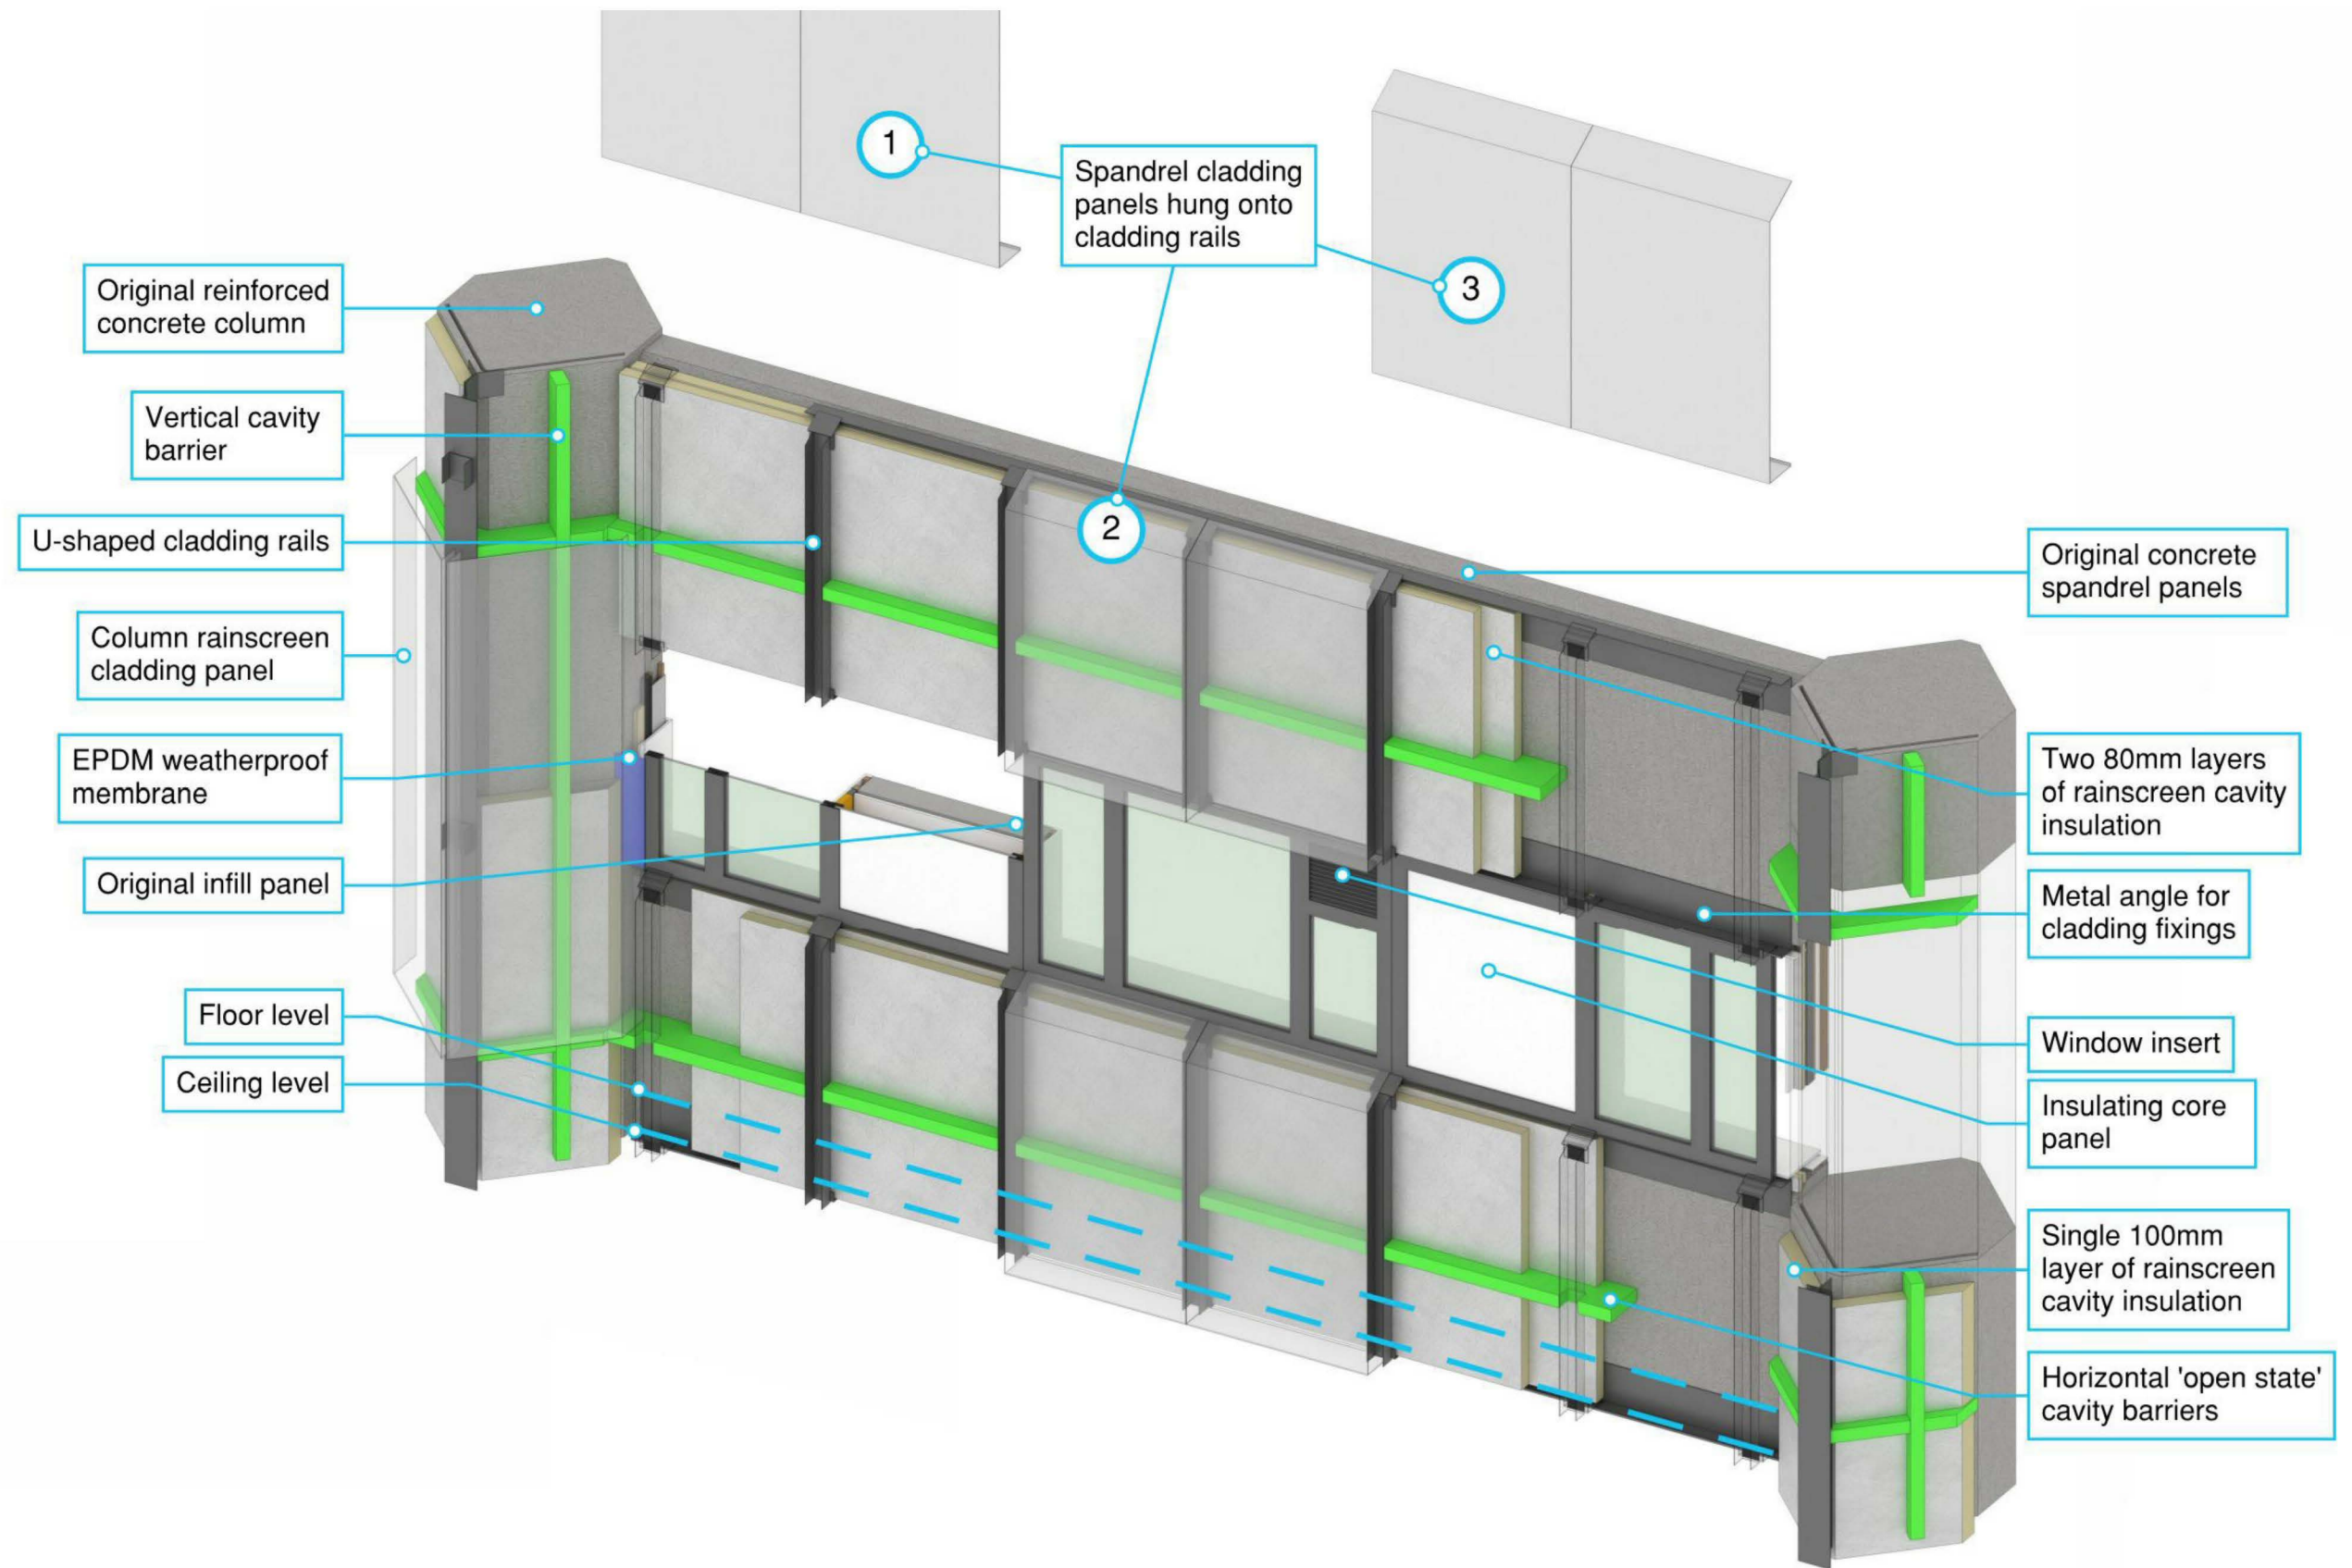
Figure 4.23: Render of external wall construction after completion of the refurbishment works

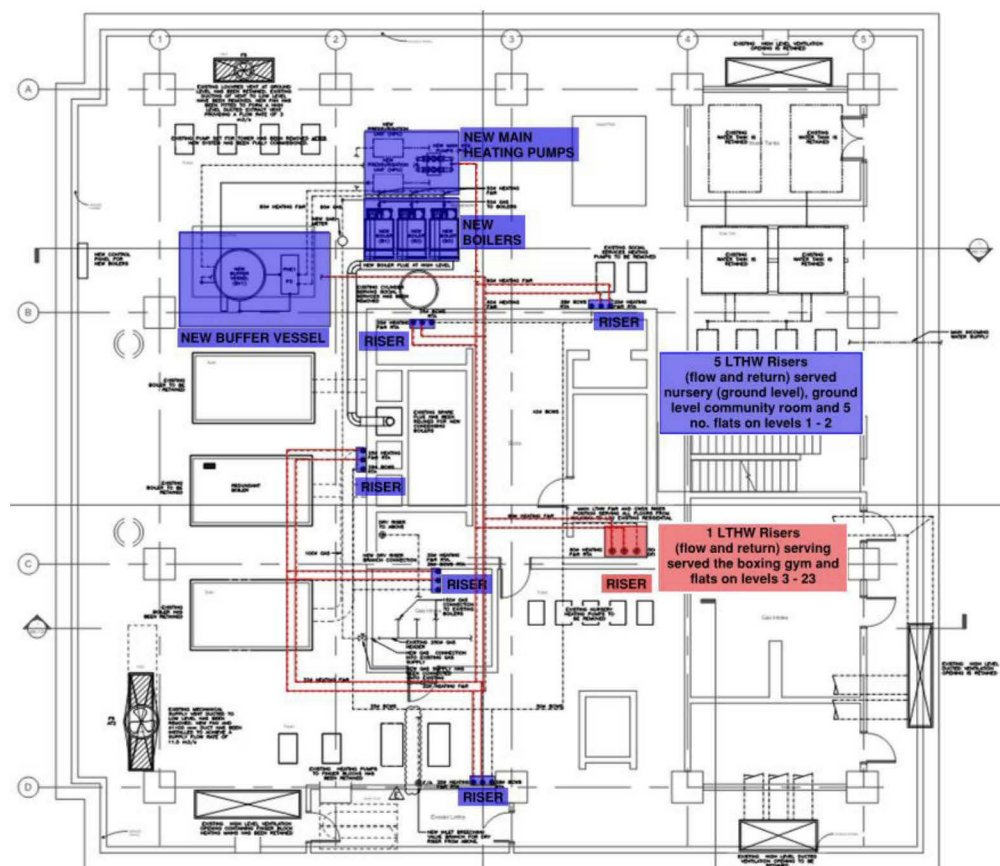
- 4.7.49** A new central gas-fired boiler plant was provided in the basement which consisted of 3 no. gas-fired condensing boilers (duty and standby boilers provided for space heating and hot water supply), as shown in Figure 4.28. The existing main boiler plant continued to serve the 'Finger Block' flats, which are in separate buildings from Grenfell Tower. (RYD00000577)

Figure 4.28: New central boiler plant and LTHW piping distribution on basement level (RYD00000577)

- 4.7.52** As indicated in Figure 4.28, the pipes serving Levels 3 to 23 enter the existing Southeast riser in the core on the basement level. On Level 3, the LTHW flow and return pipes leave the Southeast riser (south of protected stairway), run laterally through the common lobby, and enter the protected stairway, as shown in Figure 4.29. These pipes rise to level 4, where a new service cupboard was created as part of the refurbishment works. A new service cupboard was created in the same place in the lobbies on each level from level 4 – 23 as part of the 2012 – 2016 refurbishment works. The LTHW pipes rise through these cupboards to level 23. (RYD00000577)

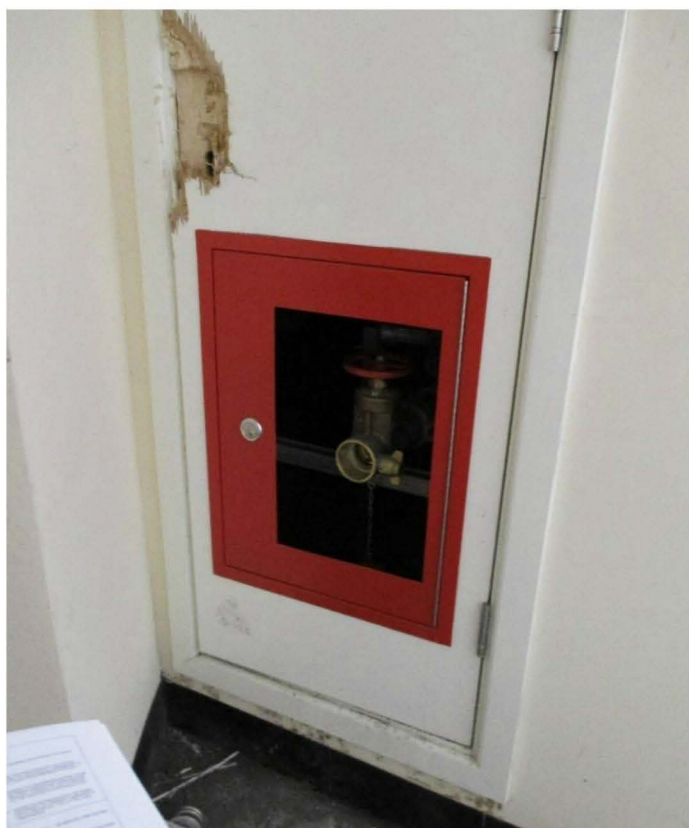
4.7.92 A schematic of these modifications is shown in Figure 4.41 (RYD00000577). The revised outlet location on Level 2 is indicated in Figure 4.42, with a photograph of it from my post fire inspection provided in Figure 4.40.

Figure 4.40: Example new dry rising fire main outlet at Level 2

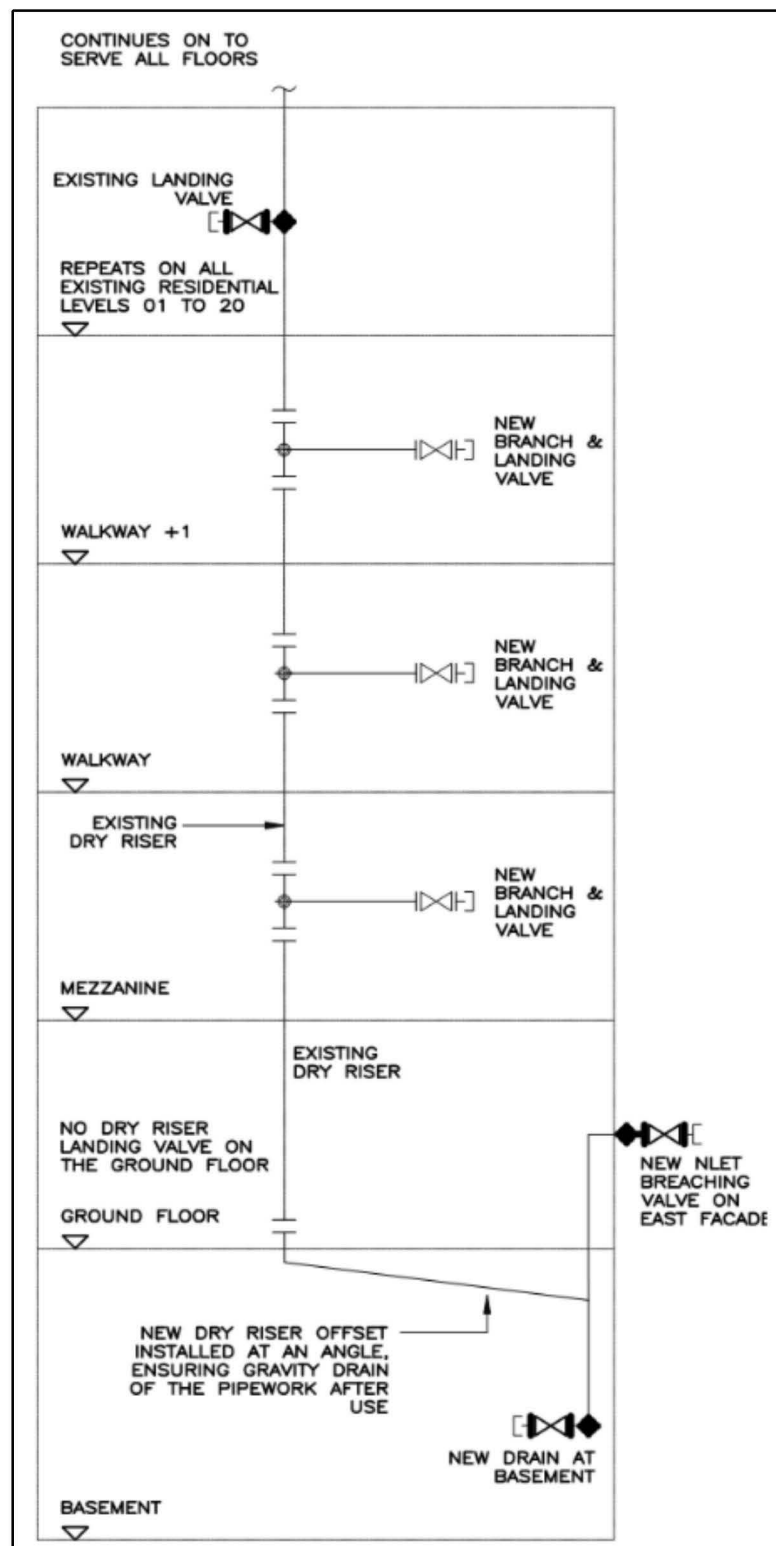
Figure 4.41: Dry riser schematic (RYD00000577)

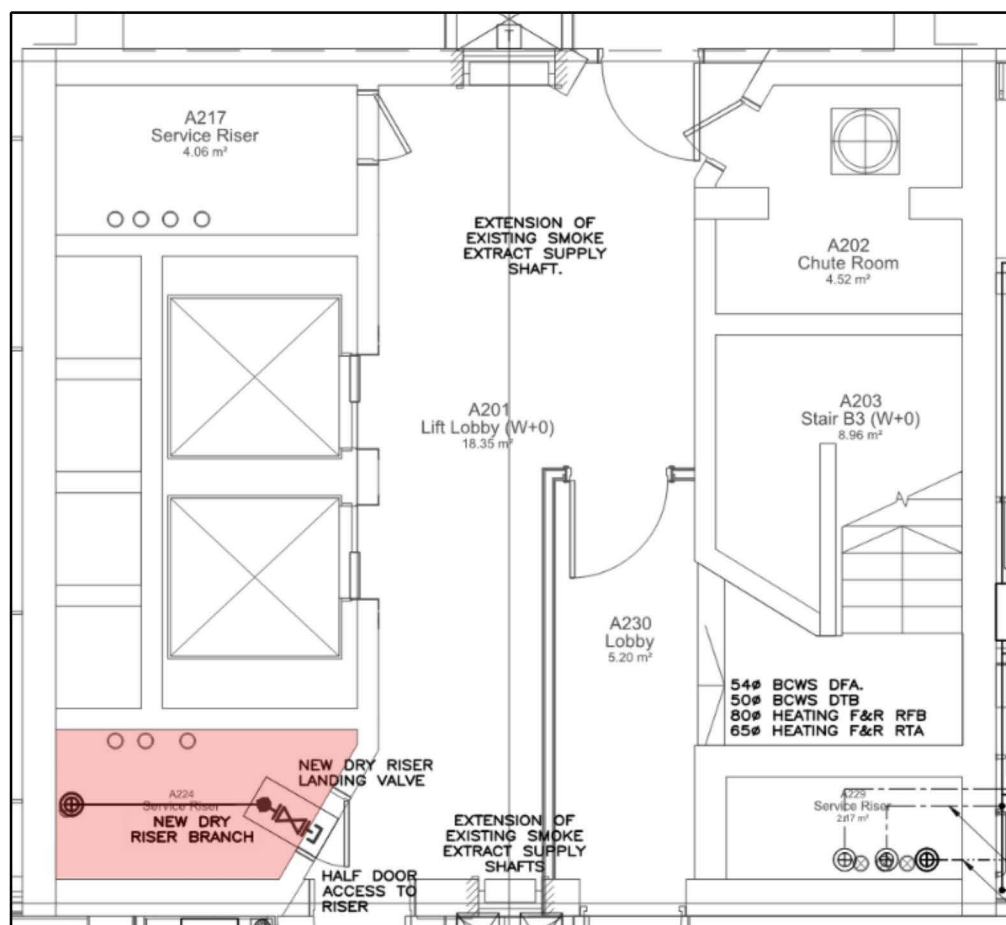
Figure 4.42: New dry riser on level 2 (RYD00000577)

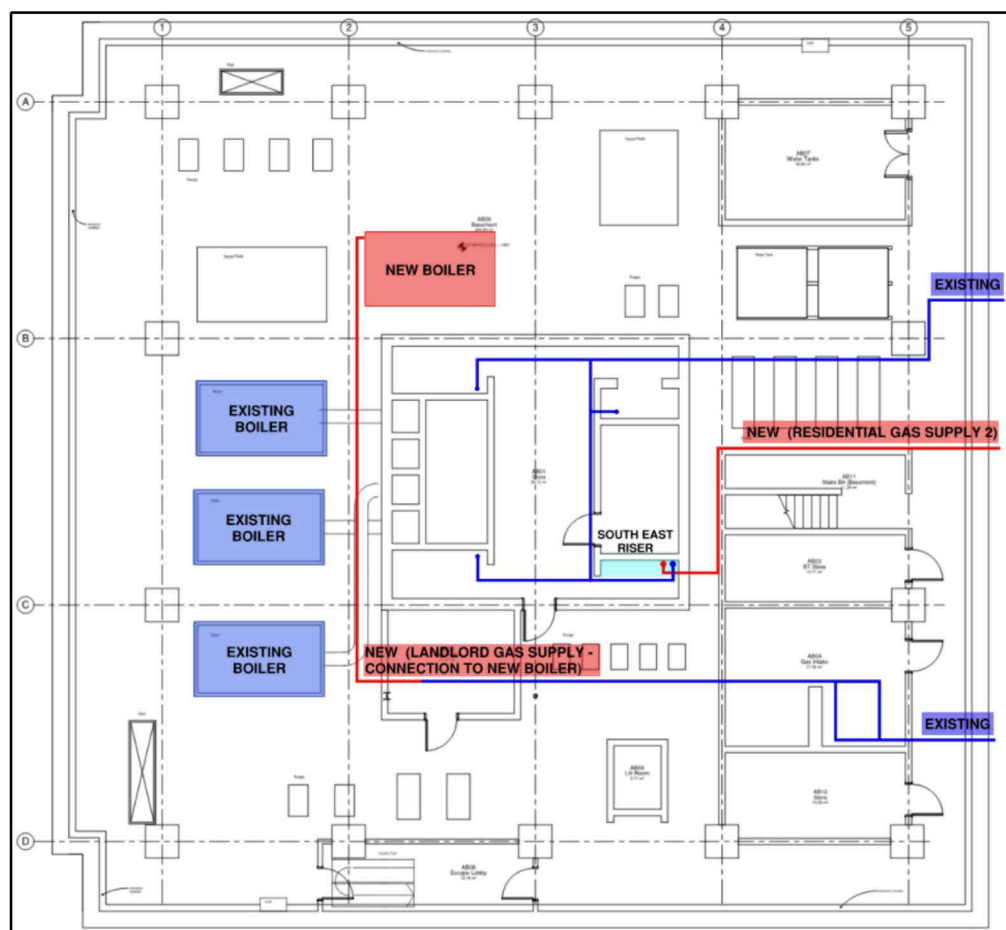
4.7.96 A new connection from the existing gas system, referenced as the ‘Landlord Gas Supply’ in Appendix K, was also provided during the refurbishment works to serve the new boiler. This pipe connection is shown in red in Figure 4.43.

Figure 4.43: Gas works in basement (based on HAR00007951)
