Grenfell Tower – fire safety investigation: The fire protection measures in place on the night of the fire, and conclusions as to:

Phase 1 Report - Section 5

The observed events of 14th June 2017

Dr Barbara Lane FREng FRSE CEng

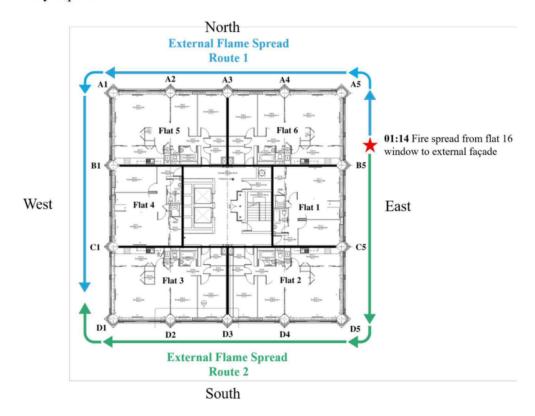
- 5.2.2 The vertical fire spread was primarily along column lines. The lateral fire spread was primarily along the cladding above and below window lines, and along the new polystyrene sandwich panel infill between windows, and was aided by some of the construction materials surrounding the windows and some of the construction materials surrounding the cavity formed between the new and old infill panels. I explain this in detail in Section 9 and Section 10 of my report.

Figure 5.2: External flame spread routes around Grenfell Tower (SEA00010474)

5.2.3 Once the fire spread to the building envelope adjacent to column B5, it spread in two lateral directions around the building – towards the North and South of the building. The fire eventually spread to the building envelope on all elevations, fully enveloping the building perimeter at approximately 04:03.

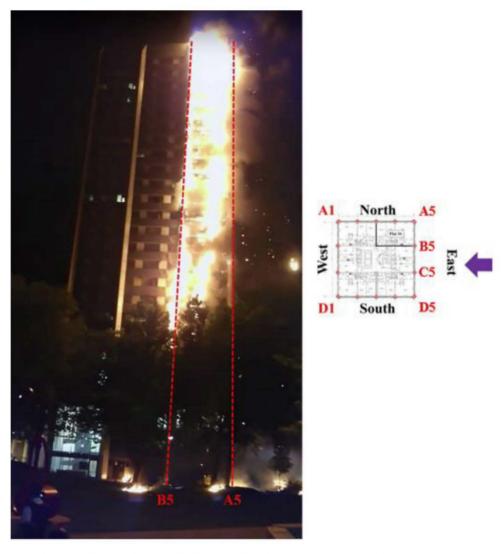
- 5.4.13 LFB then make the call to "Make pumps 15, Aerials X2" at 01:27 (LFB00000003).
- 5.4.14 Very quickly after that, LFB make a further call to "Make pumps 20, fire rescue units X2" at 01:29 (LFB00000003). This is 21 minutes after the fire spread to the building envelope.
- 5.4.15 By 01:29, the fire has spread vertically to the top of the building along Column B5, as shown in Figure 5.13. At this stage, the fire was also spreading horizontally across the building envelope, from Column B5 to Column A5.

Figure 5.13: Fire on East elevation of the building envelope on 14 June 2017, estimated time 01:29 (SEA00010474)²

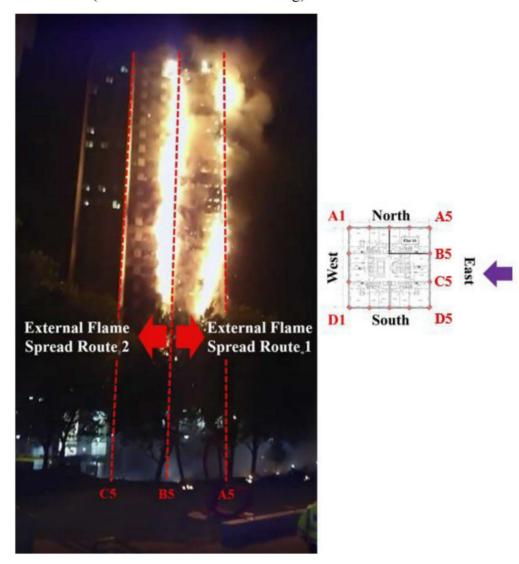
- **5.4.16** At 01:31 LFB decide to "Make pumps 25" (LFB00000003).
- 5.4.17 By 01:36 the fire was spreading in two lateral directions on the East elevation of the building envelope, as shown in Figure 5.14. The fire spread from column B5 towards A5 (northeast corner of the building) and from column B5 towards C5 (southeast corner of the building).

Figure 5.14: Fire on East elevation of the building envelope on 14 June 2017, estimated time 01:36 (SEA00010474)³

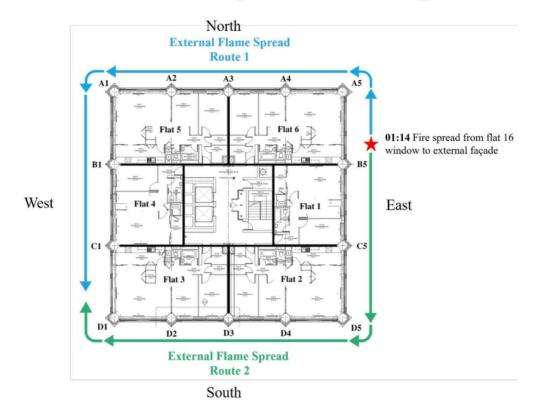
5.4.18 These two distinct external flame spread routes are shown in Figure 5.15.

Figure 5.15: External flame spread routes around Grenfell Tower (SEA00010474)

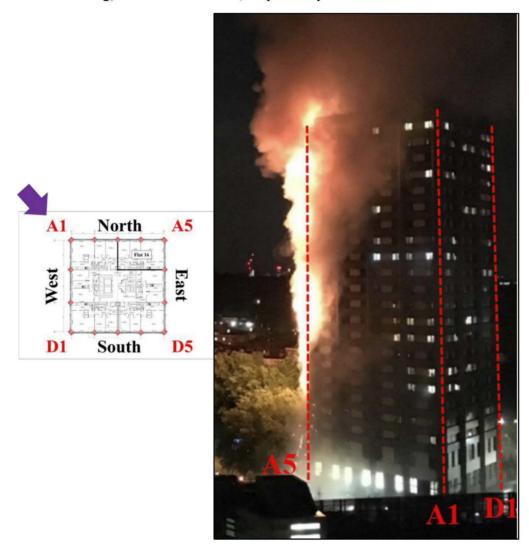
- 5.4.25 This section describes the progression of External Flame Spread Route 1 (direction of column B5 to A5).
- 5.4.26 Figure 5.17 and Figure 5.18 show fire spread to column A5 (northeast corner of the building) at 01:36 and 01:38, respectively.

Figure 5.17: Fire spread along column A1 (northeast corner of building) at 01:36 on 14 June 2017 (MET00012593) (SEA00010474)

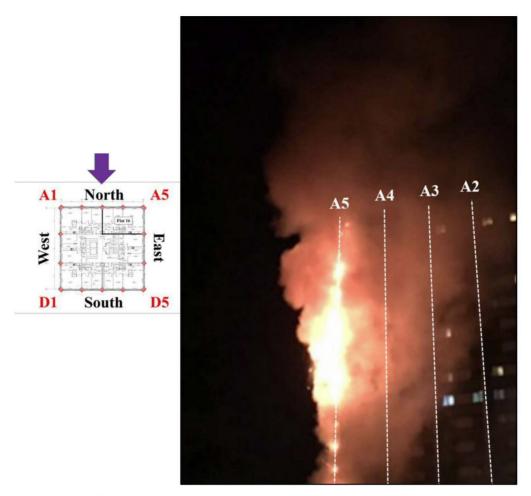
Figure 5.18: Fire spread along column A1 (northeast corner of building) at 01:38 on 14 June 2017 (MET00012593) (SEA00010474)

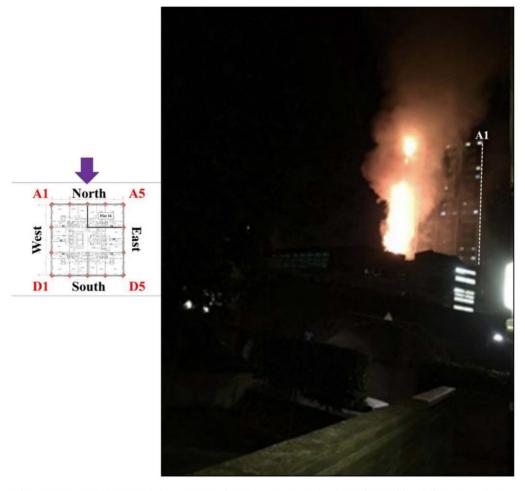
5.4.27 According to Metropolitan Police Service, the fire spread from the East elevation to the North elevation of the building envelope by 01:42; refer to Figure 5.19 (MET0000802).

Figure 5.19: Fire spread from East elevation to North elevation of building envelope at 01:42 on 14 June 2017 (MET00012593) (SEA00010474)

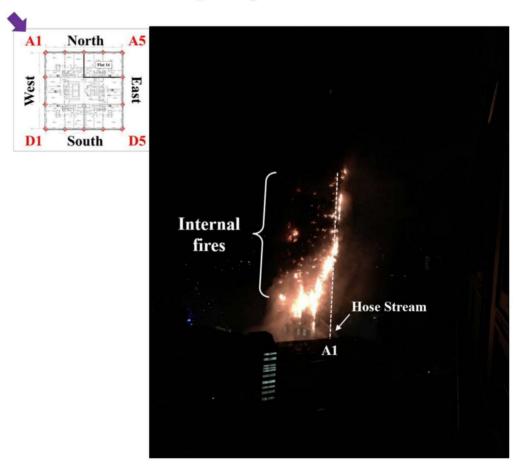
- 5.4.37 According to the Metropolitan Police Service, the fire spread from the North elevation to the West elevation of the building envelope, around column A1 (northwest corner of the building), at 02:51 (MET00012593).
- 5.4.38 The fire continued to spread laterally on the West elevation of the building envelope towards the Southeast corner of the building, as shown in Figure 5.22. This photograph also shows a firefighting jet was being applied to the North elevation of the building envelope at 03:08.

Figure 5.22: Internal fires burning on North elevation and fire spread on the North and West elevations of the building envelope at 03:08 on 14 June 2017 (MET00012593) (SEA00010474)

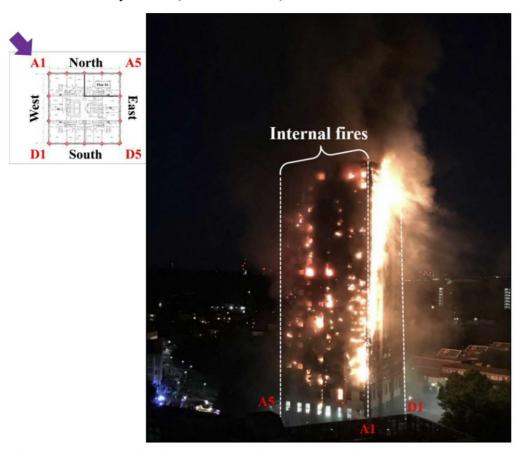
5.4.39 The North elevation of the building envelope was reported to be fully involved in fire by 03:23. (MET00012593)

Figure 5.23: Internal fires burning on North elevation and fire spread on North elevation and West elevation of the building envelope at 03:23 on 14 June 2017 (MET00012593) (SEA00010474)

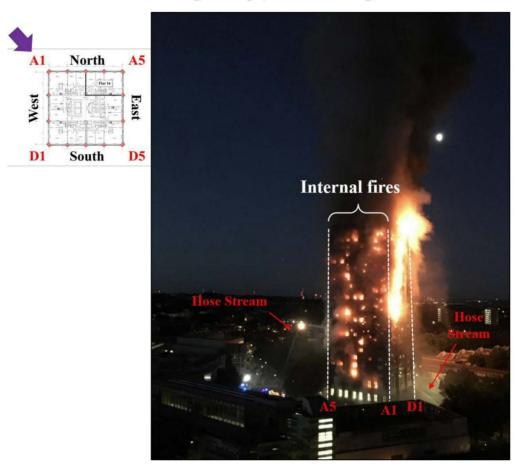
The fire continued to spread towards the Southwest corner of the building (column D1), and two (2) firefighting jets were applied to the building at 03:44, one on the East elevation of the building envelope and the other on the West elevation of the building envelope, as shown in Figure 5.24.

Figure 5.24: Internal fires burning on North building elevation and fire spread on West elevation of the building envelope at 03:44 on 14 June 2017 (MET00012593) (SEA00010474)

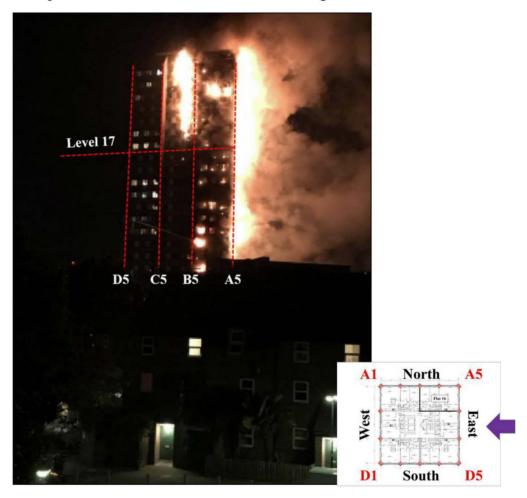
- 5.4.43 This section describes the progression of External Flame Spread Route 2 (direction of column B5 to D5 on building East elevation i.e. East to South).
- 5.4.44 The fire spread laterally across the East elevation of the building envelope from column B5 to column C5 on Levels 17 to 23, as shown in Figure 5.25. Multiple internal fires can be seen in the building.

Figure 5.25: Fire spread on East elevation of the building envelope at 01:52 on 14 June 2017 (MET00012593) (SEA00010474)

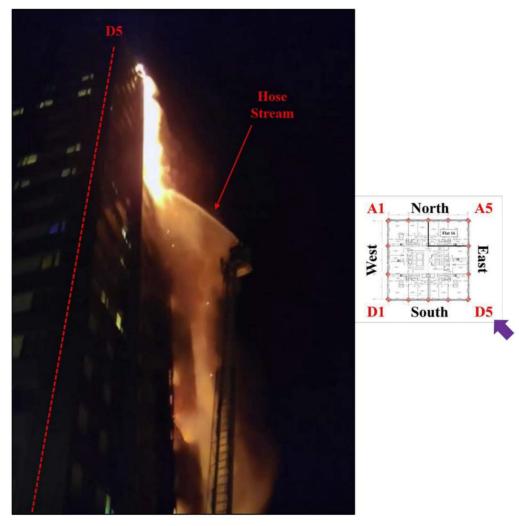
- 5.4.45 LFB "Make pumps 40" at 02:04 (LFB00000003).
- As shown in Figure 5.26 an LFB aerial appliance was active close to the East elevation of the building envelope at approximately 02:05.

Figure 5.26: High reach (aerial) fire fighting jet on East elevation of building envelope, estimated time 02:05 (SEA00010474)⁴

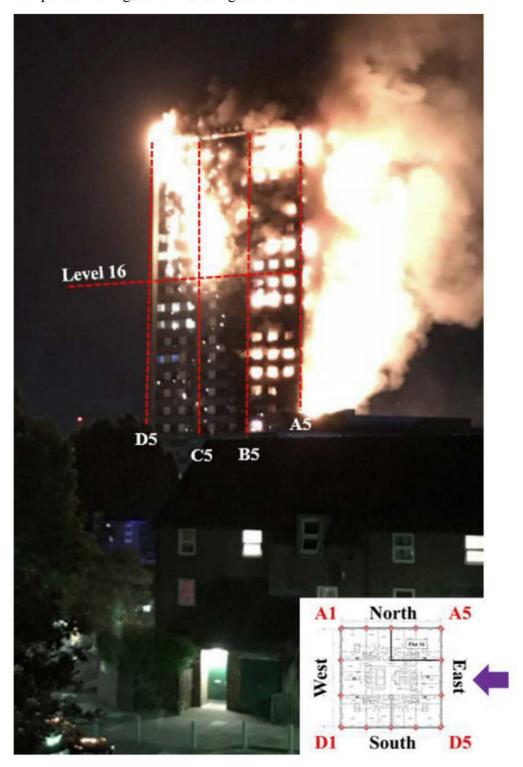
5.4.50 By 02:22 the fire reached column D5 (southeast corner of the building), as shown in Figure 5.28 and Figure 5.29. It also appears the fire spread downwards from level 18 to level 16 between 02:08 and 02:22, based on a comparison of Figure 5.27 and Figure 5.28.

Figure 5.28: Fire spread on East elevation of the building envelope at 02:22 on 14 June 2017 (MET00012593) (SEA00010474)

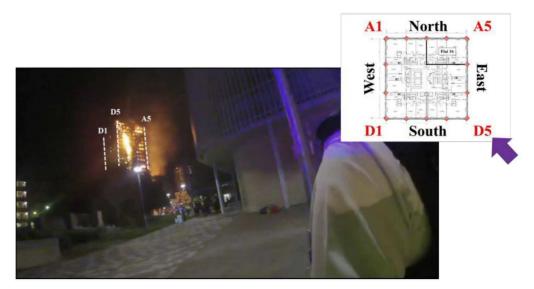
Figure 5.29: Fire spread on East elevation of the building envelope at 02:24 on 14 June 2017 (MET00012593) (SEA00010474)

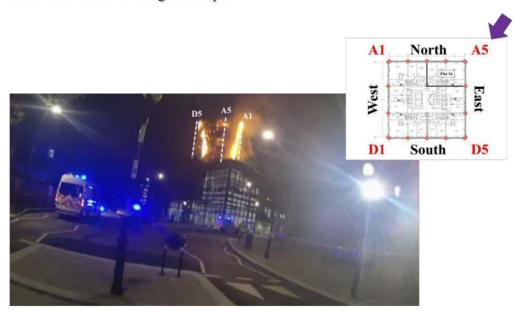
- According to the MPS, the fire spread to the South elevation of the building envelope at 02:25 (MET00012593).
- Figure 5.30 shows both flame spread routes at Grenfell Tower at 02:27 on 14th June 2017. External Flame Spread Route 1 is spreading from column A5 towards D5 on the East elevation of the building envelope, whereas External Flame Spread Route 2 is spreading from column A5 towards A1 on the North elevation of the building envelope.

Figure 5.30: Two flame spread routes on East elevation and North elevation of the building envelope at 02:27 on 14 June 2017 (MET00012593) (SEA00010474)

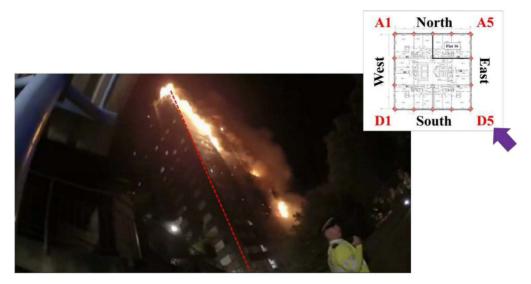
5.4.53 Figure 5.31 and Figure 5.32 show that the initial fire spread from the East elevation to the South elevation of the building envelope was at Level 23, around column D5 (southeast corner of the building).

Figure 5.31: Fire spread around column D5 (southeast corner of building), from East elevation to South elevation of the building envelope at 02:33 on 14 June 2017 (MET00012593) (SEA00010474)

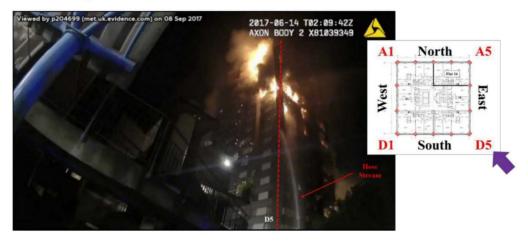
- 5.4.58 Fire fighting crews continued to apply a fire fighting jet to the Southeast corner of the building, as shown in Figure 5.34 and Figure 5.35. An aerial appliance was used to deliver a fire fighting jet to the East elevation of the building envelope by 03:32.
- 5.4.59 The fire did not spread below Level 10 on Column D5 (southeast corner of the building).

Figure 5.34: Fire spread on East elevation and South elevation of the building envelope at 03:09 on 14 June 2017 (MET00012593) (SEA00010474)

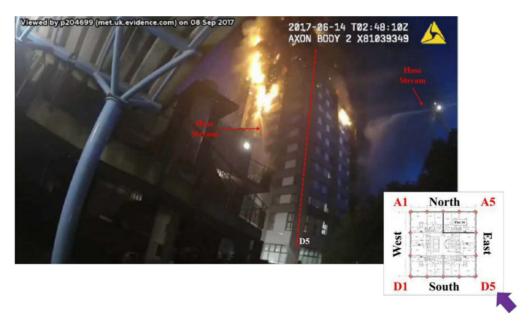
Figure 5.35: Fire spread on South elevation of building envelope at 03:48 on 14 June 2017 (MET00012593) (SEA00010474)

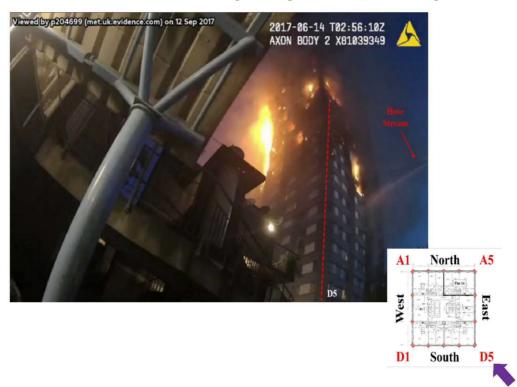
Figure 5.36 shows that the fire spread on the South elevation of the building envelope has reached the Southwest corner of the building (column D1) by 03:56.

The high rise (aerial) appliance was still being used to apply a fire fighting jet to the East elevation of the building envelope at 03:56; refer to Figure 5.36.

Figure 5.36: Fire spread on South elevation of the building envelope at 03:56 on 14 June 2017 (MET00012593) (SEA00010474)

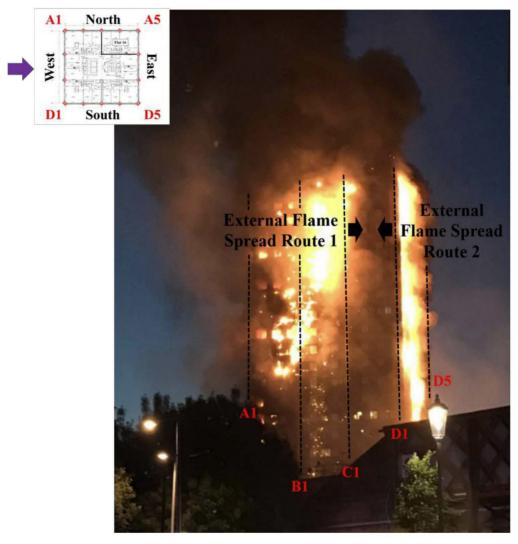
5.4.67 As shown in Figure 5.37, External Flame Spread Route 1 and External Flame Spread Route 2 were approaching each other on the West elevation of the building envelope, between columns C1 and D1, at 03:48.

Figure 5.37: Internal fires burning on West building elevation and fire spreading from column C1 and D1 on the West elevation of the building envelope at 03:48 on 14 June 2017 (MET00012593) (SEA00010474)

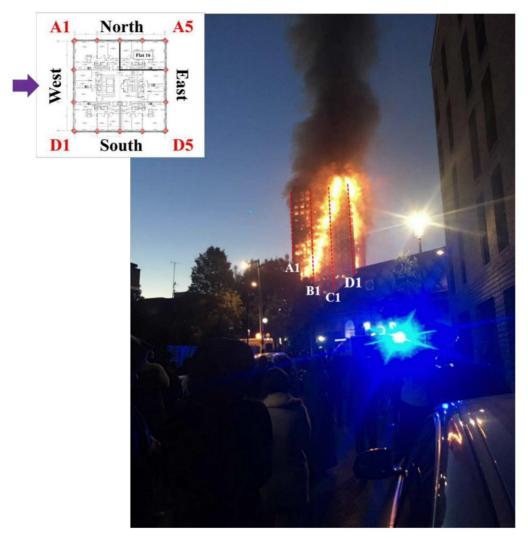
5.4.68 At approximately 04:03, these two flame fronts appear to effectively converge at the crown, near the southwest corner of the building; as shown in Figure 5.38.

Figure 5.38: Fire spread on West elevation and South elevation of the building envelope at 04:03 on 14 June 2017 (MET00012593) (SEA00010474)

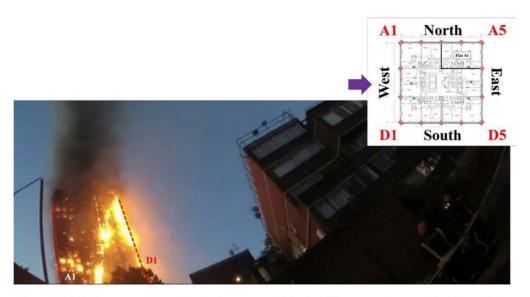
Figure 5.40: Fire spread on West elevation of the building envelope at 04:15 on 14 June 2017 (MET00012593) (SEA00010474)

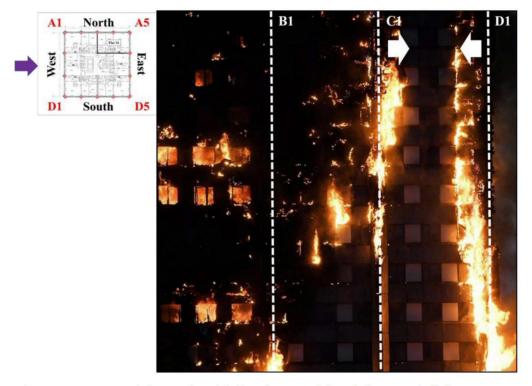
- 5.4.69 The two flame fronts spread laterally towards each other between columns C1 and D1, fully enveloping the building's perimeter, as shown in Figure 5.39, Figure 5.40, Figure 5.41, and Figure 5.42.
- 5.4.70 On 14 June 2017, civil twilight was from 03:55 and sunrise was at 04:42. I have estimated the timings for some of the following images based on this daylight information and my visual observations of fire development, benchmarked to images with known times.
- **5.4.71** Figure 5.39 shows fire burning in and around the crown cladding construction.

Figure 5.41: External fire enclosed full perimeter of Grenfell Tower building envelope on West elevation on 14 June 2017 (unknown time) (SEA00010474)⁶

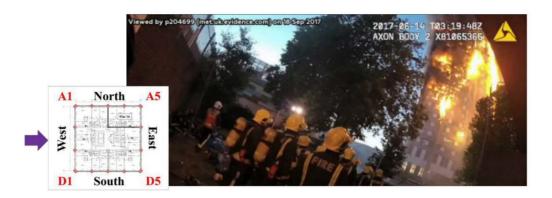
Figure 5.42: Fire on West elevation of the building envelope at 04:19 on 14 June 2017 (MET00012593) (SEA00010474)

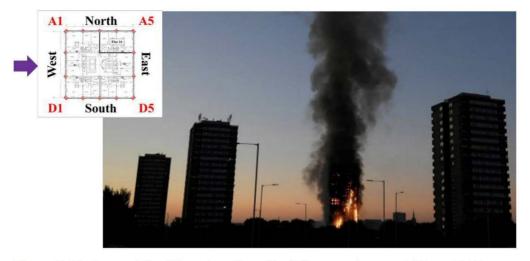
- 5.4.72 Figure 5.43, Figure 5.44, and Figure 5.45 show several internal fires burning while the building envelope on the West elevation continues to burn. These photographs are estimated to be between 04:03 and 04:42.
- 5.4.73 Figure 5.43 shows fire burning in and around the crown cladding construction.

Figure 5.44: External fire West elevation of building envelope on 14 June 2017 (exact time between 04:03 and 04:42 unknown) (SEA00010474)⁸

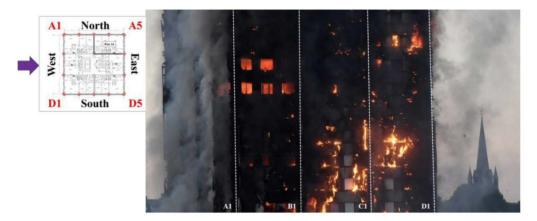
Figure 5.45: External fire West elevation of building envelope on 14 June 2017 (exact time between 04:03 and 04:42 unknown own) (SEA00010474)⁹

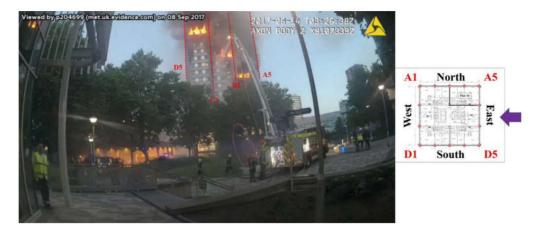
5.4.74 Multiple internal fires were burning in other areas of the building. Figure 5.46 shows a high reach (aerial) appliance firefighting jet being applied to internal fires on the East elevation of the building envelope at 04:26.

Figure 5.46: Internal fires on East building envelope at 04:26 on 14 June 2017 (MET00012593) (SEA00010474)

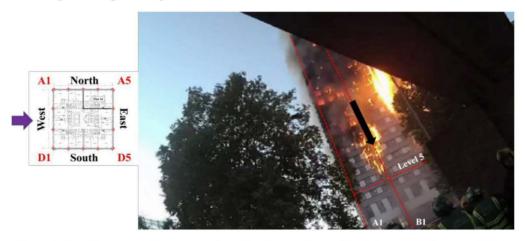
5.4.75 Figure 5.47 shows fire spreading vertically down the West elevation of the building envelope along column B1.

Figure 5.47: Downward fire spread on West elevation of building envelope at 04:31 on 14 June 2017 (MET00012593) (SEA00010474)

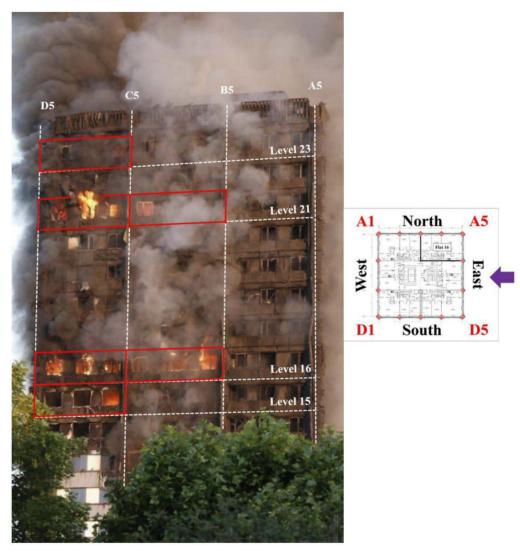
5.4.79 Figure 5.50 and Figure 5.51 show internal fires on the East building elevation at unknown times. Based on Figure 5.51, at least two (2) fire fighter jets were being applied at this time – one on the North elevation and one on the East elevation.

Figure 5.50: Internal fires on East elevation on 14 June 2017 (unknown time) $(SEA00010474)^{10}$

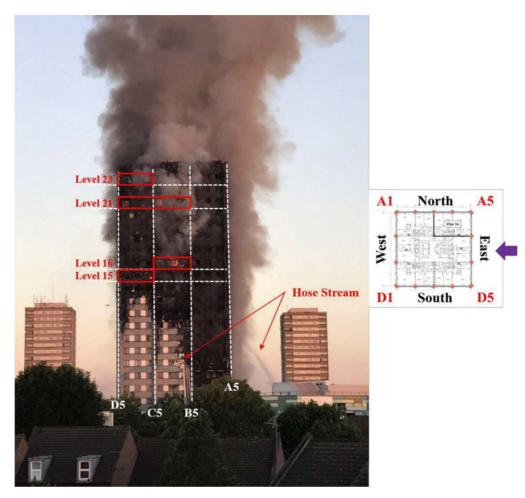
Figure 5.51: Internal fires observed on East elevation (unknown time) (MET00006799) (SEA00010474)

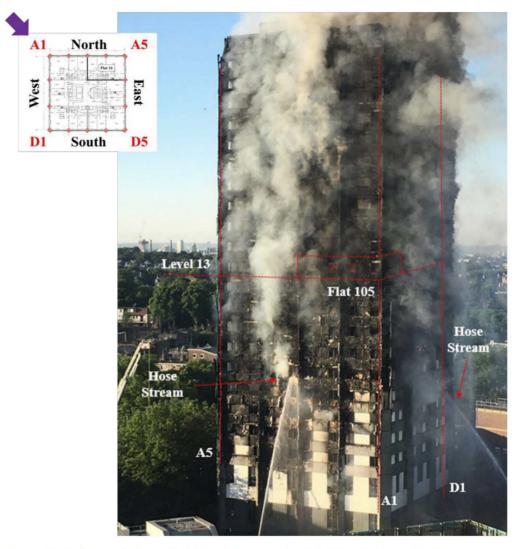
5.4.82 Based on Figure 5.54, there was an internal fire in Flat 105 on Level 13 at 06:07 and at least two (2) fire fighter jets were being applied several floors below Flat 105 – one on the North and one on the West elevation.

Figure 5.54: Internal fire in flat 105 on Level 13 at 06:07 on 14 June 2017 (MET00012593) (SEA00010474)

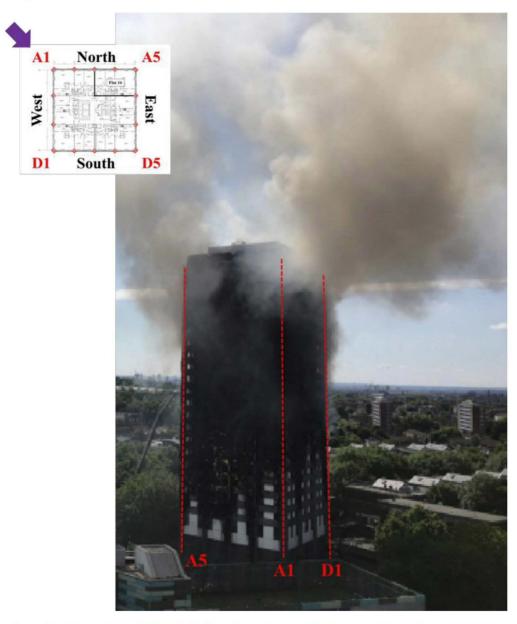
5.4.84 Figure 5.56 shows the North and West elevations of the building at 11:03. There are no visible internal fires on the North or South elevations in this photograph. However, this does not provide positive evidence that there were no internal fires at this time. I would expect that the majority of any fuel load available was consumed by this time; except for any gas acting as a fuel source.

Figure 5.56: North and West building elevations at 11:03 on 14 June 2017 (MET00012593) (SEA00010474)

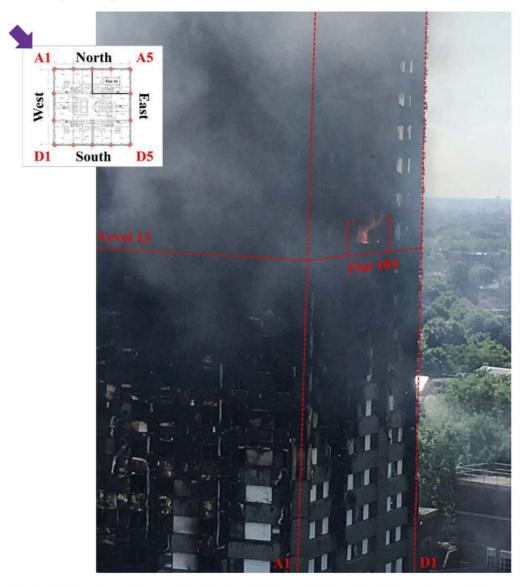
Based on Figure 5.57, there was an internal fire in Flat 104 on Level 13 at approximately 11:38. This is the time the photograph was posted to Twitter. Unlike other images posted by this person on Twitter, the time the image was taken was not indicated in the post. Therefore, I am relying on the time of the Twitter post only.

Figure 5.57: Internal fire in flat 104 (level 13) on building West elevation on 14 June 2017apparently at approximately 11:38 (SEA00010474)¹¹

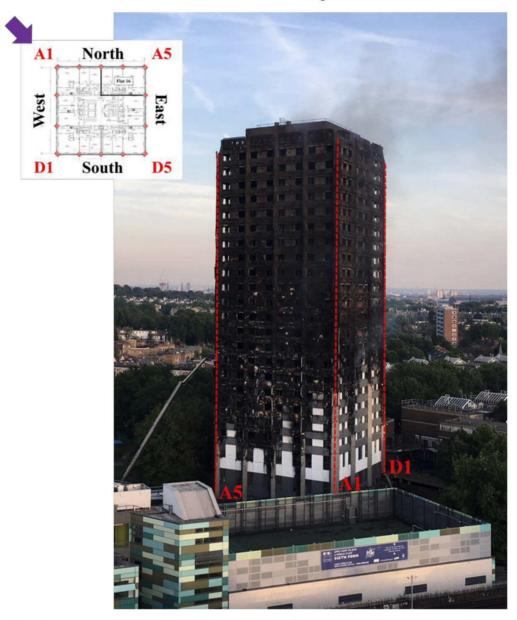
- 5.4.87 The LFB handed over active control of the site to the Major Incident Command at 20:00 (LFB00000003).
- **5.4.88** Figure 5.58 shows the North and West elevations of the building at 20:25. I cannot see any internal fires in this photograph.
- 5.4.89 However, I can see internal fires in multiple flats on the building's North and West elevations at 21:50 in Figure 5.59.
- 5.4.90 It is unclear what the source of fuel is from these photos.

Figure 5.58: North and West elevations of the building apparently at 20:25 on 14 June 2017 (SEA00010474)¹²

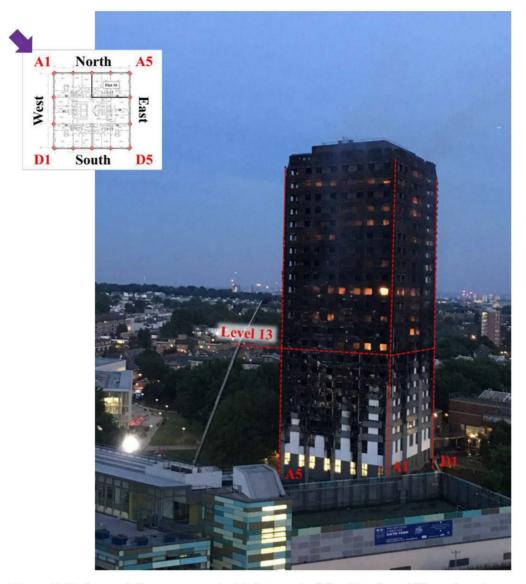
Figure 5.59: Internal fires apparent in 19 flats on building North and West elevations apparently at 21:50 on 14 June 2017 (SEA00010474)¹³

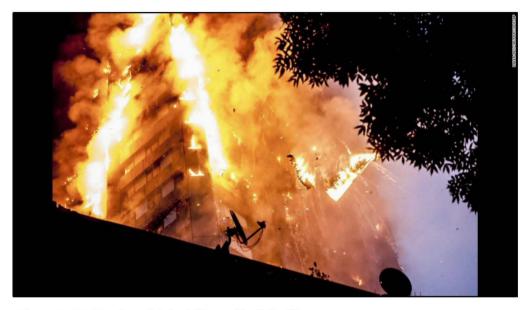
5.5.1 A significant amount of debris fell off the building envelope of Grenfell Tower on 14th June 2017. A large amount of this debris was on fire, as shown in Figure 5.60 and Figure 5.61.

Figure 5.60: Burning debris falling of building¹⁴

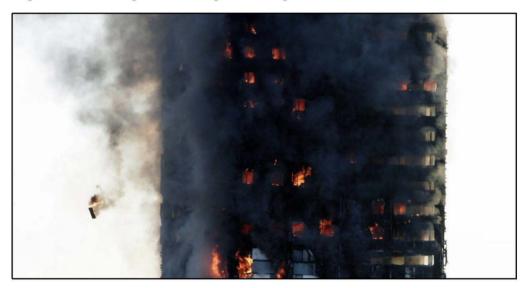
Figure 5.61: Burning debris falling off building¹⁵
