**Grenfell Tower – fire safety investigation:**  
**The fire protection measures in place on the night of the fire, and conclusions as to:**

**Phase 1 Report – Section 8**

**The external wall – materials and construction**

**Dr Barbara Lane FREng FRSE CEng**

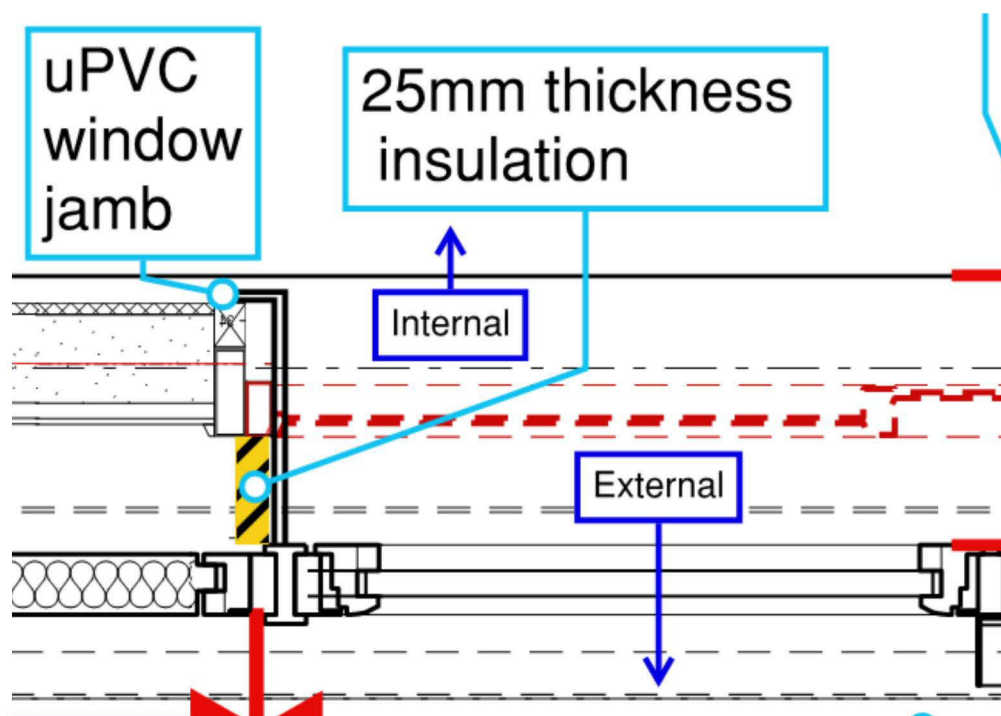
- 8.7.15** In this case, the insulation was fitted to enclose the new cavity created between the new and existing in-fill panels (excerpt of Figure 8.7 enlarged and annotated below):

Figure 8.17: Enlarged plan of window jamb detail in centre of window opening  
(Based on HAR00003765, onsite measurement of 25mm insulation)

- 8.7.16** In design drawings there was no evidence that this cavity was intended to have any intermediate barriers or insulation installed. Figure 8.19 identifies that the cavity between the new insulating core panel (Aluglaze) and original non-combustible infill panel was unbroken over the full length to the adjacent window reveal.

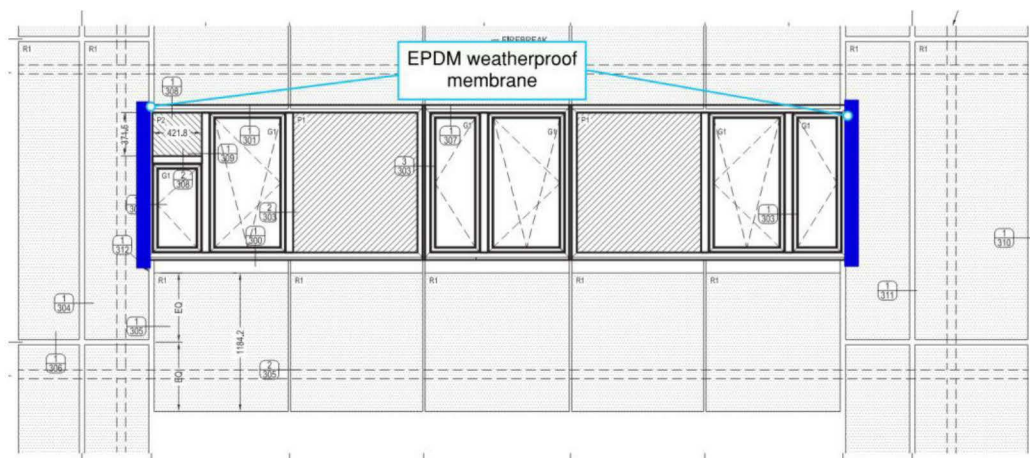
8.8.1 To close the gap introduced by the alterations to the windows as shown in Figure 8.15, a weatherproof membrane of Ethylene Propylene Diene Monomer (EPDM) rubber was used as a seal, in the location shown in Figure 8.20:

Figure 8.20: Location of EPDM weatherproof membrane (underneath insulation and rainscreen) (Based on HAR00008581)

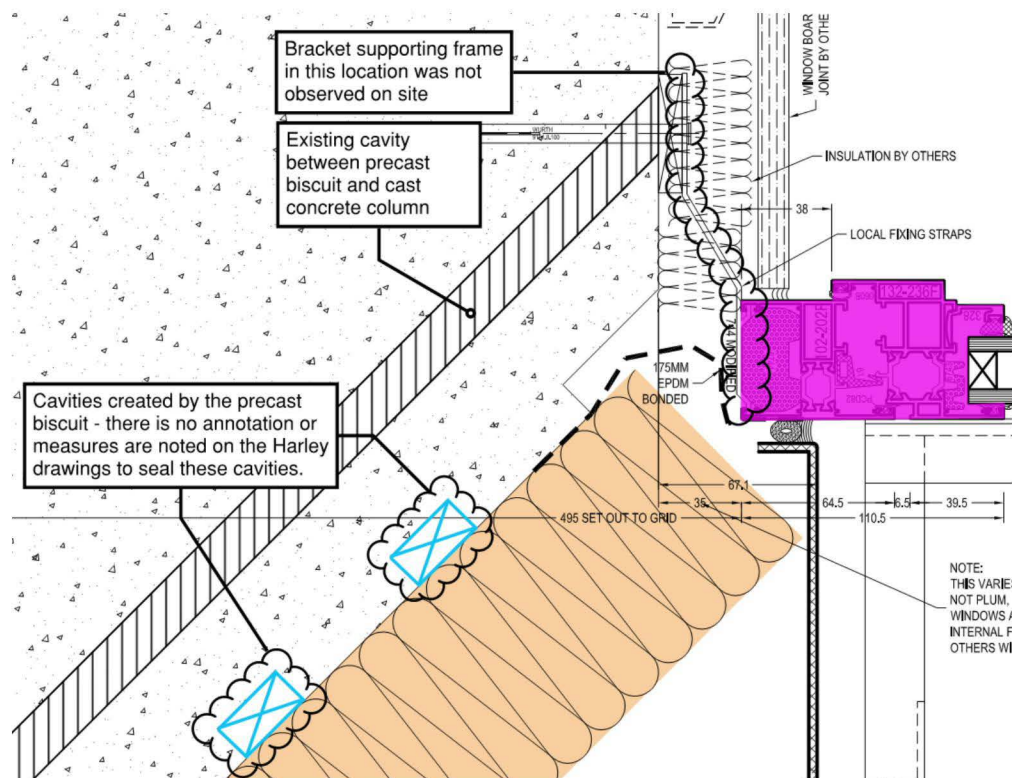
**8.9.13**      Cavities were also created by the ridged form of the precast concrete biscuit (slabs affixed to the outside face of the cast concrete column, see Figure 34 below) and the application of the rainscreen cavity insulation and cavity barriers. I have not seen any evidence either in the Harley construction drawings or from onsite observations of an attempt to seal these cavities:

Figure 8.35: Precast biscuit cavities formed by the application of the rainscreen cavity insulation

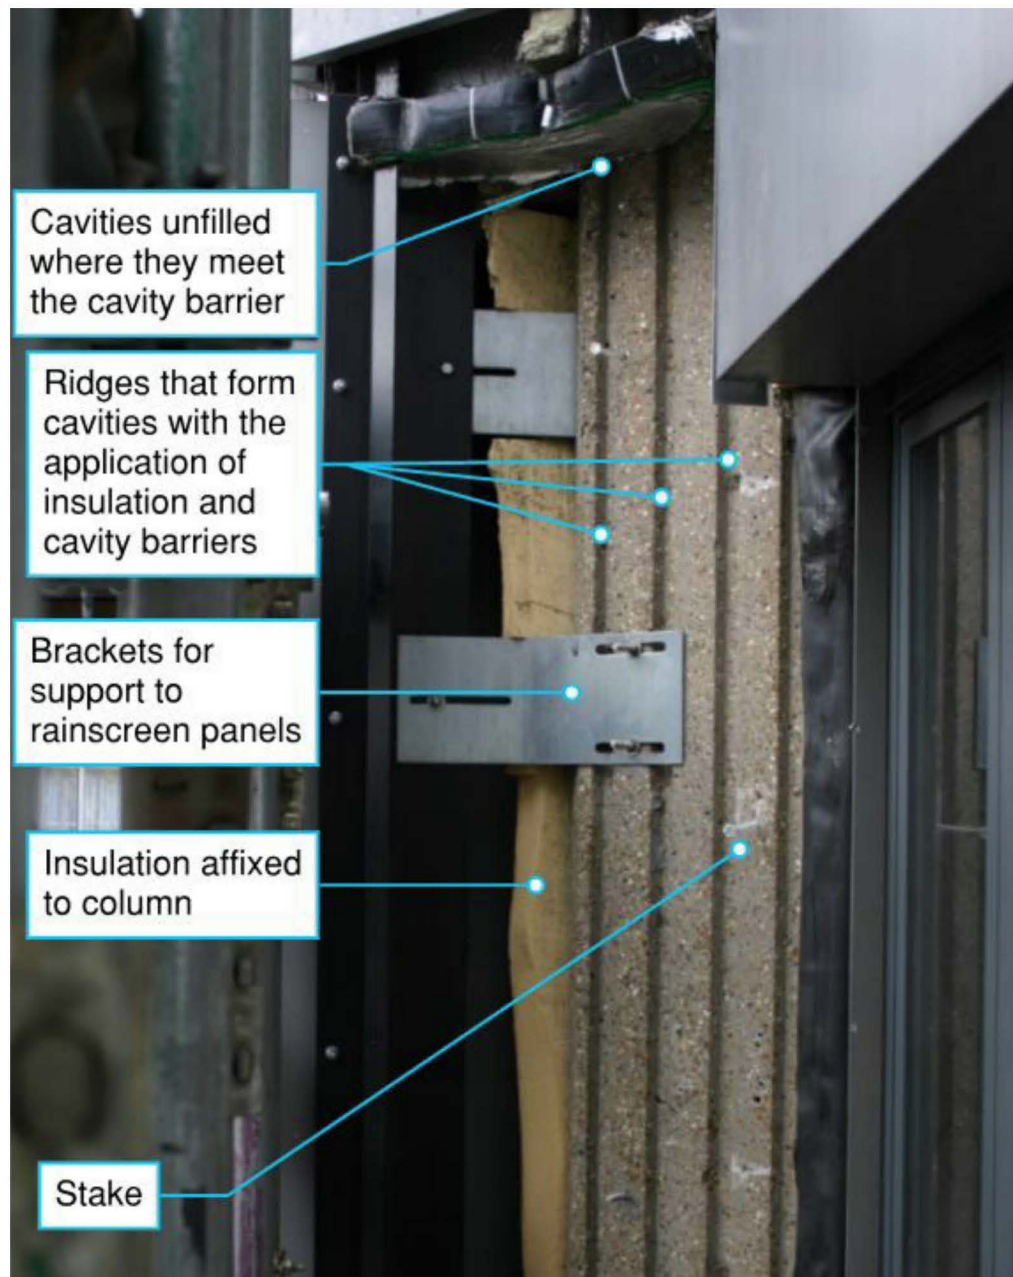
The visible brackets in Figure 8.36 were for the support of the rainscreen cladding system only and provide no structural support to the insulation.

Figure 8.36: Photograph showing insulation affixed to column and rainscreen cladding brackets

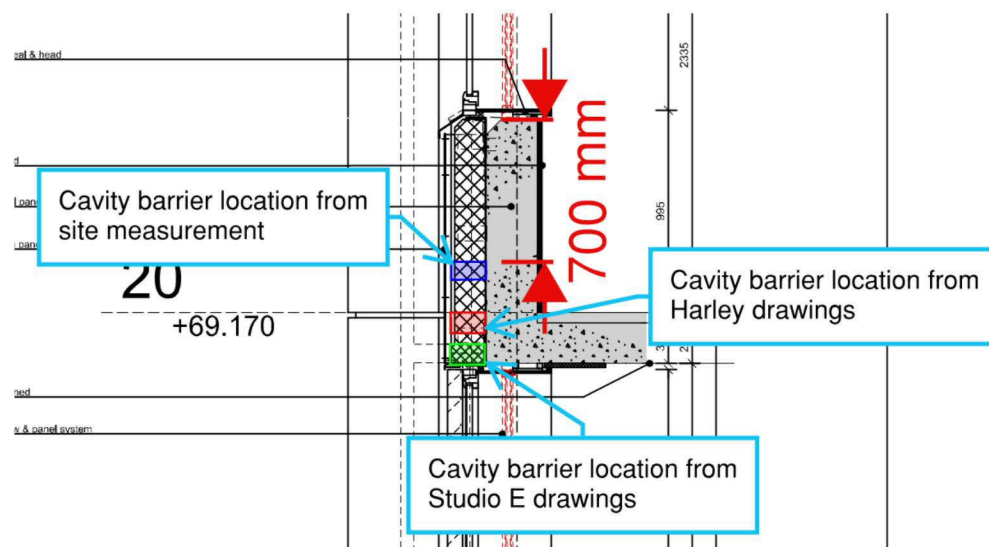
**8.9.33** As indicated in Figure 8.41 and Figure 8.42, the position of the horizontal cavity barriers differed between the design information and the location measured on site. This difference means that combustible insulation was installed directly above the head of the window, where the Studio E design would have positioned the cavity barrier in this location (which is formed of non-combustible material).

Figure 8.41: Horizontal cavity barrier locations (onsite measurement of 700mm and annotations based on SEA00002551)

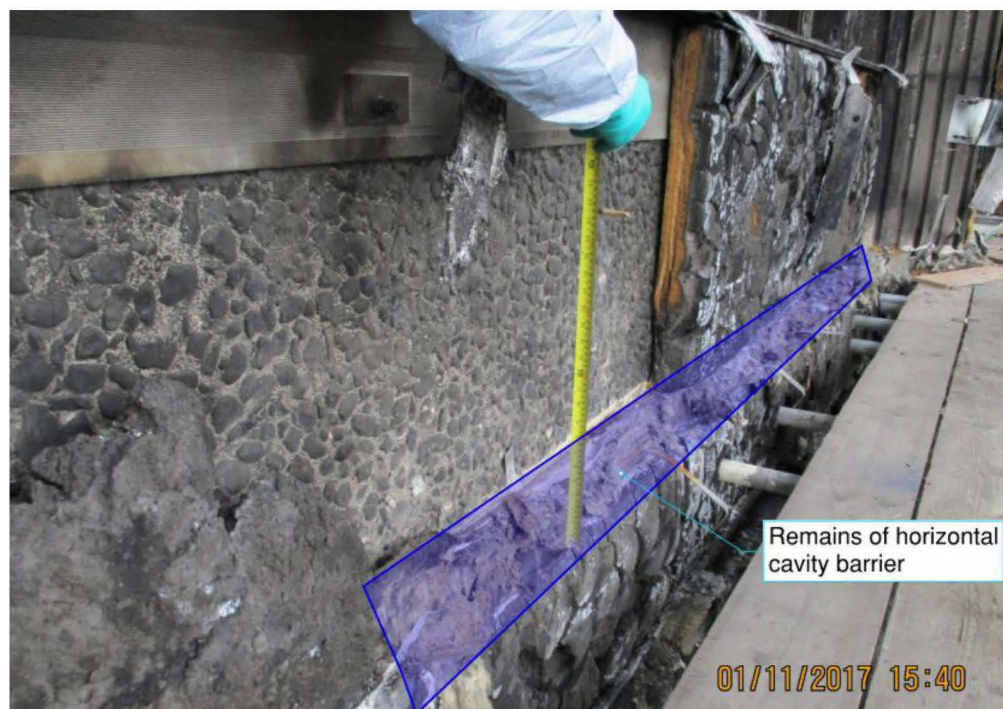
Figure 8.42: Evidence from site of position of cavity barrier (Flat 16, Bedroom 2)

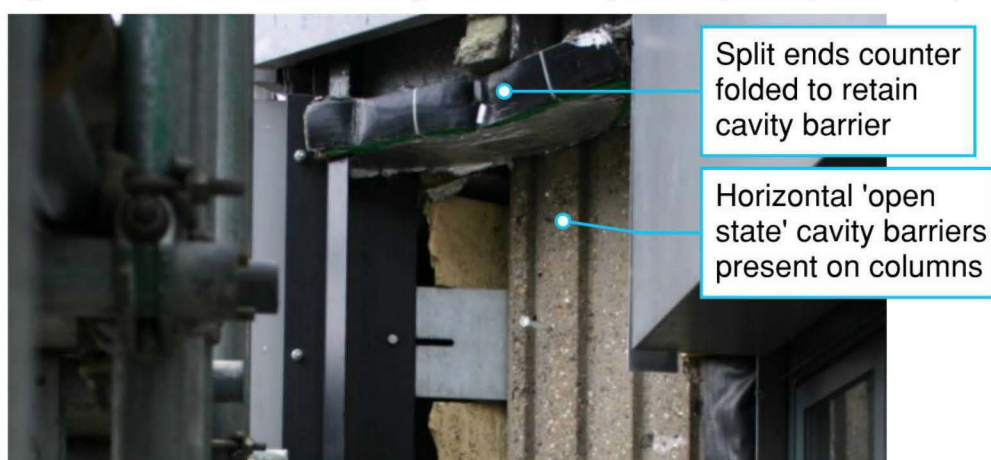
Figure 8.43: Horizontal cavity barriers on column, showing fixing method.

**8.9.35** According to the Siderise data sheet *SIDERISE RH and RV cavity barriers for use in the external envelope or fabric of buildings* (SIL00000230), the brackets are drilled on site and should be secured to the inner structural wall using non-combustible steel anchors or screws. The outer fixing method was observed to be a metal strip split into two and folded back against the cavity barrier in each direction. I have not been able to confirm the types of fixings used on site and therefore I have not determined the compliance of the installation and spacing of the mechanical fixings for the cavity barriers.

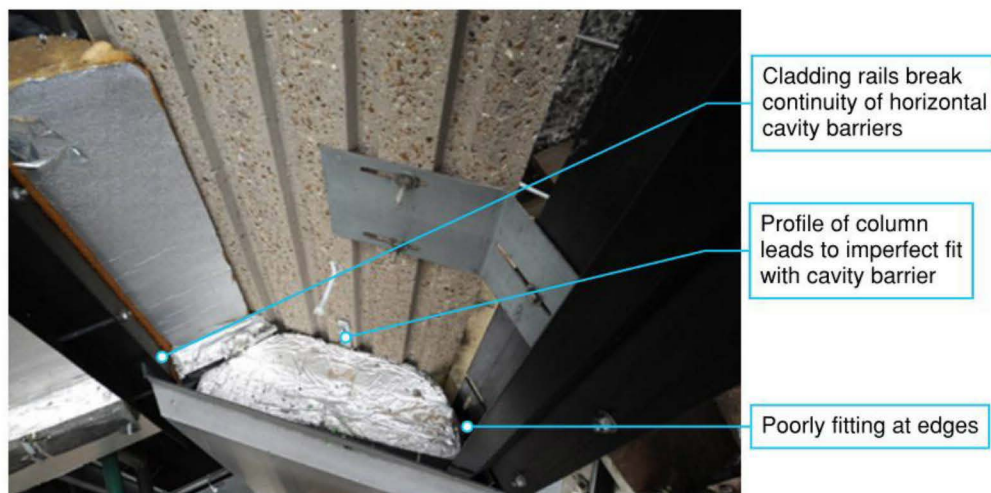
Figure 8.44: Junction of column and spandrel horizontal cavity barrier. External of Flat 12.

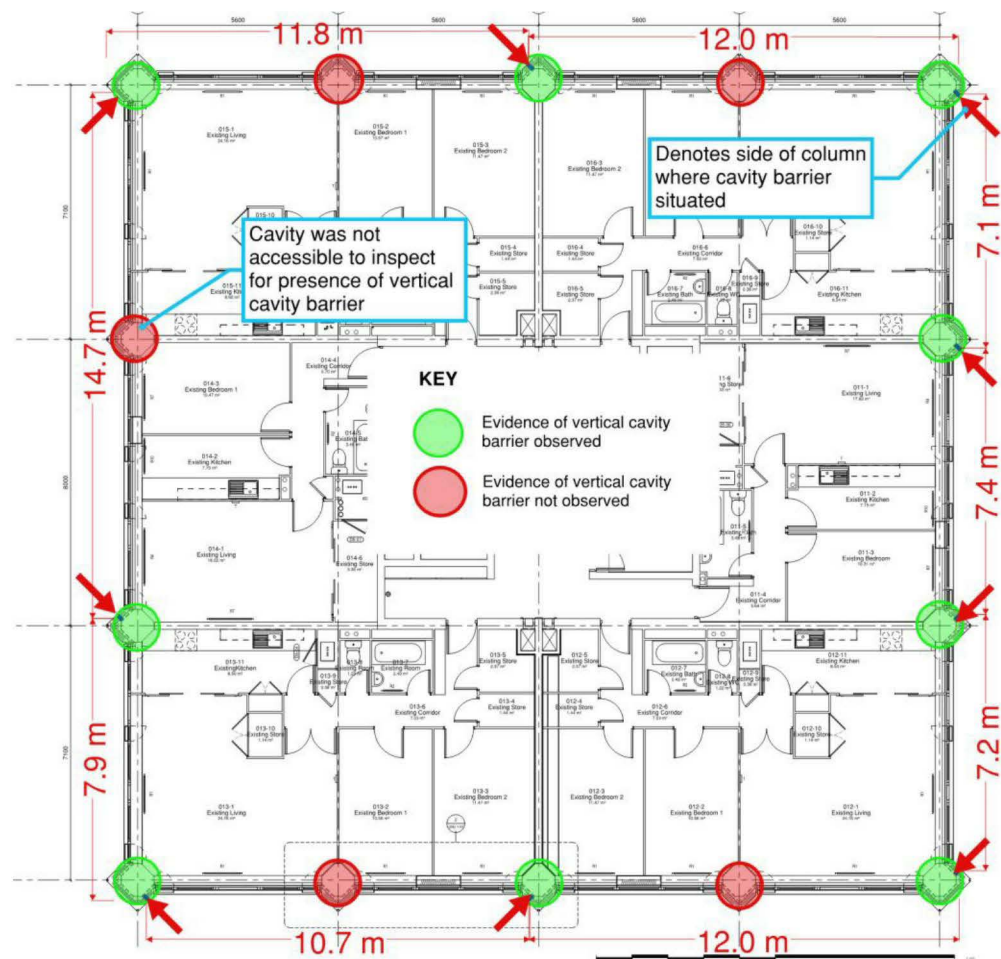
**8.9.55** This is in agreement with my site observations (Figure 8.51), which were collated both from inspection through the panel gaps on Level 3 of the building and from the evidence of vertical cavity barriers remaining on Levels 16-23.

**8.9.56** It should be noted that due to restricted access I was not able to inspect for the presence of vertical cavity barriers on a fifth column, column B1 (West façade).

Figure 8.51: Site observations for locations of vertical cavity barriers

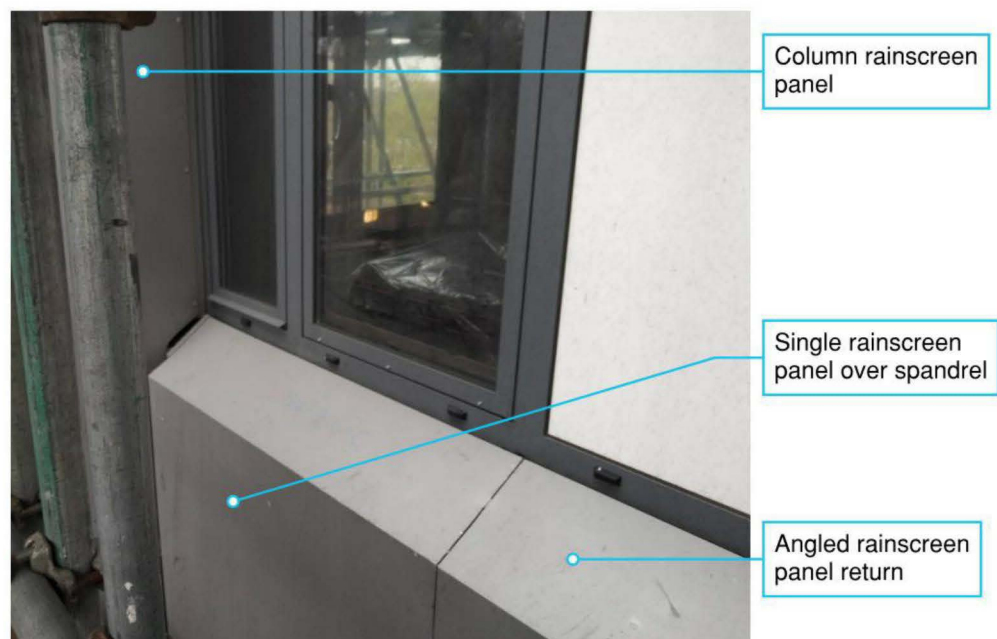
Figure 8.55: Spandrel rainscreen panel. External Flat 12.

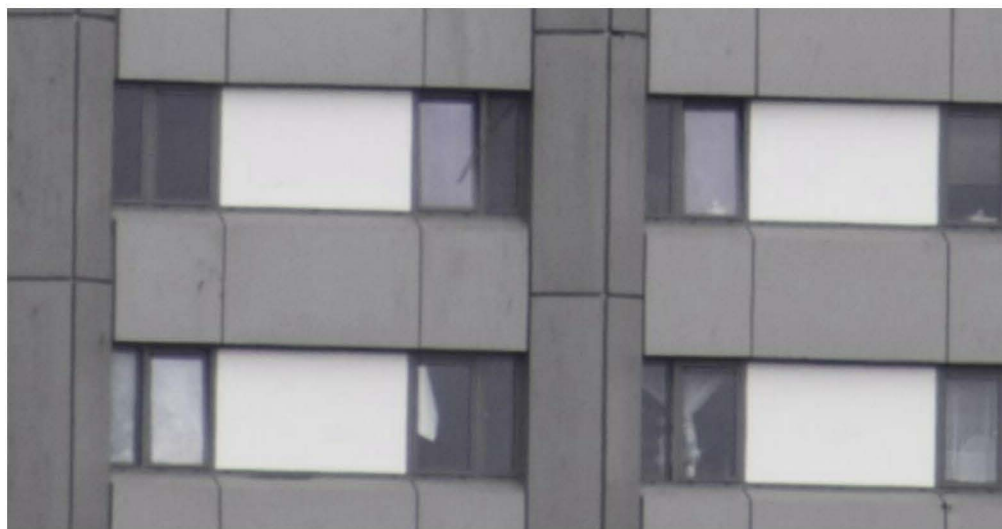
Figure 8.56: Close-up photograph of cladding to residential floors.

- 8.10.29** The columns were clad with 1 panel per face, that is 2 rainscreen panels on the intermediate columns and 3 rainscreen panels on the corner columns (Figure 8.56).

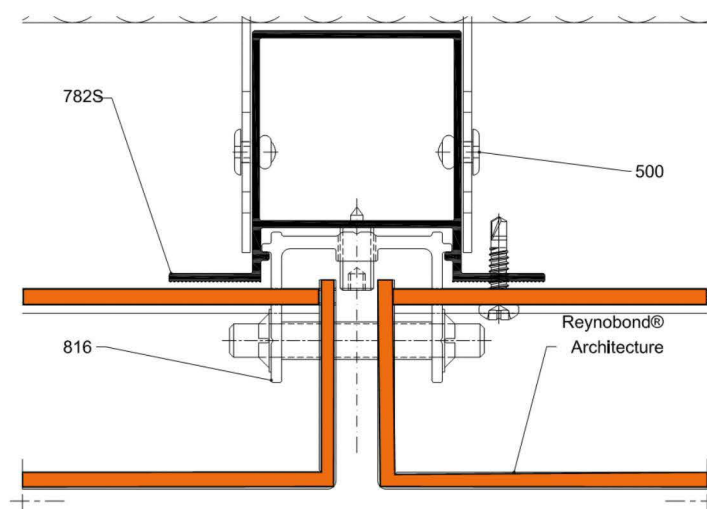
Figure 8.57 Arconic Modular cassette (riveted)<sup>4</sup> (Reynobond panel highlighted in orange)

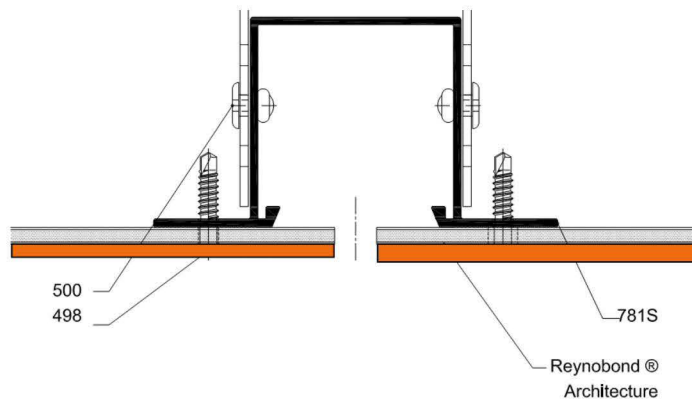
Figure 8.58 Flat panel (Screw fixed)<sup>4</sup> (Reynobond panel highlighted in orange)

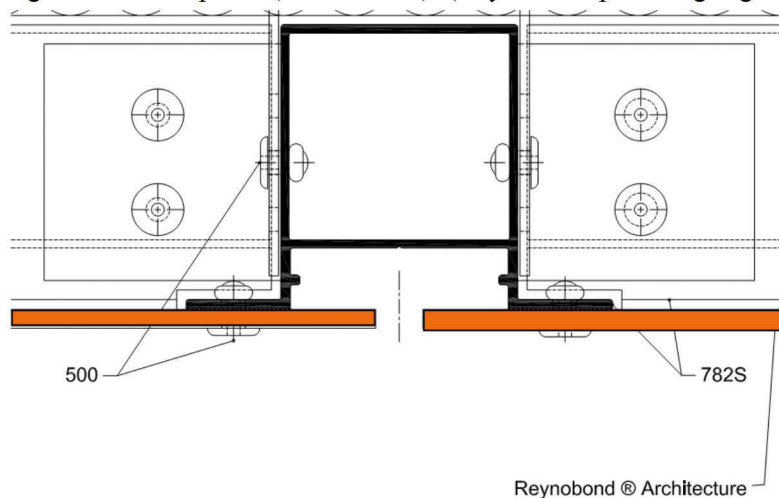
Figure 8.59 Arconic Flat panel (riveted)<sup>4</sup> (Reynobond panel highlighted in orange)

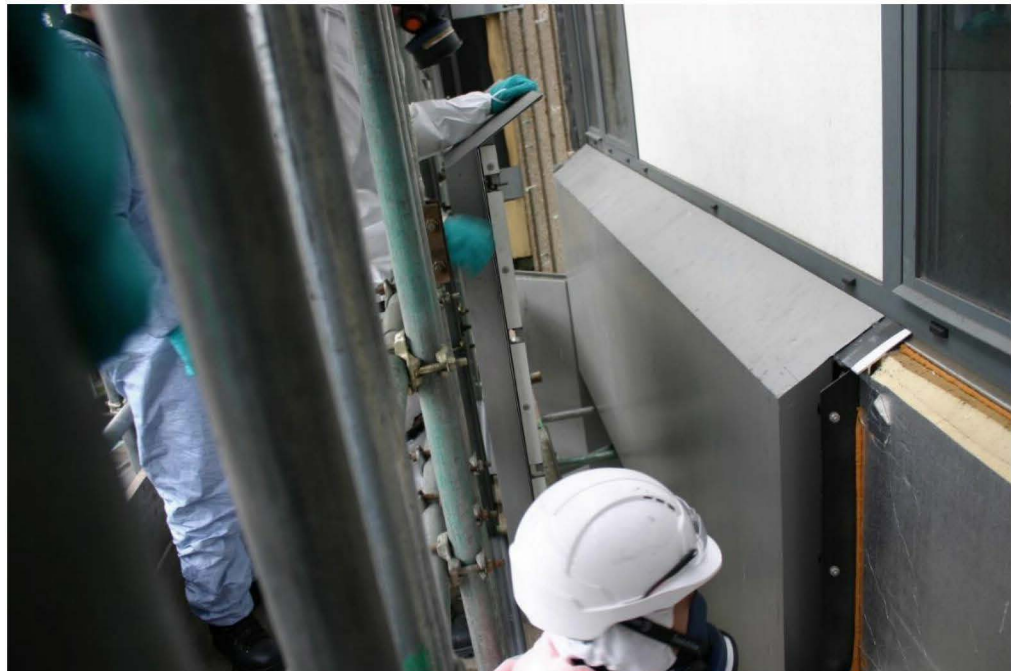
On Grenfell Tower, I observed that the panels were formed into shapes as shown in Figure 8.60 and hung on bolts through a carrier rail. I have therefore, compared the system to Arconic's standard details for modular cassette systems.

Figure 8.60 ACM panels formed into 3D shape

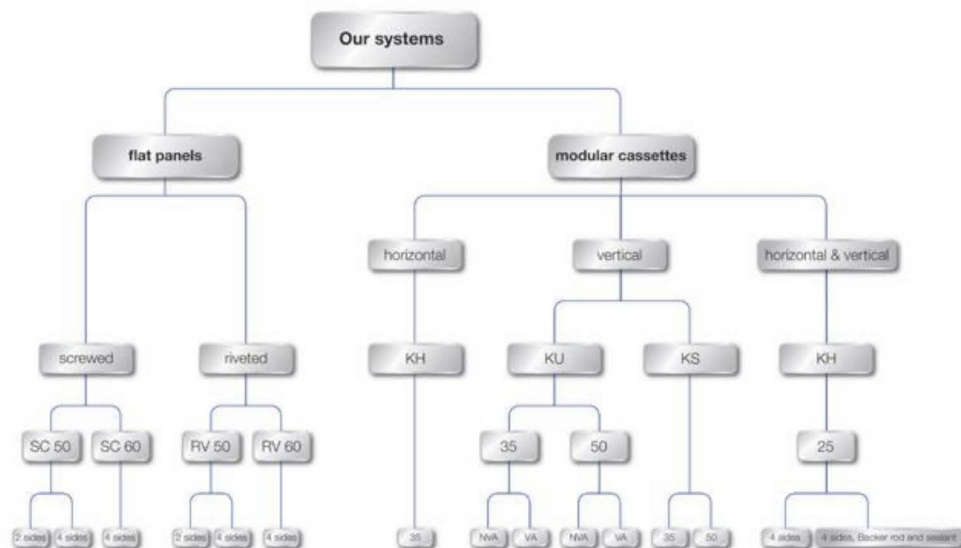
**8.10.19** Based on review of the Arconic standard details for modular cassettes I have determined that these systems are designated by Arconic as either KU, KS, or KH-25/35/50 or VA or NVA, depending on the dimensions of the panel, how they are hung and how they are fixed. This is shown in Figure 8.61.

Figure 8.61 Arconic panel designations (adapted from Arconic website<sup>4</sup>)

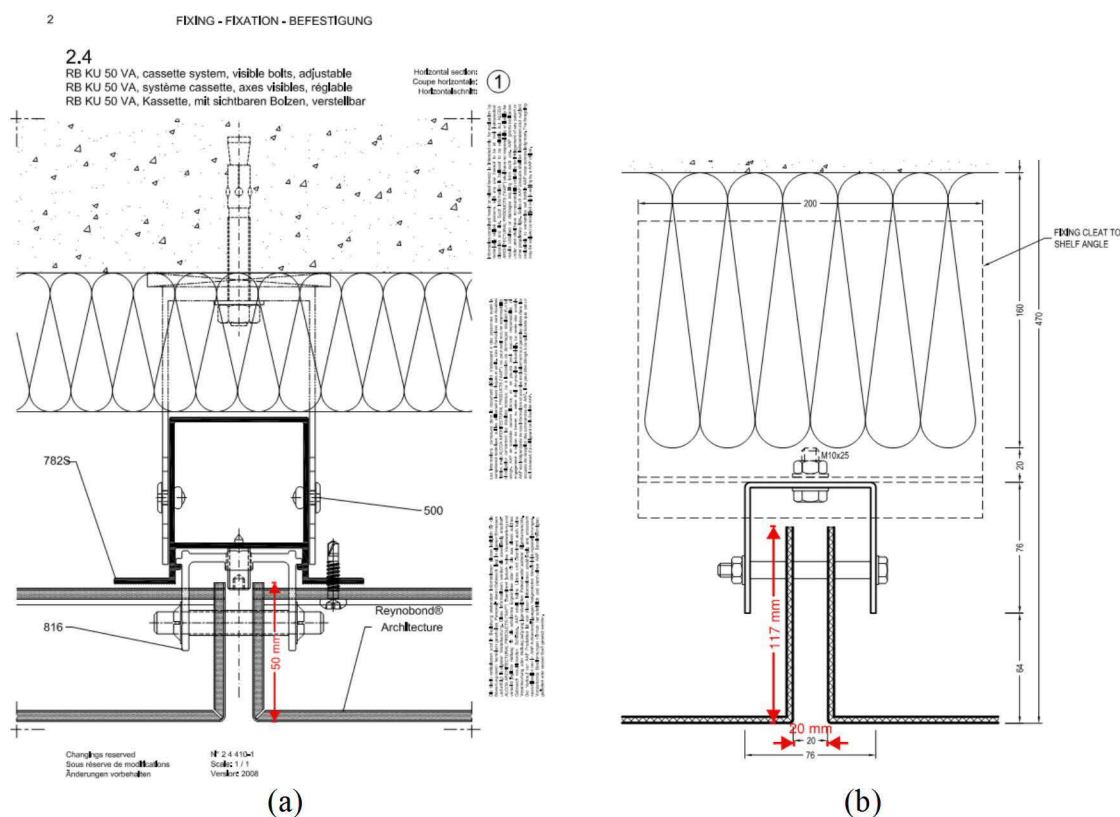
panel). In Figure 8.62 I have compared the Arconic KU50 panel which shows a panel return depth of 50mm (the largest described by the Arconic standard details) to the detail specified for Grenfell Tower, which I also observed onsite. It shows an equivalent panel return dimension of 117mm.

Figure 8.62 (a) Arconic Standard detail for KU50 (50mm return of ACP panel) (b) Depth of return of Grenfell Cladding panel (measured from C1059-305 Rev D [HAR00008903])

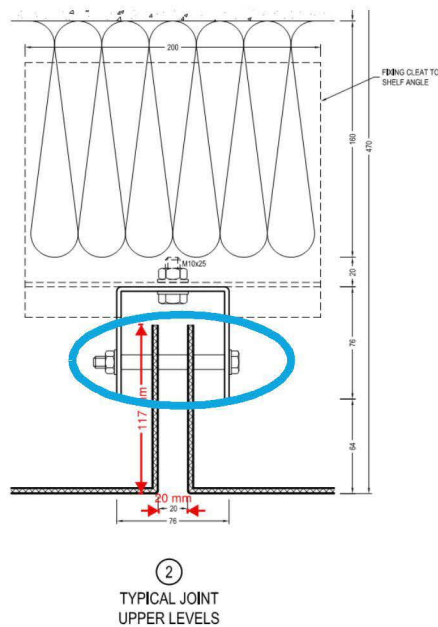
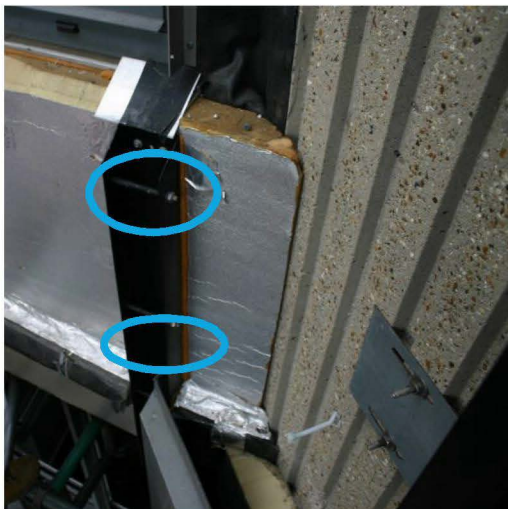
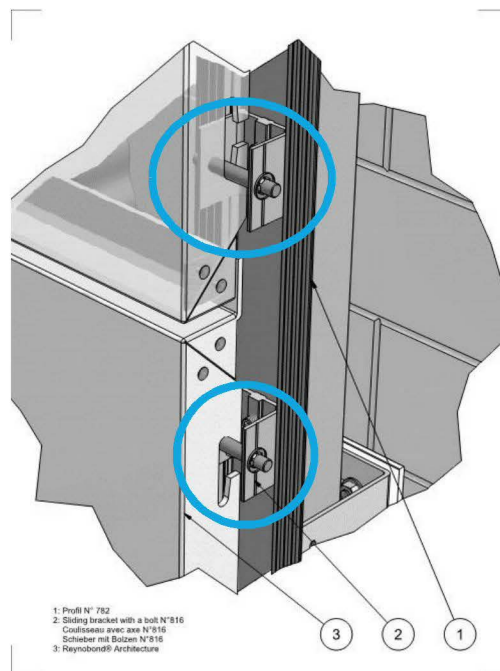
Figure 8.64 Comparison of Grenfell Tower Cladding fixing detail to the Standards Arconic detail for an example KU 50 VA

a) Grenfell Tower Cladding detail (Adapted from C1059-305 Rev D [HAR00008903]) and site photo (note bolts circled in blue fixed into a continuous rail not individual brackets)

b) Standard fixing detail for an Arconic Reynobond KU 50 VA (Modular cassette system hung on bolts) (note bolts circled in blue fixed into individual brackets)

**8.10.24** It can be seen that the Grenfell Tower cladding panels are hooked onto bolts attached to a continuous cladding rail (Figure 8.64 (a)) whereas in the Standard Arconic system (Figure 8.64 (b)) the bolt is fixed into individual brackets which are then attached to a cladding rail.

**8.10.25** As the dimensions of the panels observed on site, both in terms of their shape and fixing method, deviate from the standard Arconic details, I believe it is

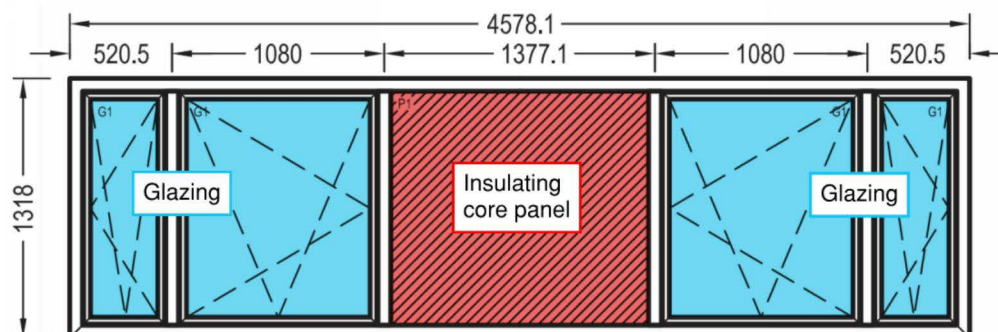
8.10.33 Set into the windows themselves were two types of unglazed elements in various configurations. See Figure 8.69 and Figure 8.70 for the two typical arrangements as specified in Studio E and Harley design information. The insulating core panels were approximately 1318mm in height and vary from approximately 820mm to 1375mm in width.

Figure 8.69: Typical elevation for two-window configuration (Based on HAR00008145)

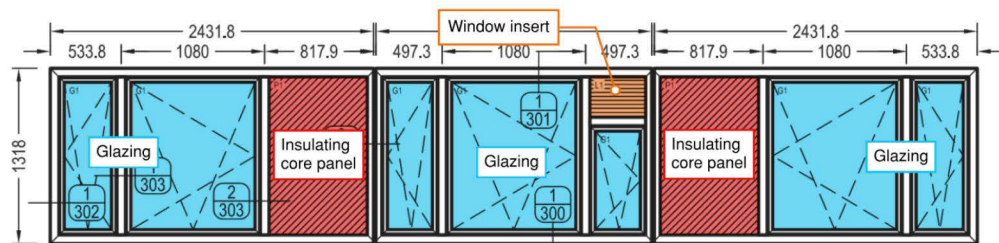
Figure 8.70: Typical elevation for three-window configuration (Based on HAR00008145)

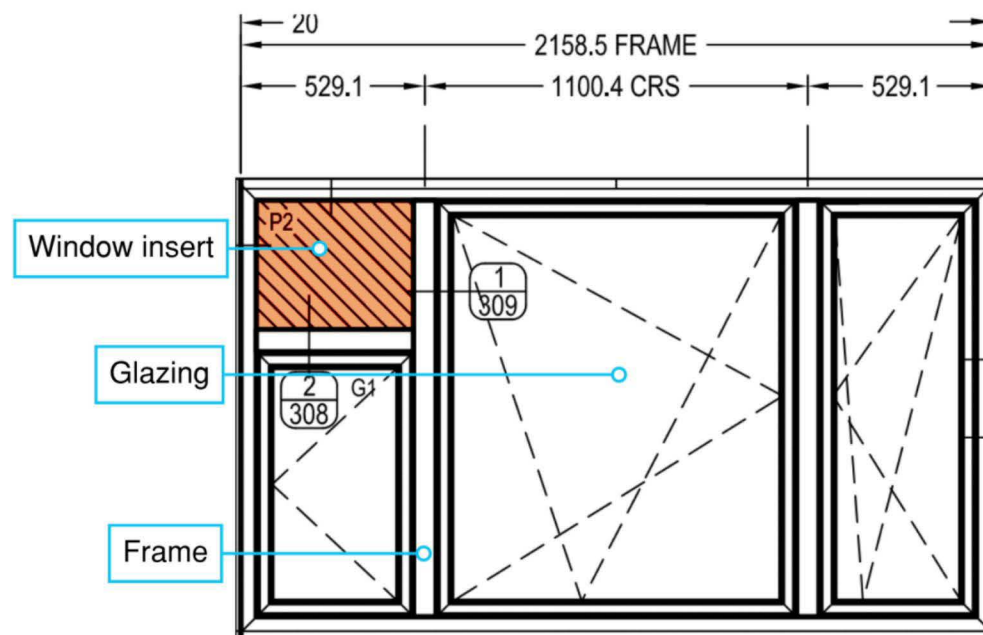
**8.10.39** Within the kitchen window framing system, a vent was placed in the upper corner of the window, as shown in Figure 8.71. According to the Harley specification (HAR00008991) the construction of this element was to be as follows:

- 1.5mm aluminium skin;
- a core of 25mm Kingspan TP10 PIR insulation (combustible);
- 1.5mm aluminium skin;
- Finished with PPC (polyester powder coating) on both outer surfaces.

Figure 8.71: Typical kitchen window insert insulating core panel and vent location (Based on HAR00008145)
