Grenfell Tower – fire safety investigation:
The fire protection measures in place on the night of the fire, and conclusions as to:

Phase 1 Report – Section 9

Routes for fire spread out through the window openings

24th October 2018

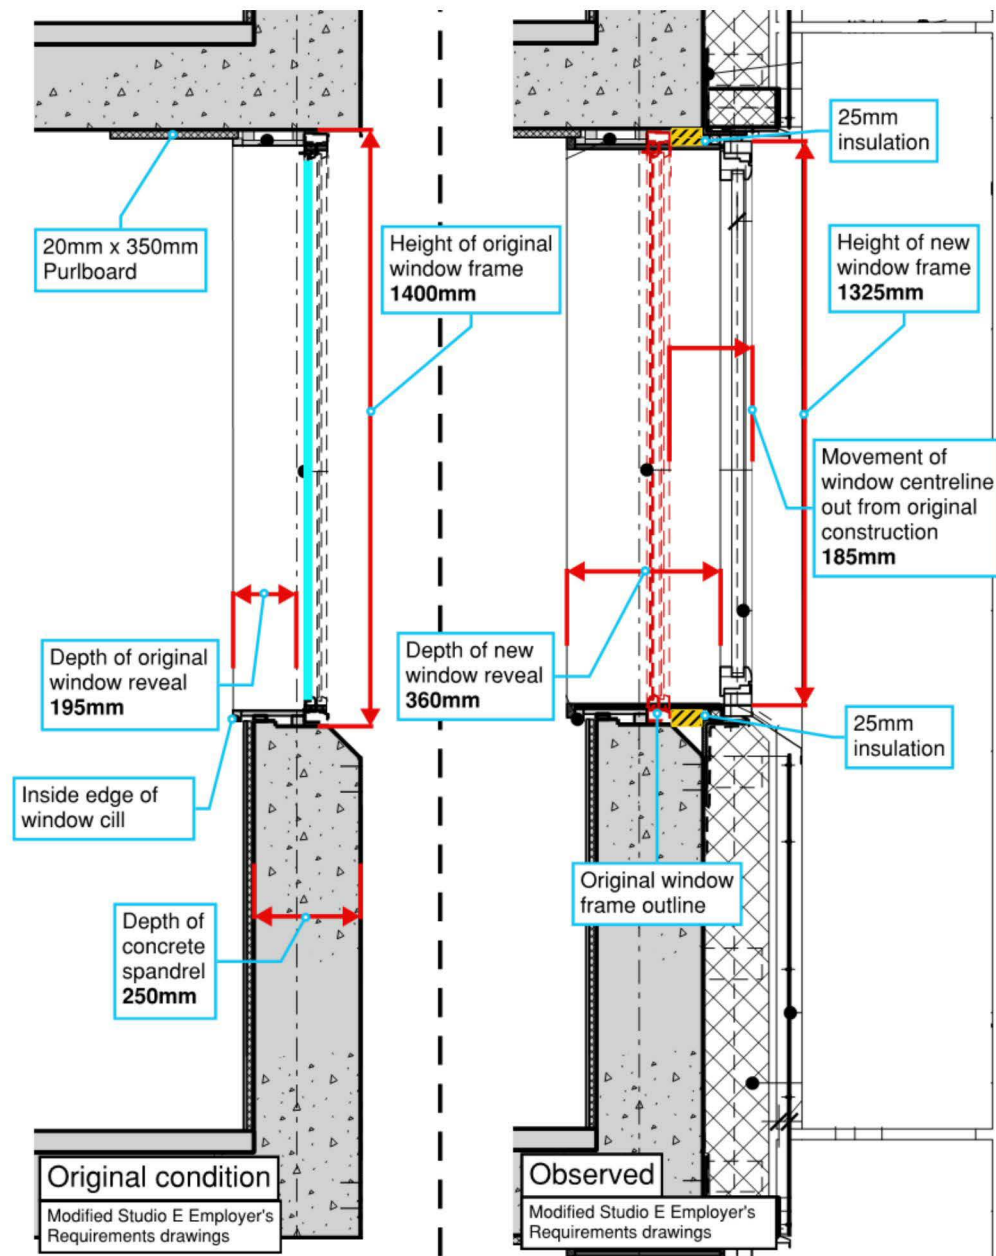
Figure 9.6: Vertical section view of original [left] and post refurbishment [right] window openings (Based on SEA00013045)

- 9.2.11** The relationship of that external wall cavity to the internal cavity at the jamb is also shown. It is clear in Figure 9.5 that the EPDM weatherproof membrane is the only thing separating these two spaces.
- 9.2.12** I have reproduced Figure 8.3 from Section 8 here (Figure 9.6 below) as a reminder of the location of the new window, relative to both the old and new external wall, and this is the reason for the creation of these cavities, in behind the window reveal linings.

- 9.2.13** Each of these cavities contained combustible insulation. In the internal cavities (a) to (d) above, these were localised insulation materials attempting to seal the window (Figure 9.1). In the main external wall cavity this was the Celotex/Kingspan product attached to the original concrete wall.
- 9.2.14** The cavities around the window also contained remnants of the original wooden window reveal linings and supporting timber battens. These items were left in place during the refurbishment works, with the new uPVC reveal linings being glued to the outside of the timber reveal linings. The original timber reveal linings are a further set of combustible materials behind the uPVC reveal linings (visible in Figure 9.2).

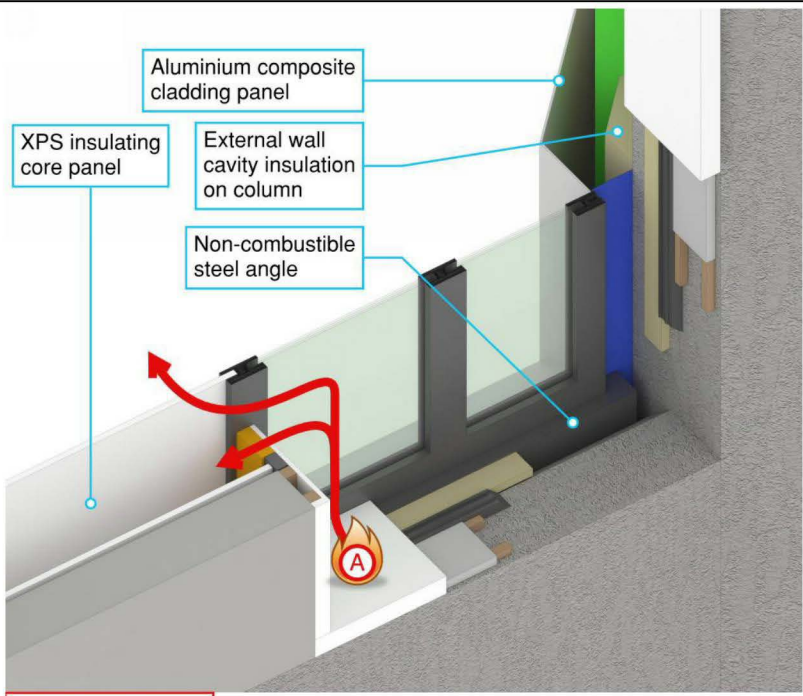
Fire Scenario	Route of fire spread through the window to the extensive external wall cavities
<p>A</p> <p>A fire starts adjacent to the window jamb at the infill panel side of the window, it could spread into the cavity behind the window reveal and onwards into the external wall cavity via the new combustible insulating core panel.</p> <p>Fire source: Combustible flat contents stored/positioned on the window sill, or near the window jamb</p>

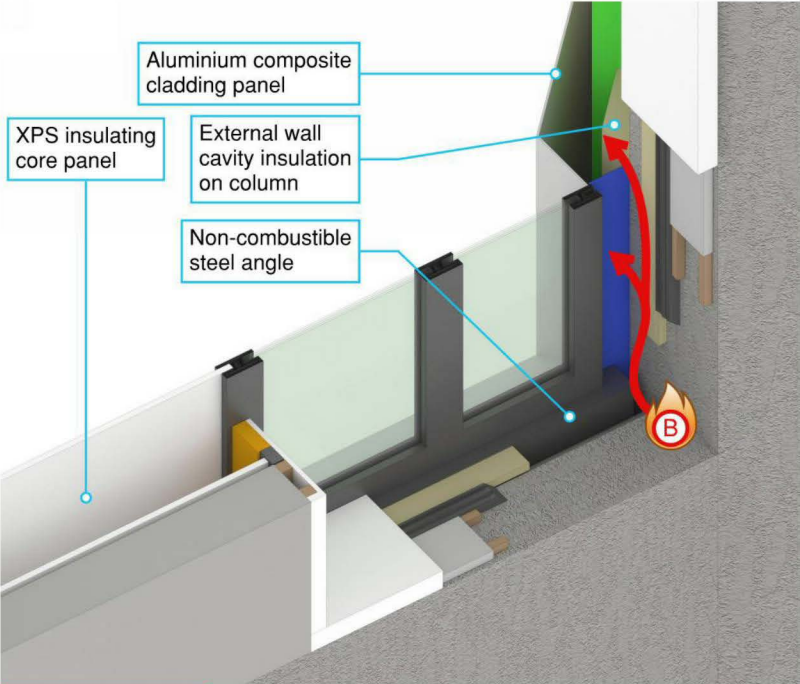
Fire Scenario	Route of fire spread through the window to the extensive external wall cavities
<p>B</p> <p>A fire starts on the column side of the window, it could break through the window reveal lining there and into the external wall cavity via the gap at the window jamb which is sealed with a damp proof membrane only.</p> <p>Fire source: Combustible flat contents stored/positioned on the window cill or near the window jamb</p>

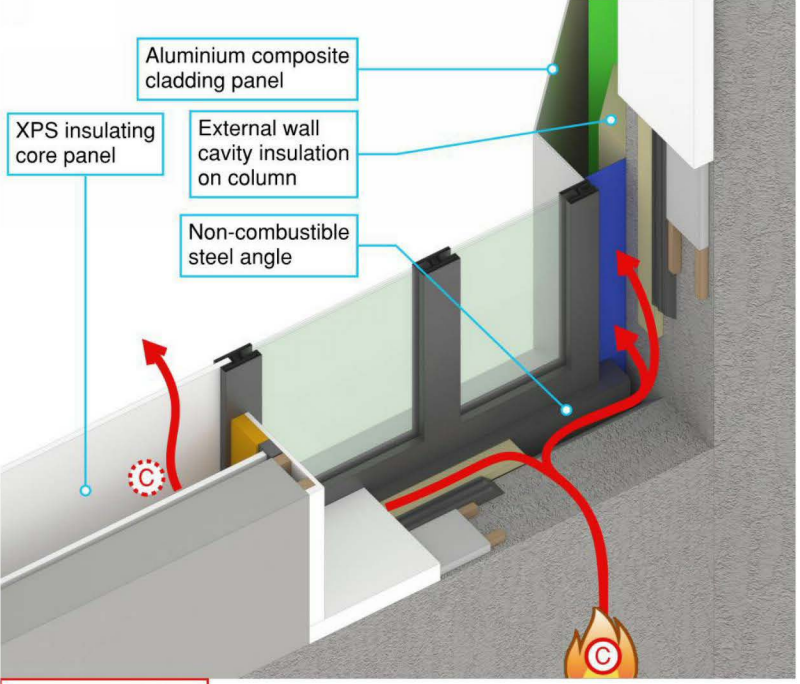
<p>Aluminium composite cladding panel</p> <p>XPS insulating core panel</p> <p>External wall cavity insulation on column</p> <p>Non-combustible steel angle</p> <p>Window cill view</p>
<p>C</p> <p>A fire starts under or next to the window cill, it could break into the materials forming the window reveal there and spread through those materials into the external wall cavity. This could occur via the gap between the window cill and window jamb. And also via the gap into the insulating core panel cavity.</p> <p>Fire source: Combustible flat contents stored/positioned next to the window</p>

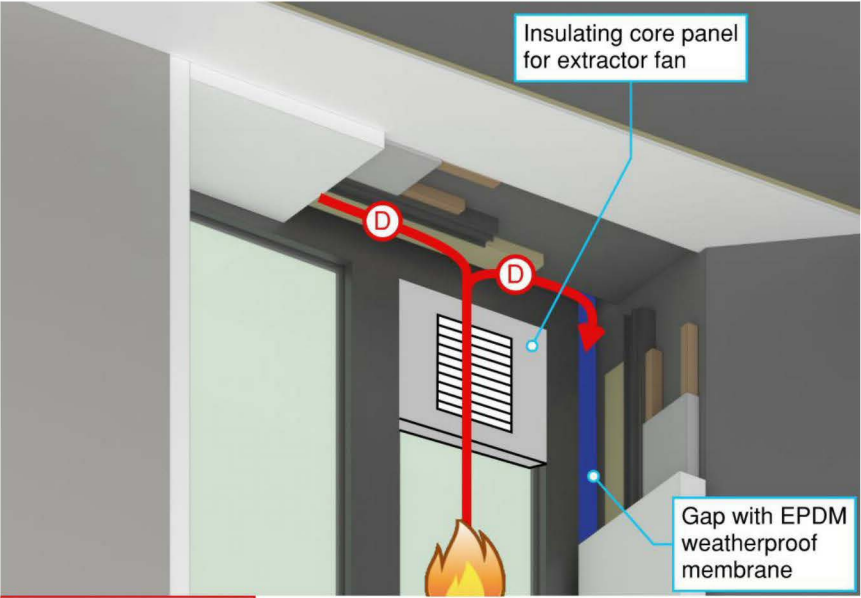
Fire Scenario	Route of fire spread through the window to the extensive external wall cavities
<p>D</p> <p>A fire could spread into the cavity at the head of the window, and onwards into the external wall cavity via the gap at the window jamb and via the insulating core panel.</p> <p>Fire source: Ceiling jet from fire within the kitchen or from combustible flat contents positioned/stored next to window</p>

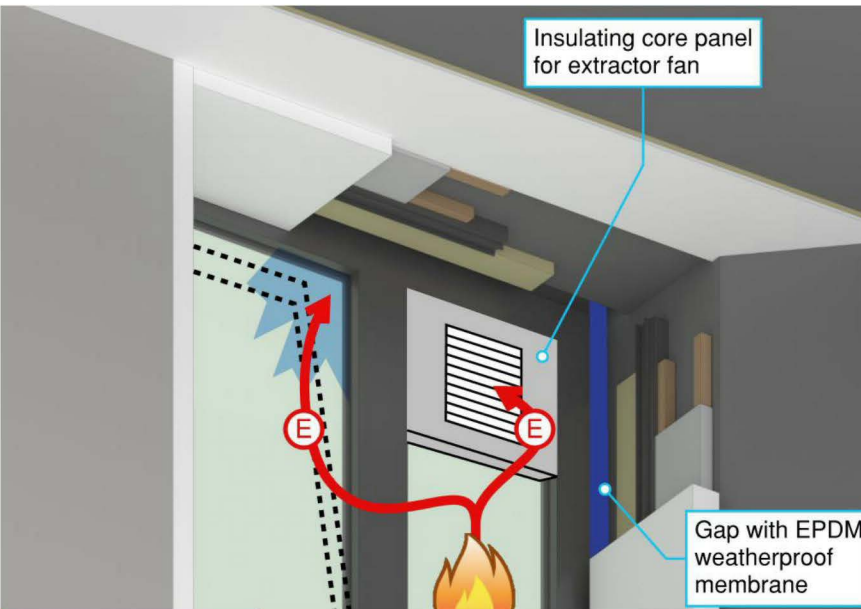
<p>Window head view</p>
<p>E</p> <p>A fire could break through the window frame via the insulating core panel which houses the extractor fan, or via broken or open glazing and into the external wall cavity above and adjacent.</p> <p>Fire source: Ceiling jet from fire within the kitchen or from combustible flat contents positioned/stored next to window</p>

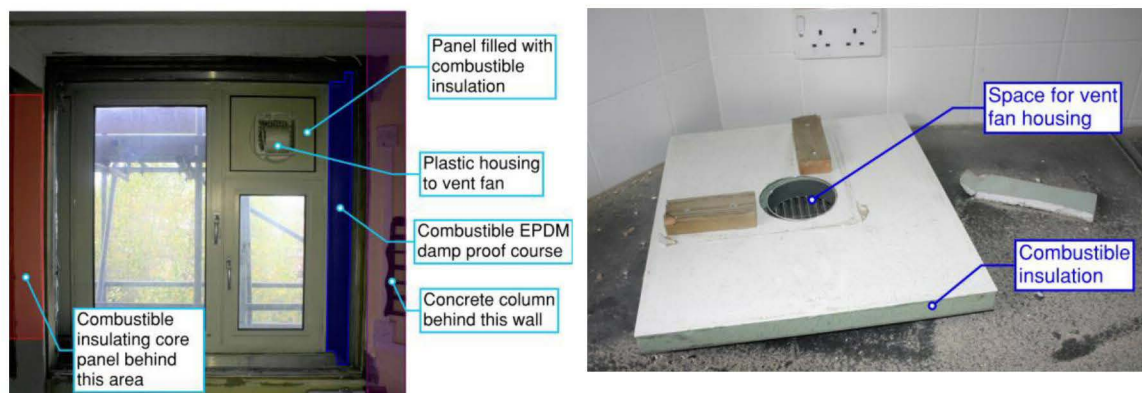
Figure 9.18: (a) Example kitchen window from Flat 13, (b) Evidence of window insert construction

- 9.5.7** Flat 46 has the same configuration of the kitchen window as flat 16, and Figure 9.18, thus the ‘left hand side’ of the window is the side opposite the column and kitchen vent insulating core panel. This therefore represents evidence in support of route A, fire spreading via the window reveal lining covering the cavity between the infill panel and insulating core panel.

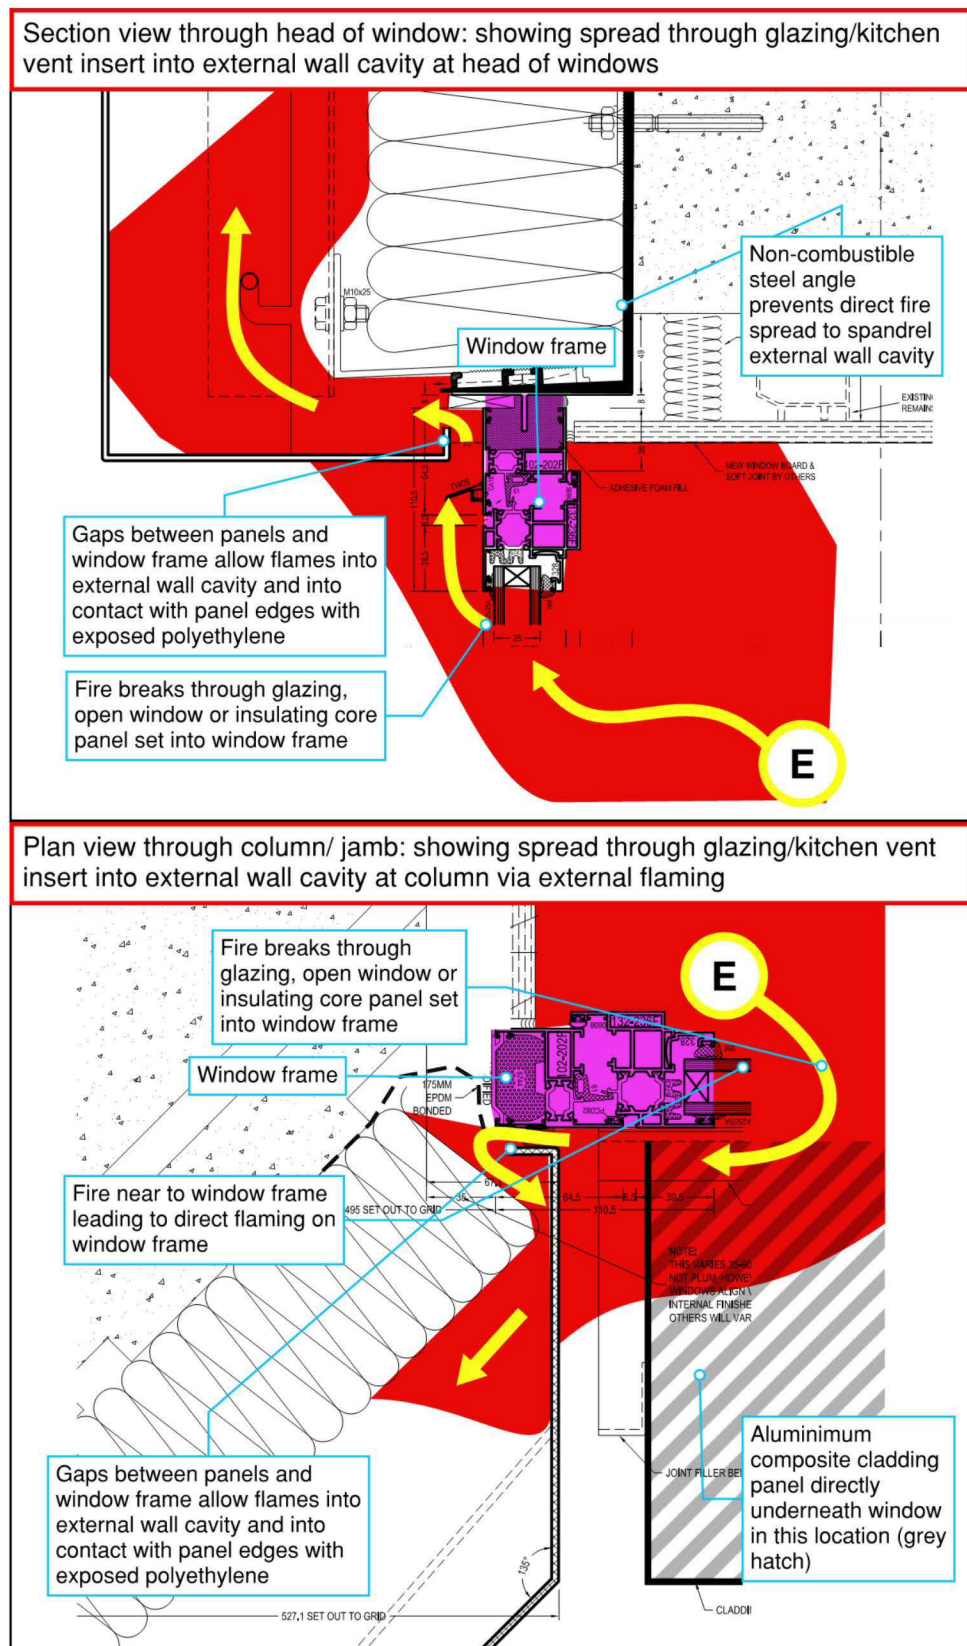
Figure 9.22: Diagram of route E originating from a localised fire on or adjacent to cill, or from a fire remote to window with ceiling plume. External flaming resulting

in fire spread to the external wall cavity at both the column (above) and the head of the window (below) (HAR00008901, HAR00008902).

9.5.26 However, even though cavity barriers were not installed around the windows, the fire interface with insulation in the column (indicated in Figure 9.22) would still occur, permitting fire to spread vertically into the column external wall cavity.

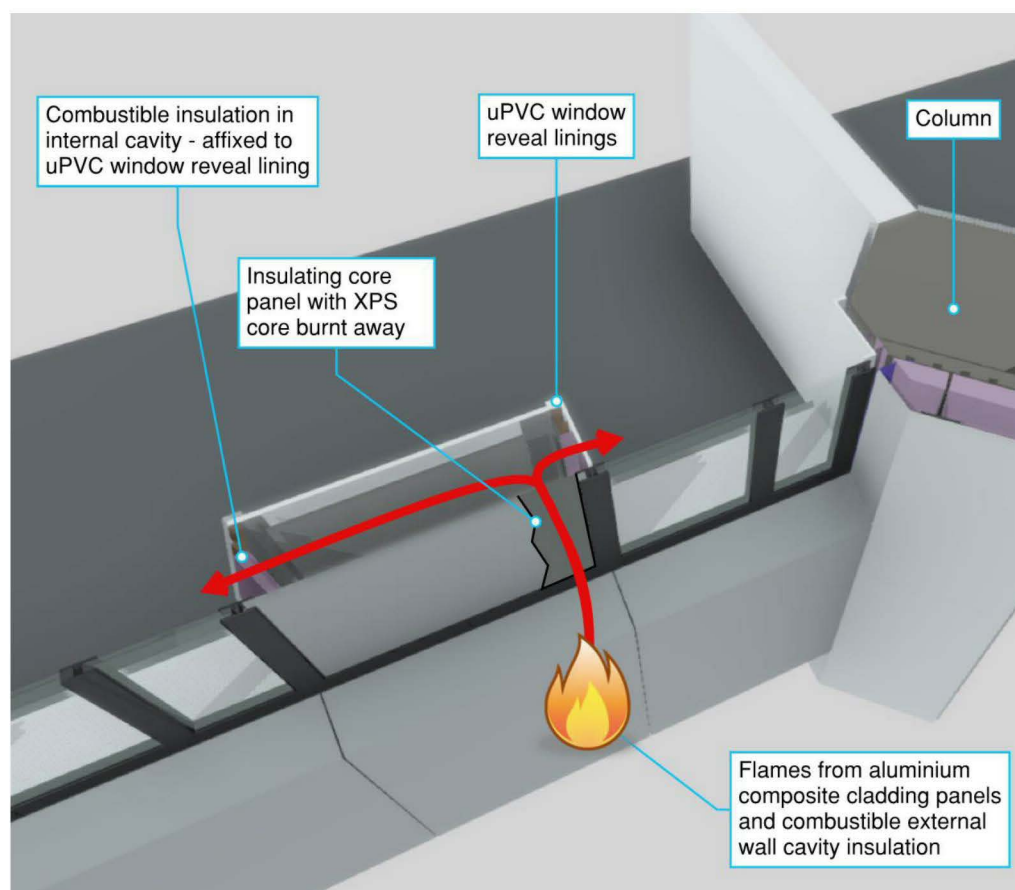
Figure 9.27: 3D model indicating routes of fire spread into flats via combustible seal either side of the new Styrofoam XPS insulating core panels, or via a failed panel itself.

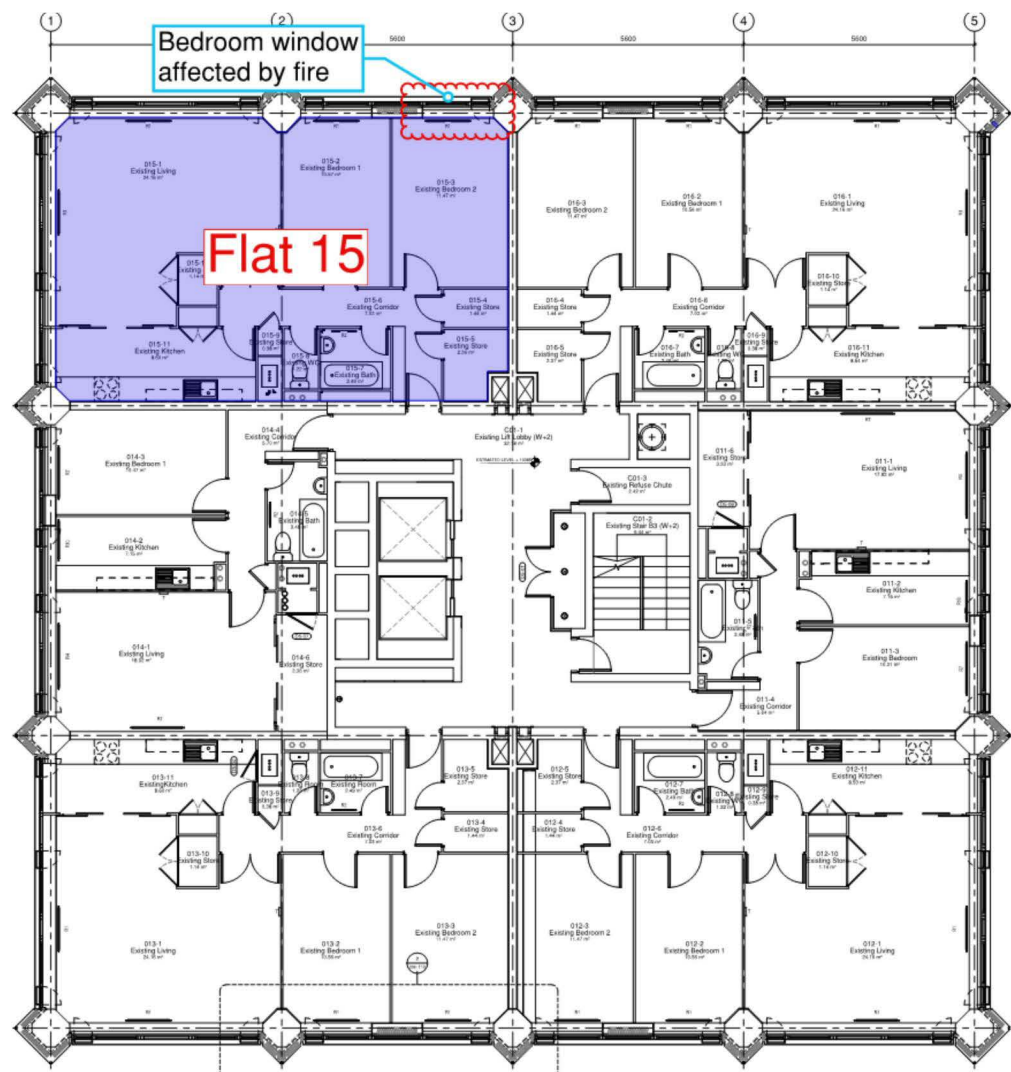
Figure 9.28: Marked up Studio E drawing indicating location of Flat 15, and the window shown in Figure 9.29 (Based on SEA00010474)

9.5.2 In my inspection of Flat 15 on Level 4 (Figure 9.28), I observed that there was a window exhibiting evidence of fire spread from outside the building to the inside, shown in Figure 9.29. The evidence of fire spread showed that the entry route for the fire was in the top corner of the window, adjacent to the column, consistent with the mechanism of fire spread presented in Section 9.4. That is a fire being able to penetrate from outside the building, into the cavity behind the new uPVC reveal linings via the EPDM weatherproof membrane (route B).

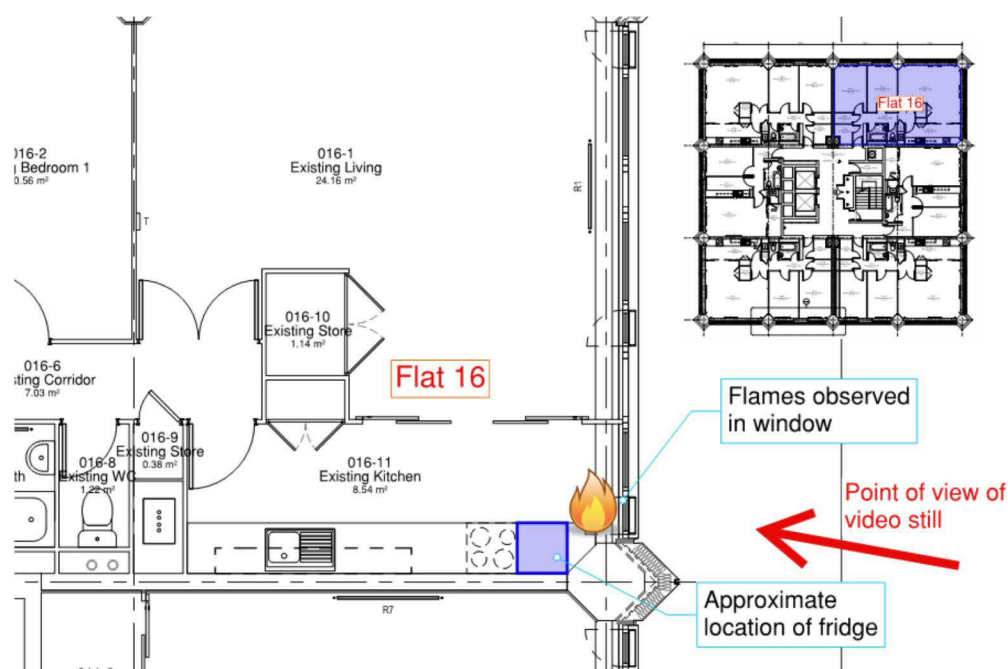
Figure 9.33: Marked up Studio E drawing indicating location and orientation of resident camera footage (Based on SEA00010474)

9.5.13 The following images are stills extracted from videos taken by the resident of Flat 16 on his mobile phone and a photograph submitted to the inquiry by a witness (MET000083356, MET000083357 and IWS00000051). Whilst the precise time of the videos is not known, the file name would suggest that the videos were taken at approximately 01:08 and 01:09 respectively. The precise time will depend on the accuracy of the timings on the mobile phone. The footage has been shot from the direction indicated in Figure 9.33. The photograph in Figure 9.35 is estimated to have been taken at 01:08.

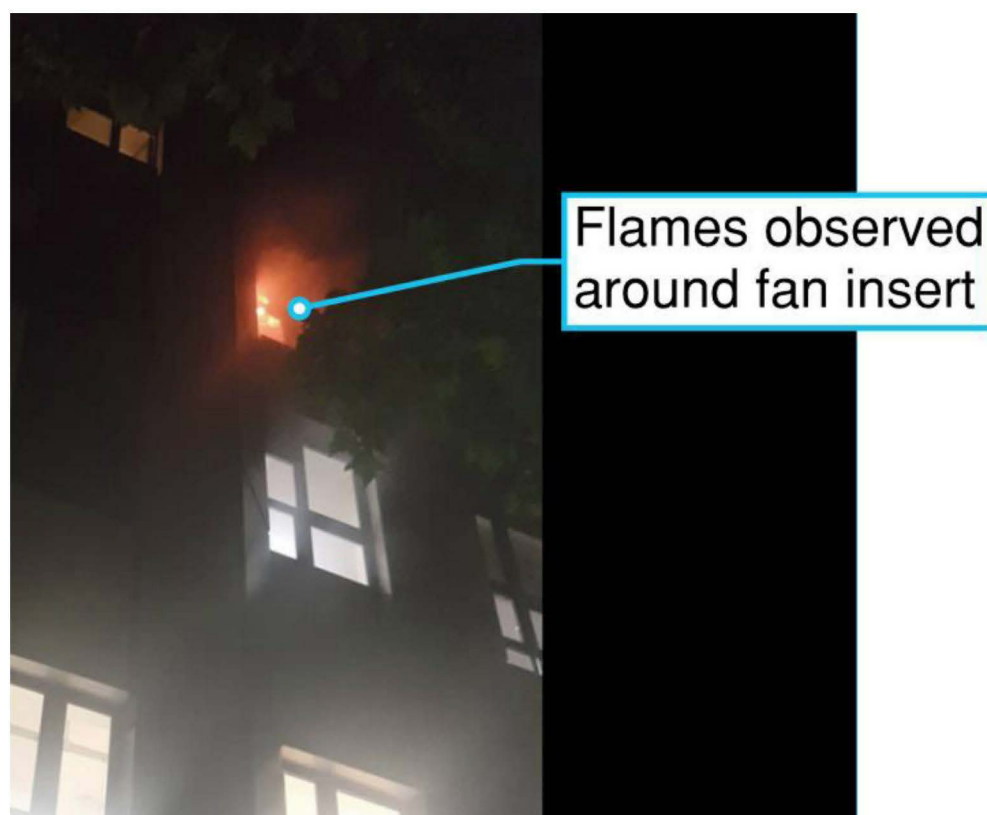
Figure 9.34: Still No.1 from video footage - (MET000083356)

9.5.14 Figure 9.34, Figure 9.35 and Figure 9.36 show how flames are present at the head of the Flat 16 kitchen window.

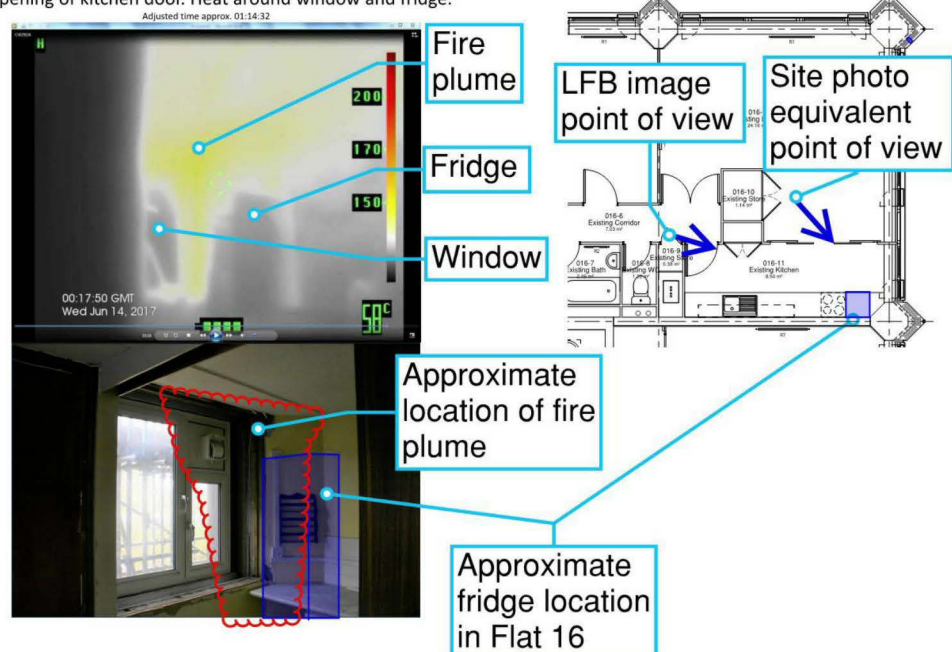
9.5.16 Figure 9.37 is a video still from LFB thermal imaging footage of the first fire fighters entering the kitchen in Flat 16 (MET00006109). This footage is taken at approximately 01:14 and also identifies flames at the top corner of the window, behind the side of the fridge freezer (please refer to Professor Niamh Nic Daeid's report regarding the Flat 16 kitchen and the fire), and in the region near the fan insert.

9.5.17 The LFB footage does not indicate that a post flashover fire had occurred at that time (01:14). It is clearly a localised fire beside the window opening only.

2nd opening of kitchen door. Heat around window and fridge.

Figure 9.37: LFB thermal imaging camera footage - 01:14 (MPS document JRB TIC 01, MET00006109) above a marked up site photograph of Flat 13, where the kitchen
