**Preliminary Fire Investigation
Status Report to the Grenfell
Tower Public Inquiry**

Delmar “Trey” Morrison III, Ph.D., P.E., CFEI
John Martens, M.B.A., Ph.D., P.E., CFEI
Exponent, Inc.
4580 Weaver Parkway, Suite 100
Warrenville, Illinois, USA 60555

22 January 2018

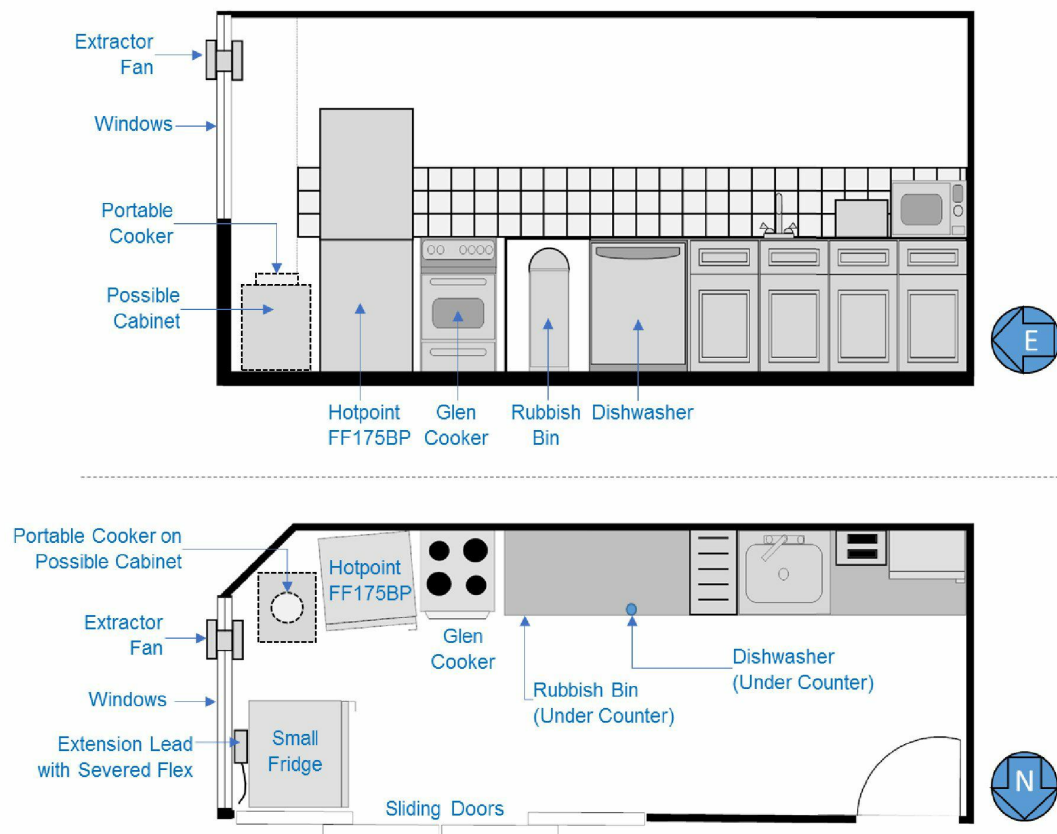
From the photographs, Exponent was unable to determine whether or not the kitchen contained wall cabinets above the counter before the fire, but those cabinets would be expected in typical kitchen construction. The kitchen was observed to contain several appliances including a dishwasher, an electric cooker (a Glen branded unit), a Hotpoint FF175BP fridge freezer, a window-mounted extractor fan, two small fridges (only one is depicted because the other was either to the right or on top of the one depicted at the time of the fire), and an extension lead positioned behind the small fridge and in front of the window. The corner between the FF175BP fridge freezer and the window also contained burned debris (possibly from a cabinet or shelf

unit), a burned portable electric cooker, and other materials. The kitchen was accessible through a traditional door to the west end of the kitchen or through the sliding doors on the north wall.

Figure 4. Diagrams showing Exponent's reconstruction of the Flat 16 kitchen: elevation view (top) and plan view (bottom).

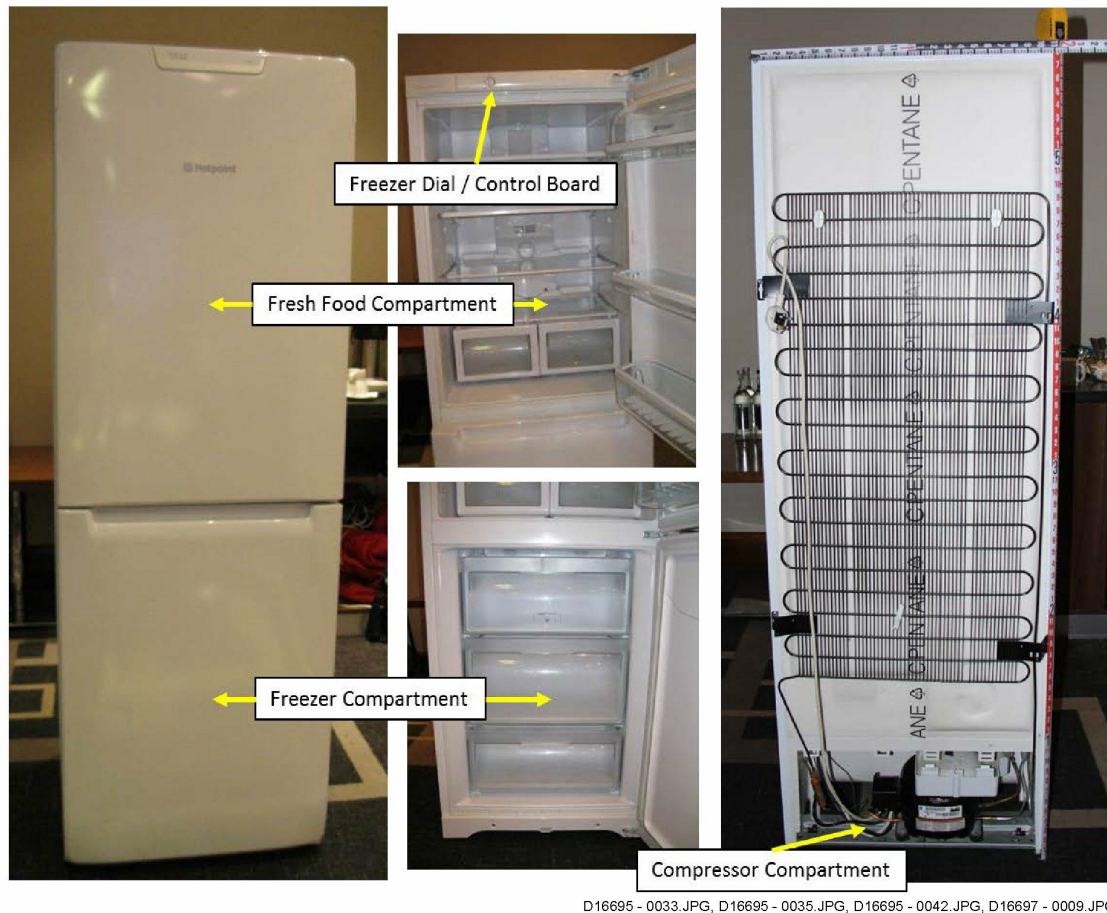
D16695 - 0033.JPG, D16695 - 0035.JPG, D16695 - 0042.JPG, D16697 - 0009.JPG

Figure 6. Exemplar FF175BP (S/N 705263184, manufactured in 2007) examined with representatives from BEIS on 28 June 2017. There are slight differences in the condenser coil and compressor between the exemplar and the subject unit.

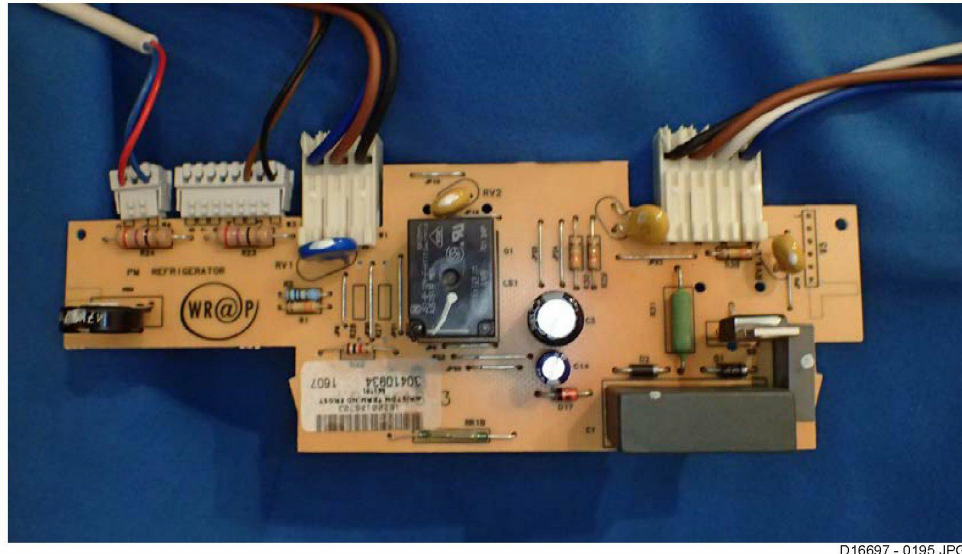
D16697 - 0195.JPG

Figure 7. Control board from the exemplar FF175BP (S/N 705263184) examined on 28 June 2017. There are slight differences in this control board from the one in the subject FF175BP.

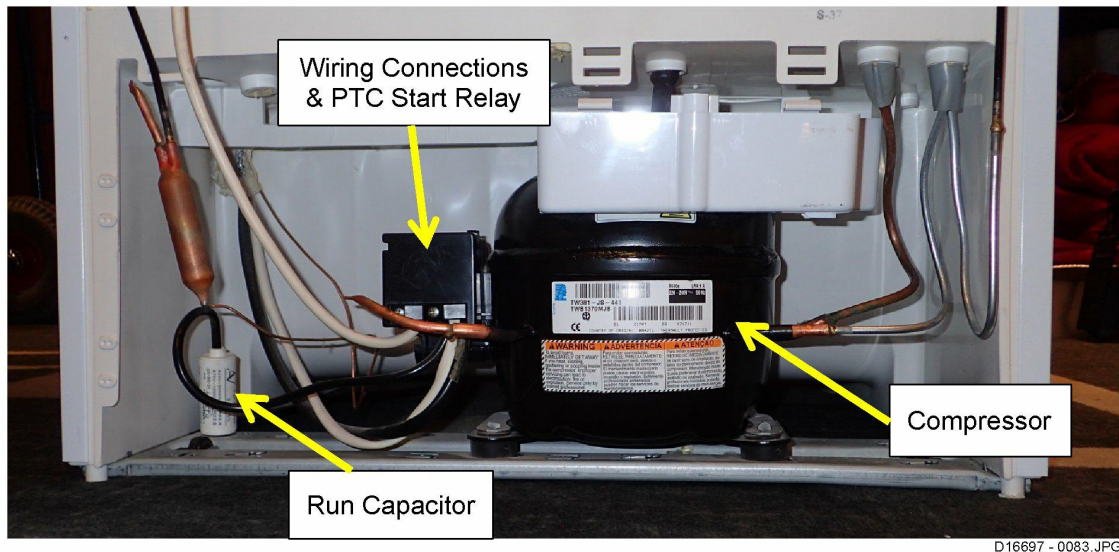
Figure 8. Compressor compartment from the exemplar FF175BP (S/N 705263184) examined on 28 June 2017. The exemplar contained a Tecumseh-manufactured compressor that is similar to the Embraco-manufactured compressor in the subject unit. The exemplar was equipped with a class P0 run capacitor, but was mounted in the same location as the class P2 run capacitor would be in the subject fridge freezer.
