GRENFELL TOWER: PHASE 1 REPORT

Prof. José L. Torero CEng, RPEQ, FREng, FRSE, FTSE, FIFE, FSFPE, FICE, FCI

23rd May 2018

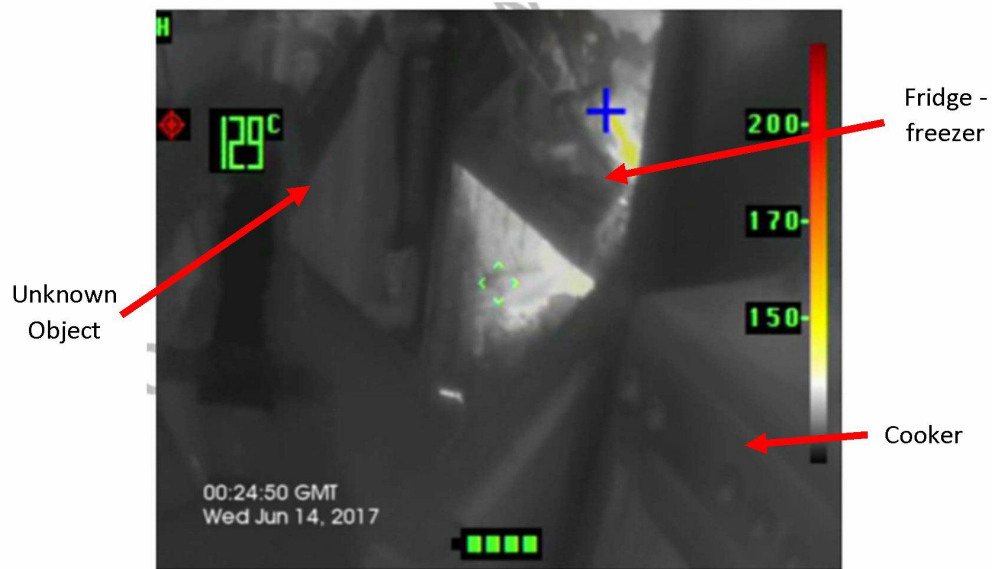
1033 A number of items known to be present in the kitchen contain flammable materials. These are labelled
1034 in the diagram in Figure 2. Most items are well identified however the exact nature of any objects
1035 between the Hotpoint fridge freezer and the window have not been fully confirmed at the time this
1036 report was written¹⁹. Sufficient detail is not provided in the witness statement by the flat occupant
1037 [MET00006339] or included on the annotated sketch of the kitchen [MET00005190]. It is visible
1038 however in the thermal imaging camera footage [MET00005816] as identified by Prof. Bisby [5]. A
1039 report by Exponent [14] designate this as some kind of cabinet. Prof. Nic Daeid [2] also identifies that
1040 as yet unknown items were likely located there. This is deemed relevant as the occupant that
1041 discovered the fire describes smoke coming from the area between the fridge and the window

FIGURE 3: THE IMAGE FROM [MET00005816] SHOWS AN UNKNOWN OBJECT BETWEEN THE FRIDGE-FREEZER AND THE WINDOW IN FRONT OF THE CORNER COLUMN.

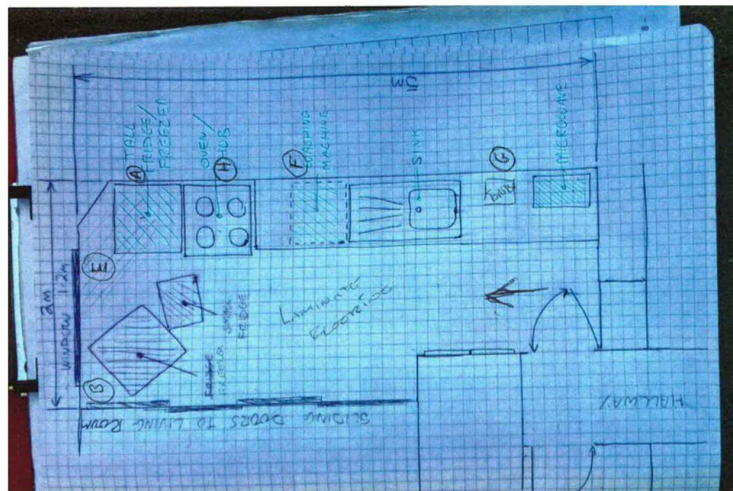
1042 [MET00006339] and identifies this area on their sketch, shown in Figure 4. The sketch does not show
1043 anything between the fridge-freezer and the window, however, to the extent of the evidence
1044 available, all other items are apparently shown.

FIGURE 4: SKETCH [MET00005190] PRODUCED ALONGSIDE STATEMENT [MET00006339] OF FLAT OCCUPANT THAT INITIALLY DISCOVERED THE FIRE. LOCATION MARKED E IS THAT IDENTIFIED BY OCCUPANT AS AREA WHERE THEY SAW SMOKE.

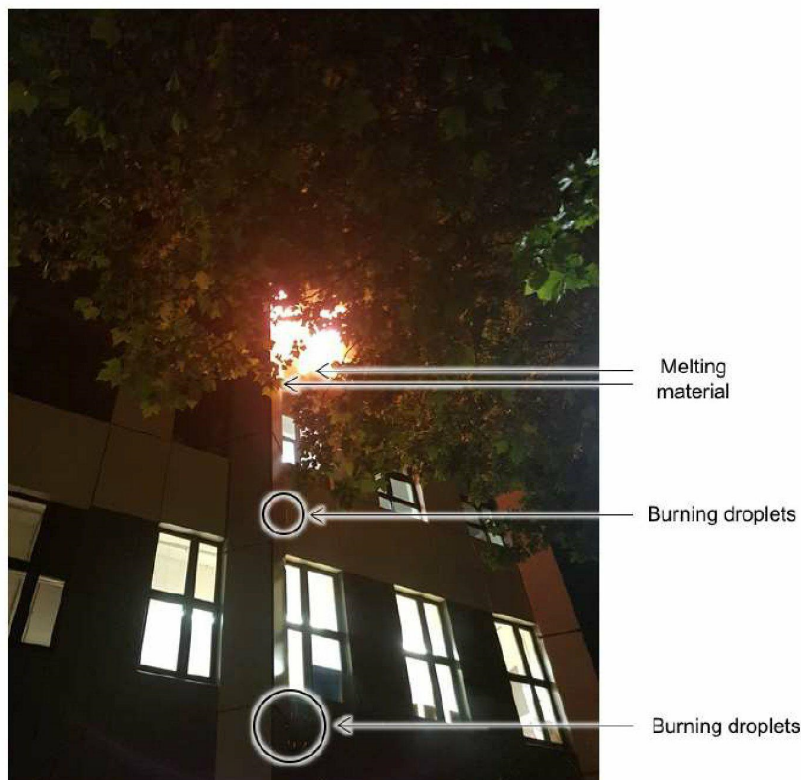
1067 An image taken by a member of the public at 01:14:53 [MET00006589] shows the fire to be well
1068 established on the outside of the cladding system, again to the left side of the Flat 16 kitchen window
1069 as viewed from the outside. This image is shown in Figure 5.

1071 **FIGURE 5: IMAGE FROM MET00006589 SHOWS A SIGNIFICANT EXTERNAL FIRE ENGULFING THE LEFT SIDE OF THE FLAT**
1072 **16 KITCHEN WINDOW. EXTRACTED FROM PROF. BISBY [5]**

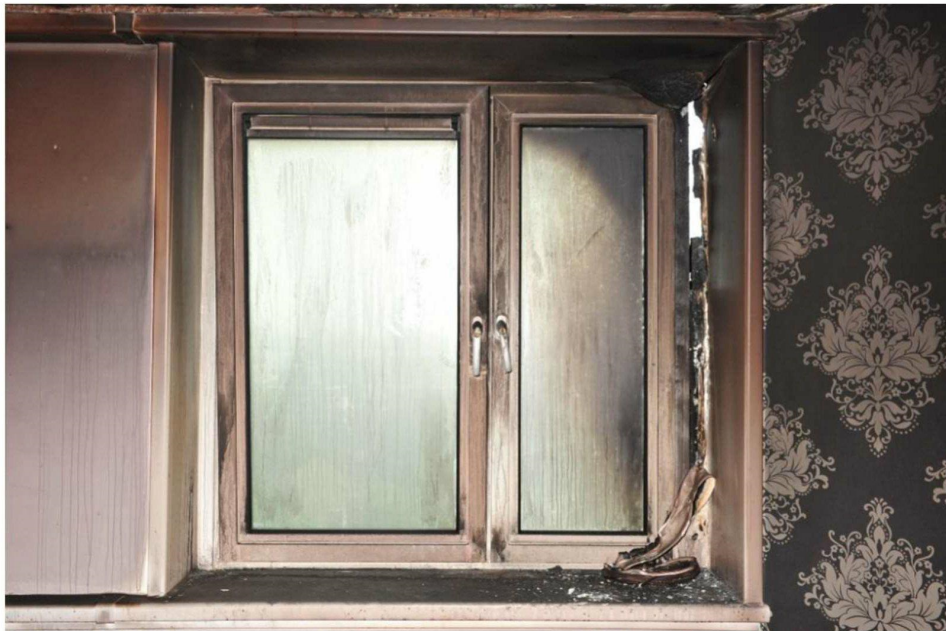
1244 Photographic evidence obtained following the fire at the Grenfell Tower has identified many instances
 1245 of this type of failure as shown in Figure 11. It should be noted that these elements do not all show
 1246 signs of charring implying that they did not all combust but simply lost stiffness. Typically, it is the head
 1247 and jambs that exhibit de-bonding as this mechanism is gravity assisted for these elements.

FIGURE 11: A RANGE OF EXAMPLES OF DEBONDING OF UPVC ELEMENTS OF THE WINDOW SURROUNDS DUE TO HEAT EXPOSURE. (A) SHOWS DEBONDING OF A WINDOW JAMB THAT HIS LOST RIGIDITY DUE TO HEATING FROM THE EXTERNAL FIRE CREATING AN OPEN PASSAGE BETWEEN THE INTERIOR AND EXTERIOR. (B) SHOWS THE WINDOW UPPER PEELING AWAY (C) SHOWS THE MAIN WINDOW JAMBS DEBONDING FROM THE SIDE OF THE WINDOW CAVITY.

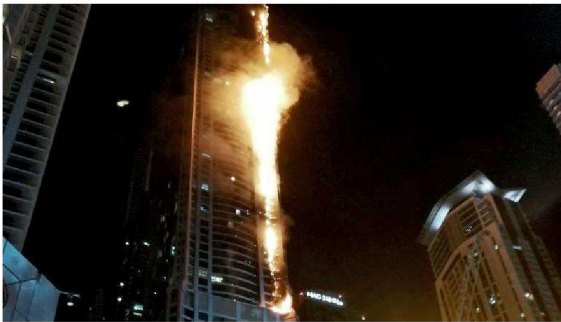
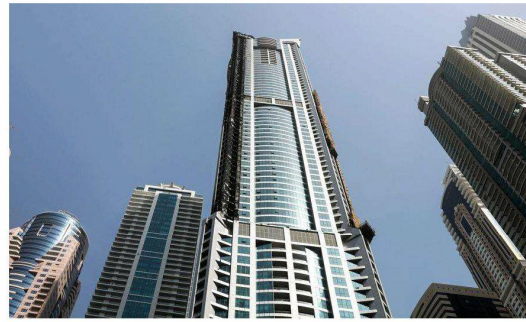
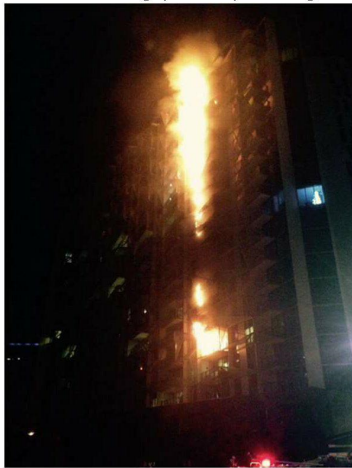
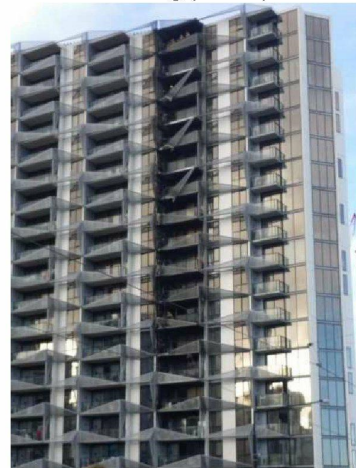
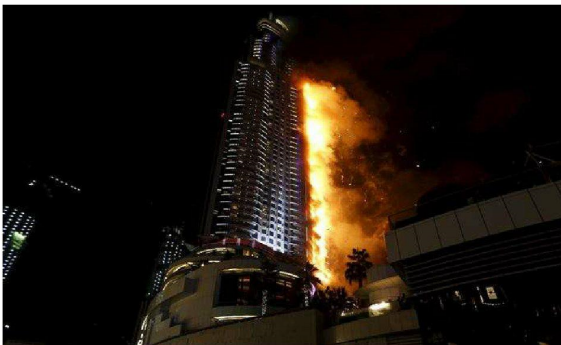
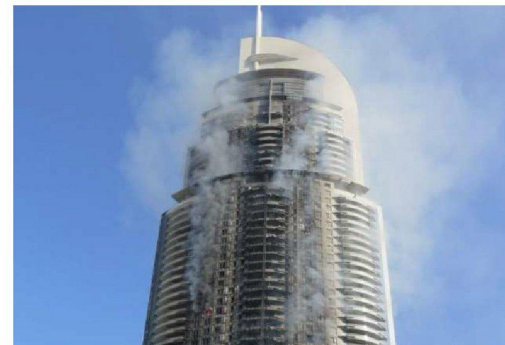
Literature review on past fire events in high-rise buildings involving vertical flame spread via external cladding shows a very similar behaviour in most cases. This literature includes official reports, media, video footage, and industry and academic papers. Quantified rates of vertical flame spread based on available evidence were developed and are presented in Figure 23. As can be seen from Figure 23, vertical flame spread for Grenfell Tower is among the lowest reported. Fire spread rates range from less than 1 m/min to approximately 20 m/min .

FIGURE 21: EXAMPLES OF VERTICAL FIRE PROPAGATION WHERE THERE WAS MINOR HORIZONTAL FIRE SPREAD.

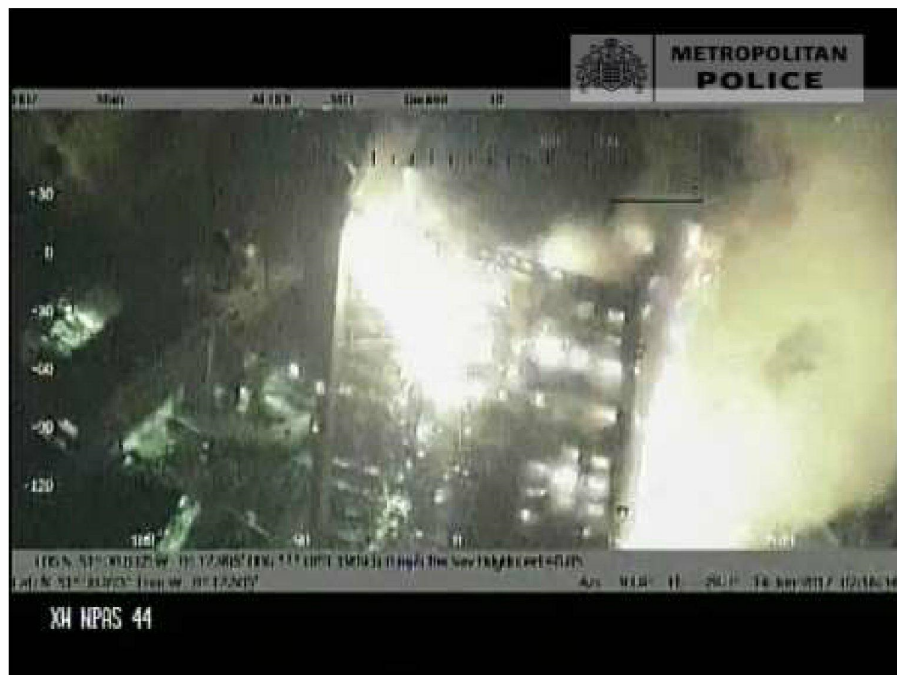
2014 Figure 28 shows a view of the East façade where it can be clearly seen that the fire is propagating
2015 faster over the architectural crown structure. The following figure shows how debris from this fire
2016 starts to ignite the areas below. In the meantime, the fire continues to propagate through the
2017 architectural crown structure towards the South-East corner.

2026 **FIGURE 28: EAST FAÇADE – SIGNIFICANT DOWNWARD FIRE SPREADS IN 6 MINUTES (2:16:14)**

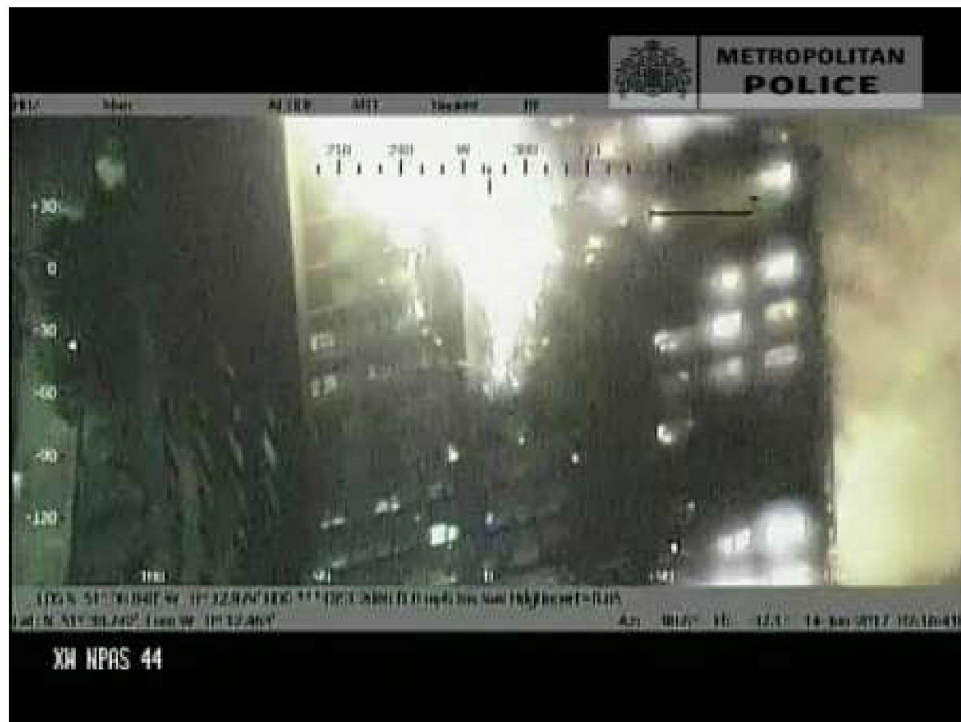
2028 Figure 29: Flaming falling debris have ignited 3 further floors downwards (02:16:41)

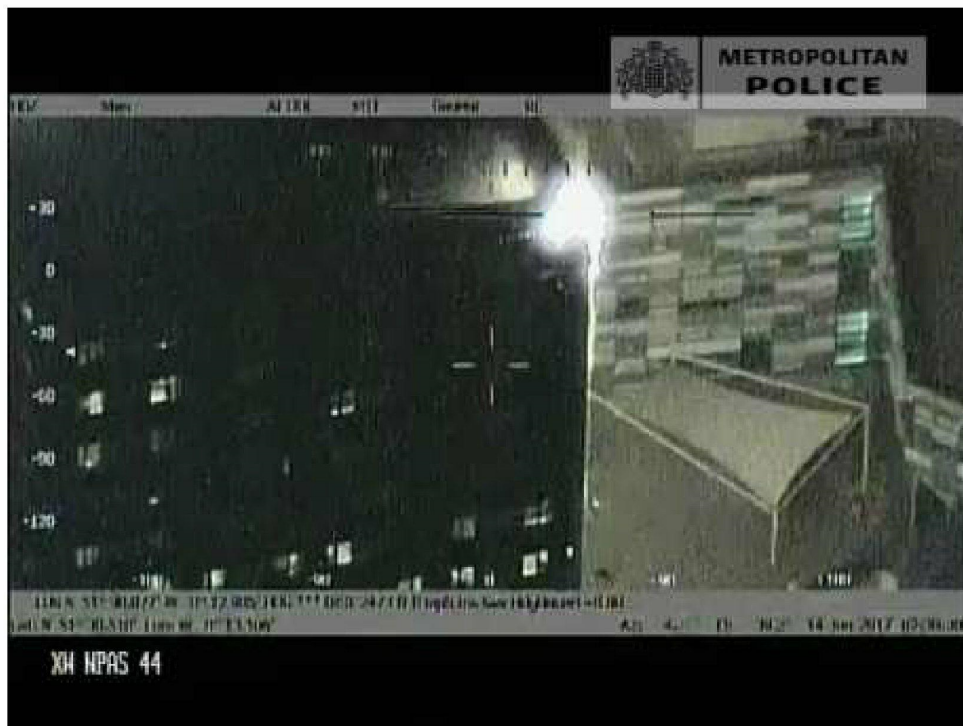
2030 Figure 30: Fire spreading to south façade from east façade architectural crown (2:30:10)

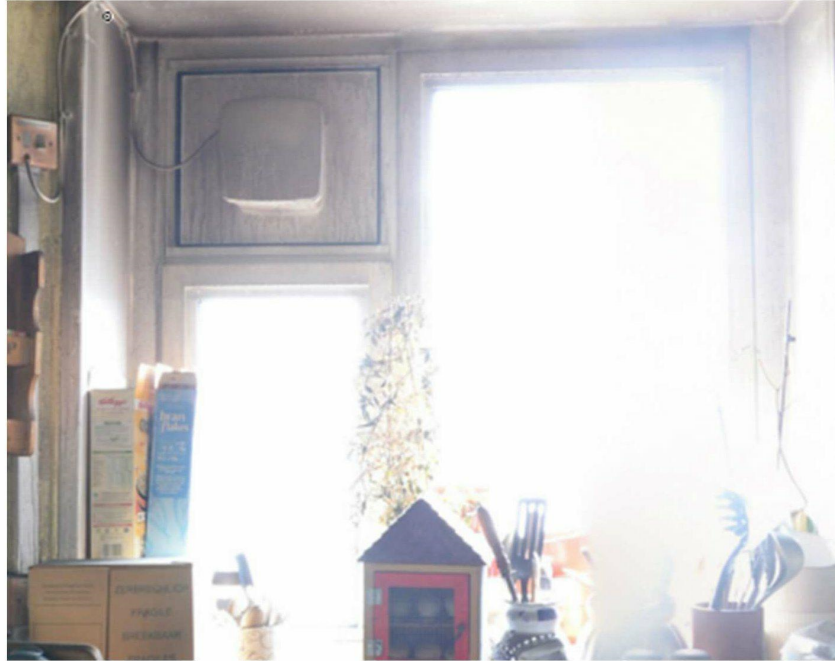
2181 Figure 36: Kitchen window Level 9, Flat 62

2161 Figure 36 shows a scenario where the heat fluxes available have not been able to breach any of the
2162 components of the window i.e. flames have not penetrated through any component of the window. But the
2163 detailing of the window, as described by [4,5], does not provide an adequate barrier between the interior and
2164 the exterior of the building and thus smoke is observed to have entered through any of the existing gaps.

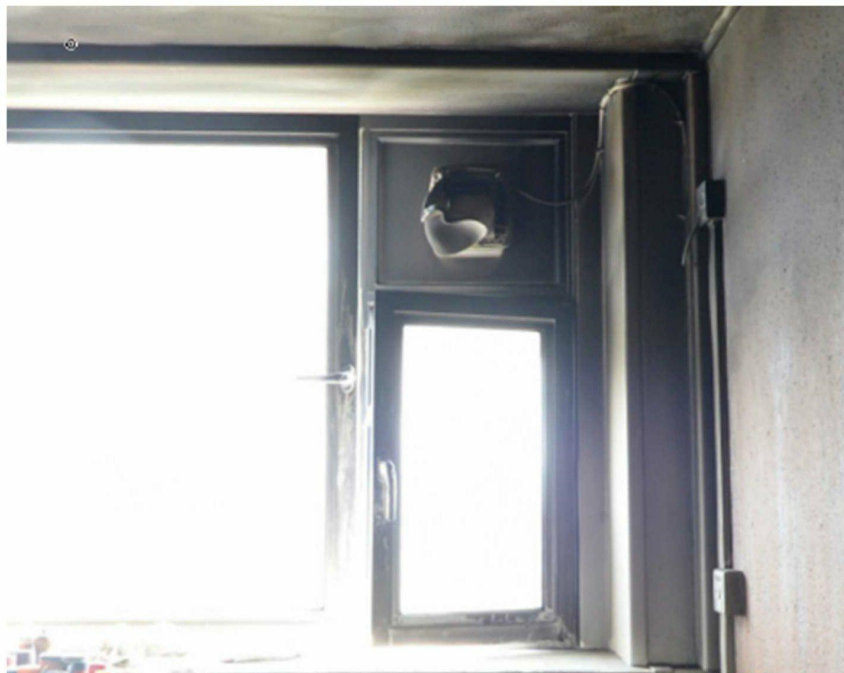
2183 **FIGURE 37: KITCHEN WINDOW LEVEL 10, FLAT 71**

2165 Figure 37 shows a slightly higher level of heat insult. This time the fan, which appears to be the weakest
2166 component (to heat), has deformed and is beginning to fall from its casing. A greater amount of smoke is
2167 present in the interior of the unit but this has not resulted in the ignition of any of the combustible materials
2168 of the compartment. It is important to note that in this case, the window is open allowing for smoke to
2169 penetrate freely.

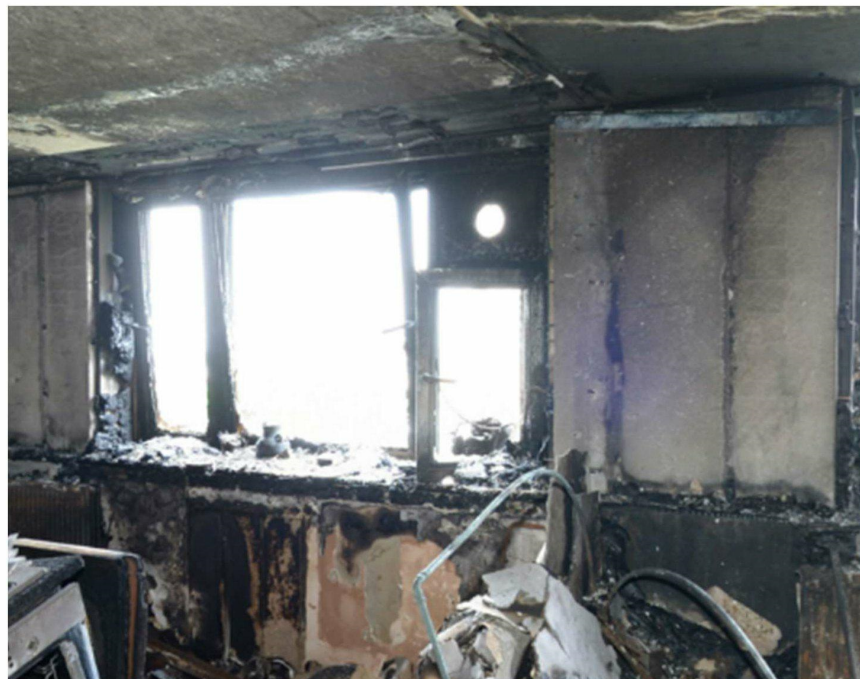
2187 Figure 39: Kitchen window, level 7, Flat 44

2174 In the next sequence of images (Figure 39, Figure 40 and Figure 41) the fan has failed, the windows are open,
2175 the glazing has, in some cases, failed (in others not) and the fire has penetrated and damaged the unit. In all
2176 of these cases, the panel originally holding the fan is still in place.

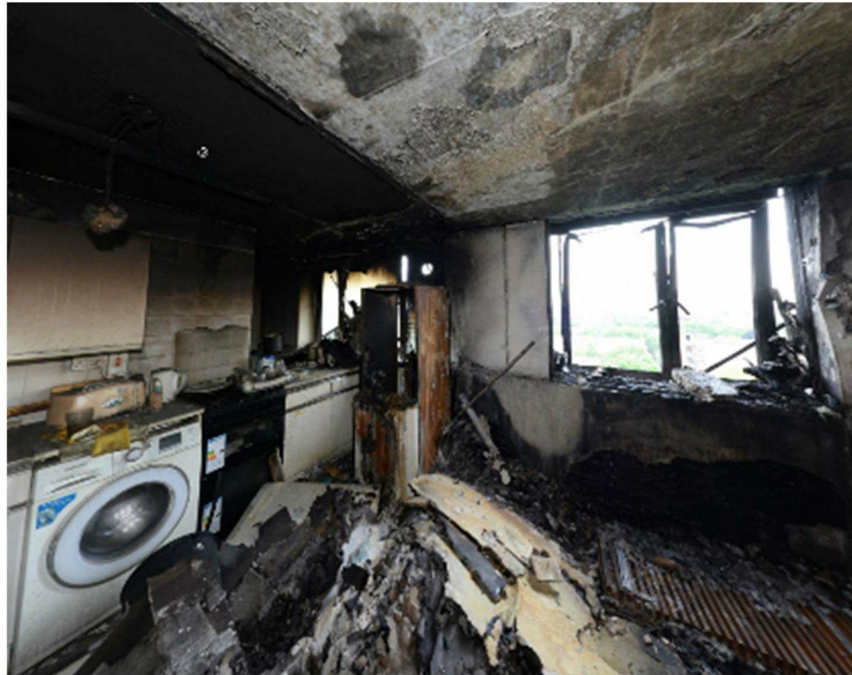
2193 Figure 42: Kitchen window, level 8, flat 54

2194 Figure 43, Figure 44 and Figure 45 show examples where the extractor fan panel has failed and the adjacent
2195 rooms have suffered different levels of damage. In Figure 42 and Figure 43 the external flames have ignited
2196 some elements of the unit while in Figure 44 and Figure 45 the elements of the unit are intact while the linings
2197 of the unit have been damaged but with very minor signs of a fire. Different levels of damage can also be
2198 observed on the window. Different levels of charring can be observed on the uPVC covering the window side
2199 (Figure 44 and Figure 45) while in other cases the window side is undamaged.

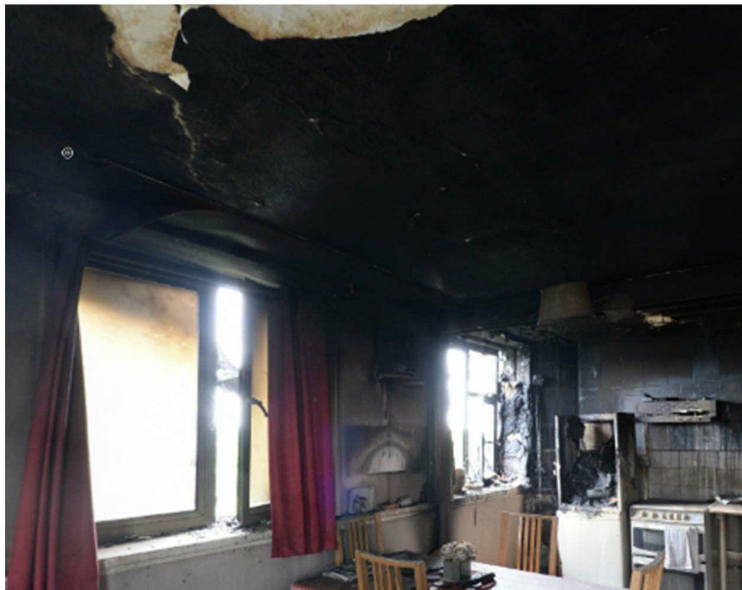
2201 Figure 43: Kitchen window, Level 6, Flat 36

2177 A similar scenario can be seen in Figure 43 where the kitchen and adjacent room are significantly damaged,
2178 but the extractor fan panel still remains in place. The window in the room adjacent to the kitchen is severely
2179 damaged including the frame.

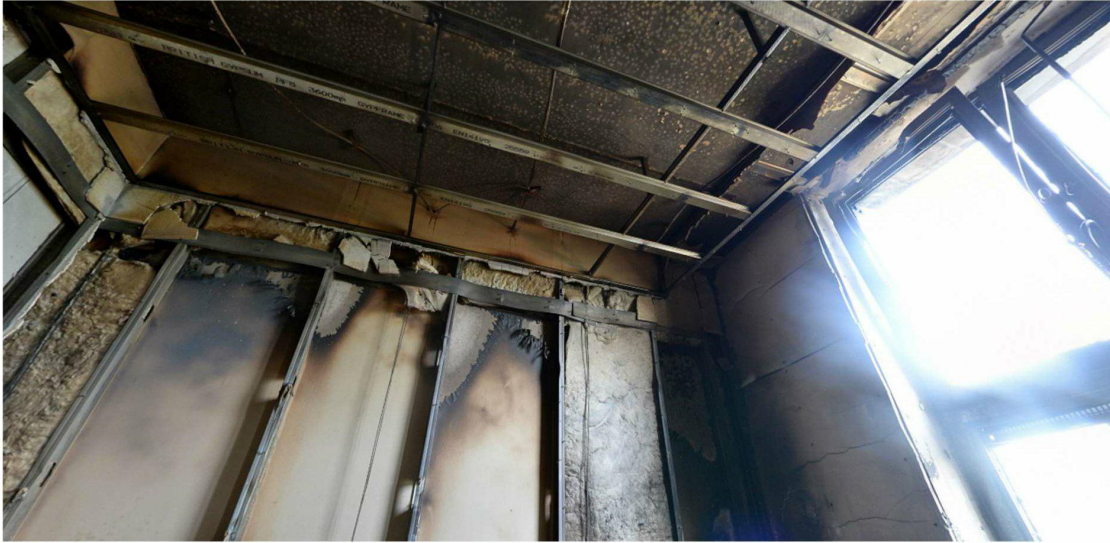
2230 ceiling, but be too thin to be able to provide sufficient radiation to ignite materials close to the floor (these
2231 flames are commonly referred to as optically thin). It is therefore possible, in these very unique circumstances,
2232 to have very hot gases that can ignite materials when touching them but that will not lead to generalized
2233 burning or flashover. Figure 46 and Figure 47 show two examples of such cases. The damage in each case is
2234 different, more structural damage is evident in Figure 47, while more fire damage is evident in Figure 46, but
2235 neither case experienced flashover.

2237 **FIGURE 46: FLAT 9 (LEVEL 3) WHERE THE FIRE IGNITED CEILING MATERIAL LEADING TO SPALLING, BUT FAILED TO ATTAIN**
 2238 **FLASHOVER**

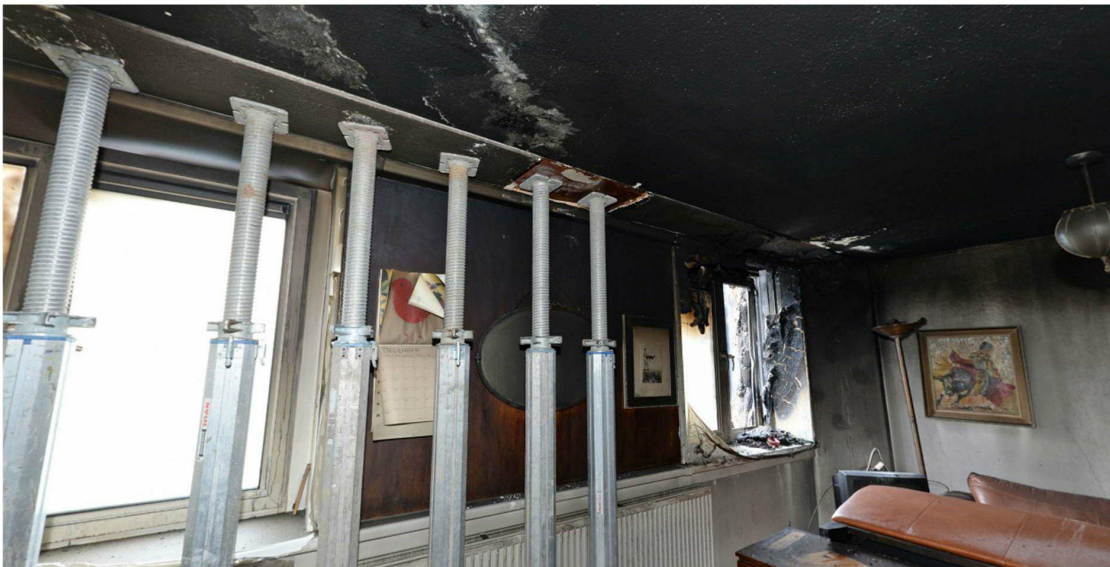
2245 **FIGURE 47: FLAT 35 (LEVEL 6) CEILING SUSTAINED SEVERE DAMAGE, NECESSITATING STRUCTURAL SUPPORT WITHOUT REACHING**
 2246 **FLASHOVER CONDITIONS**

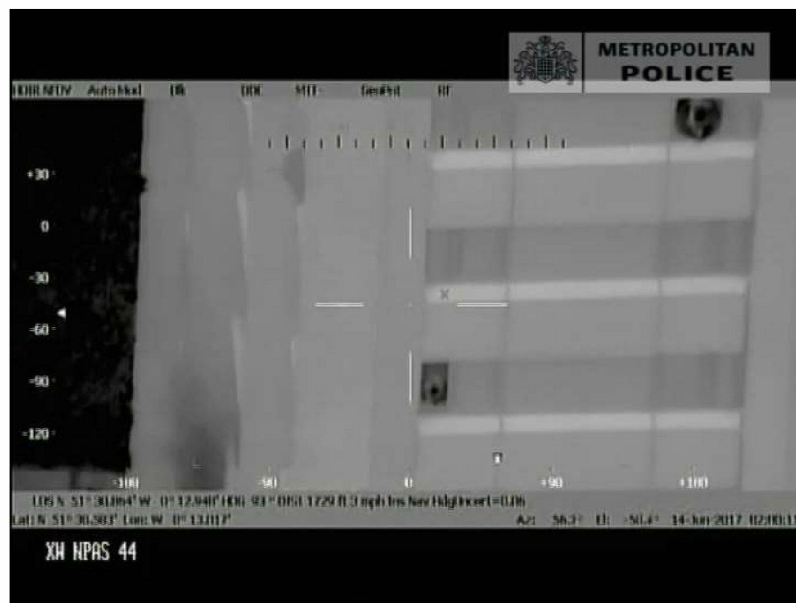
2248 Once fires have entered the building, the next level of protection are the boundaries of the units. These
 2249 boundaries are fire resistant walls and doors. These fire-resistant walls and doors are intended to stop the
 2250 propagation of flames and smoke into the lobbies and stairs. The requirements for these doors are described
 2251 in Dr Lane's Phase One Expert report (Section 2.21 and Appendix I) [4]. These requirements pertain to fire
 2252 resistance, smoke seals and self-closing mechanisms. It is clear from the earlier stages of the fire at Grenfell
 2253 Tower that internal compartmentalization was breached and smoke had migrated into the stair lobby. Smoke
 2254 was observed from very early on emerging from windows in areas very far from where the external fire was
 2255 progressing (Figure 48 to Figure 52). This clearly indicates that the boundaries of at least two units had been

FIGURE 48: NIGHT VISION CAMERA (TIME: 2:00:12), SOUTH FAÇADE, SMOKE COMING FROM MID-LEVEL APARTMENT WINDOW

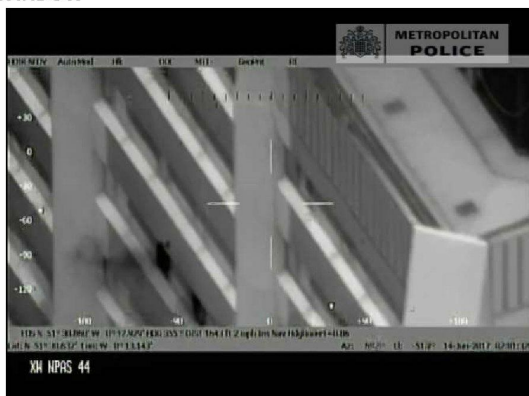
FIGURE 49: NIGHT VISION CAMERA (TIME: 2:01:30), WEST FAÇADE, SMOKE COMING FROM MULTIPLE WINDOWS ON LEVEL 20

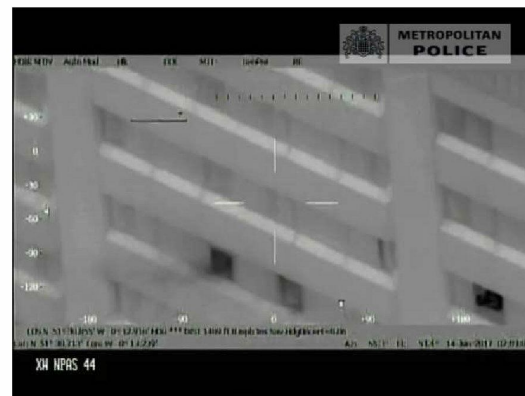
FIGURE 50: NIGHT VISION CAMERA (TIME: 2:03:00), WEST FAÇADE, SMOKE COMING FROM MULTIPLE WINDOWS ON LEVEL 20 (FLAT 174)

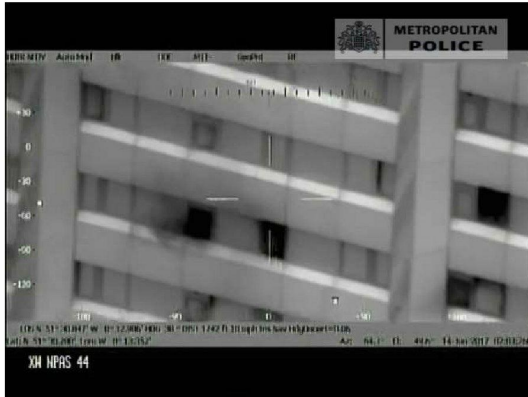
FIGURE 51: NIGHT VISION CAMERA (TIME: 2:03:30), WEST FAÇADE, SMOKE COMING FROM MULTIPLE WINDOWS ON LEVEL 20 (FLAT 174 AND 175)

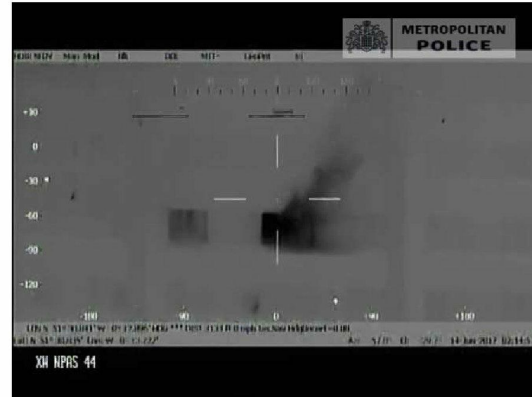
FIGURE 52: NIGHT VISION CAMERA (TIME: 2:14:57), WEST FAÇADE, SMOKE COMING FROM MIDLEVEL FLAT.

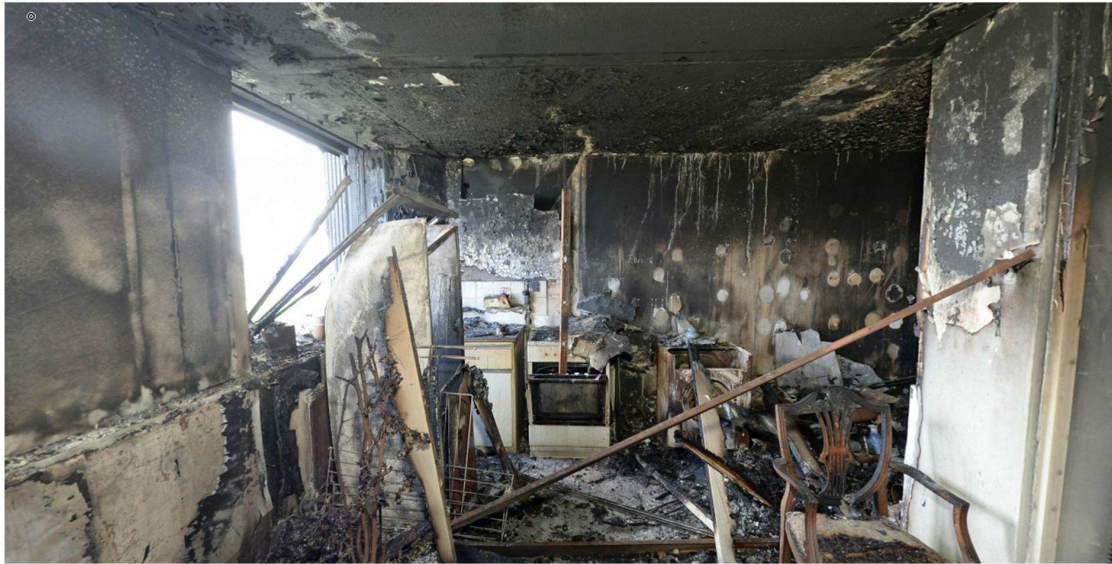
It is important to note that, despite major damage in many of the units, a significant number of flats never attained flashover. This impacts on the potential temperatures of the smoke and its capacity to ignite other combustible materials, although it has to be interpreted with caution. As indicated earlier in this section, the presence of an external flame can result in a very hot and potentially thin ceiling layer creating the very unique circumstances of having a layer of very hot gases that could ignite materials when touching them but that will not lead to generalized flashover. Examples of this scenario can be seen in Figure 54 and Figure 55.

2335 **FIGURE 54: FLAT 63 (LEVEL 9) SHOWING SEVERELY DAMAGED CEILING IN ROOM THAT DID NOT REACH FLASHOVER. NOTE**
2336 **UPHOLSTERED CHAIR IN LOWER RIGHT**

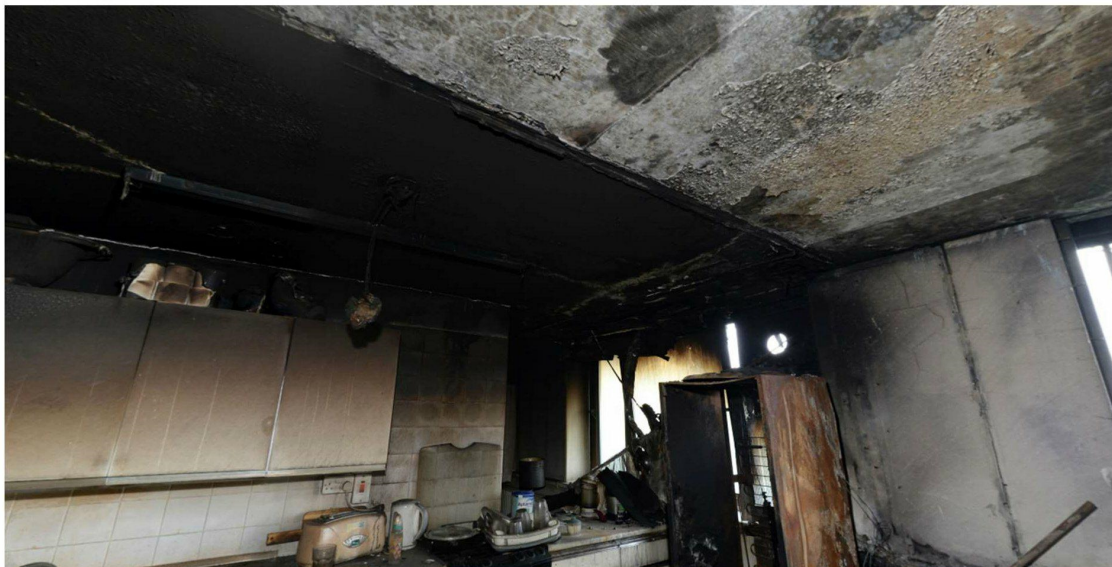
2338 **FIGURE 55: FLAT 54 (LEVEL 8) SHOWS SEVERELY DAMAGED CEILING IN KITCHEN, HOWEVER FLASHOVER HAS NOT OCCURRED**

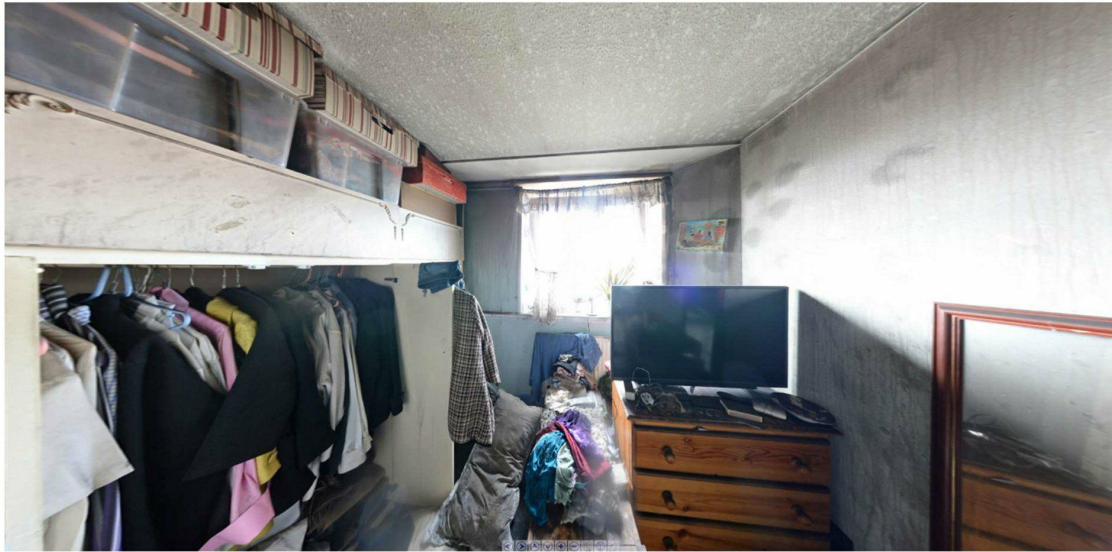
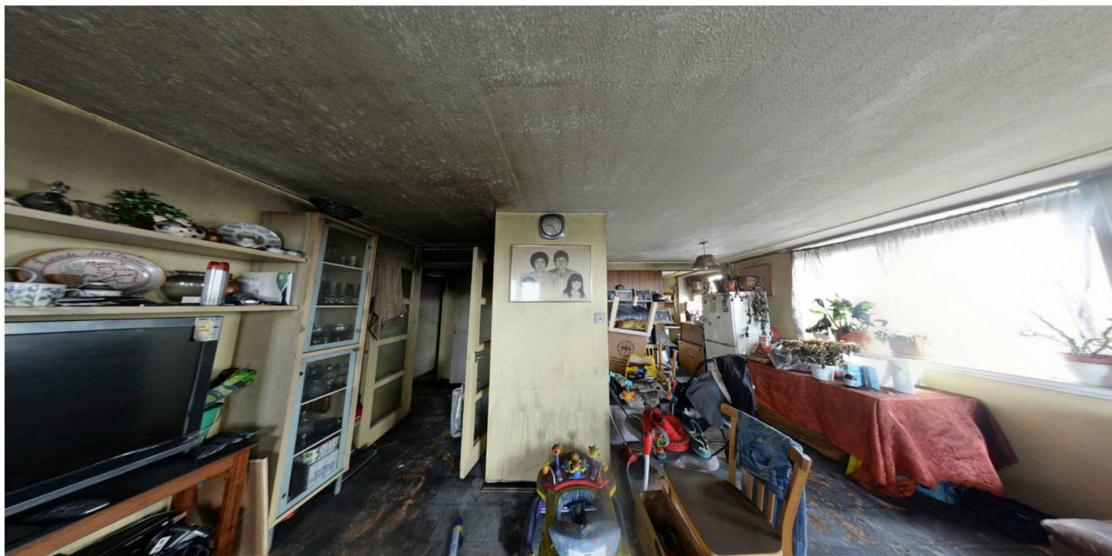
2342 Minor damage is defined as smoke ingress, low levels of heat damage, or small localised fires around the point
2343 of entry. This may be in the form of soot deposition, localised deformation of polymer-based furniture and
2344 fittings, or evidence of localised burning. Figure 56 and Figure 57 shows typical examples of this level of
2345 damage. This is not expected to challenge the compartmentalization of the flat unit.

2382 **FIGURE 56: EXAMPLE OF MINOR DAMAGE FROM FLAT 62, FLOOR 9.**

2385 **FIGURE 57: EXAMPLES OF MINOR DAMAGE FROM FLAT 62, FLOOR 9.**

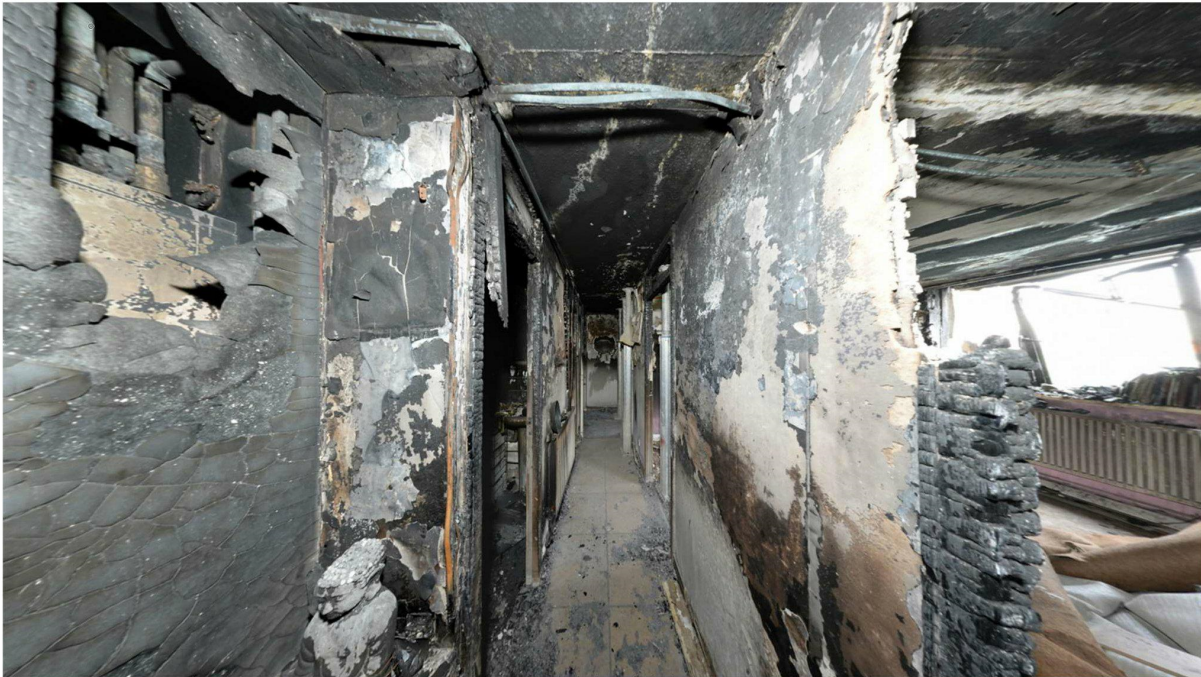
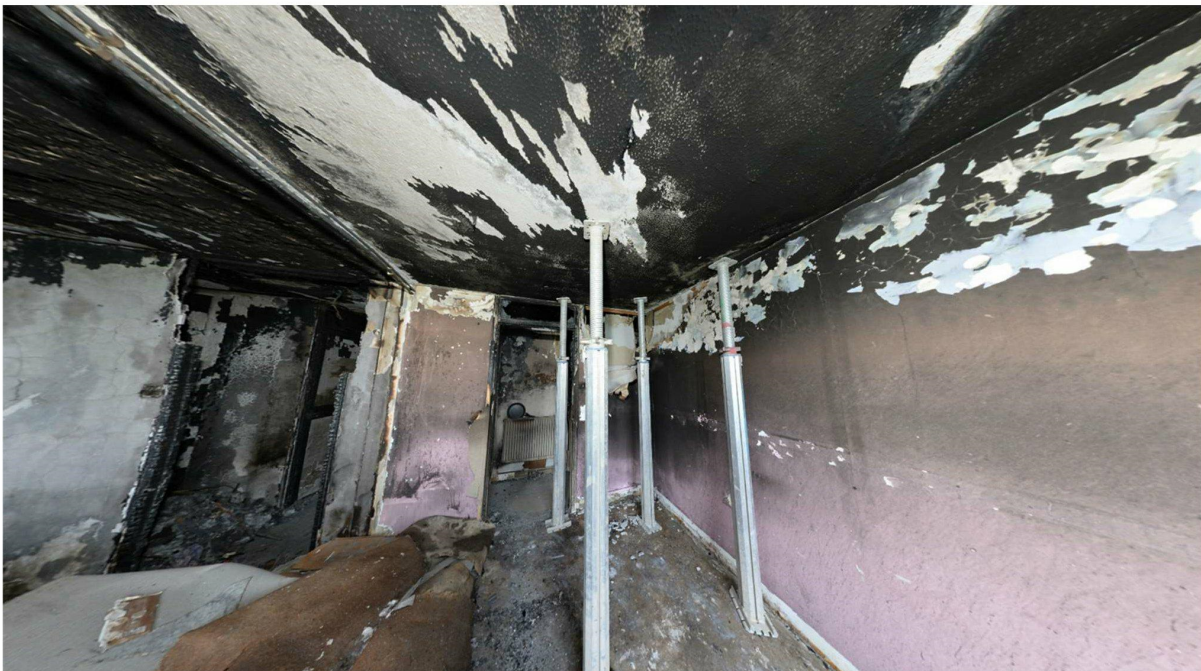
Severe damage is characterized by the presence of spalling on ceilings and compartment walls, as well as evidence of structural damage to ceilings and compartment walls. In some cases, one room may have significant structural damage (e.g. living room), while the remainder of rooms had no visible structural damage with spalling on ceilings and walls present and sometimes not present. Examples of this degree of damage are displayed in Figure 60 and Figure 61. The impact of these fires on compartmentalization is difficult to assess, nevertheless it is expected that damage to the walls and doors separating the unit from the lobby would have been minor. This is mostly because of the distance between the perimeter of the building and the boundary to the lobby.

2394 **FIGURE 60: EXAMPLES OF SEVERE DAMAGE FROM FLAT 45, FLOOR 7.**

2397 **FIGURE 61: EXAMPLES OF SEVERE DAMAGE FROM FLAT 45, FLOOR 7.**

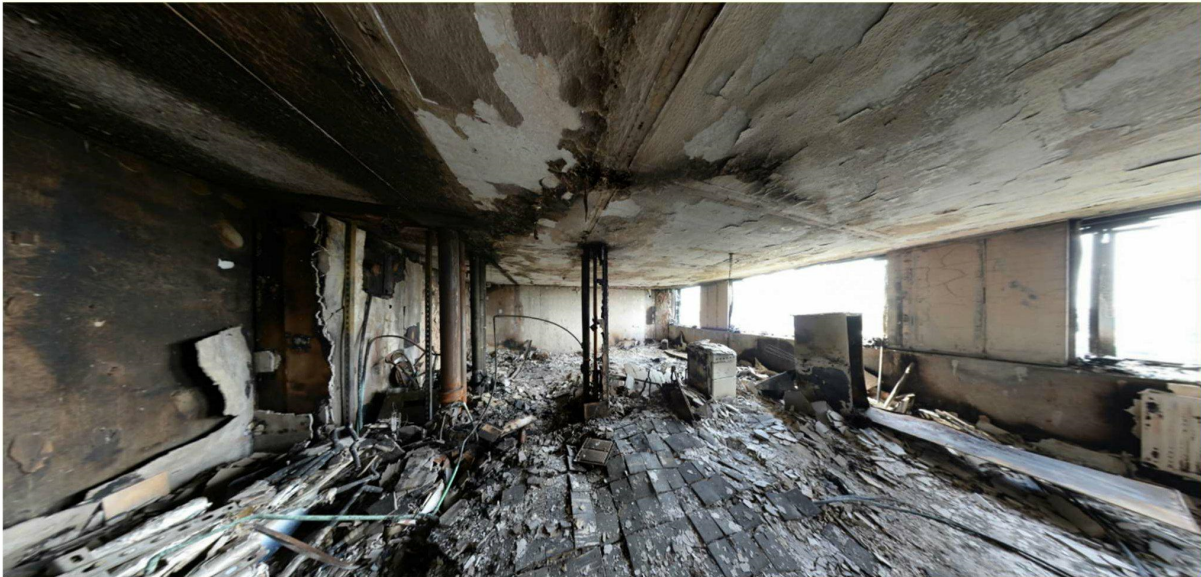
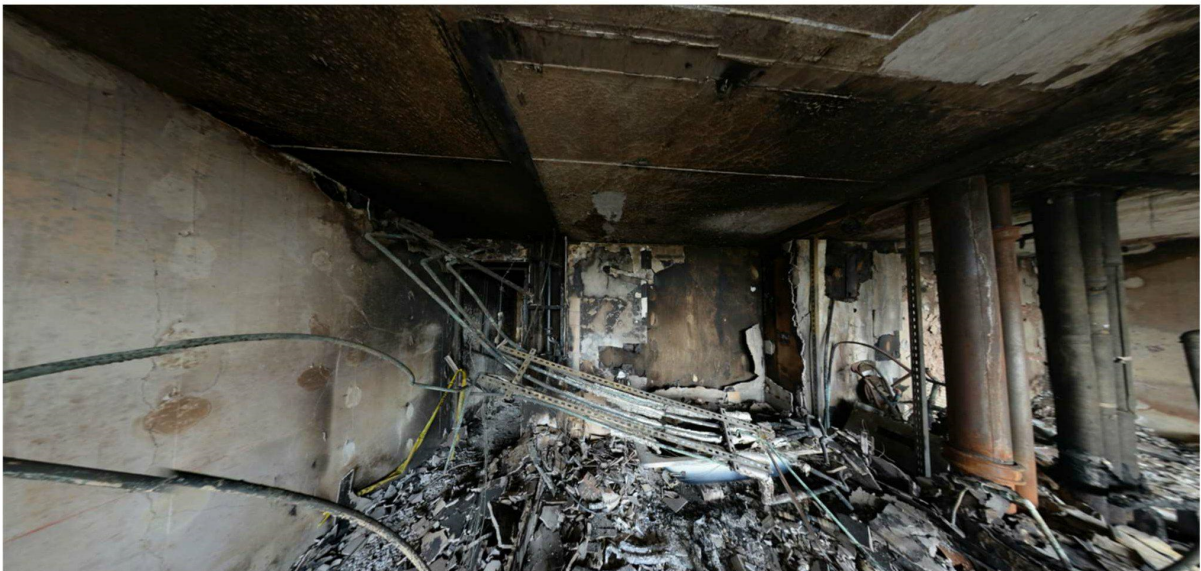
Major damage is typified by an ignition resulting from external flaming that subsequently develops into a fully-developed compartment fire (flashover). The majority of the sources of fuel within the room or even flat would be involved in the fire and without intervention, consumed by it. This level of fire is expected to challenge the compartmentalization. Examples of this type of damage are shown in Figure 62 and Figure 63.

2400 **FIGURE 62: EXAMPLES OF SEVERE DAMAGE FROM FLAT 114, FLOOR 14.**

2402 **FIGURE 63: EXAMPLES OF SEVERE DAMAGE FROM FLAT 114, FLOOR 14.**2403 **5.3.2.2 FAILURE OF FLAT DOORS**

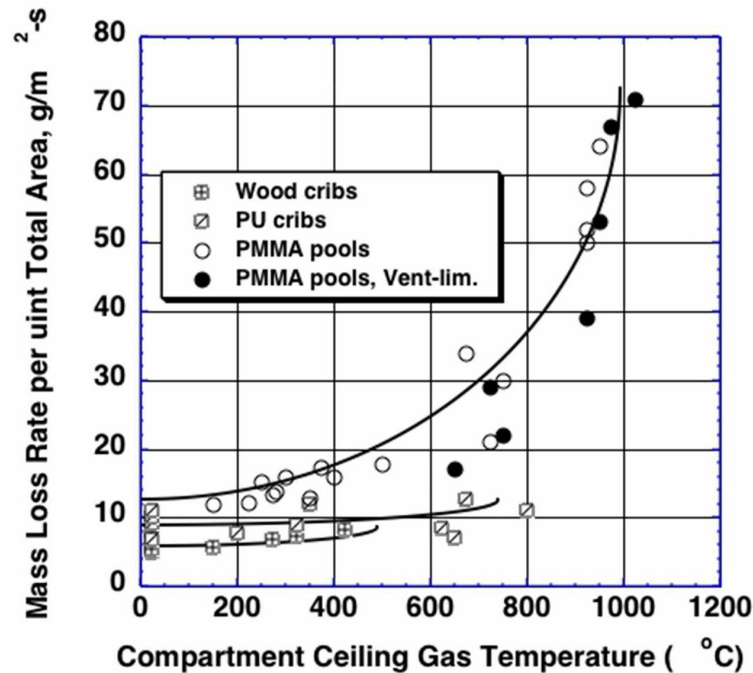
2438 **FIGURE 65: THE PLOT BY KAWAGOE [38] DEFINES BURNING RATE [G/M².S] AS A FUNCTION OF COMPARTMENT TEMPERATURE**
 2439 **[°C].**

2440 Eurocode 1 [39] gives an average fire load density for a dwelling of 780 MJ/m². For the assumed fuel sources,
 2441 the typical energy content is taken as ~30 MJ/kg [40], which equates to a fuel load of approximately 26 kg/m².
 2442 Given the estimated range of burning rates from Figure 65, this gives a fire duration of the order of 25 – 35
 2443 minutes for a single compartment.

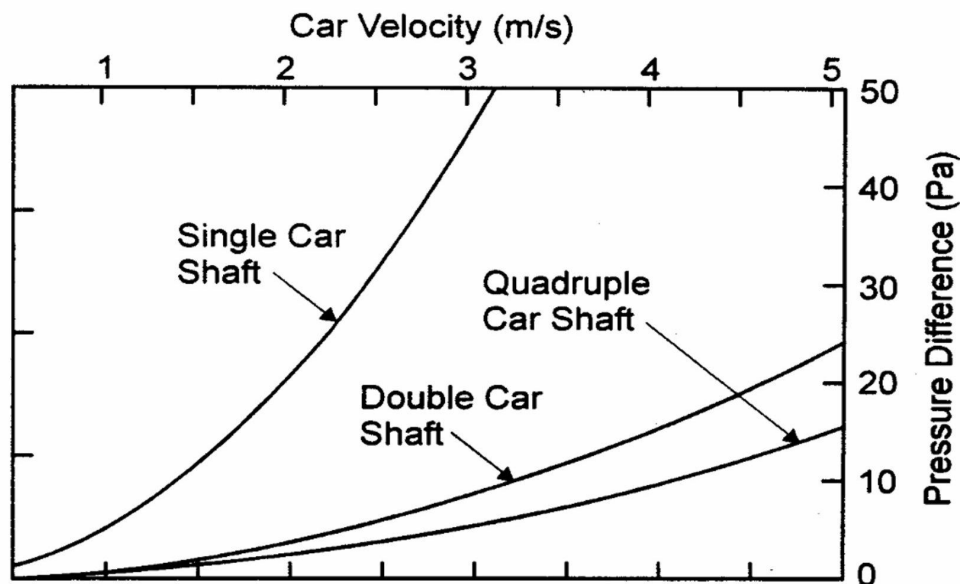
2618 The number of necessary assumptions regarding the air flow and exact conditions of the building preclude the
 2619 undertaking of a detailed analysis of the impact of this effect. However, the NFPA reference "Smoke
 2620 Movement and Control in High Rise Buildings" chapter 4.5 [42] provides a comprehensive background to this
 2621 issue. In a multiple-car elevator shaft, the adverse effects of a single elevator moving are typically negligible.
 2622 From video evidence [MetUSB:NORTHLEIGH/Op Northleigh Spread of Fire/Interactive/CCTV/Southlift.mp4] of
 2623 the south lift it can be inferred that this lift remained at the 2nd floor between approximately 01:03 and 01:37,
 2624 thus it can be assumed that these early stages of a fire can be treated as a single car in a double car shaft. The
 2625 chart Figure 67 shows the upper limit pressure difference between the elevator shaft and the lobby and it has

2626 been calculated that the elevator car in Grenfell Tower moved at between approximately 1.5 m/s. Thus, the
 2627 max pressure difference is around 3 Pa, which is negligible. This effect can therefore be discounted and should
 2628 be given no further attention.

2629
 2630 **FIGURE 67: PRESSURE DIFFERENCES AS A FUNCTION OF CAR VELOCITY FOR LIFT SHAFTS.**

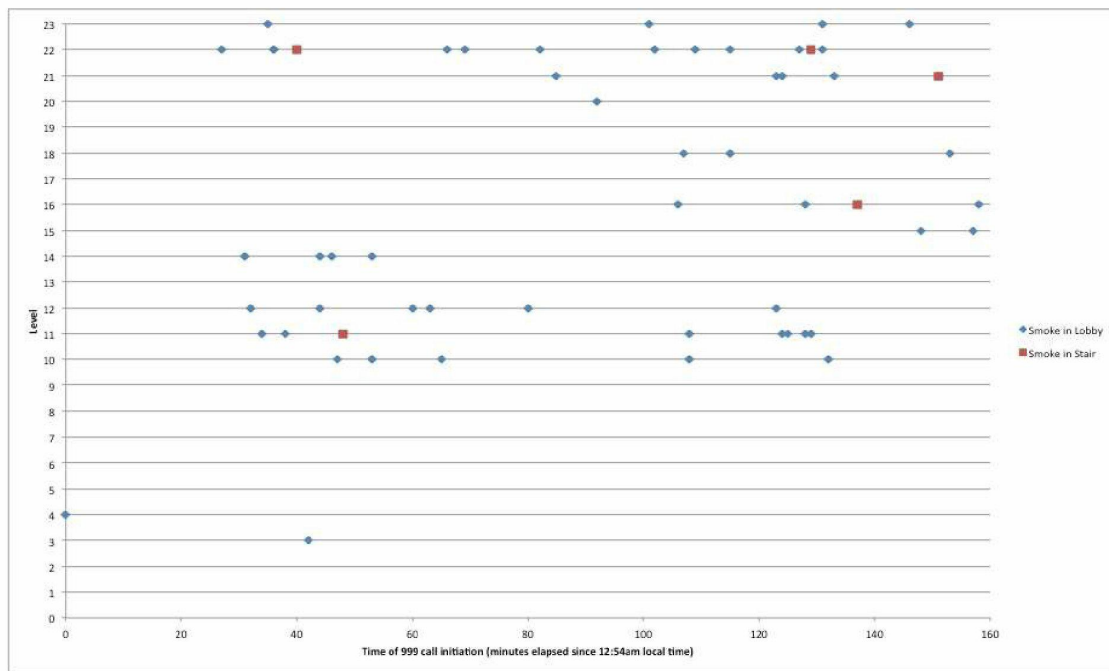
2680 Figure 68 shows that smoke was reported for the first time in the lobby area in 11th to 14th and 24th floors
 2681 approximately 30-35 minutes after the first 999 call. Figure 70 shows that at approximately the same time,
 2682 internal fires were reported on the 12th and 22nd floors. The fire on the 12th floor is in Flat 96, directly above
 2683 the flat of fire origin. This flat was reported on fire at 01:24. The location of the flat on the 22nd floor is not
 2684 identified in the 999 call transcript.

FIGURE 68: LOCATIONS OF 999 CALLERS DESCRIBING SMOKE IN LIFT LOBBIES & SMOKE IN STAIRS. NOTE THAT THE LOCATIONS SHOWN HERE ARE NOT NECESSARILY ON THE SAME FLOOR AS THE FIRE OR SMOKE BEING DESCRIBED BY THE CALLER, BUT INSTEAD THE LOCATION OF THE CALLER AT THE TIME. NO CALLS RECORDED FROM LEVEL 13 CAN BE ATTRIBUTED TO THE EARLY EVACUATION OF LEVEL 13 OCCUPANTS IN THE FIRST 30 MINUTES OF THE FIRE EVENT. ADDITIONAL CALL RECEIVED AT T=251 FROM CALLER ON 10TH FLOOR, DESCRIBING SMOKE IN LOBBY.

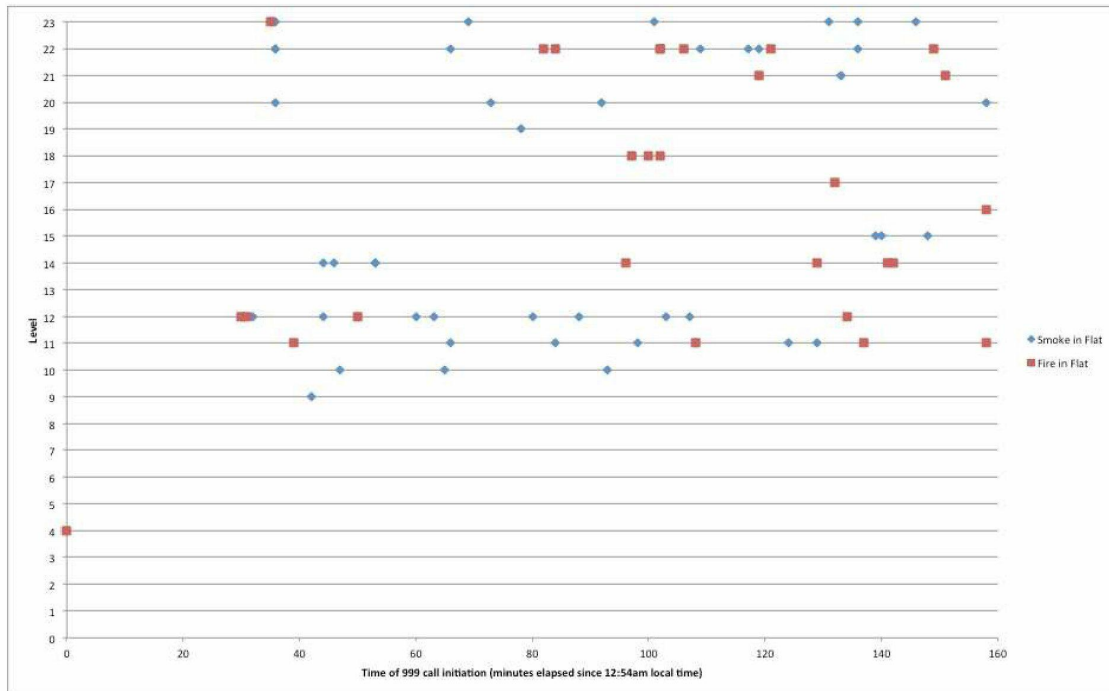
FIGURE 69: LOCATIONS FROM WHICH 999 CALLS WERE MADE DESCRIBING SMOKE AND FIRE IN FLATS. NOTE THAT THE LOCATIONS SHOWN HERE ARE NOT NECESSARILY ON THE SAME FLOOR AS THE FIRE OR SMOKE BEING DESCRIBED BY THE CALLER. PLOT DOES NOT CAPTURE CALL DURATIONS; FOR EXAMPLE, CALL FROM LEVEL 23 AT T=35 LASTS FOR 55 MINUTES, NOT KNOWN AT WHAT TIME DURING CALLER DESCRIBES FIRE IN FLAT. NO CALLS RECORDED FROM LEVEL 13 CAN BE ATTRIBUTED TO THE EARLY EVACUATION OF LEVEL 13 OCCUPANTS WITHIN THE FIRST 30 MINUTES OF THE FIRE EVENT. ADDITIONAL CALL RECEIVED AT T=251 FROM CALLER ON 10TH FLOOR, DESCRIBING SMOKE IN FLAT.

At some point during this third stage of the fire, as more and more compartment fires were ignited, and smoke migrated into the egress paths and unaffected flats, general conditions within the building can be deemed to have become untenable²⁵. Figure 68 and Figure 69 show the increase in calls reporting smoke and fires in units as well as smoke in the lift lobbies and stairs.
