GRENFELL TOWER: PHASE 1 REPORT

Prof. José L. Torero CEng, RPEQ, FREng, FRSE, FTSE, FIFE, FSFPE, FICE, FCI

23rd May 2018

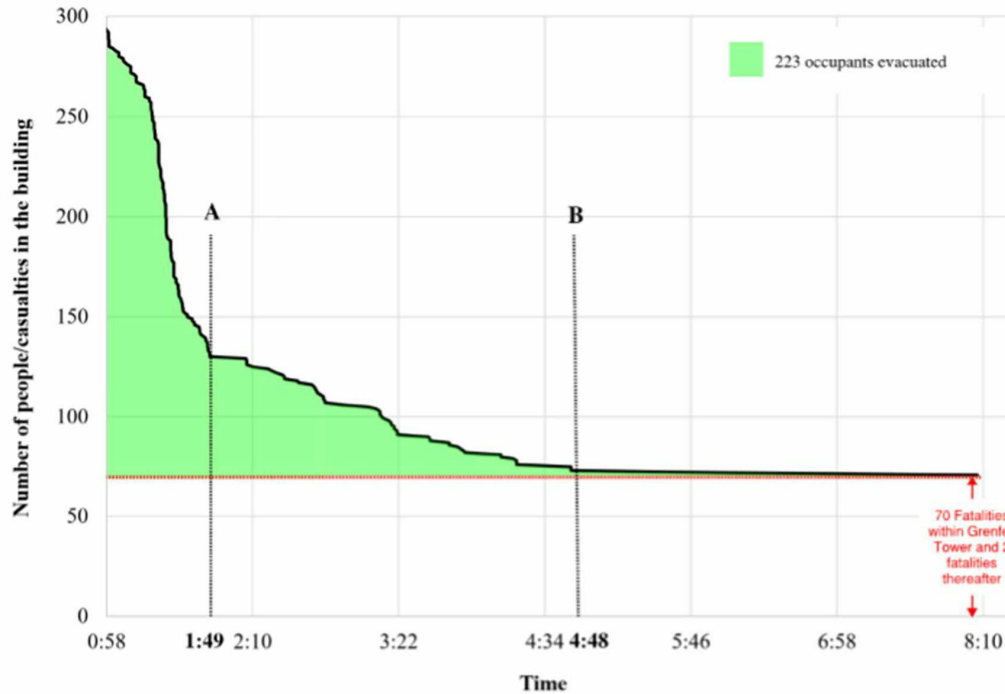
FIGURE 71: NUMBER OF OCCUPANTS IN GRENFELL TOWER DURING THE FIRE EVENT FROM [4].

Dr Lane's Phase One expert report [4] shows an overview of the number of people remaining in the building over time from the onset of the fire (Figure 71). The rate of evacuation slowed significantly at 01:50. At this point the fire has reached the East elevation windows of approximately 25 separate flats, and the North elevation windows of approximately 9 of those same flats (Figure 72). In this first hour of the fire most of the calls reporting smoke are localized in areas where the fires have been observed to breach the external envelope of the building (Floors 11th to 16th and 22nd and above). Given the significance of the external spread on all subsequent events potentially leading to the involvement of the compartment and then the breaching of the unit, the consistency of all this information is as expected.

During this stage of the fire, the smoke was passable by firefighters with Breathing Apparatus (BA), and as shown in Figure 71 (adapted from Figure 14.17[4]), during this period at approx. 01:50, occupants stop evacuating the building. At this point, there was a period of approximately 20 minutes where no egress took place. At 02:06 the fire was declared a major incident and from this point, egress appears to have resumed however at a much lesser rate than before. The reasons for this are unclear.

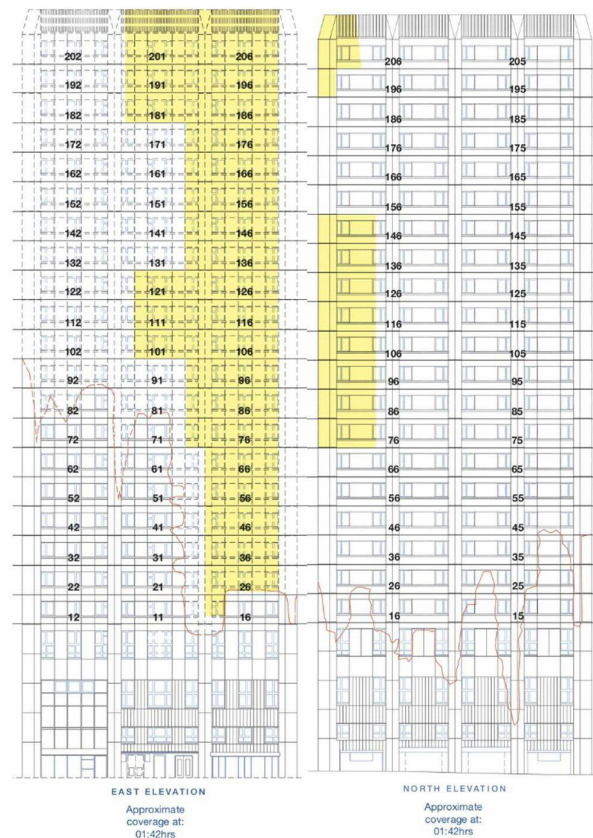
FIGURE 72: APPROXIMATE EXTENT OF EXTERNAL FLAME SPREAD AT 01:42 AM, THE TIME OF THE INITIAL SIGNIFICANT DECREASE IN THE RATE OF PEOPLE EGRESSING THE BUILDING NOTICEABLY DECREASED.

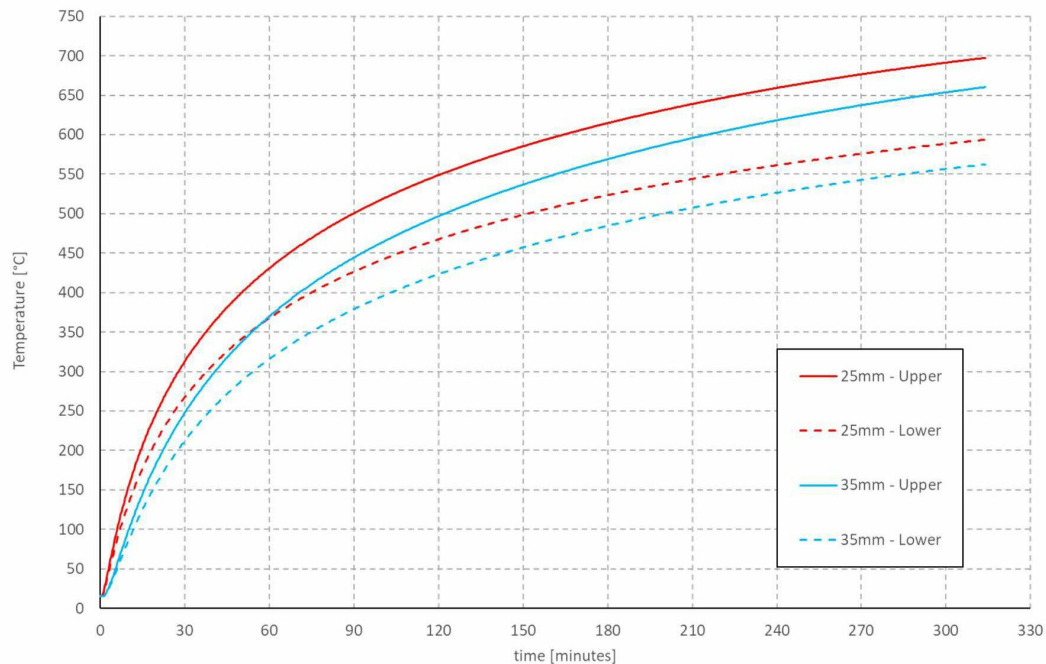
The model assumes that the rebar temperature can be conservatively approximated as the temperature of the concrete between 25mm and 35mm depth in to the concrete slab [44]. The gas phase temperature was taken as having a lower bounding value of 850°C and an upper value of 1000°C as estimated in Section 5.4. A conservative estimate for the onset of the rebar degradation is 300°C so this will be taken as a lower bound failure criterion, while 550°C is more commonly taken as a failure condition for the rebar, this will be used as the upper bound failure criterion. The plot in Figure 73 presents the results of the two heating regimes implemented. The results are summarised in Table 6.

FIGURE 73: HEATING CURVES FOR SLAB REBAR LOCATED AT 25MM AND 35MM ABOVE THE BASE OF THE CONCRETE SLAB FOR UPPER BOUND (1000°C) AND LOWER BOUND (850°C) GAS PHASE TEMPERATURE EXPOSURES.

Given that the characteristic times of impingement of external flames on the interior slabs will be less than 25 minutes at this stage, it is clear that this mechanism of heating would also not impact the global stability of the structure. This is due to the short exposure time, the expectation that the temperature of the impinging flames will be no greater than the values assessed above, and the fact that the heat application is typically only localised around the window (see Section 5.3.2.1).

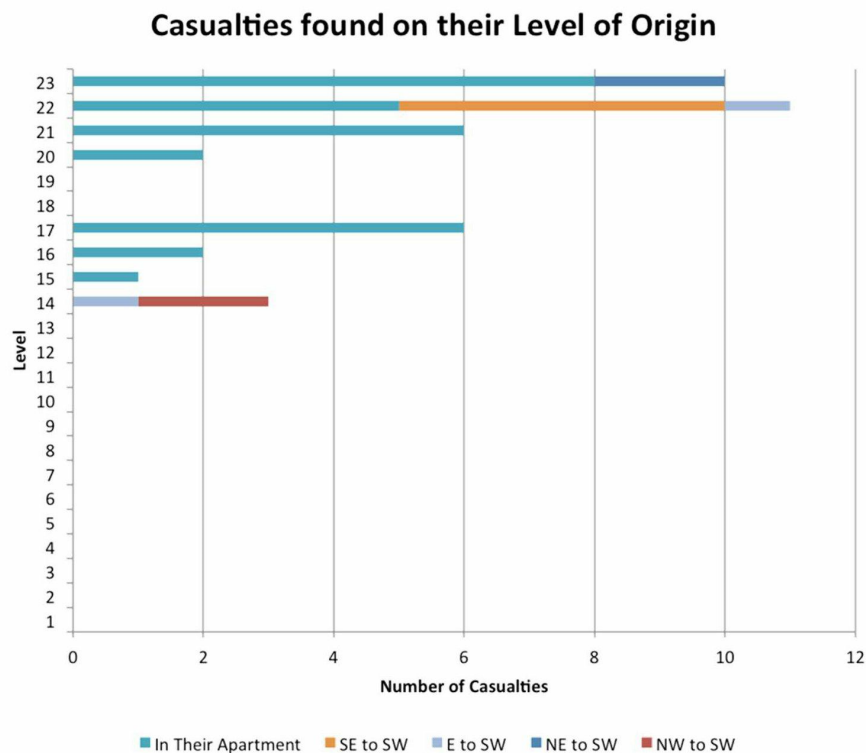
Based on the DVI Reconciliation Unit final floor plan of recoveries from Grenfell Tower [MET00008018], the location and movement of casualties based on their apartment of origin and their end location was tabulated. Figure 74 shows a visualisation of casualties found on the same level on which they were known to have lived.

FIGURE 74: VISUAL REPRESENTATION OF CASUALTIES FOUND ON THE SAME LEVEL AS THEIR APARTMENT OF ORIGIN. IN SOME INSTANCES, CASUALTIES MOVED Laterally FROM THEIR OWN APARTMENT TO APARTMENTS IN THE SOUTHWEST CORNER OF

THE BUILDING (APARTMENTS '3'). THE SOUTHWEST CORNER OF THE BUILDING WAS THE LAST CORNER TO BE DIRECTLY EXPOSED TO EXTERNAL FLAME SPREAD ON THE BUILDING FAÇADE.

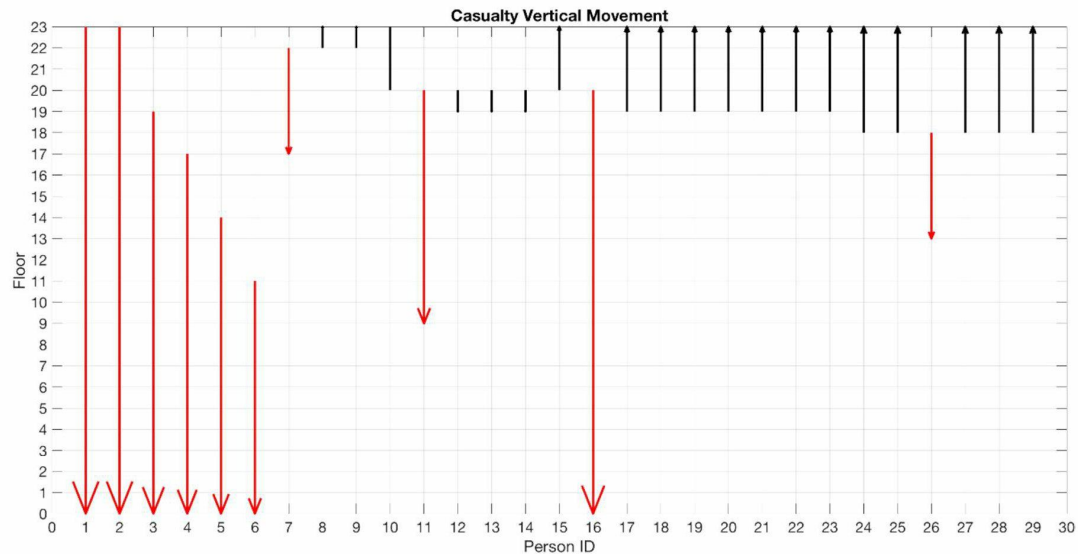
While most casualties were found within their apartment of origin, twenty-nine (29) casualties were found in other locations. Their movement is visually represented in Figure 75.

FIGURE 75: VISUAL REPRESENTATION OF CASUALTIES FOUND ON A FLOOR OTHER THAN THE ONE OF THEIR OWN FLAT. DATA SOURCED FROM MET00008018. 19 CASUALTIES WERE ABLE TO REACH THE EXIT STAIR BUT PROCEEDED UPWARDS RATHER THAN DOWN THE STAIR. 3 CASUALTIES WERE FOUND EITHER IN THE STAIR OR IN ADJACENT LOBBIES, SUGGESTING THEY ATTEMPTED TO TRAVEL DOWN THE EGRESS STAIR.

There is a clear cut off above Levels 12 – 13 where the vast majority of occupants living on or below these floors survived. Above these levels fatalities are grouped into two distinct bands.

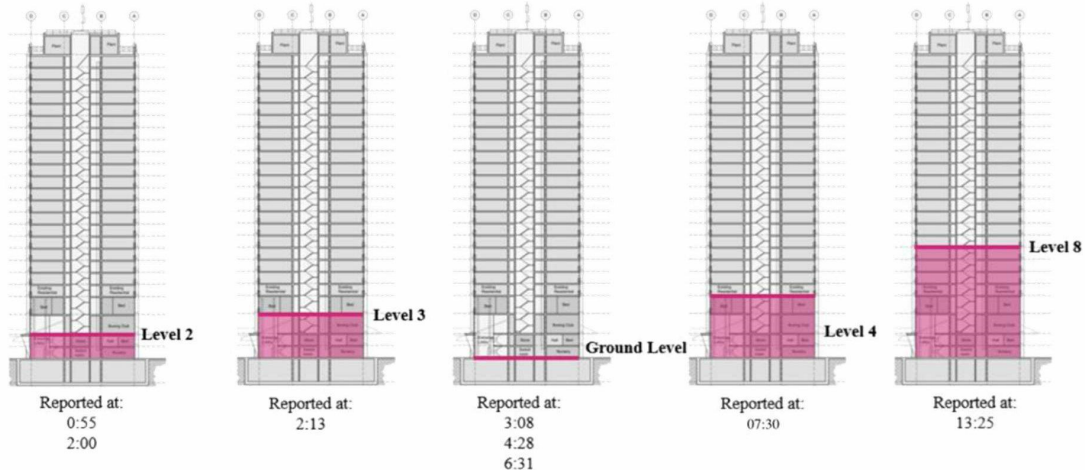
While rescue operations continued throughout the first hours of this stage, it is unclear from exactly where these rescues took place. The dynamic location of the bridgehead does however provide some indication as to the levels which firefighters were able to reach. The following diagram (Figure 76) adapted from [4] can be used to illustrate this movement.

FIGURE 76: LOCATION OF THE BRIDGEHEAD THROUGHOUT FIREFIGHTING ACTIVITIES AT GRENFELL TOWER [4].

The diagram shows that, following the onset of generalised untenable conditions, firefighters were attempting to move up the building however were soon forced back down due to smoke concentrations as far down the building as Level 3. The implications of the extent of usable duration of breathing apparatus would mean that the firefighters were generally operating at lower levels over this period of time, therefore rescue operations would likely have been concentrated beneath Levels 10-12.

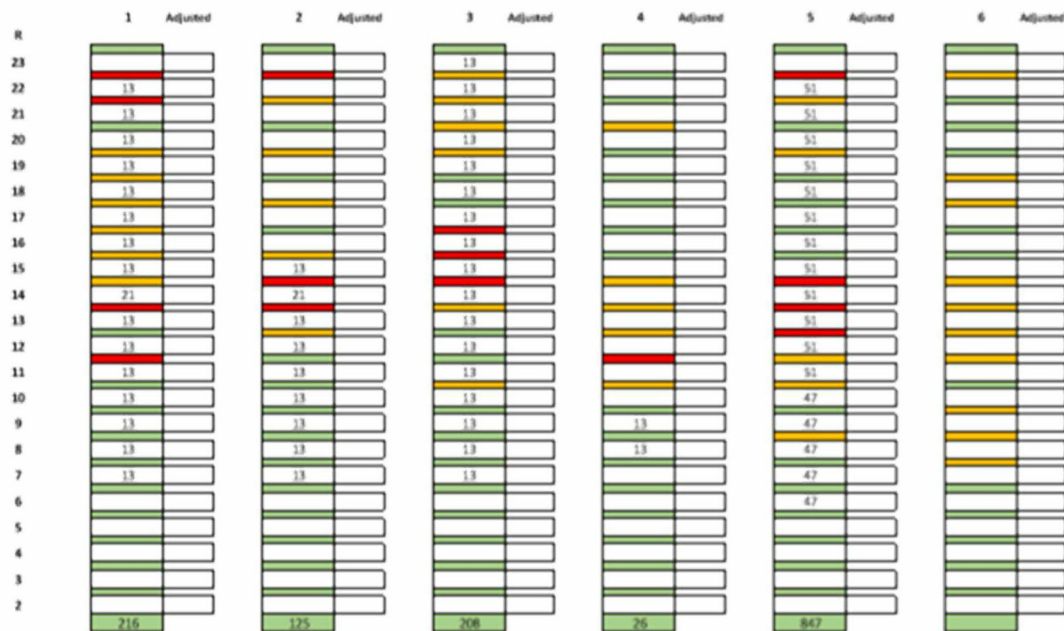
2976 A post-fire structural assessment has been conducted by DeconstructUK [43] followed by shoring up of the
 2977 structure to enable safe inspection of the site. In general, aside from sporadic inconsistencies, the authors note
 2978 that the worst effects of the fire, in terms of structural damage, are found between the 10th to 14th floor. Above
 2979 this, fire damage is extensive but not as serious in structural terms. Below this, damage to the structure is
 2980 typically negligible.

2981 The authors state that, in all but a few locations, the effect of the fire is on the cover (the outer layer).
 2982 Internally, the concrete appears unaffected. This is indicated by assessment of sample cores taken from the
 2983 building. Spalling of concrete columns at 14th, 16th, 20th, and 21st floor levels has left rebar exposed, with
 2984 spalling depths ranging from 35 to 100 mm. In two locations, this reinforcement has yielded. However, the
 2985 authors do not believe this to be a concern in terms of the stability of the structure.

2987 **FIGURE 77: THIS FIGURE TAKEN FROM [43] INDICATES DEGREES OF STRUCTURAL DAMAGE THROUGHOUT THE GRENFELL TOWER.**
 2988 **GREEN REPRESENTS FLATS WITH LITTLE OR NO DAMAGE AND IMPERCEPTIBLE DEFLECTION. AMBER REPRESENTS FLATS WHERE**
 2989 **SPALLING HAS OCCURRED, REINFORCEMENT IS PARTIALLY VISIBLE, AND / OR VISIBLE DEFLECTIONS ARE LESS THAN 100MM. RED**
 2990 **REPRESENTS SPALLING HAS OCCURRED, REINFORCEMENT IS VISIBLE AND DETACHED FROM THE SLAB OR THE SLAB IS IN A**
 2991 **DEGRADED STATE, AND / OR DEFLECTIONS ARE LARGER THAN 100MM. NO EXPLANATION OF THE NUMBERING SYSTEM SHOWN**
 2992 **IN THE GRAPHIC IS PROVIDED.**

2993 Figure 77 provides an overview of the structural damage by floor and by flat extracted from the DeconstructUK
 2994 report [43]. Where slabs are coloured green, this represents flats with little or no damage and imperceptible
 2995 deflection. Amber represents flats where spalling has occurred, reinforcement is partially visible, and / or
 2996 visible deflections are less than 100mm. Red represents spalling has occurred, reinforcement is visible and
 2997 detached from the slab or the slab is in a degraded state, and / or deflections are larger than 100mm. No
 2998 explanation of the numbering system shown in the graphic is provided.

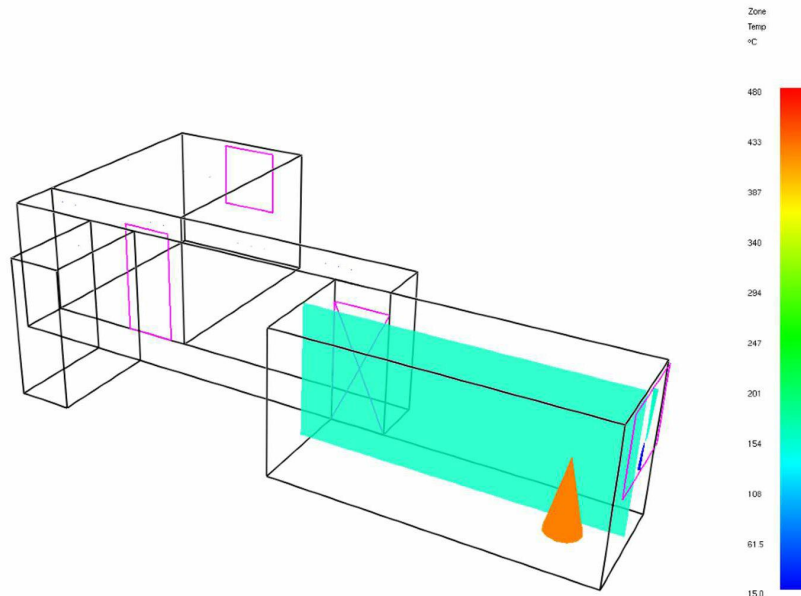
Two model variations of the Flat 16 fire scenario have been constructed. Scenario 1 represents the assumed ventilation conditions during the kitchen fire event based on the available evidence. The kitchen door is closed and the kitchen window is only partially open. An example of this scenario is shown in Figure 80. The purpose of this model is to provide verification of the range of compartment temperature and HRR estimated by the analytical approach described in the main body of this report.

FIGURE 80: SCENARIO 1: KITCHEN FIRE SCENARIO WITH VENTILATION CONDITIONS BASED ON OBSERVED EVIDENCE. THE KITCHEN DOOR IS CLOSED, AND KITCHEN WINDOW IS PARTIALLY OPEN.

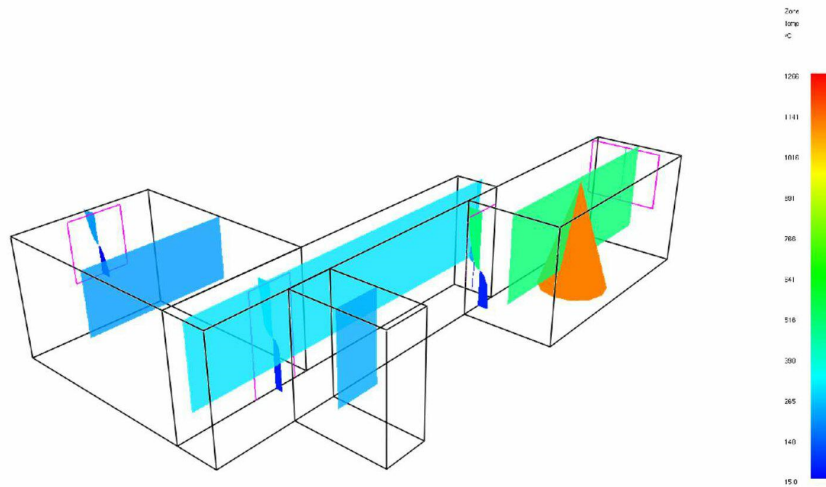
Scenario 2 takes advantage of the extra functionality of the model to explore the potential conditions that could result from different ventilation configurations, namely if the kitchen door was open or closed for the duration of the fire, to try to provide confirmation of this potential variable. Thermal imaging camera footage [MET00005810-17] show the door and window to Bedroom 1 open as the firefighters enter and search the flat for the first time. The Scenario 2 model replicated this.

FIGURE 81: SCENARIO 2: KITCHEN FIRE SCENARIO WITH WINDOW PARTIALLY OPEN AND KITCHEN DOOR FULLY OPEN. THE DOOR FROM THE CORRIDOR TO BEDROOM 1 AND WINDOW IN BEDROOM 1 ARE ALSO OPEN AS OBSERVED IN THERMAL IMAGING CAMERA FOOTAGE [MET00005810-17].

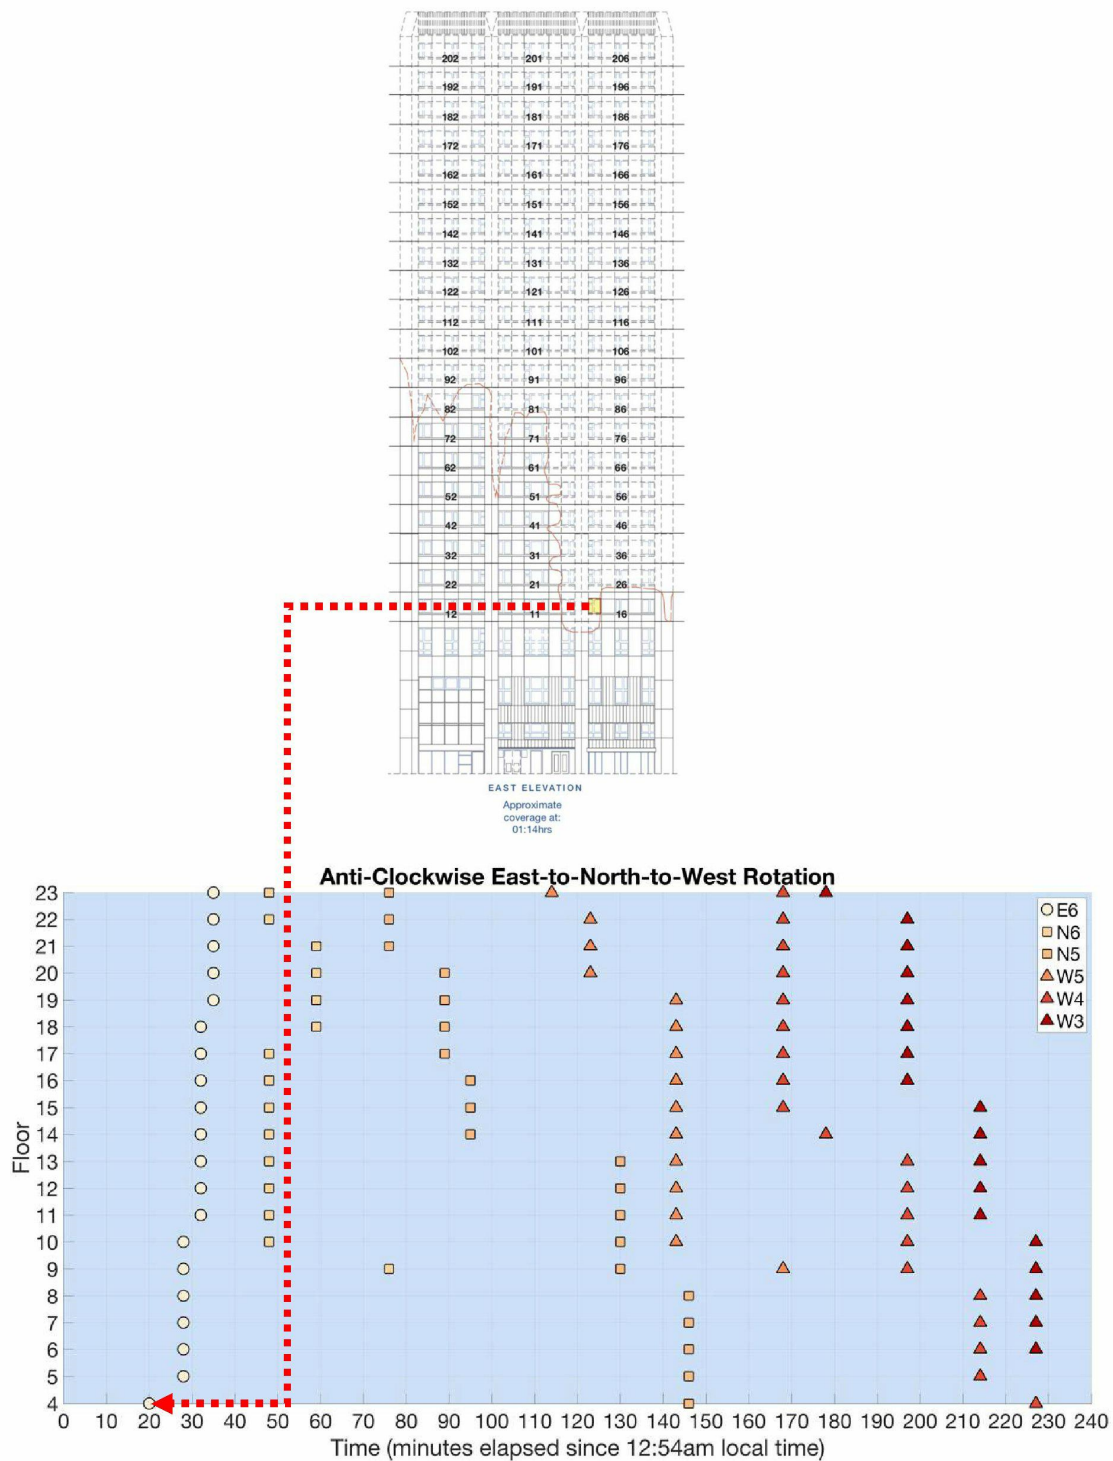
FIGURE 82: TIME HISTORY OF EXTERNAL FLAME SPREAD ON THE EASTERN (E), NORTHERN (N) AND WESTERN (W) FACADES. THE STACK OF FLATS IMPACTED BY THE EXTERNAL FLAME SPREAD ARE INDICATED USING NUMBERS 1-6 APPENDED TO THE FACADE DESCRIPTOR IN THE LEGEND. THE RED ARROW INDICATES THE ESTIMATED POSITION OF EXTERNAL FLAMES AT 01:14 AM ON THE EAST ELEVATION TOWER PLAN VIEW.

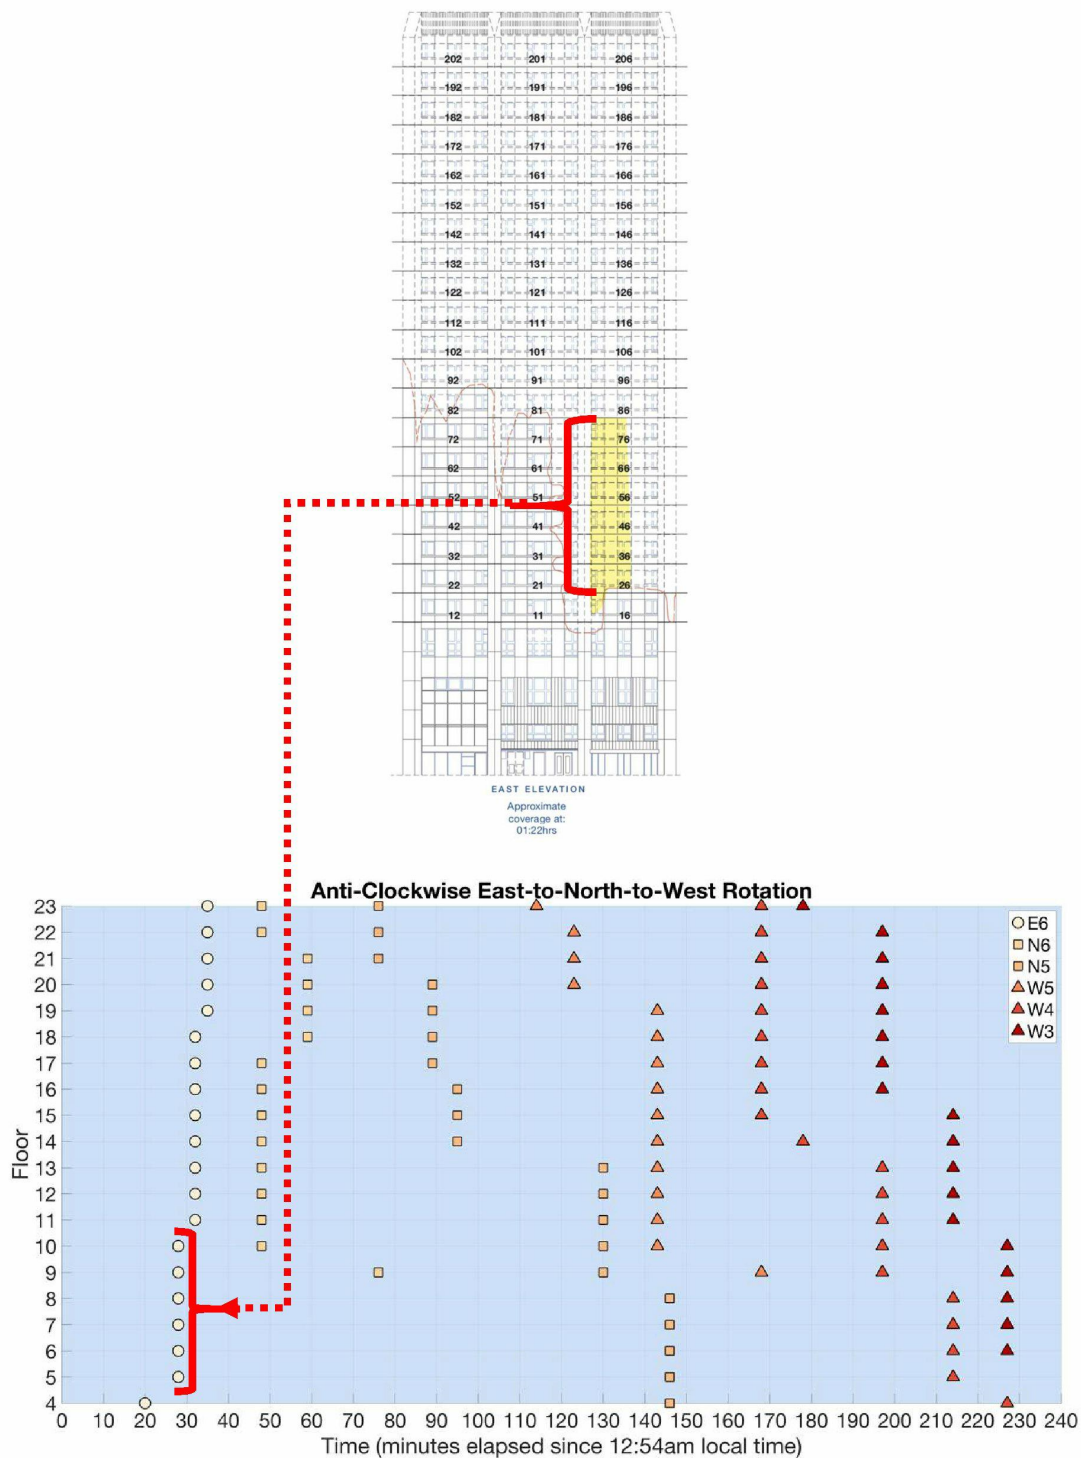
FIGURE 83: TIME HISTORY OF EXTERNAL FLAME SPREAD ON THE EASTERN (E), NORTHERN (N) AND WESTERN (W) FACADES. THE STACK OF FLATS IMPACTED BY THE EXTERNAL FLAME SPREAD ARE INDICATED USING NUMBERS 1-6 APPENDED TO THE FACADE DESCRIPTOR IN THE LEGEND. THE RED ARROW INDICATES THE ESTIMATED POSITION OF EXTERNAL FLAMES AT 01:22 AM ON THE EAST ELEVATION TOWER PLAN VIEW.

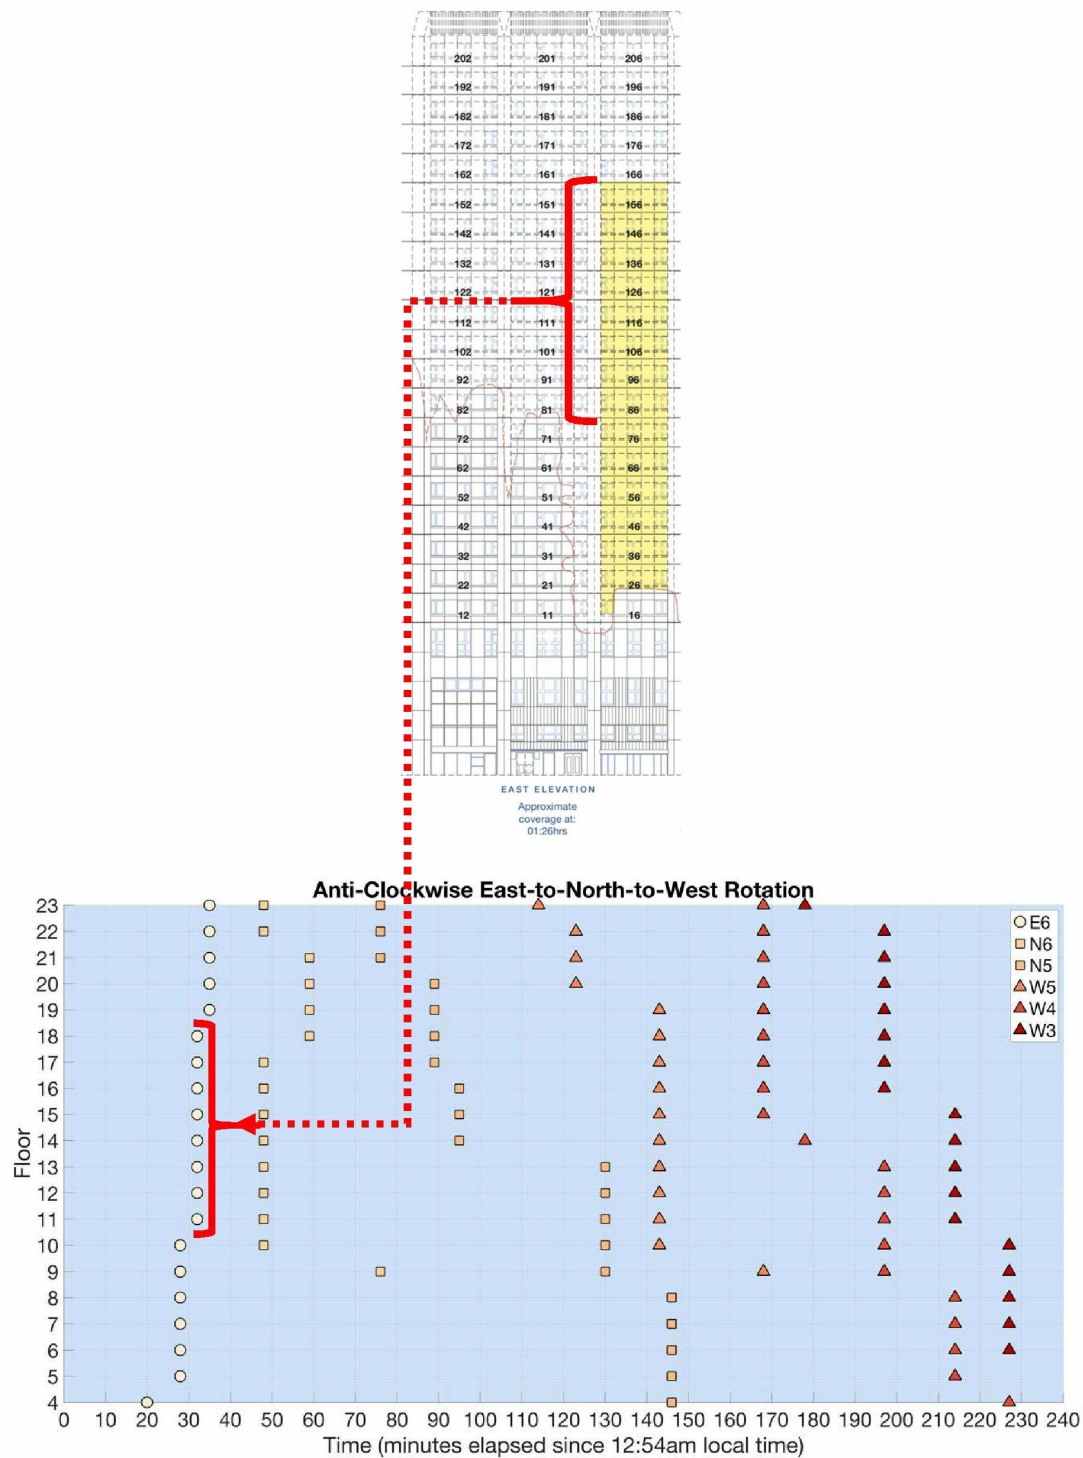
FIGURE 84: TIME HISTORY OF EXTERNAL FLAME SPREAD ON THE EASTERN (E), NORTHERN (N) AND WESTERN (W) FACADES. THE STACK OF FLATS IMPACTED BY THE EXTERNAL FLAME SPREAD ARE INDICATED USING NUMBERS 1-6 APPENDED TO THE FACADE DESCRIPTOR IN THE LEGEND. THE RED ARROW INDICATES THE ESTIMATED POSITION OF EXTERNAL FLAMES AT 01:26 AM ON THE EAST ELEVATION TOWER PLAN VIEW.

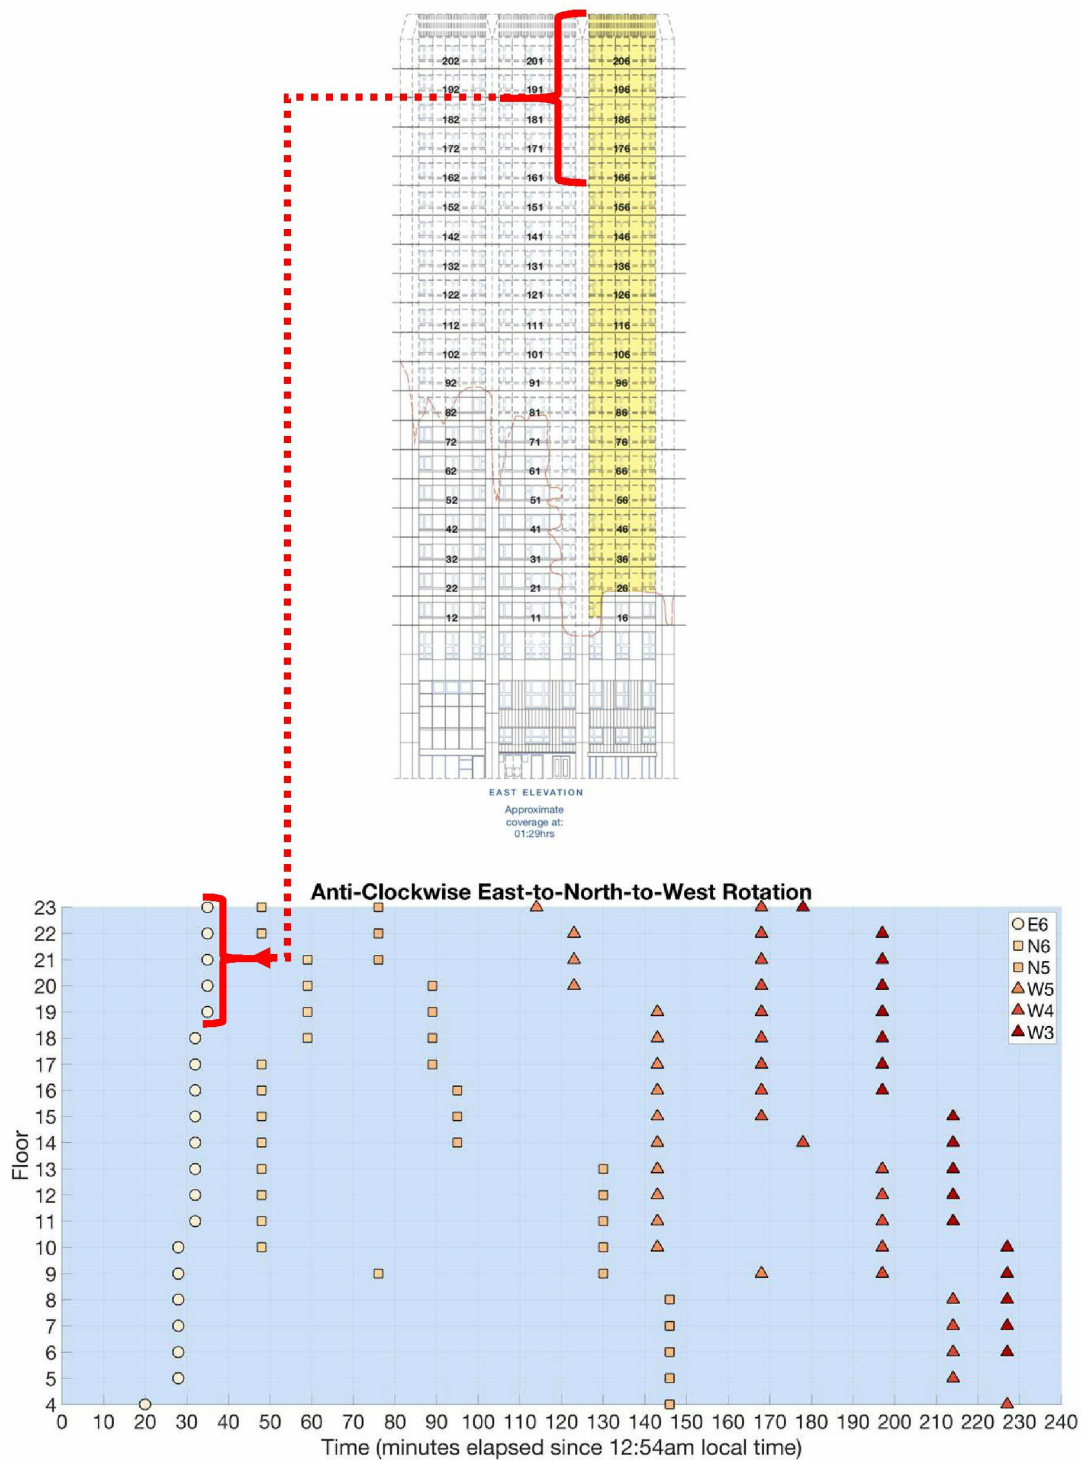
FIGURE 85: TIME HISTORY OF EXTERNAL FLAME SPREAD ON THE EASTERN (E), NORTHERN (N) AND WESTERN (W) FACADES. THE STACK OF FLATS IMPACTED BY THE EXTERNAL FLAME SPREAD ARE INDICATED USING NUMBERS 1-6 APPENDED TO THE FACADE DESCRIPTOR IN THE LEGEND. THE RED ARROW INDICATES THE ESTIMATED POSITION OF EXTERNAL FLAMES AT 01:29 AM ON THE EAST ELEVATION TOWER PLAN VIEW.

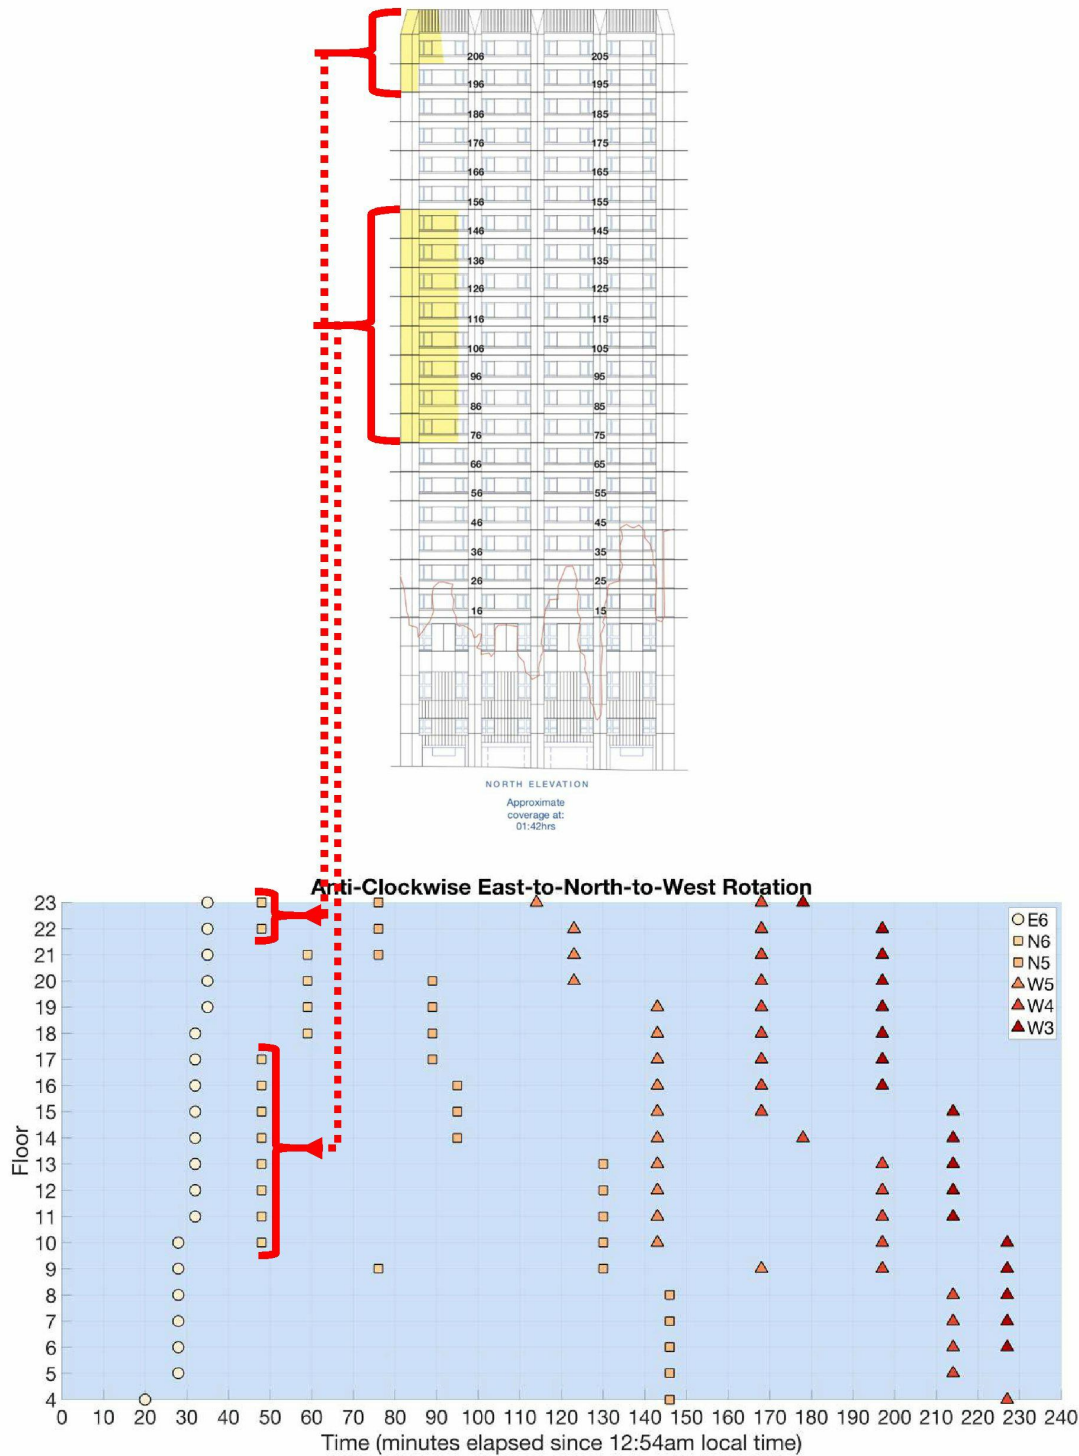
FIGURE 86: TIME HISTORY OF EXTERNAL FLAME SPREAD ON THE EASTERN (E), NORTHERN (N) AND WESTERN (W) FACADES. THE STACK OF FLATS IMPACTED BY THE EXTERNAL FLAME SPREAD ARE INDICATED USING NUMBERS 1-6 APPENDED TO THE FACADE DESCRIPTOR IN THE LEGEND. THE RED ARROWS INDICATE THE ESTIMATED POSITION OF EXTERNAL FLAMES AT 01:42 AM ON THE NORTH ELEVATION TOWER PLAN VIEW.

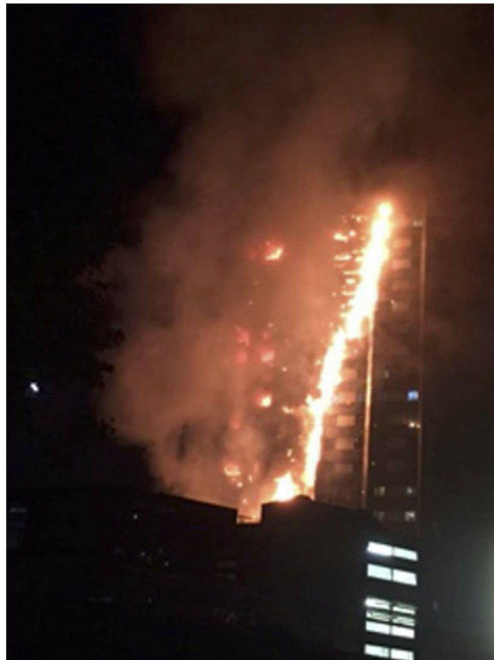
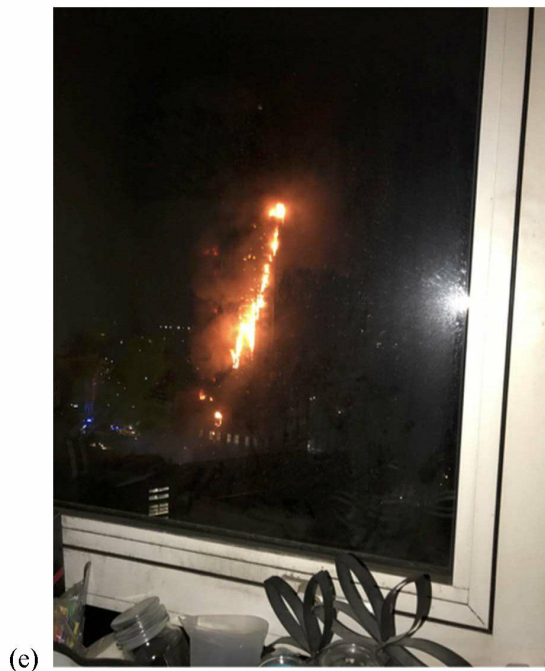
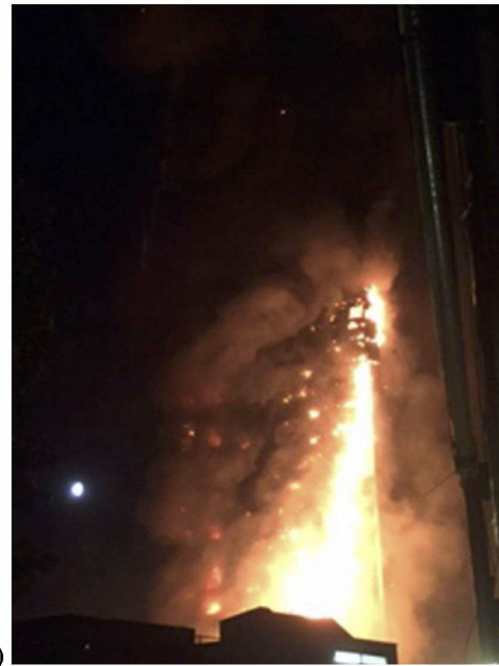
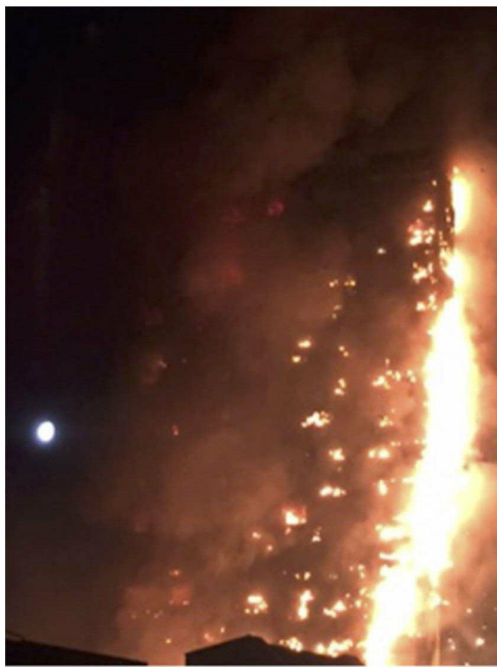
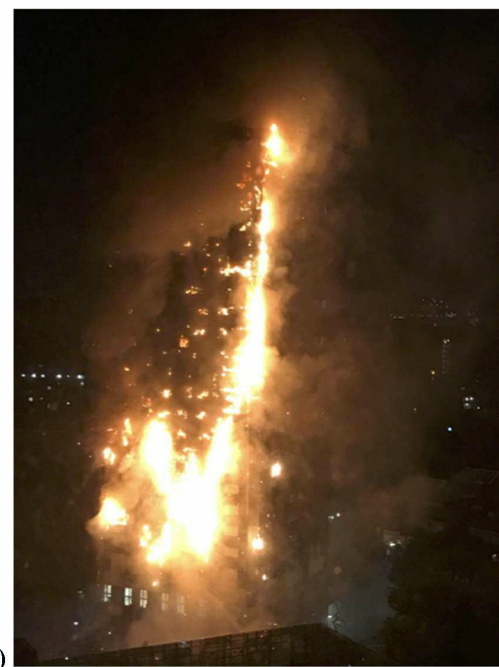
FIGURE 87: ORIGINAL PUBLIC FOOTAGE OF LATERAL AND VERTICAL (DOWNWARD) FLAME SPREAD ON THE NORTH FACADE OF GRENFELL TOWER AT (A) 01:42 AM; (B) 01:53 AM; (C) 02:23 AM; (D) 02:32 AM; (E) 02:49 AM; (F) 02:55 AM; (G) 03:04 AM; AND (H) 03:07 AM RESPECTIVELY. PHOTOS WERE SOURCED FROM MET00008024, PAGE 36.

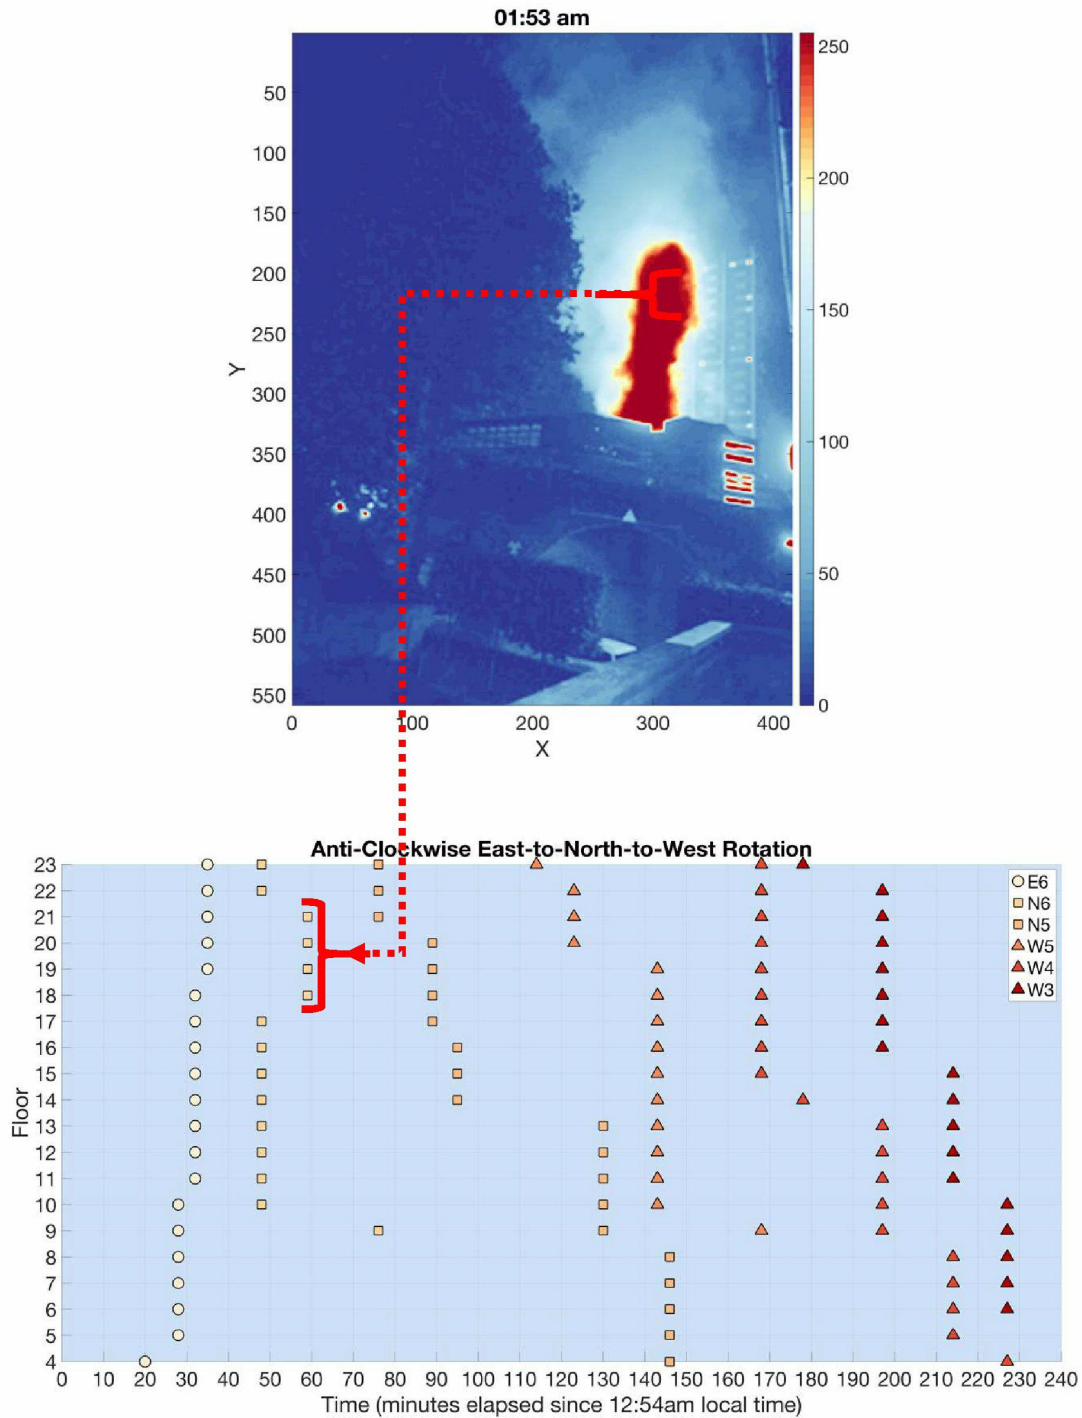
FIGURE 88: TIME HISTORY OF EXTERNAL FLAME SPREAD ON THE EASTERN (E), NORTHERN (N) AND WESTERN (W) FACADES. THE STACK OF FLATS IMPACTED BY THE EXTERNAL FLAME SPREAD ARE INDICATED USING NUMBERS 1-6 APPENDED TO THE FACADE DESCRIPTOR IN THE LEGEND. THE RED ARROW INDICATES THE ESTIMATED POSITION OF EXTERNAL FLAMES AT 01:53 AM ON THE NORTH ELEVATION PROCESSED IMAGE (FIGURE 5b).

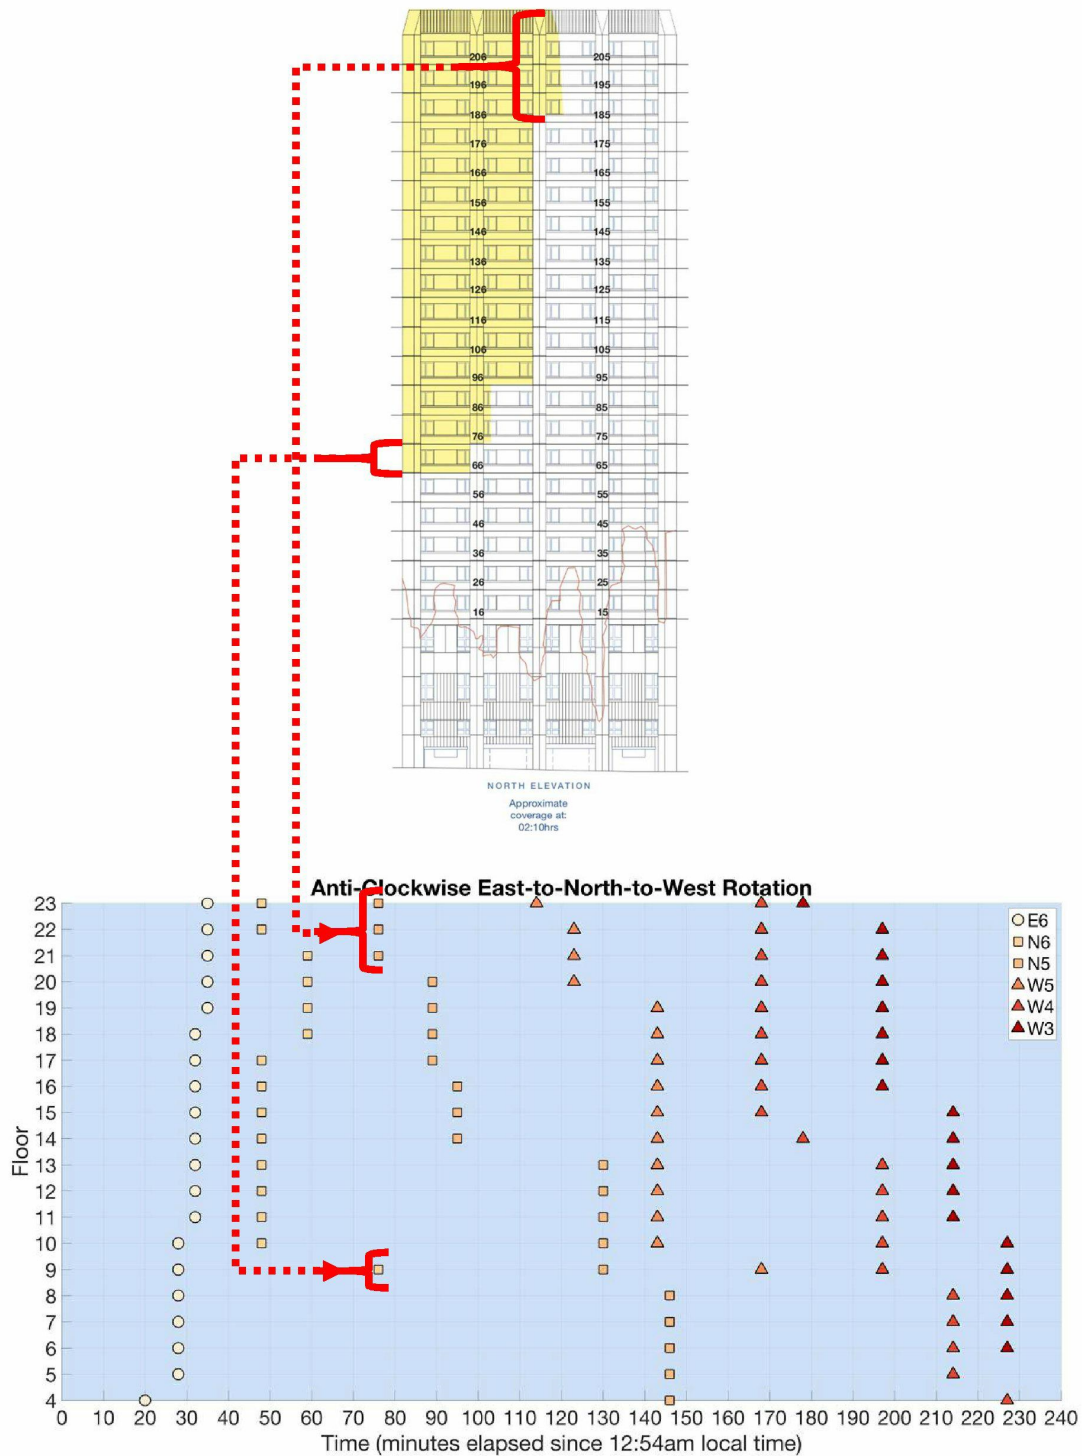
FIGURE 89: TIME HISTORY OF EXTERNAL FLAME SPREAD ON THE EASTERN (E), NORTHERN (N) AND WESTERN (W) FACADES. THE STACK OF FLATS IMPACTED BY THE EXTERNAL FLAME SPREAD ARE INDICATED USING NUMBERS 1-6 APPENDED TO THE FACADE DESCRIPTOR IN THE LEGEND. THE RED ARROWS INDICATE THE ESTIMATED POSITION OF EXTERNAL FLAMES AT 02:10 AM ON THE NORTH ELEVATION TOWER PLAN VIEW.

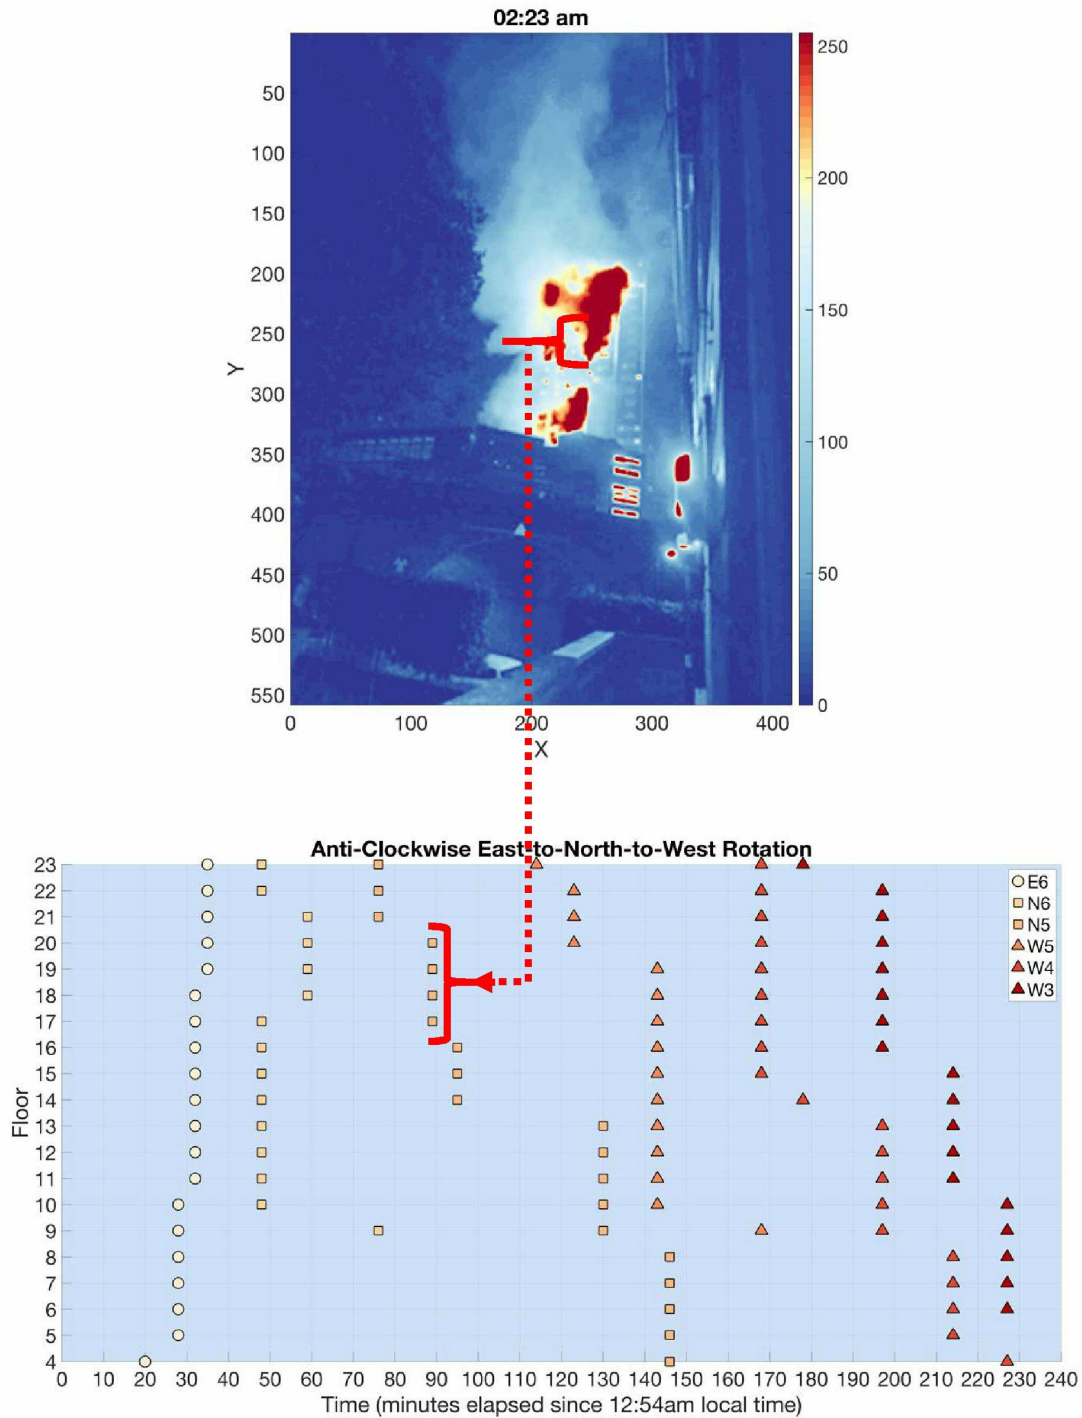
FIGURE 90: TIME HISTORY OF EXTERNAL FLAME SPREAD ON THE EASTERN (E), NORTHERN (N) AND WESTERN (W) FACADES. THE STACK OF FLATS IMPACTED BY THE EXTERNAL FLAME SPREAD ARE INDICATED USING NUMBERS 1-6 APPENDED TO THE FACADE DESCRIPTOR IN THE LEGEND. THE RED ARROW INDICATES THE ESTIMATED POSITION OF EXTERNAL FLAMES AT 02:23 AM ON THE NORTH ELEVATION PROCESSED IMAGE (FIGURE 5c).
