GRENFELL TOWER: PHASE 1 REPORT

Prof. José L. Torero CEng, RPEQ, FREng, FRSE, FTSE, FIFE, FSFPE, FICE, FCI

23rd May 2018

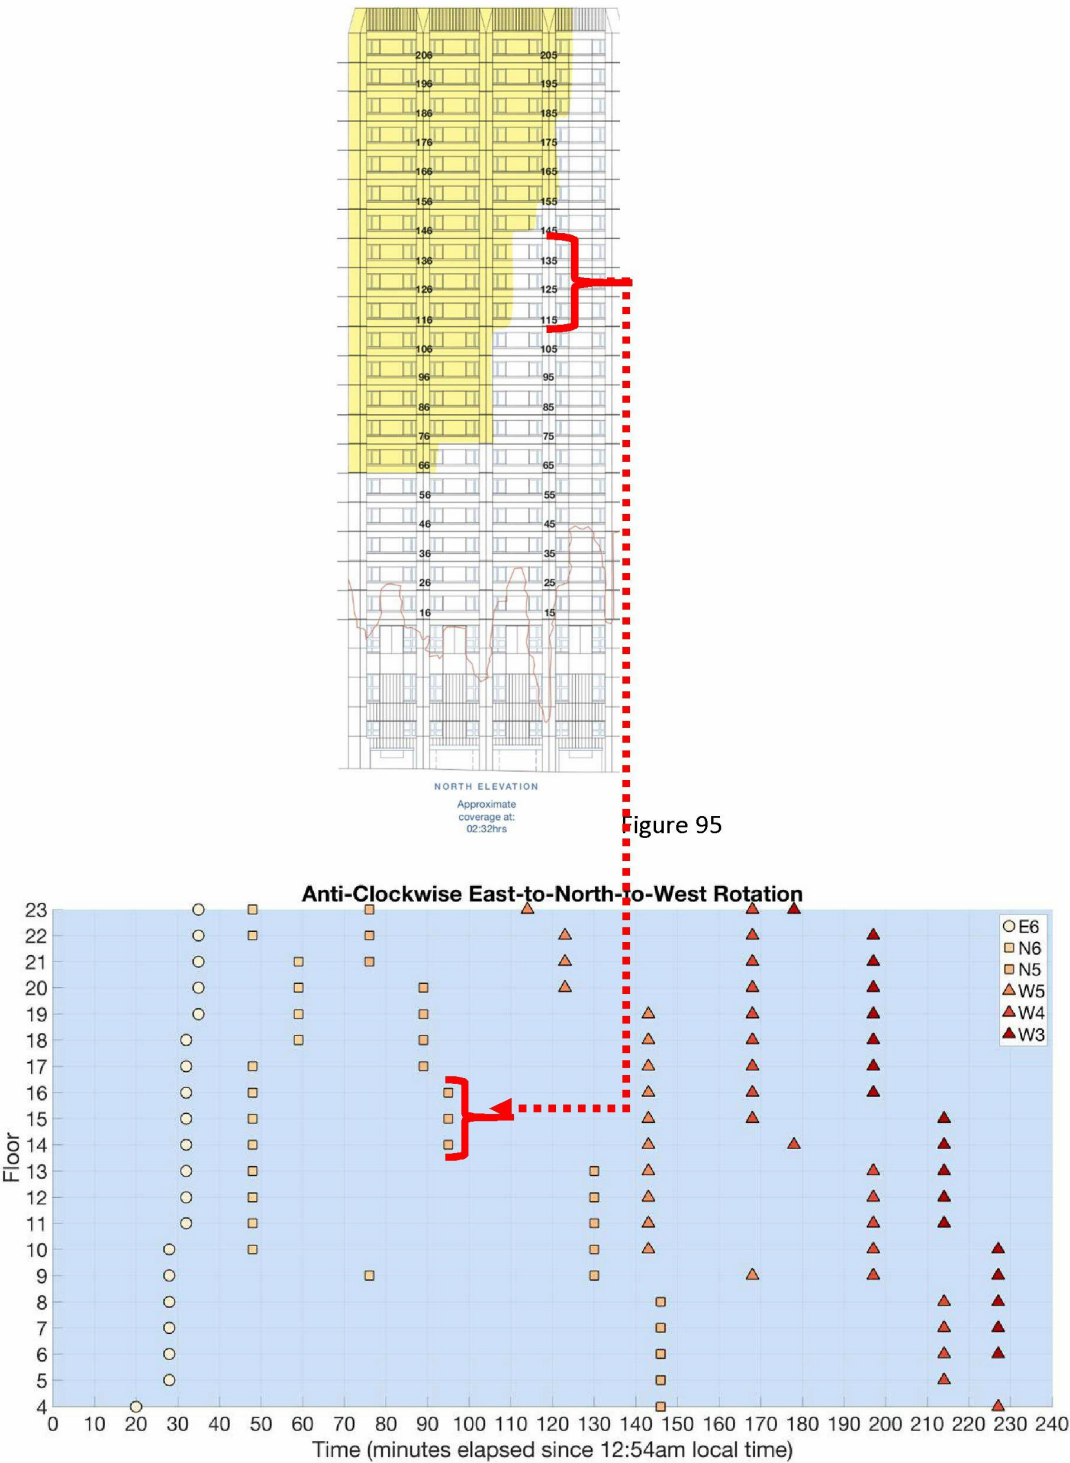
FIGURE 91: TIME HISTORY OF EXTERNAL FLAME SPREAD ON THE EASTERN (E), NORTHERN (N) AND WESTERN (W) FACADES. THE STACK OF FLATS IMPACTED BY THE EXTERNAL FLAME SPREAD ARE INDICATED USING NUMBERS 1-6 APPENDED TO THE FACADE DESCRIPTOR IN THE LEGEND. THE RED ARROW INDICATES THE ESTIMATED POSITION OF EXTERNAL FLAMES AT 02:32 AM ON THE NORTH ELEVATION TOWER PLAN VIEW.

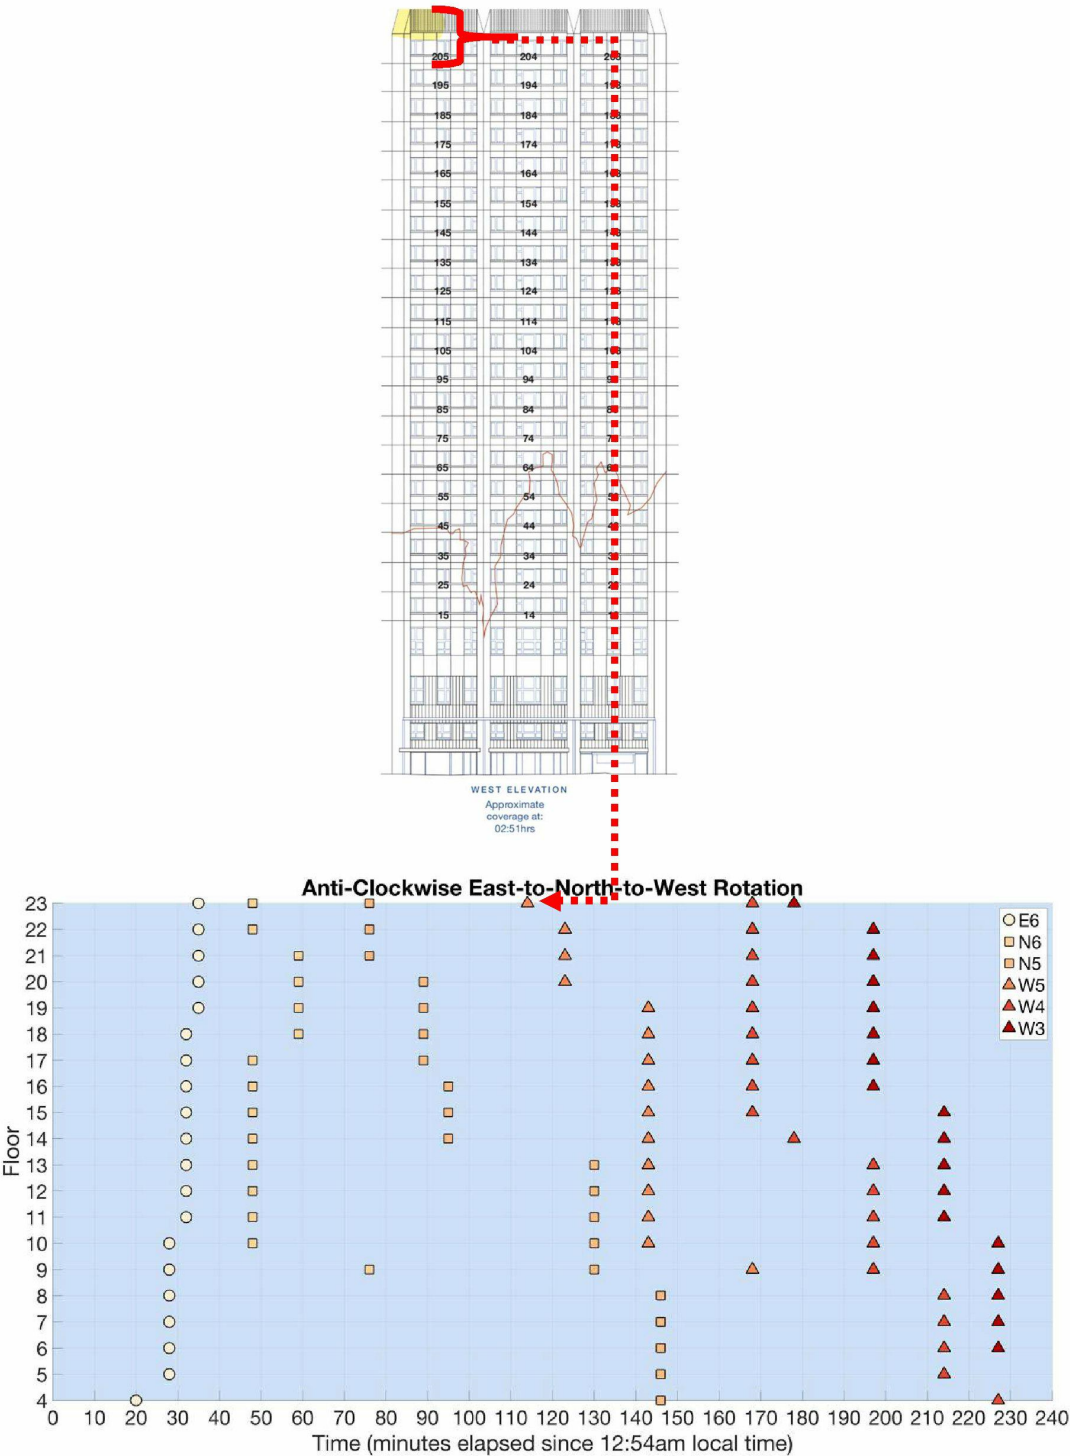
FIGURE 92: TIME HISTORY OF EXTERNAL FLAME SPREAD ON THE EASTERN (E), NORTHERN (N) AND WESTERN (W) FACADES. THE STACK OF FLATS IMPACTED BY THE EXTERNAL FLAME SPREAD ARE INDICATED USING NUMBERS 1-6 APPENDED TO THE FACADE DESCRIPTOR IN THE LEGEND. THE RED ARROW INDICATES THE ESTIMATED POSITION OF EXTERNAL FLAMES AT 02:51 AM ON THE WEST ELEVATION TOWER PLAN VIEW.

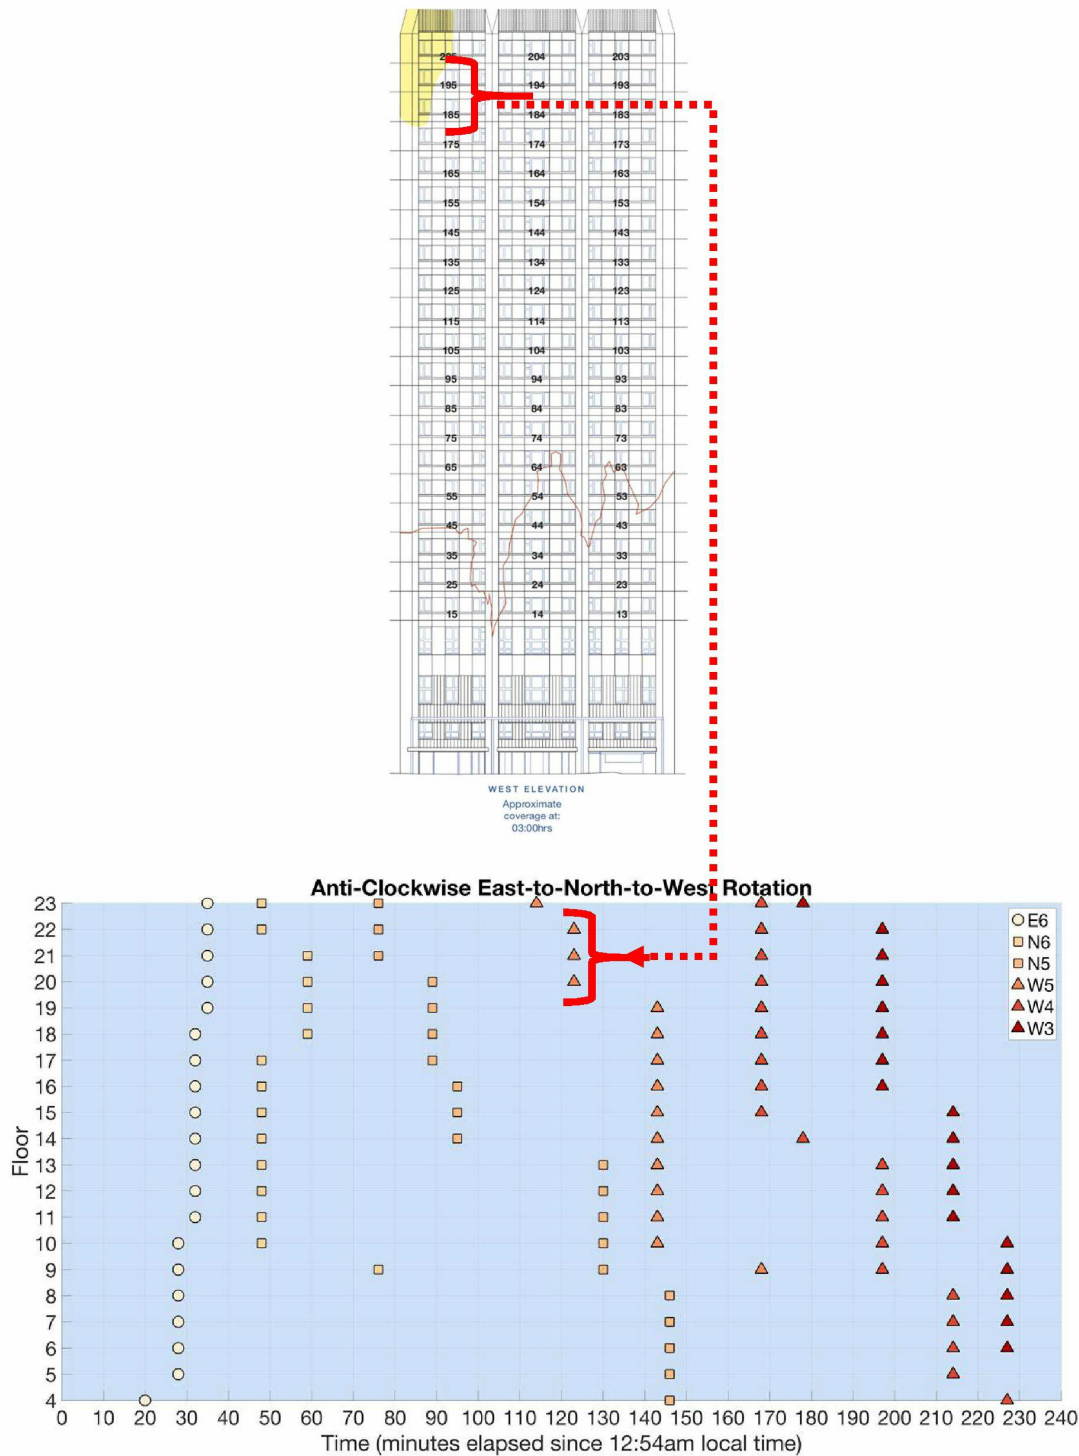
FIGURE 93: TIME HISTORY OF EXTERNAL FLAME SPREAD ON THE EASTERN (E), NORTHERN (N) AND WESTERN (W) FACADES. THE STACK OF FLATS IMPACTED BY THE EXTERNAL FLAME SPREAD ARE INDICATED USING NUMBERS 1-6 APPENDED TO THE FACADE DESCRIPTOR IN THE LEGEND. THE RED ARROW INDICATES THE ESTIMATED POSITION OF EXTERNAL FLAMES AT 02:51 AM ON THE WEST ELEVATION TOWER PLAN VIEW.

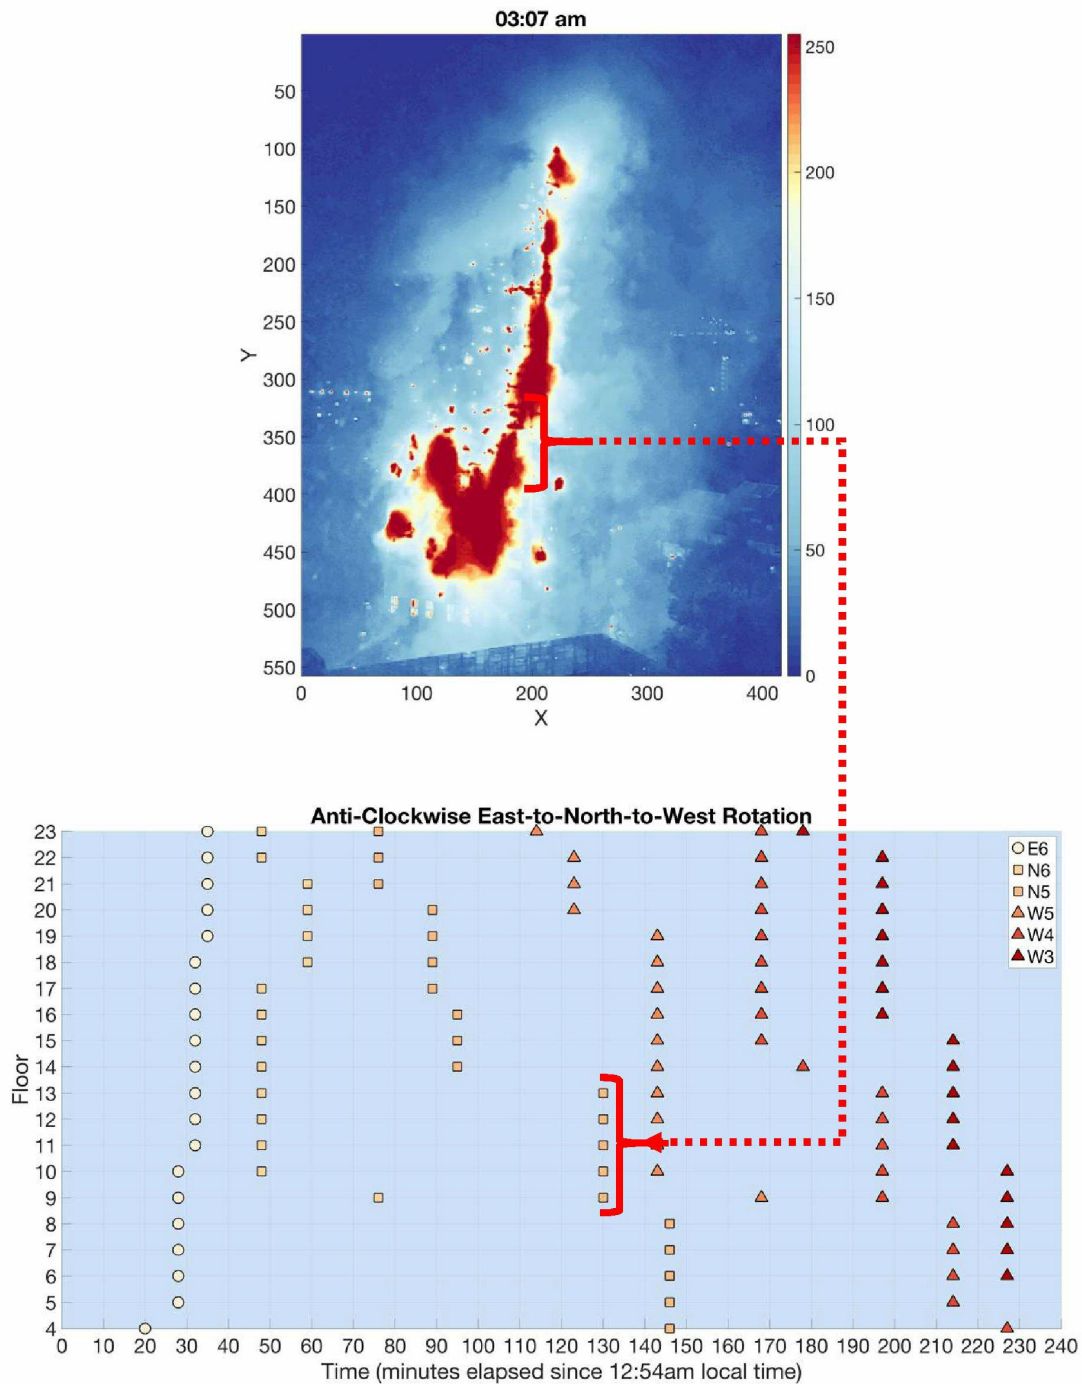
FIGURE 94: TIME HISTORY OF EXTERNAL FLAME SPREAD ON THE EASTERN (E), NORTHERN (N) AND WESTERN (W) FACADES. THE STACK OF FLATS IMPACTED BY THE EXTERNAL FLAME SPREAD ARE INDICATED USING NUMBERS 1-6 APPENDED TO THE FACADE DESCRIPTOR IN THE LEGEND. THE RED ARROW INDICATES THE ESTIMATED POSITION OF EXTERNAL FLAMES AT 03:07 AM ON THE NORTH ELEVATION PROCESSED IMAGE (FIGURE 5H).

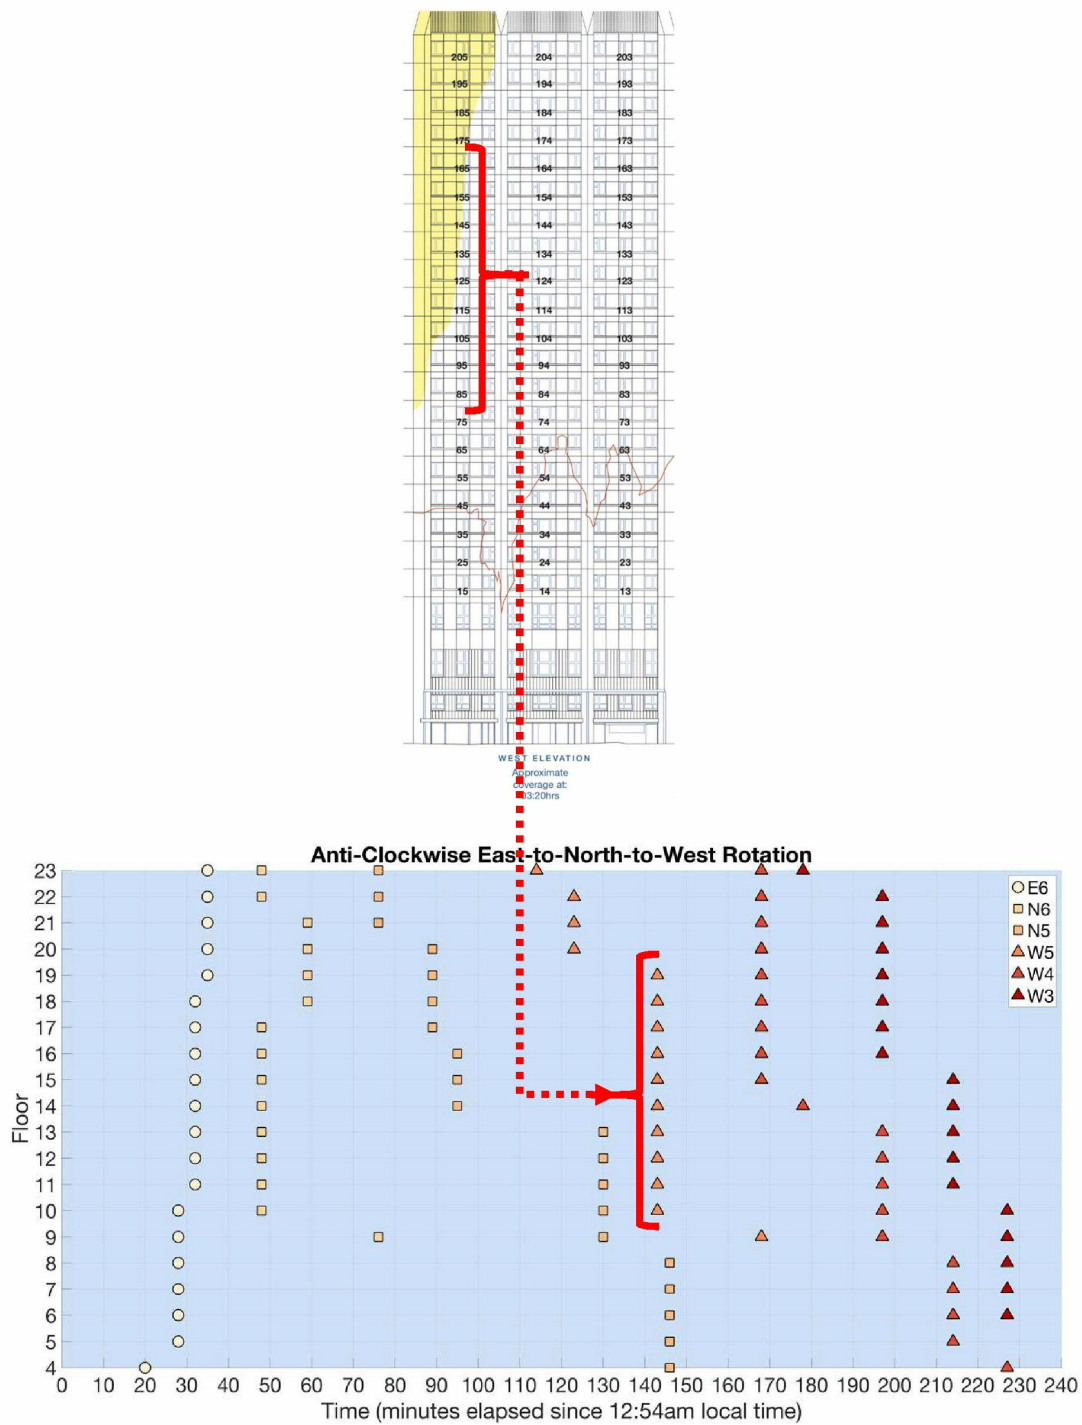
FIGURE 95: TIME HISTORY OF EXTERNAL FLAME SPREAD ON THE EASTERN (E), NORTHERN (N) AND WESTERN (W) FACADES. THE STACK OF FLATS IMPACTED BY THE EXTERNAL FLAME SPREAD ARE INDICATED USING NUMBERS 1-6 APPENDED TO THE FACADE DESCRIPTOR IN THE LEGEND. THE RED ARROW INDICATES THE ESTIMATED POSITION OF EXTERNAL FLAMES AT 03:20 AM ON THE WEST ELEVATION TOWER PLAN VIEW.

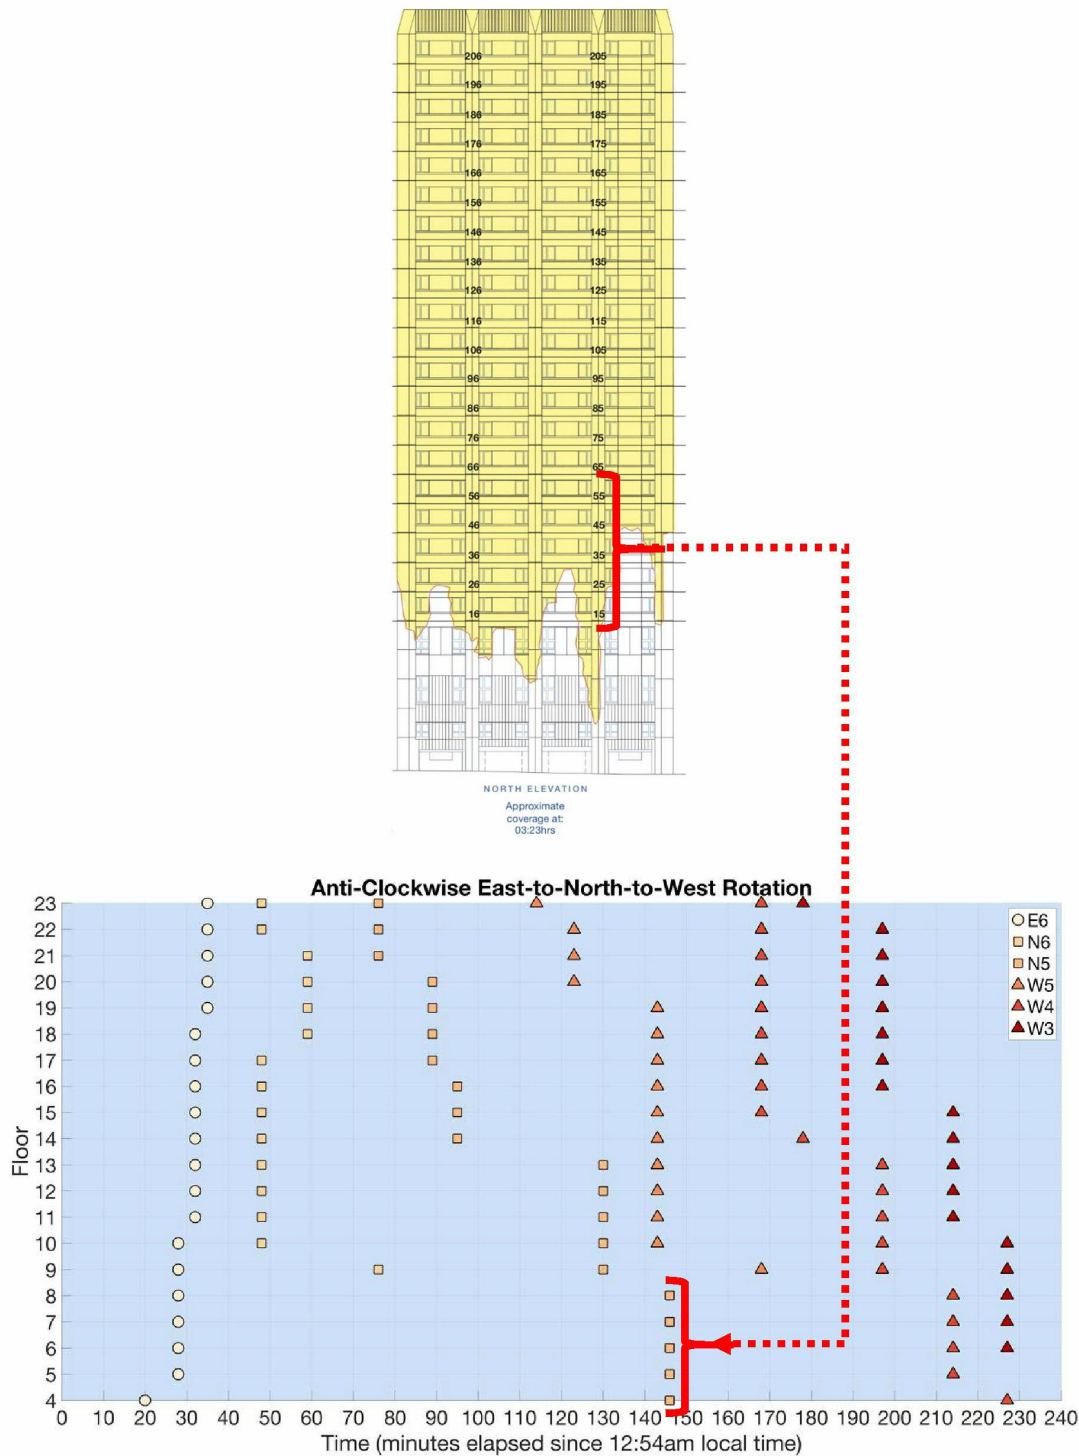
FIGURE 96: TIME HISTORY OF EXTERNAL FLAME SPREAD ON THE EASTERN (E), NORTHERN (N) AND WESTERN (W) FACADES. THE STACK OF FLATS IMPACTED BY THE EXTERNAL FLAME SPREAD ARE INDICATED USING NUMBERS 1-6 APPENDED TO THE FACADE DESCRIPTOR IN THE LEGEND. THE RED ARROW INDICATES THE ESTIMATED POSITION OF EXTERNAL FLAMES AT 03:23 AM ON THE NORTH ELEVATION TOWER PLAN VIEW.

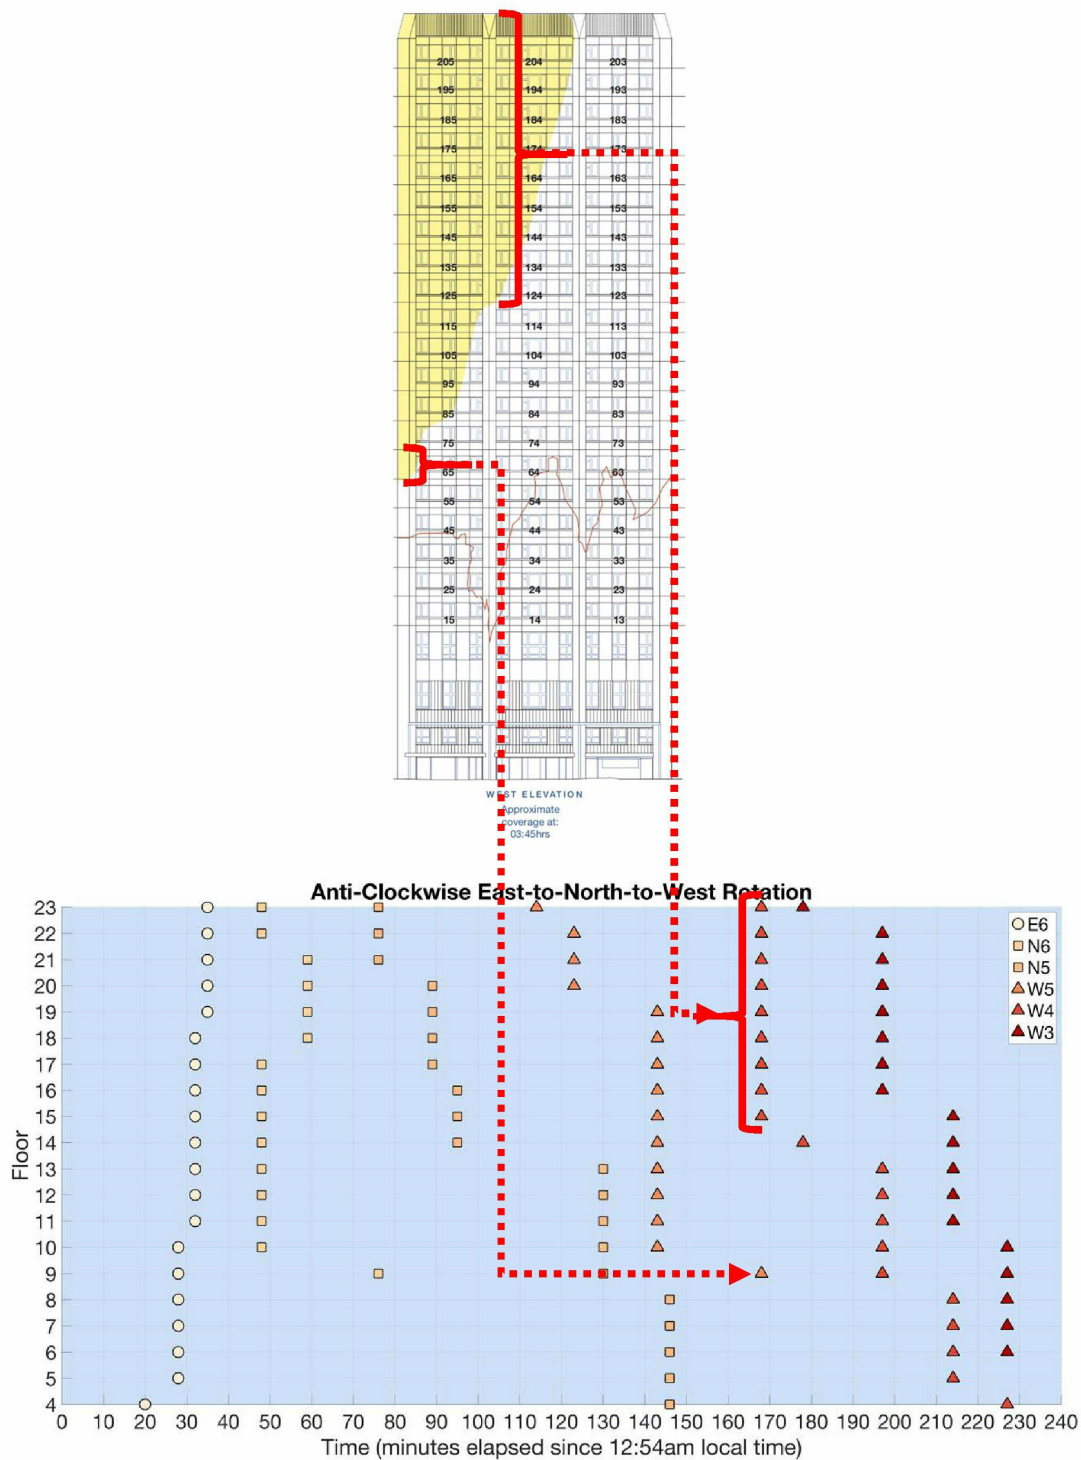
FIGURE 97: TIME HISTORY OF EXTERNAL FLAME SPREAD ON THE EASTERN (E), NORTHERN (N) AND WESTERN (W) FACADES. THE STACK OF FLATS IMPACTED BY THE EXTERNAL FLAME SPREAD ARE INDICATED USING NUMBERS 1-6 APPENDED TO THE FACADE DESCRIPTOR IN THE LEGEND. THE RED ARROWS INDICATE THE ESTIMATED POSITION OF EXTERNAL FLAMES AT 03:45 AM ON THE WEST ELEVATION TOWER PLAN VIEW.

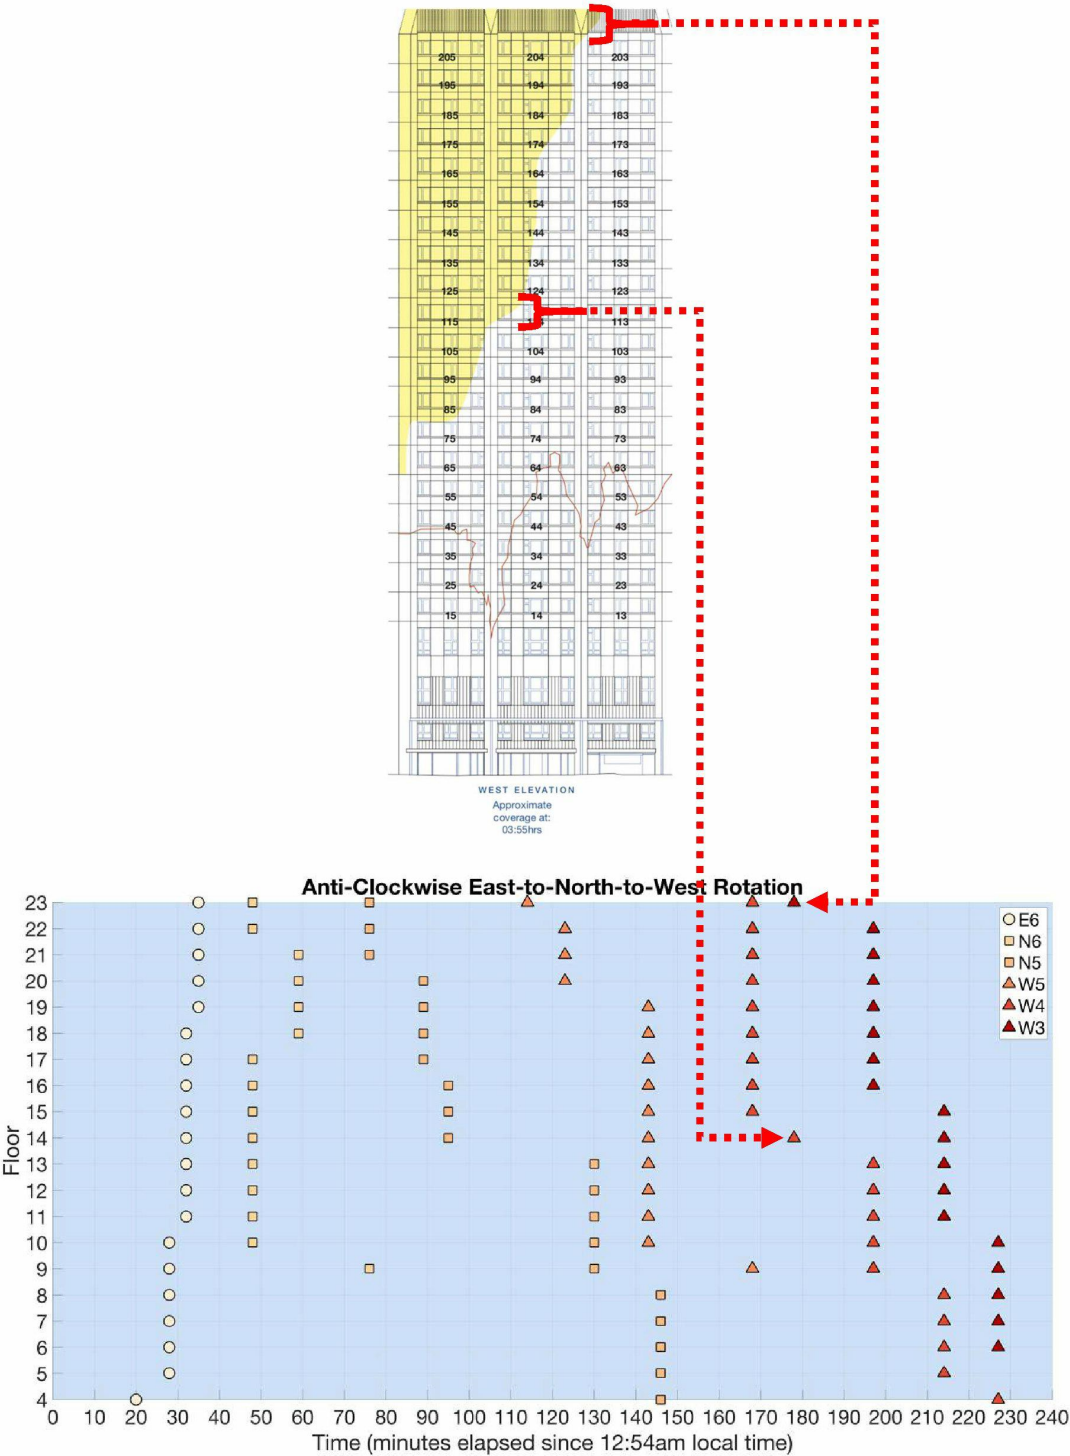
FIGURE 98: TIME HISTORY OF EXTERNAL FLAME SPREAD ON THE EASTERN (E), NORTHERN (N) AND WESTERN (W) FACADES. THE STACK OF FLATS IMPACTED BY THE EXTERNAL FLAME SPREAD ARE INDICATED USING NUMBERS 1-6 APPENDED TO THE FACADE DESCRIPTOR IN THE LEGEND. THE RED ARROWS INDICATE THE ESTIMATED POSITION OF EXTERNAL FLAMES AT 03:55 AM ON THE WEST ELEVATION TOWER PLAN VIEW.

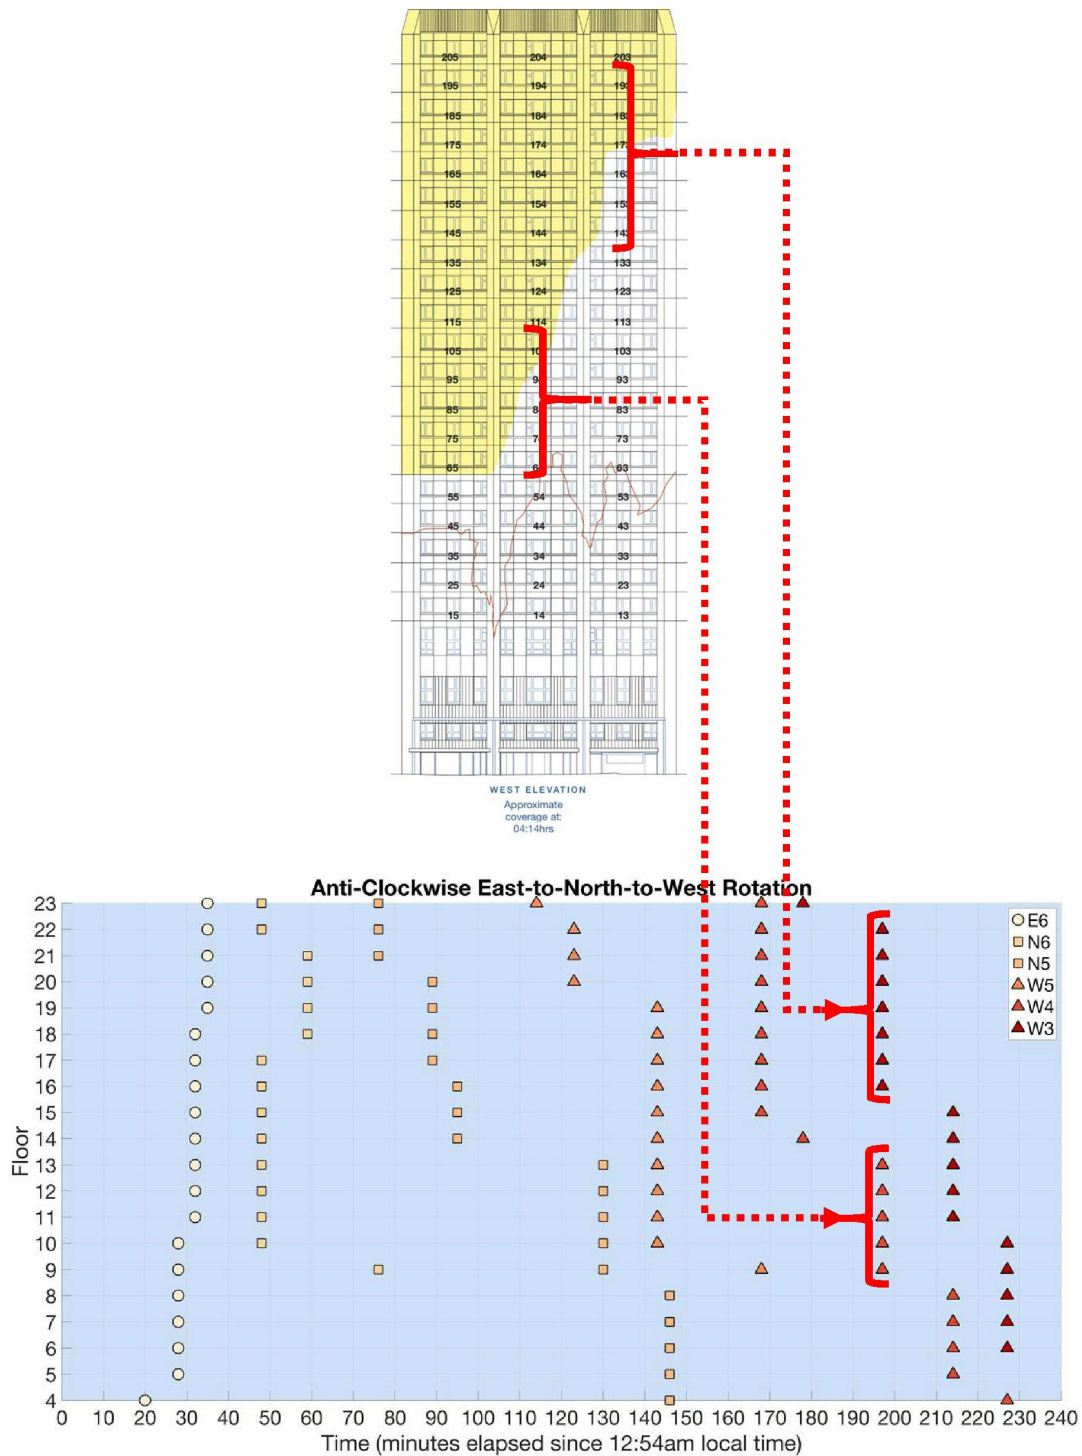
FIGURE 99: TIME HISTORY OF EXTERNAL FLAME SPREAD ON THE EASTERN (E), NORTHERN (N) AND WESTERN (W) FACADES. THE STACK OF FLATS IMPACTED BY THE EXTERNAL FLAME SPREAD ARE INDICATED USING NUMBERS 1-6 APPENDED TO THE FACADE DESCRIPTOR IN THE LEGEND. THE RED ARROWS INDICATE THE ESTIMATED POSITION OF EXTERNAL FLAMES AT 04:14 AM ON THE WEST ELEVATION TOWER PLAN VIEW.

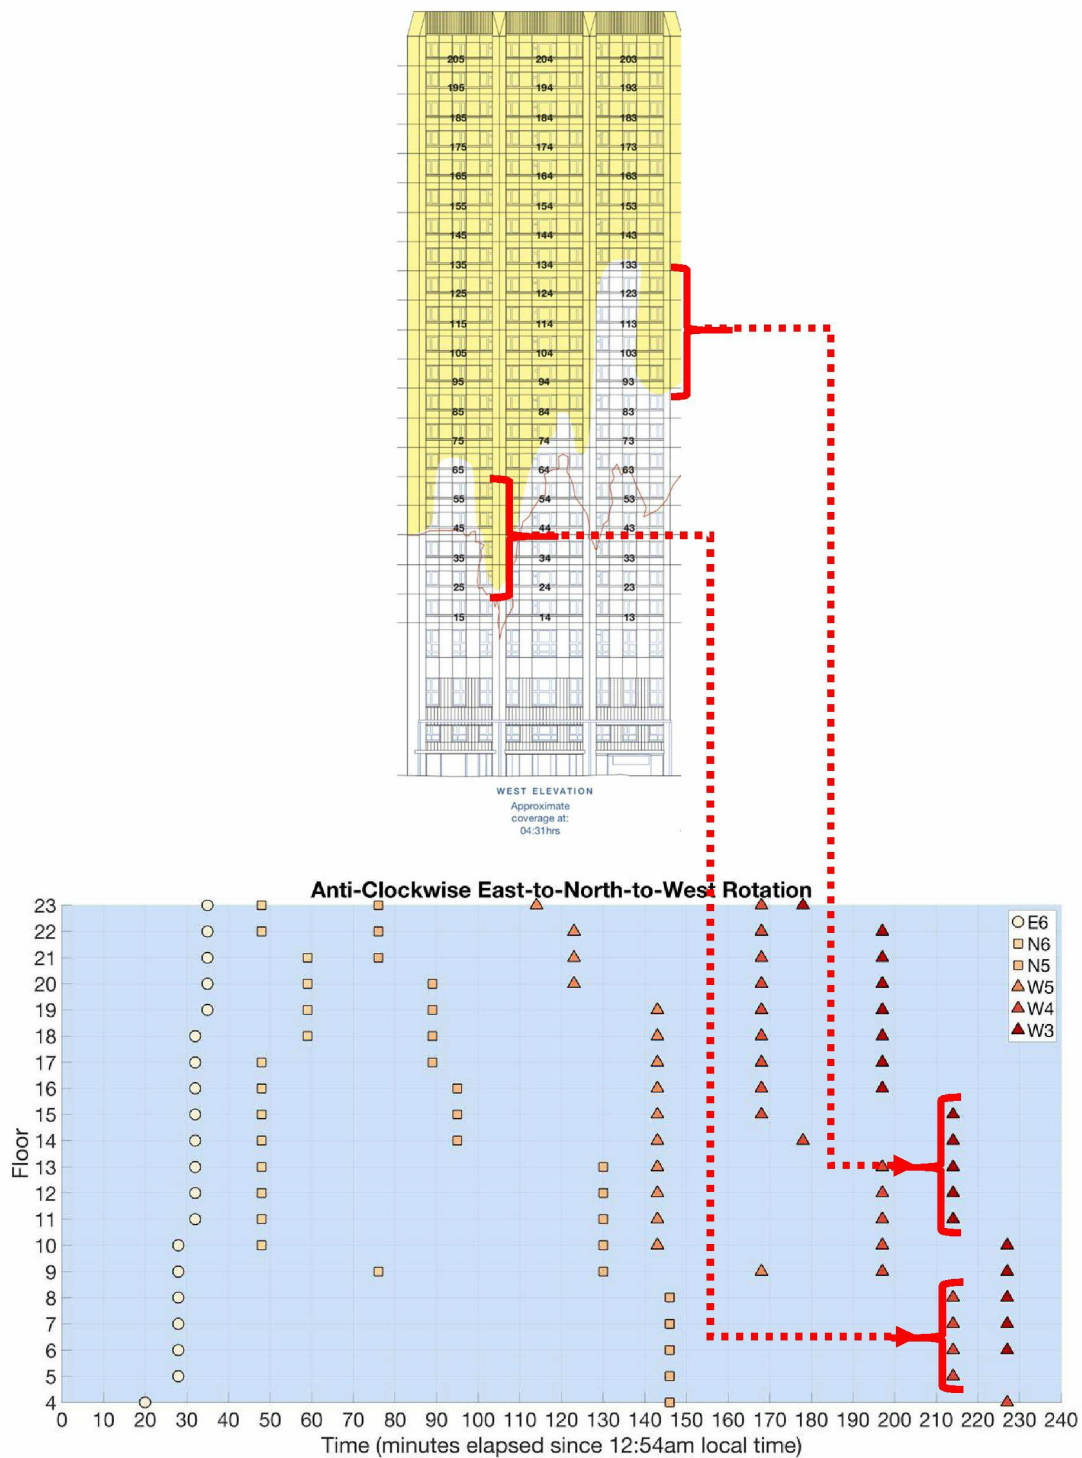
FIGURE 100: TIME HISTORY OF EXTERNAL FLAME SPREAD ON THE EASTERN (E), NORTHERN (N) AND WESTERN (W) FACADES. THE STACK OF FLATS IMPACTED BY THE EXTERNAL FLAME SPREAD ARE INDICATED USING NUMBERS 1-6 APPENDED TO THE FACADE DESCRIPTOR IN THE LEGEND. THE RED ARROWS INDICATE THE ESTIMATED POSITION OF EXTERNAL FLAMES AT 04:31 AM ON THE WEST ELEVATION TOWER PLAN VIEW.

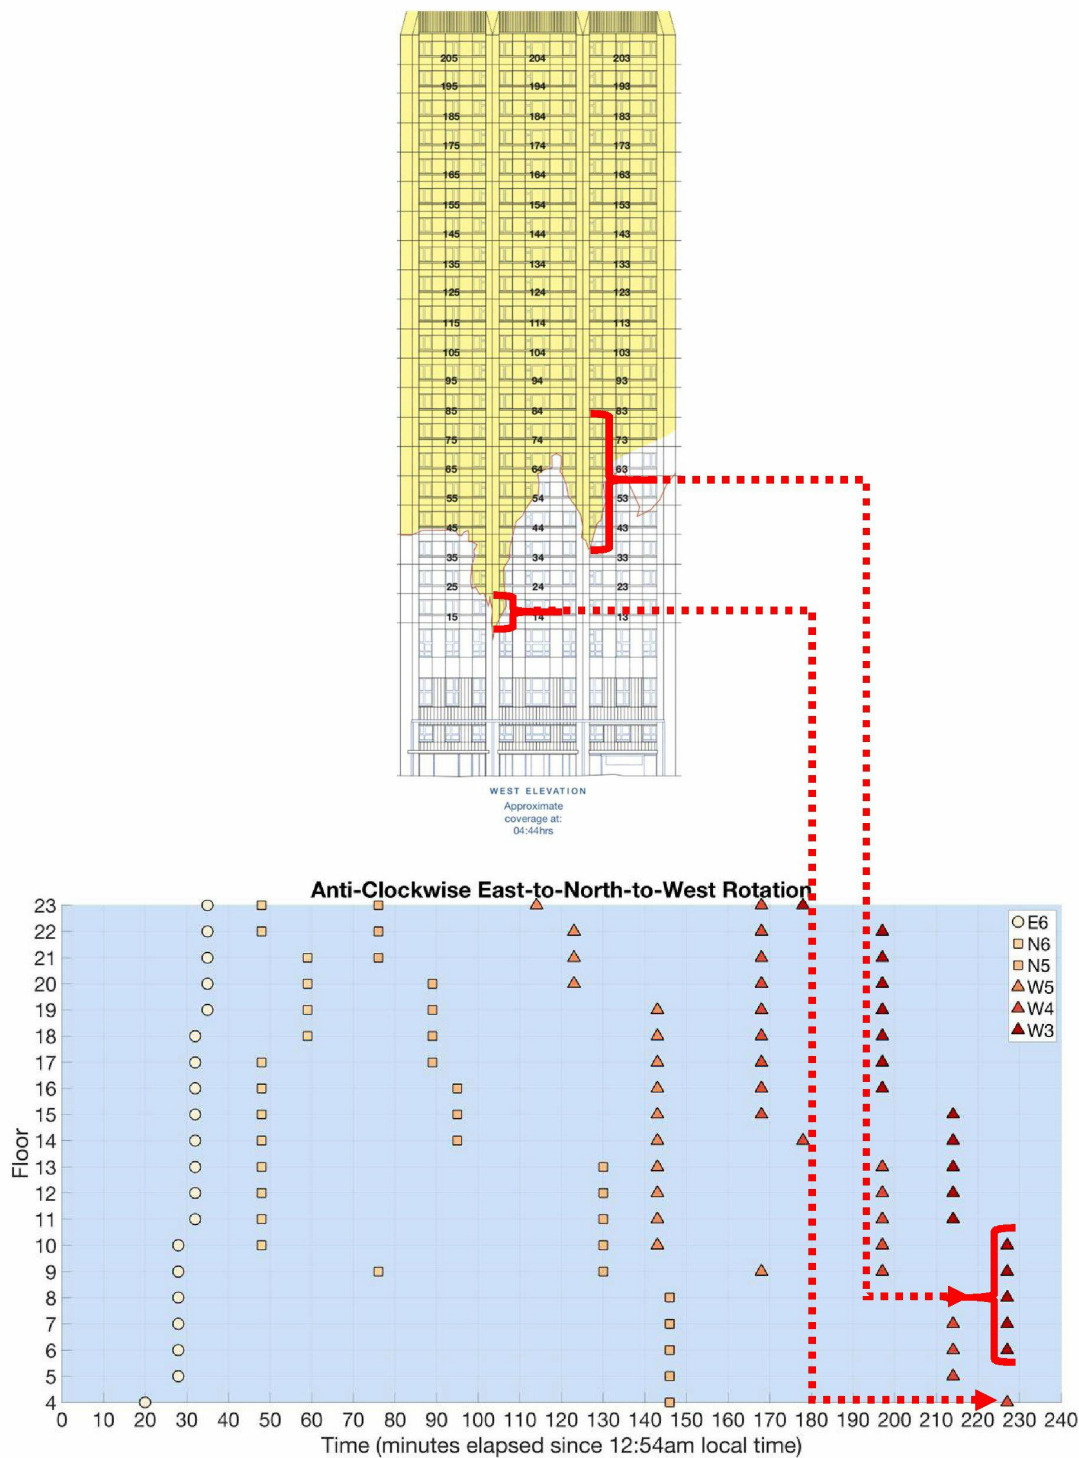
FIGURE 101: TIME HISTORY OF EXTERNAL FLAME SPREAD ON THE EASTERN (E), NORTHERN (N) AND WESTERN (W) FACADES. THE STACK OF FLATS IMPACTED BY THE EXTERNAL FLAME SPREAD ARE INDICATED USING NUMBERS 1-6 APPENDED TO THE FACADE DESCRIPTOR IN THE LEGEND. THE RED ARROWS INDICATE THE ESTIMATED POSITION OF EXTERNAL FLAMES AT 04:44 AM ON THE WEST ELEVATION TOWER PLAN VIEW.

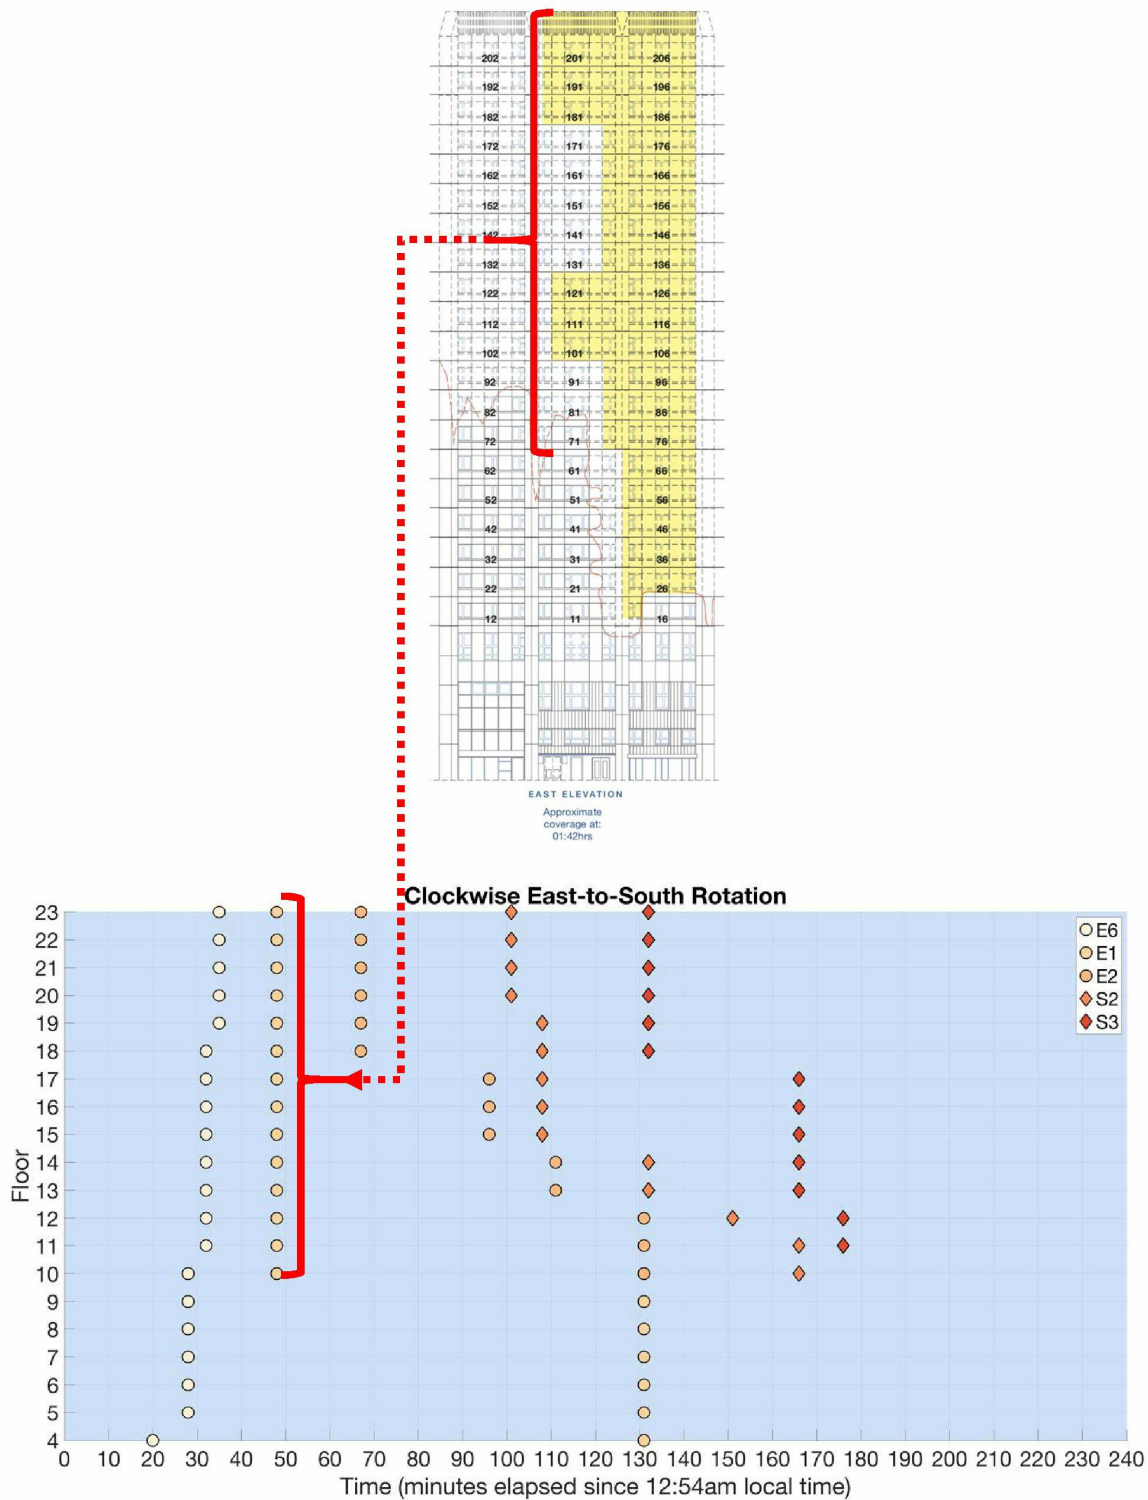
FIGURE 102: TIME HISTORY OF EXTERNAL FLAME SPREAD ON THE EASTERN (E) AND SOUTHERN (S) FACADES. THE STACK OF FLATS IMPACTED BY THE EXTERNAL FLAME SPREAD ARE INDICATED USING NUMBERS 1-6 APPENDED TO THE FACADE DESCRIPTOR IN THE LEGEND. THE RED ARROW INDICATES THE ESTIMATED POSITION OF EXTERNAL FLAMES AT 01:42 AM ON THE EAST ELEVATION TOWER PLAN VIEW.

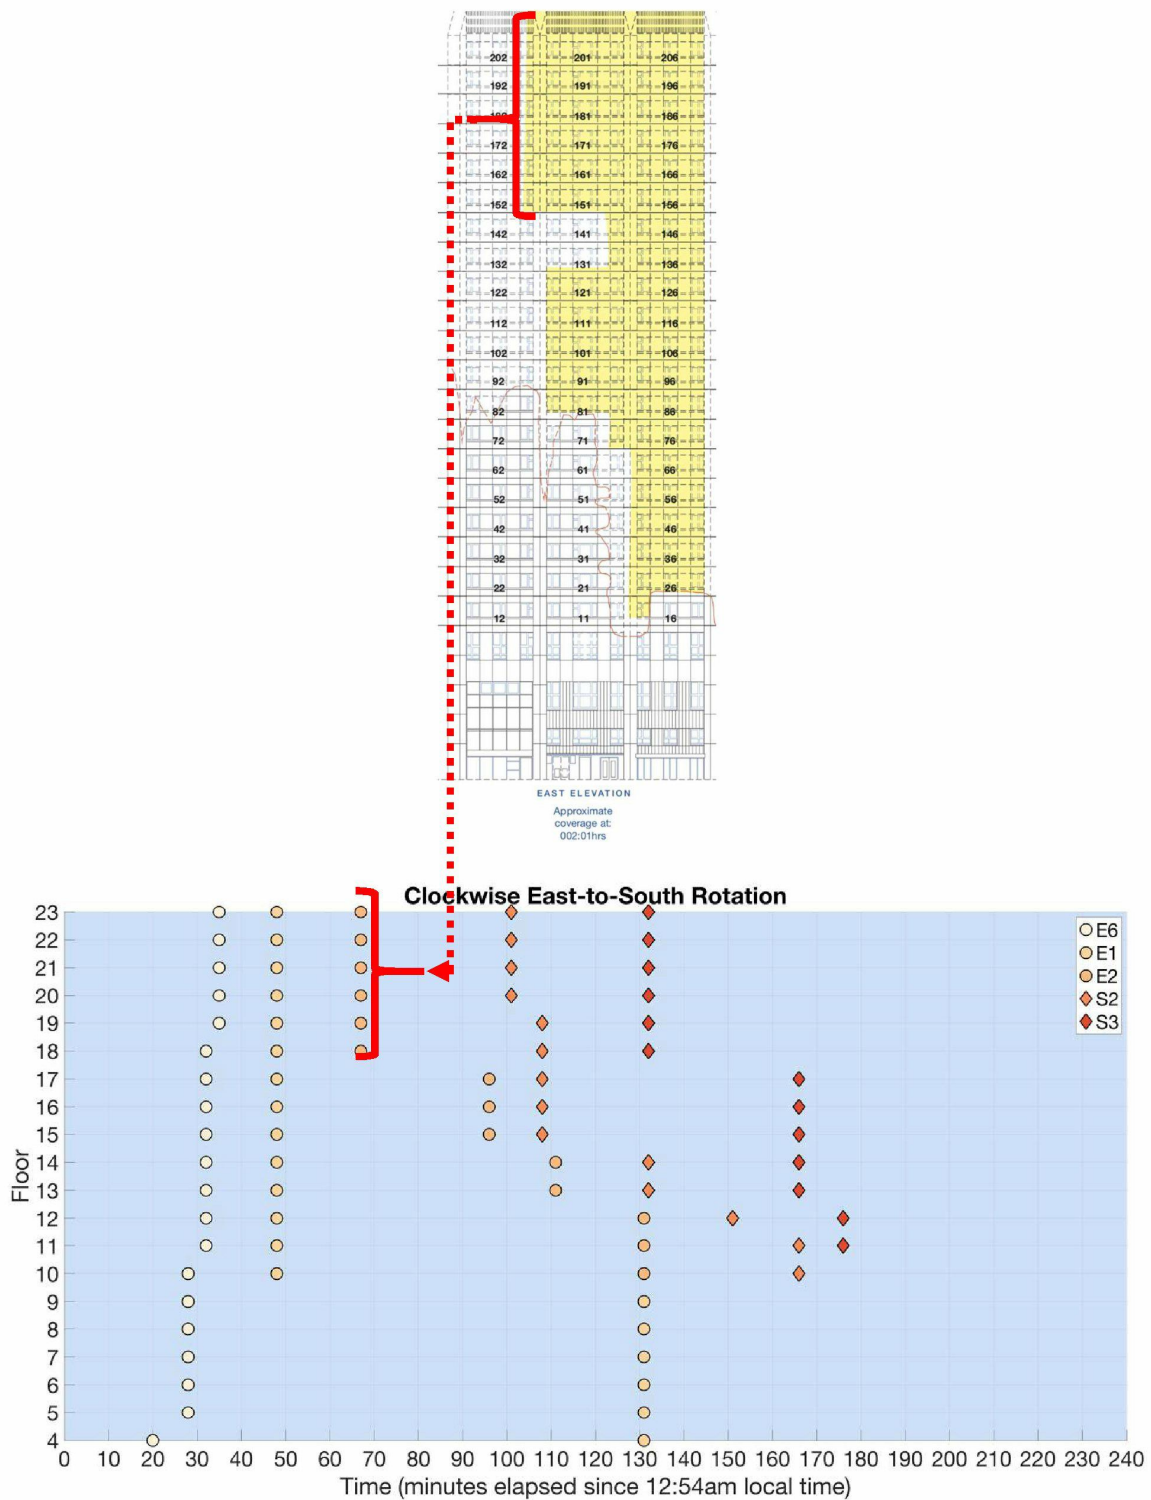
FIGURE 103: TIME HISTORY OF EXTERNAL FLAME SPREAD ON THE EASTERN (E) AND SOUTHERN (S) FACADES. THE STACK OF FLATS IMPACTED BY THE EXTERNAL FLAME SPREAD ARE INDICATED USING NUMBERS 1-6 APPENDED TO THE FACADE DESCRIPTOR IN THE LEGEND. THE RED ARROW INDICATES THE ESTIMATED POSITION OF EXTERNAL FLAMES AT 02:01 AM ON THE EAST ELEVATION TOWER PLAN VIEW.
