GRENFELL TOWER: PHASE 1 REPORT

Prof. José L. Torero CEng, RPEQ, FREng, FRSE, FTSE, FIFE, FSFPE, FICE, FCI

23rd May 2018

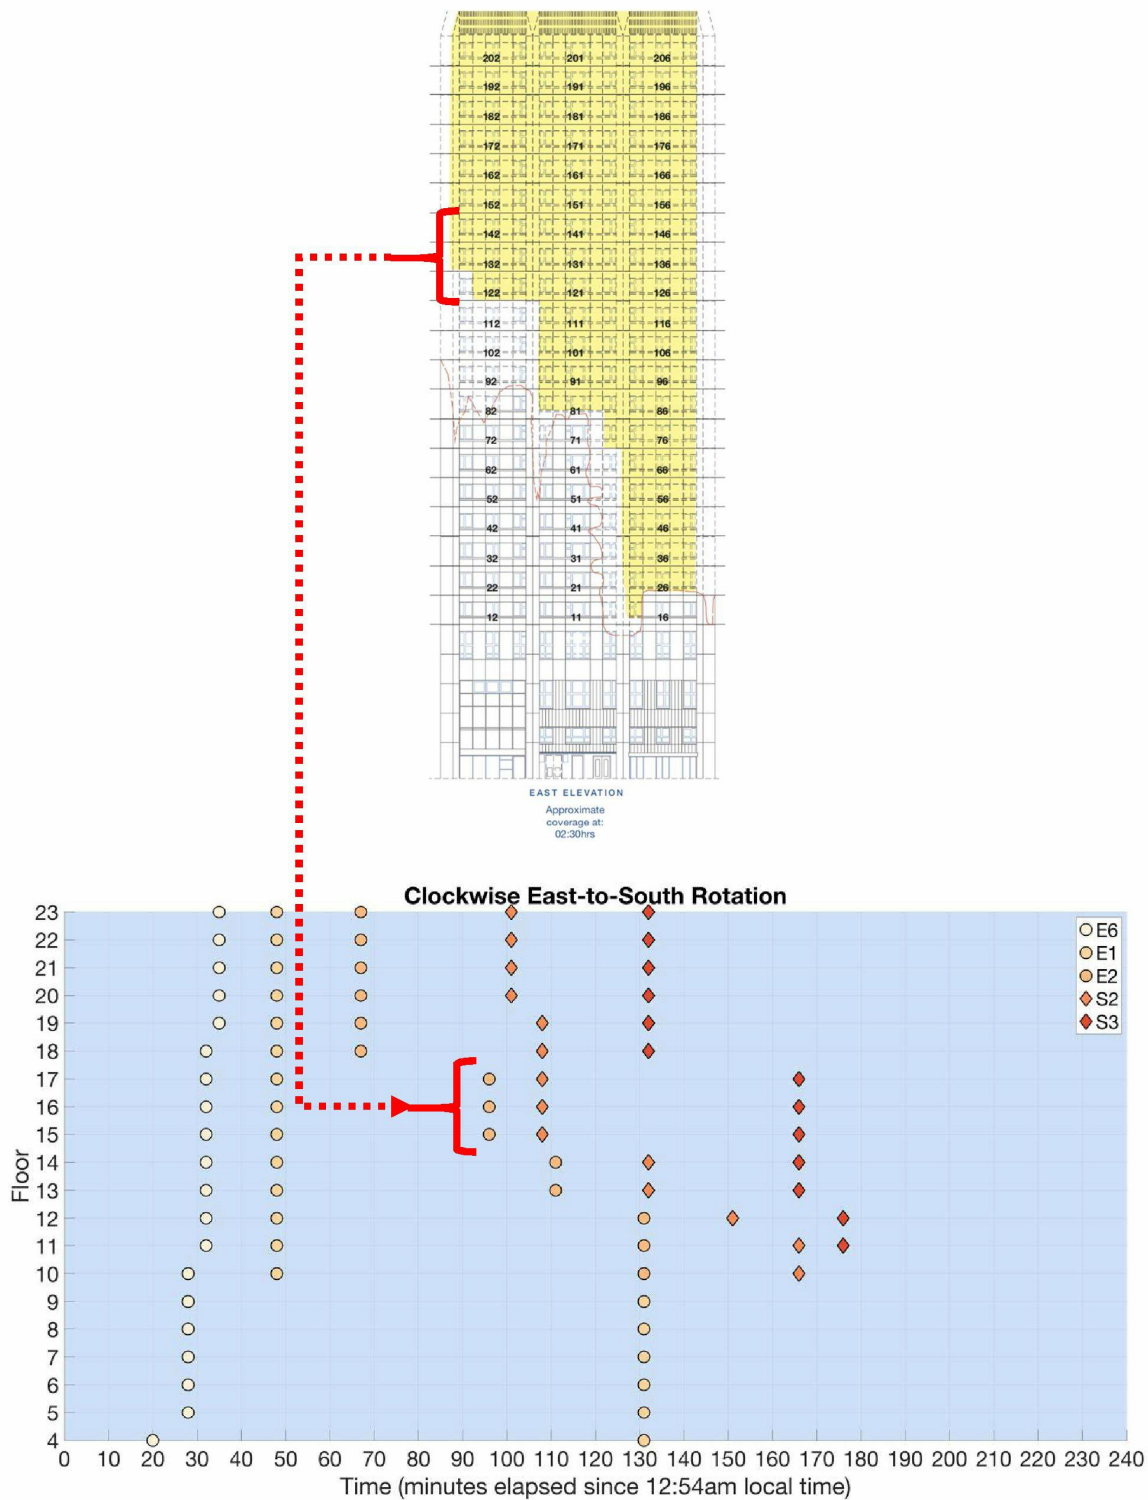
FIGURE 104: TIME HISTORY OF EXTERNAL FLAME SPREAD ON THE EASTERN (E) AND SOUTHERN (S) FACADES. THE STACK OF FLATS IMPACTED BY THE EXTERNAL FLAME SPREAD ARE INDICATED USING NUMBERS 1-6 APPENDED TO THE FACADE DESCRIPTOR IN THE LEGEND. THE RED ARROW INDICATES THE ESTIMATED POSITION OF EXTERNAL FLAMES AT 02:30 AM ON THE EAST ELEVATION TOWER PLAN VIEW.

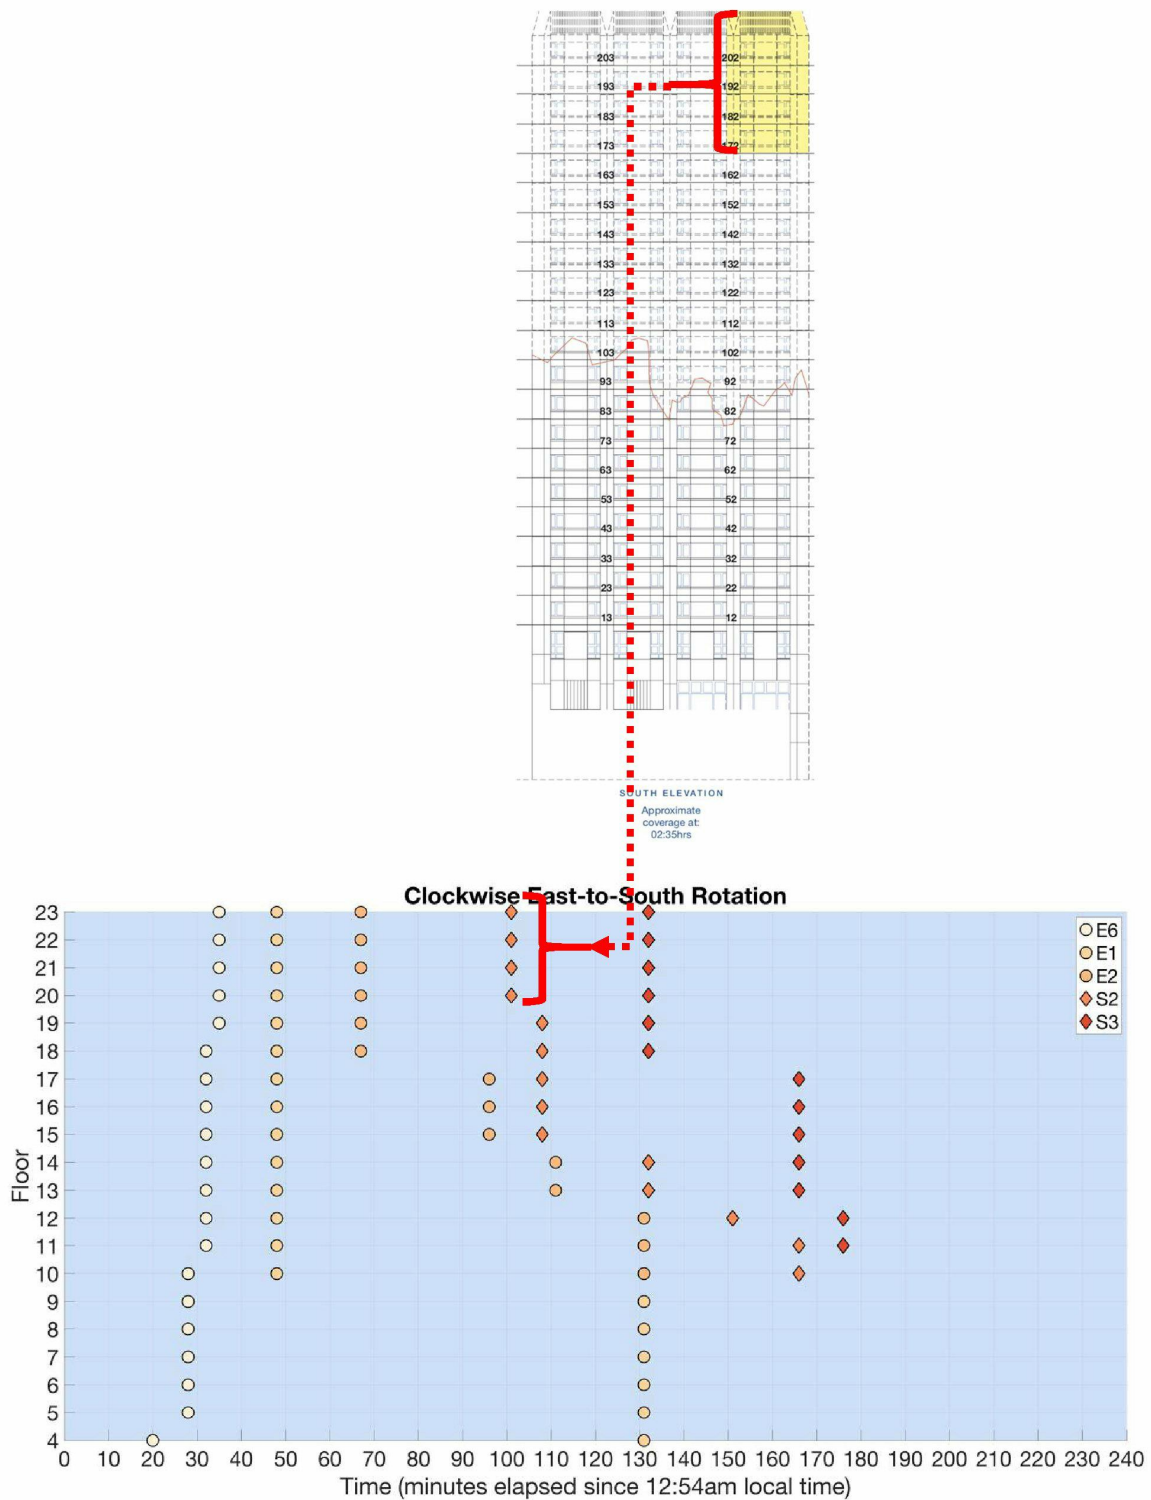
FIGURE 105: TIME HISTORY OF EXTERNAL FLAME SPREAD ON THE EASTERN (E) AND SOUTHERN (S) FACADES. THE STACK OF FLATS IMPACTED BY THE EXTERNAL FLAME SPREAD ARE INDICATED USING NUMBERS 1-6 APPENDED TO THE FACADE DESCRIPTOR IN THE LEGEND. THE RED ARROW INDICATES THE ESTIMATED POSITION OF EXTERNAL FLAMES AT 02:35 AM ON THE SOUTH ELEVATION TOWER PLAN VIEW.

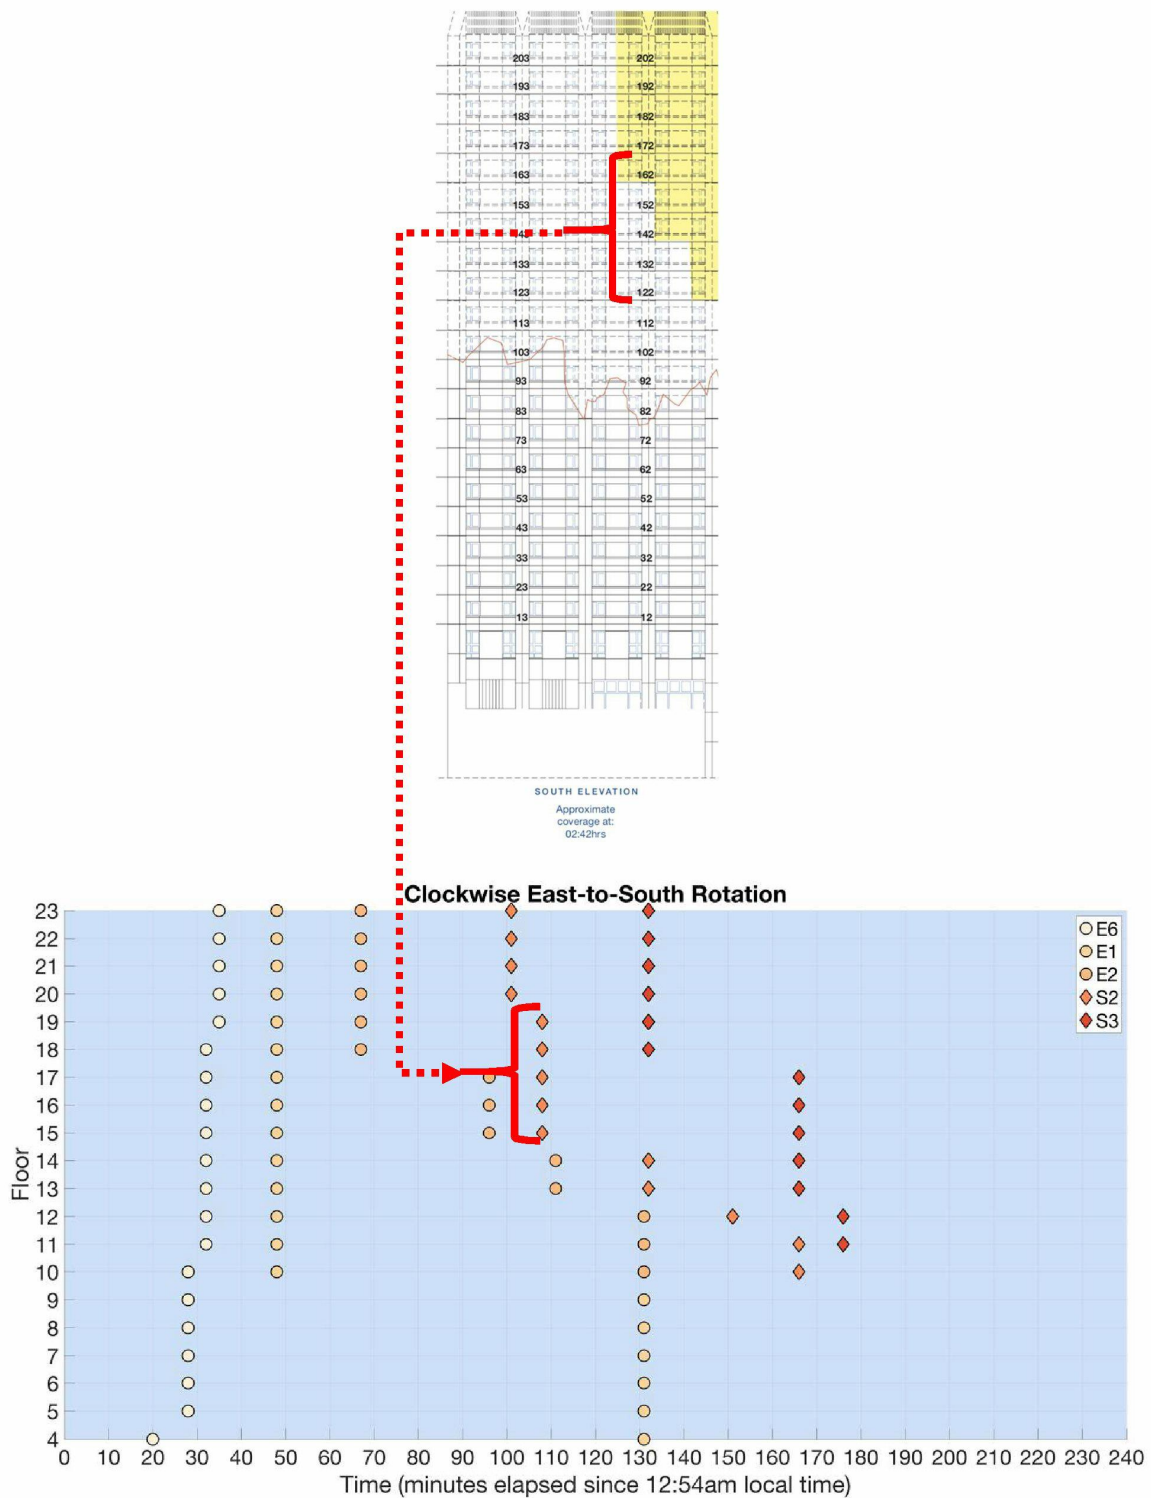
FIGURE 106: TIME HISTORY OF EXTERNAL FLAME SPREAD ON THE EASTERN (E) AND SOUTHERN (S) FACADES. THE STACK OF FLATS IMPACTED BY THE EXTERNAL FLAME SPREAD ARE INDICATED USING NUMBERS 1-6 APPENDED TO THE FACADE DESCRIPTOR IN THE LEGEND. THE RED ARROW INDICATES THE ESTIMATED POSITION OF EXTERNAL FLAMES AT 02:42 AM ON THE SOUTH ELEVATION TOWER PLAN VIEW.

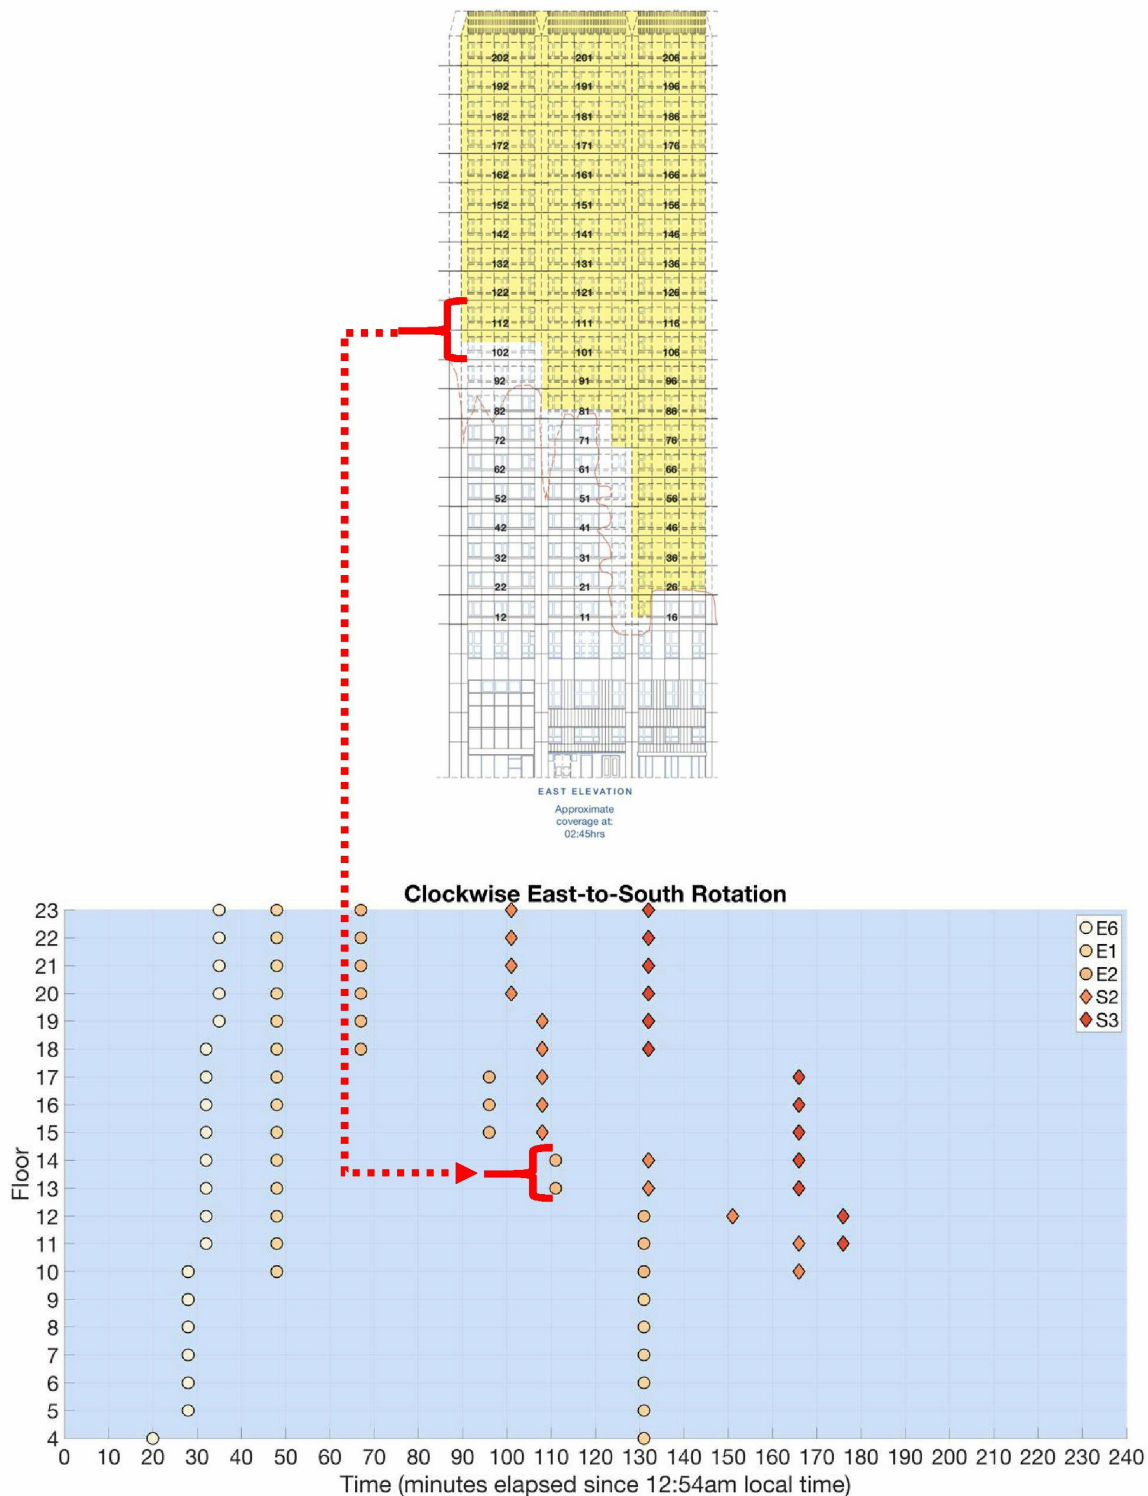
FIGURE 107: TIME HISTORY OF EXTERNAL FLAME SPREAD ON THE EASTERN (E) AND SOUTHERN (S) FACADES. THE STACK OF FLATS IMPACTED BY THE EXTERNAL FLAME SPREAD ARE INDICATED USING NUMBERS 1-6 APPENDED TO THE FACADE DESCRIPTOR IN THE LEGEND. THE RED ARROW INDICATES THE ESTIMATED POSITION OF EXTERNAL FLAMES AT 02:45 AM ON THE EAST ELEVATION TOWER PLAN VIEW.

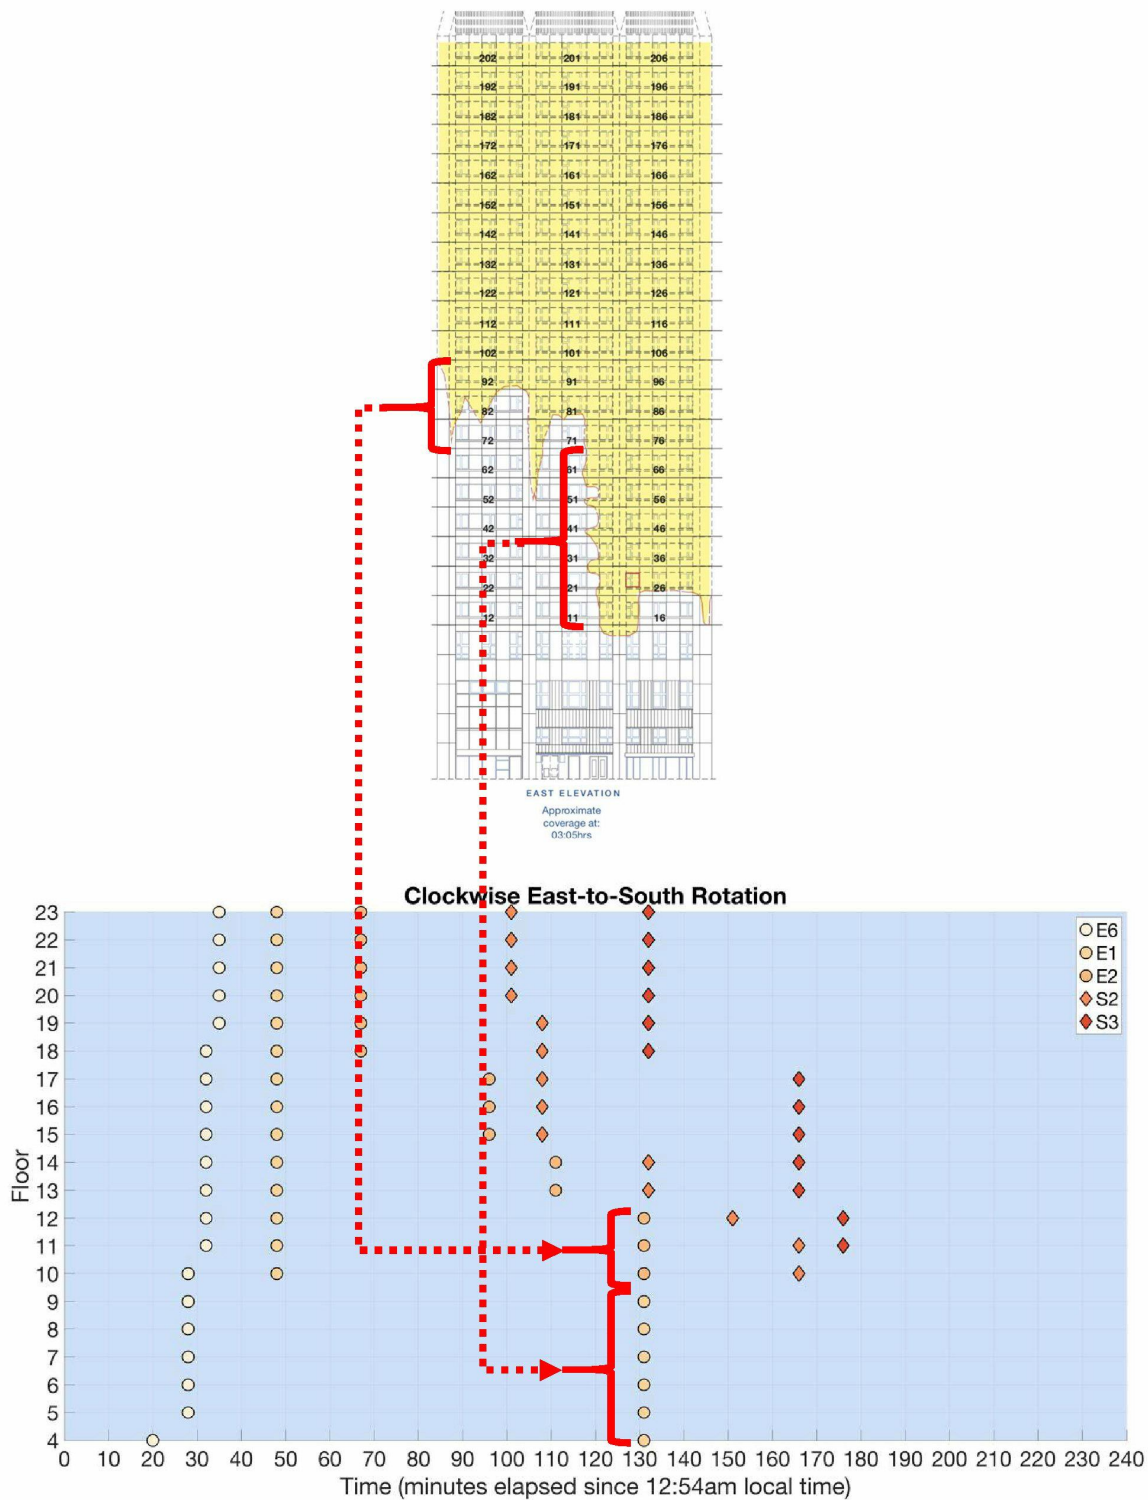
FIGURE 108: TIME HISTORY OF EXTERNAL FLAME SPREAD ON THE EASTERN (E) AND SOUTHERN (S) FACADES. THE STACK OF FLATS IMPACTED BY THE EXTERNAL FLAME SPREAD ARE INDICATED USING NUMBERS 1-6 APPENDED TO THE FACADE DESCRIPTOR IN THE LEGEND. THE RED ARROWS INDICATE THE ESTIMATED POSITION OF EXTERNAL FLAMES AT 03:05 AM ON THE EAST ELEVATION TOWER PLAN VIEW.

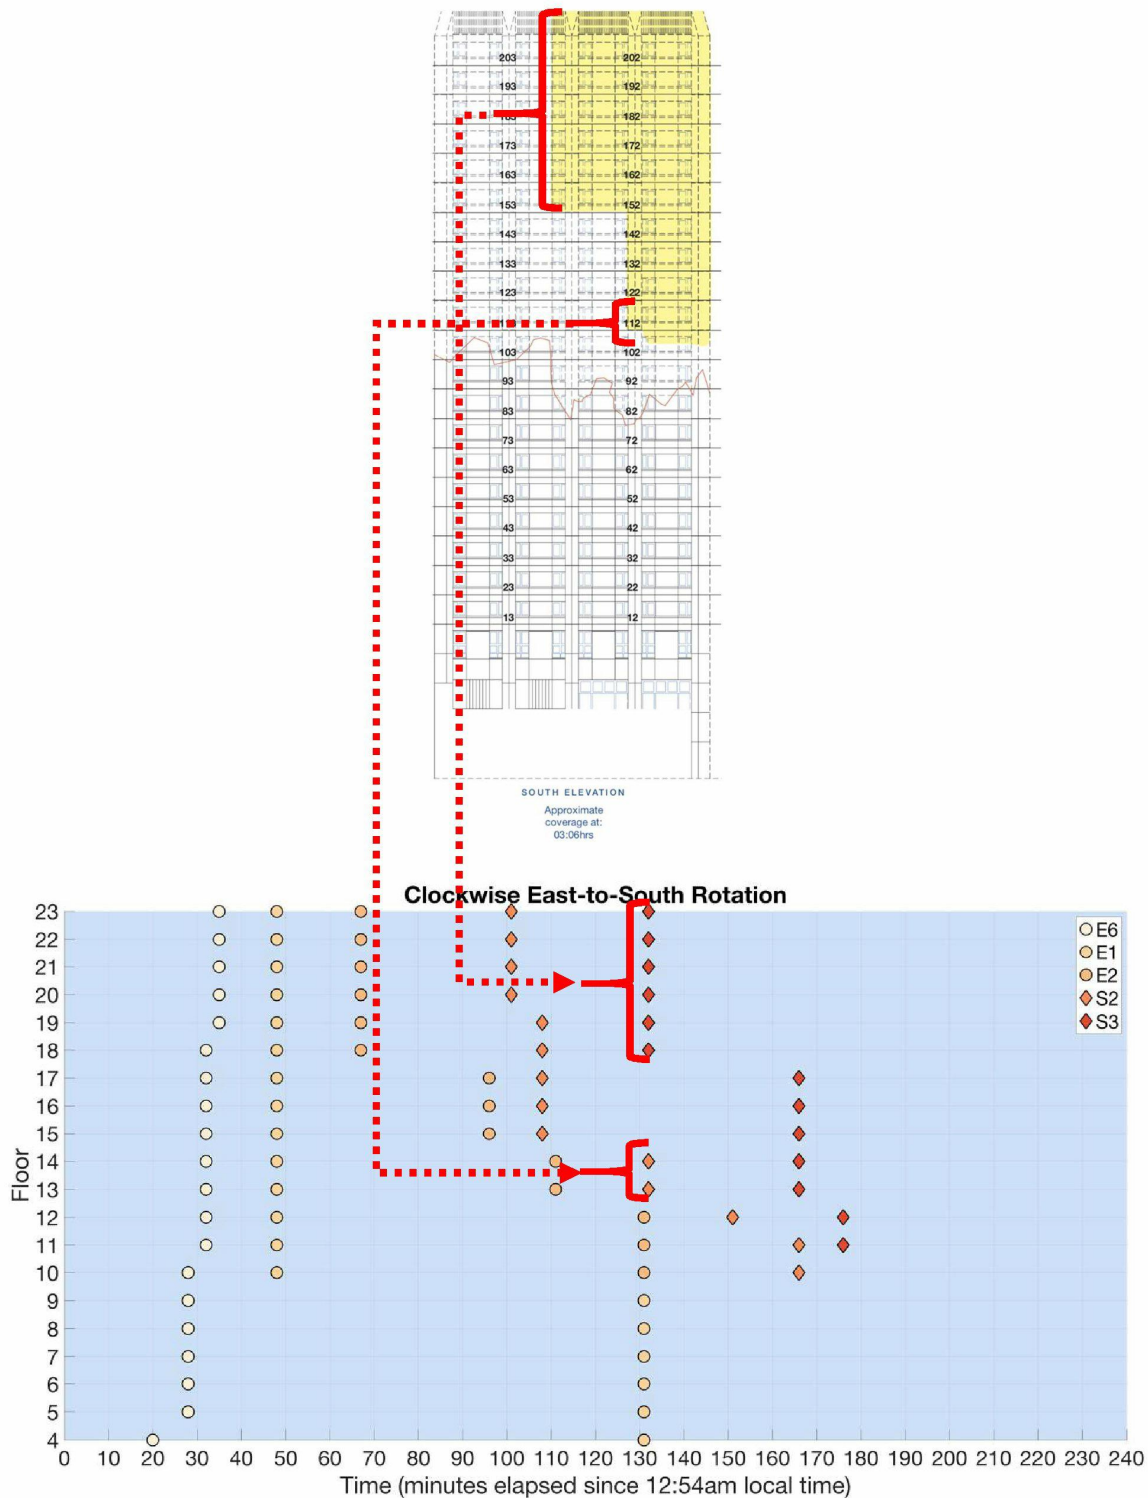
FIGURE 109: TIME HISTORY OF EXTERNAL FLAME SPREAD ON THE EASTERN (E) AND SOUTHERN (S) FACADES. THE STACK OF FLATS IMPACTED BY THE EXTERNAL FLAME SPREAD ARE INDICATED USING NUMBERS 1-6 APPENDED TO THE FACADE DESCRIPTOR IN THE LEGEND. THE RED ARROWS INDICATE THE ESTIMATED POSITION OF EXTERNAL FLAMES AT 03:06 AM ON THE SOUTH ELEVATION TOWER PLAN VIEW.

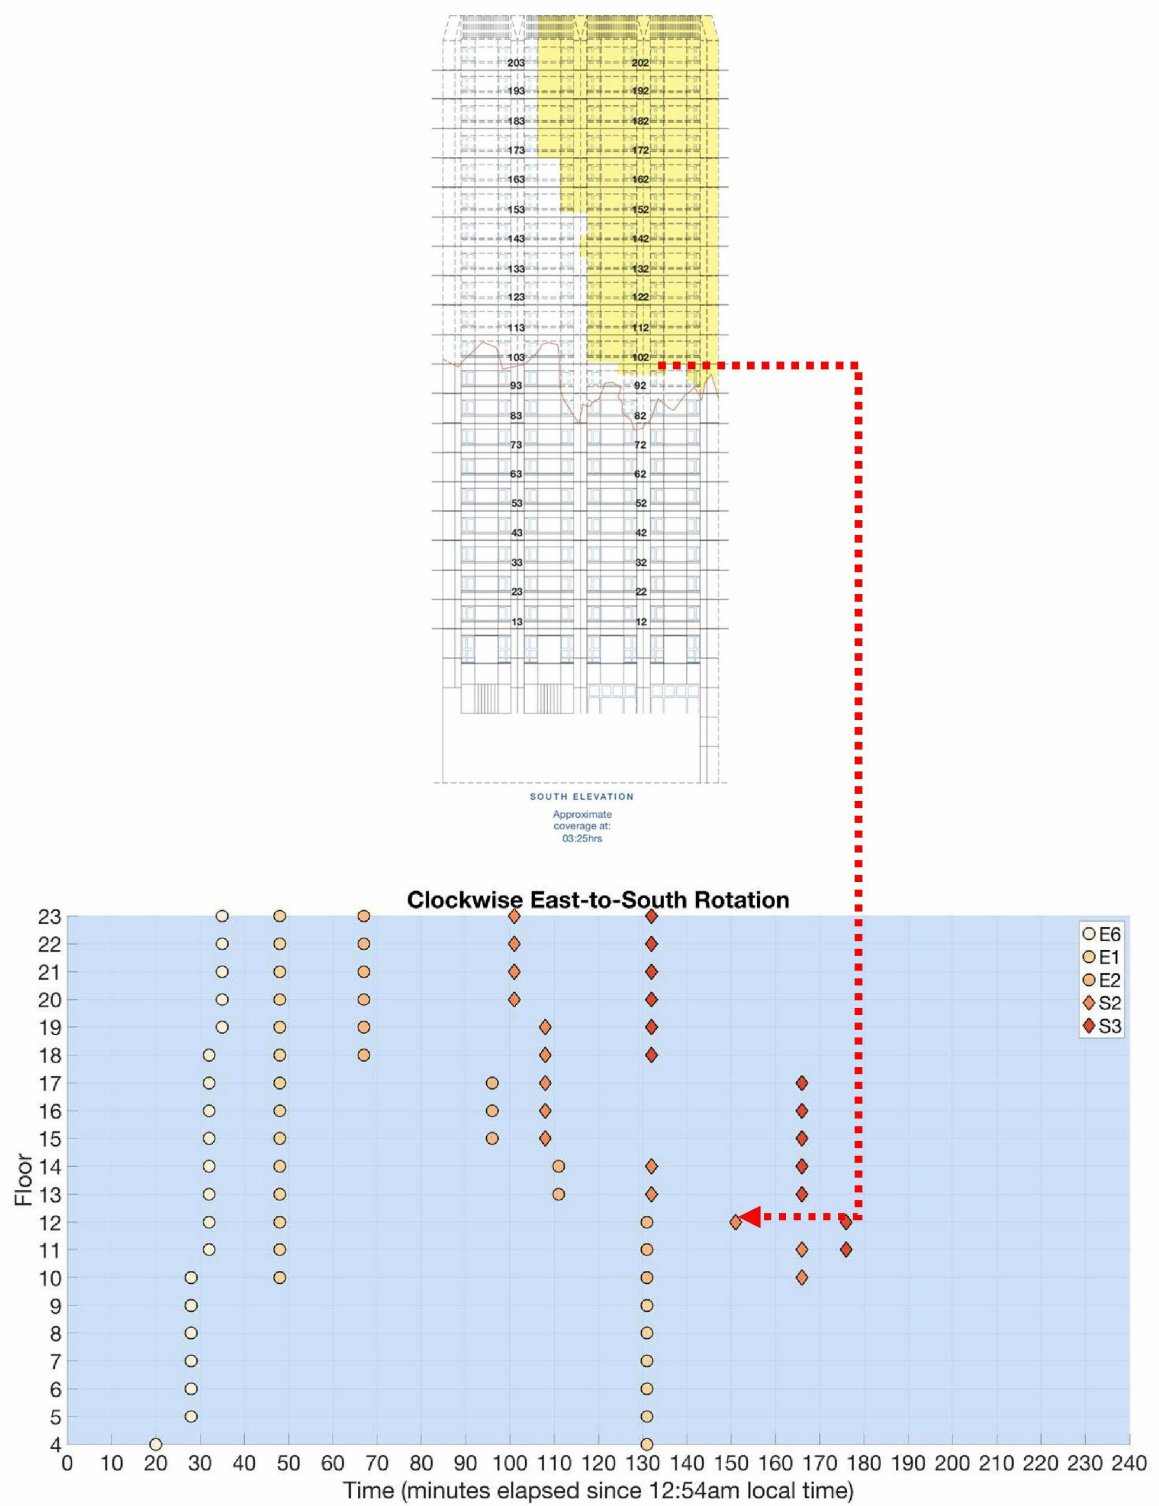
FIGURE 110: TIME HISTORY OF EXTERNAL FLAME SPREAD ON THE EASTERN (E) AND SOUTHERN (S) FACADES. THE STACK OF FLATS IMPACTED BY THE EXTERNAL FLAME SPREAD ARE INDICATED USING NUMBERS 1-6 APPENDED TO THE FACADE DESCRIPTOR IN THE LEGEND. THE RED ARROW INDICATES THE ESTIMATED POSITION OF EXTERNAL FLAMES AT 03:25 AM ON THE SOUTH ELEVATION TOWER PLAN VIEW.

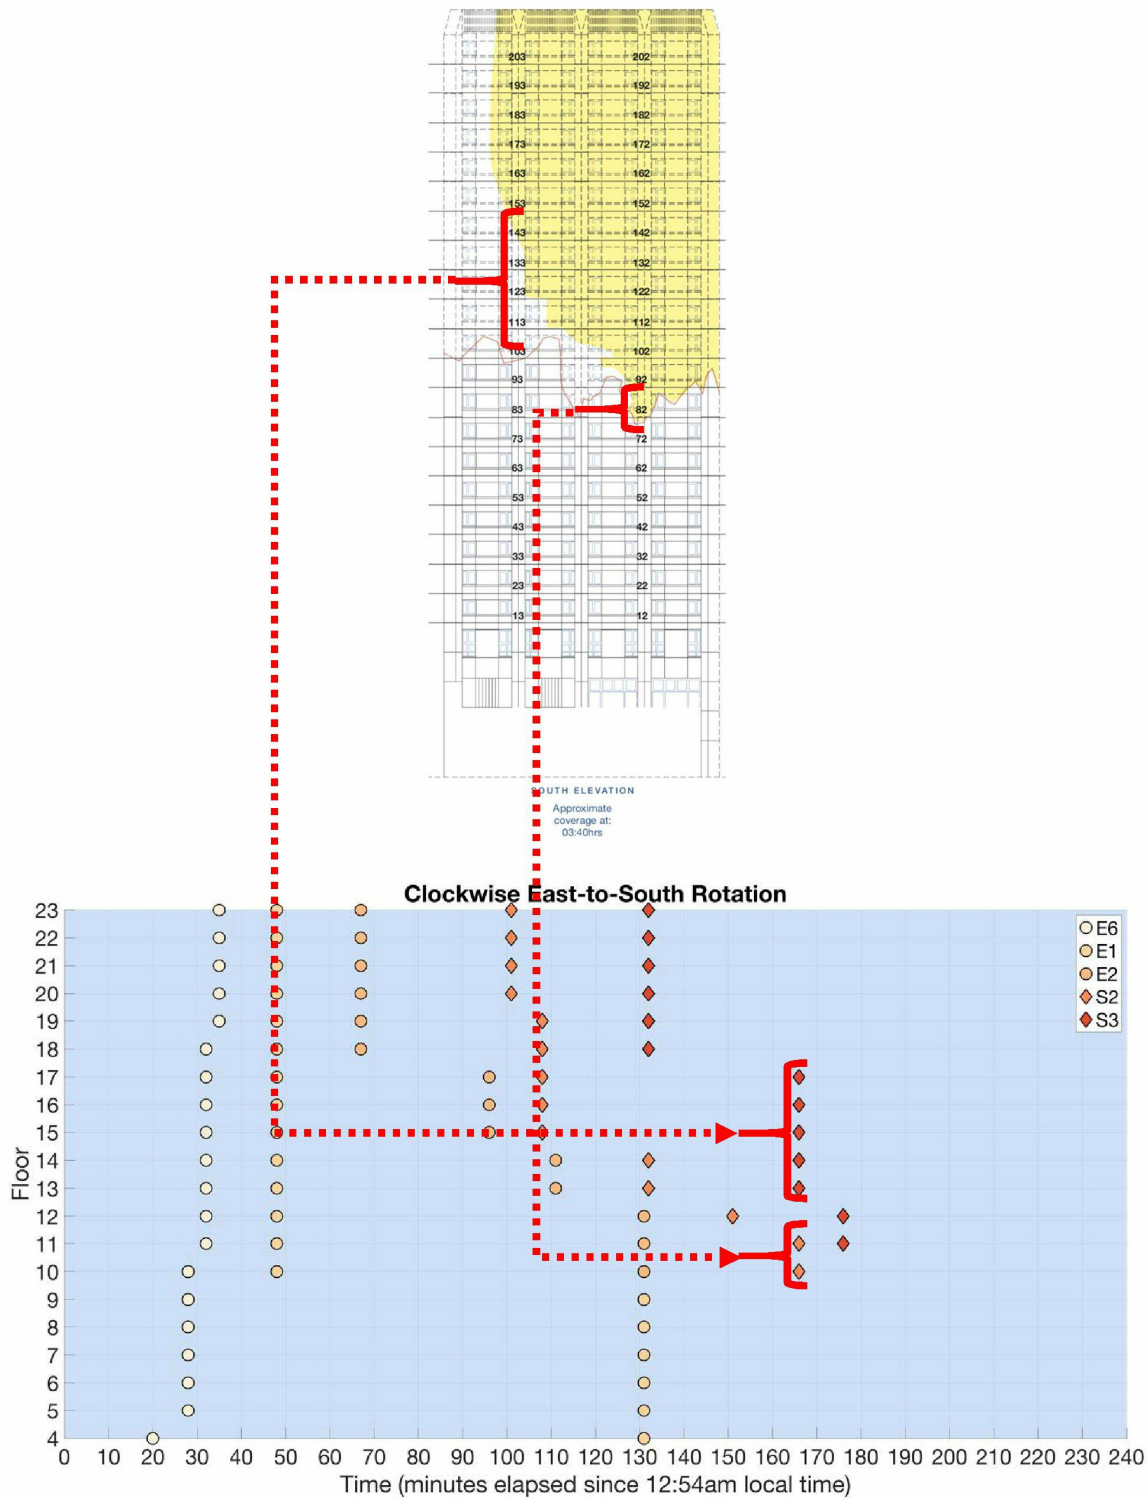
FIGURE 111: TIME HISTORY OF EXTERNAL FLAME SPREAD ON THE EASTERN (E) AND SOUTHERN (S) FACADES. THE STACK OF FLATS IMPACTED BY THE EXTERNAL FLAME SPREAD ARE INDICATED USING NUMBERS 1-6 APPENDED TO THE FACADE DESCRIPTOR IN THE LEGEND. THE RED ARROWS INDICATE THE ESTIMATED POSITION OF EXTERNAL FLAMES AT 03:40 AM ON THE SOUTH ELEVATION TOWER PLAN VIEW.

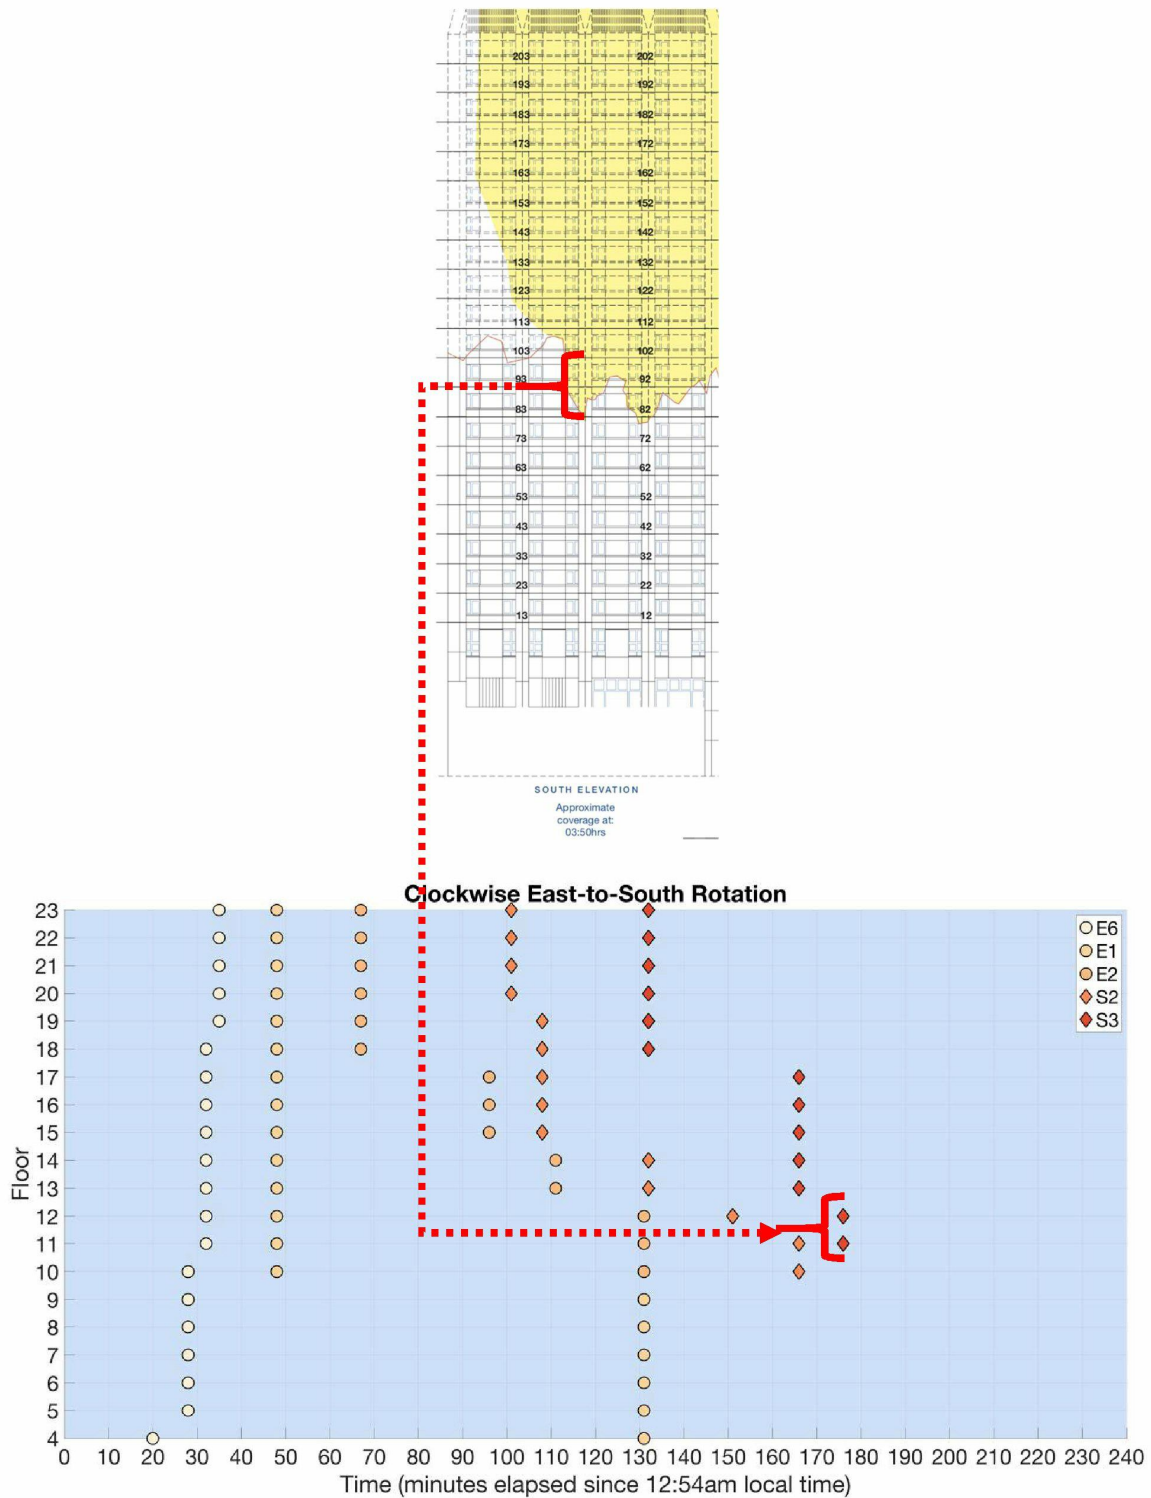
FIGURE 112: TIME HISTORY OF EXTERNAL FLAME SPREAD ON THE EASTERN (E) AND SOUTHERN (S) FACADES. THE STACK OF FLATS IMPACTED BY THE EXTERNAL FLAME SPREAD ARE INDICATED USING NUMBERS 1-6 APPENDED TO THE FACADE DESCRIPTOR IN THE LEGEND. THE RED ARROW INDICATES THE ESTIMATED POSITION OF EXTERNAL FLAMES AT 03:50 AM ON THE SOUTH ELEVATION TOWER PLAN VIEW.

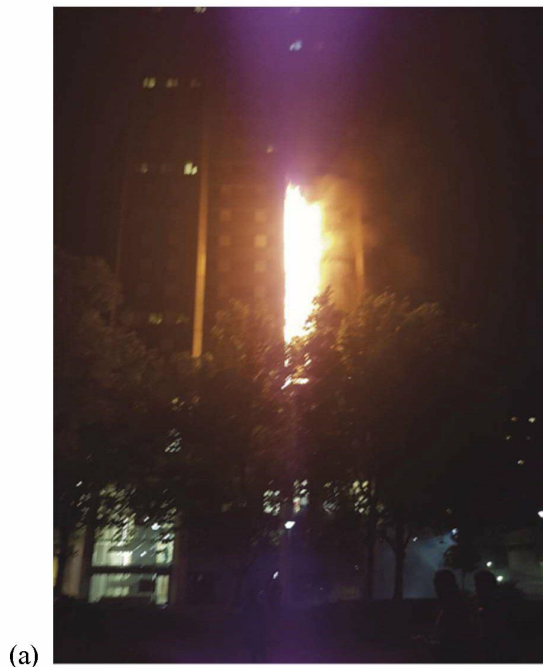
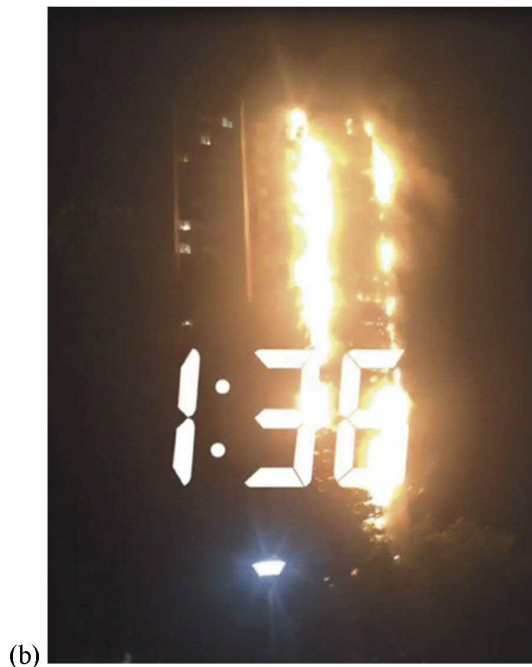
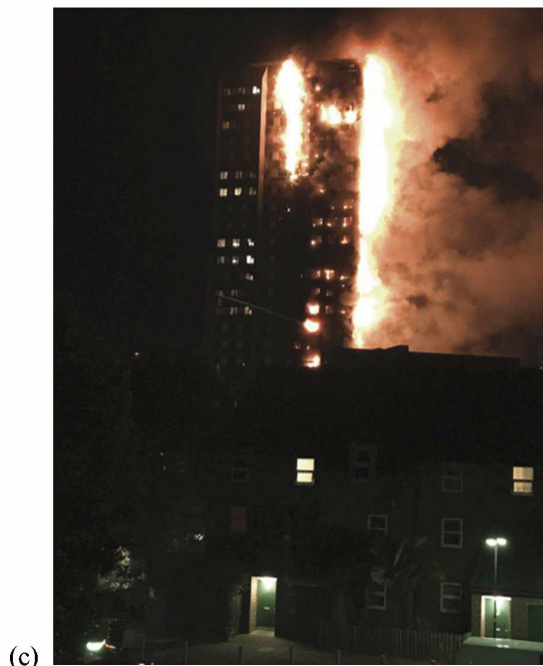
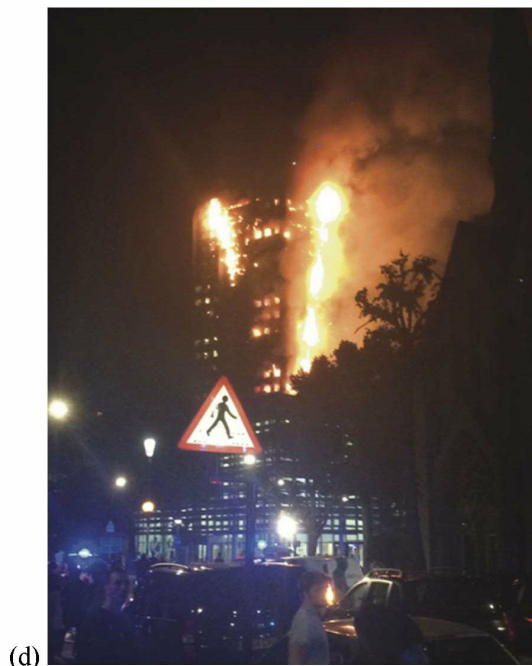
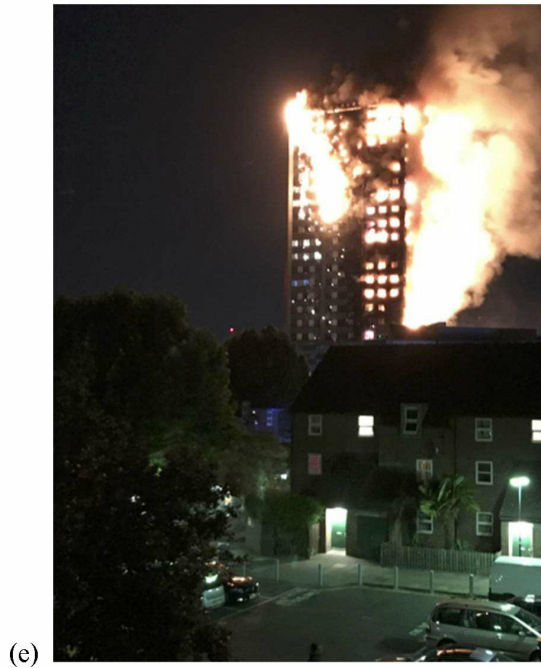
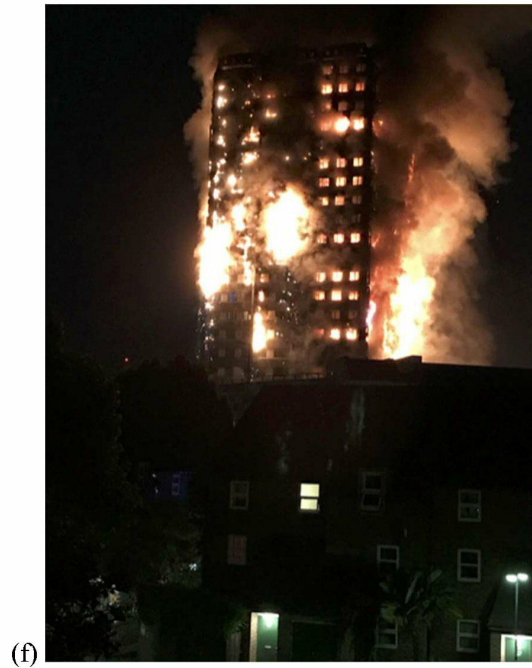
East Facade

FIGURE 113: ORIGINAL PUBLIC FOOTAGE OF LATERAL AND VERTICAL (UPWARD AND DOWNWARD) FLAME SPREAD ON THE EAST FACADE OF GRENFELL TOWER AT (A) 01:22 AM; (B) 01:36 AM; (C) 01:52 AM; (D) 02:08 AM; (E) 02:22 AM; AND (F) 02:53 AM RESPECTIVELY. PHOTOS WERE SOURCED FROM MET00008024, PAGES 28-29.

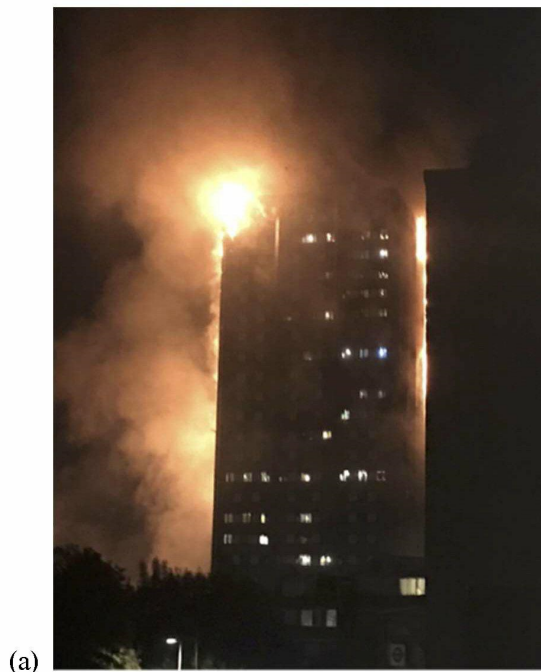
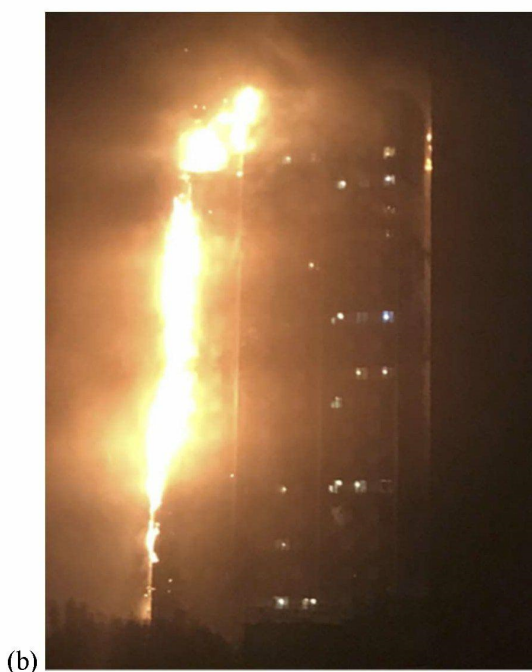
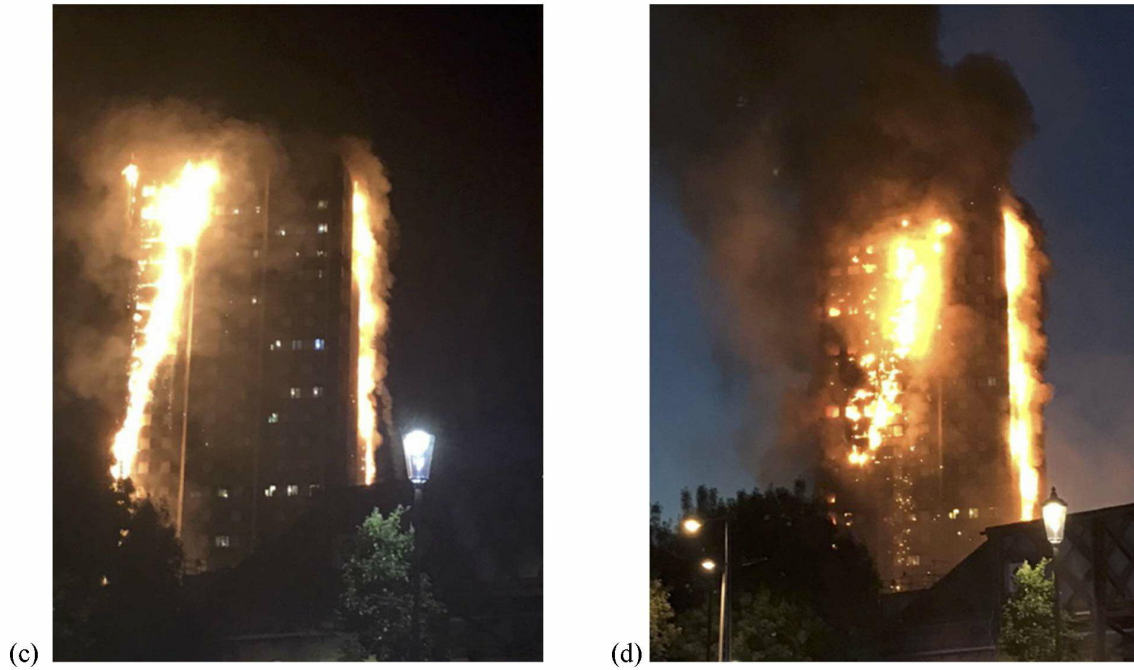
West Facade

FIGURE 114: ORIGINAL PUBLIC FOOTAGE OF LATERAL AND VERTICAL (DOWNWARD) FLAME SPREAD ON THE WEST FACADE OF GRENFELL TOWER AT (A) 02:50 AM; (B) 03:15 AM; (C) 03:20 AM; AND (D) 03:48 AM RESPECTIVELY. PHOTOS WERE SOURCED FROM MET00008024, PAGE 59.

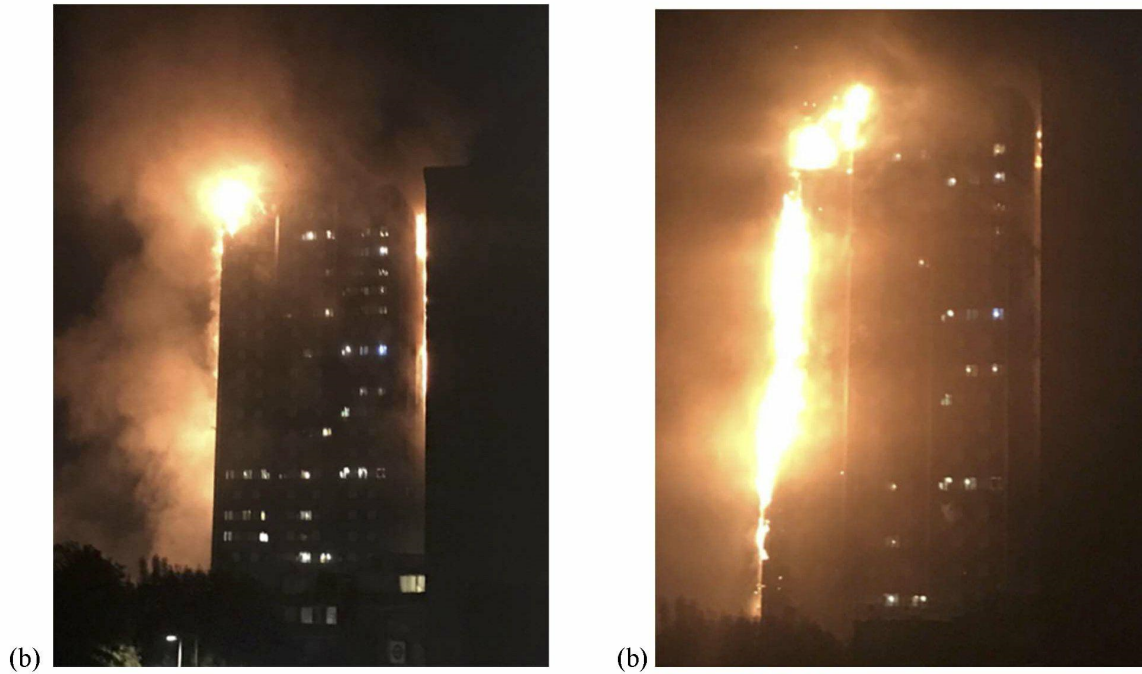
FIGURE 115: IMAGES FROM THE WEST FAÇADE CORRESPONDING TO (A) 03:20 AM; AND (B) 03:48 AM RESPECTIVELY.
