Grenfell Tower

Existing Building Overview

Prepared by
Simon Simpson
12th November 2017

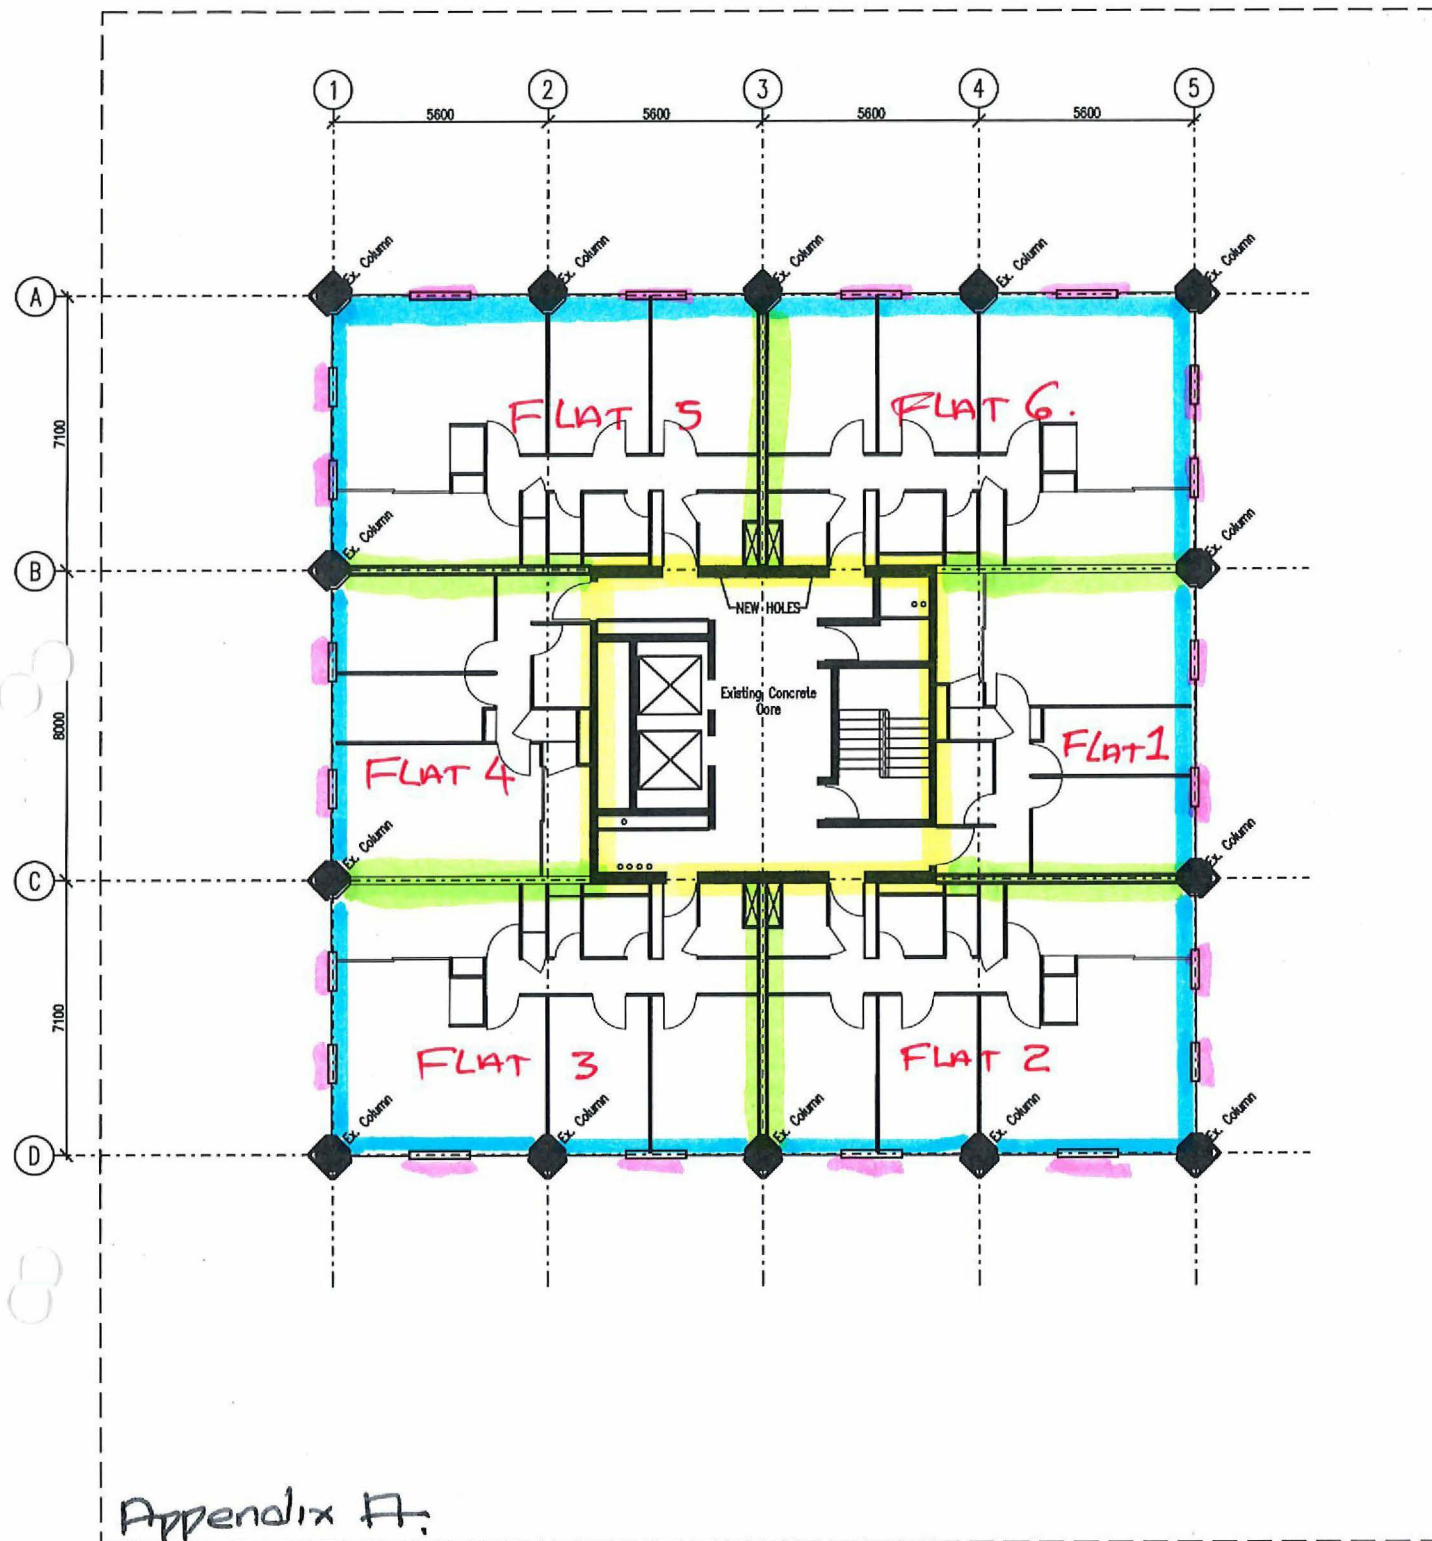
Typical Structural Floor Plan

EXISTING & PROPOSED TYPICAL RESIDENTIAL LEVEL FLOOR PLAN
Scale 1:100

Highlighting Structural Framing of building

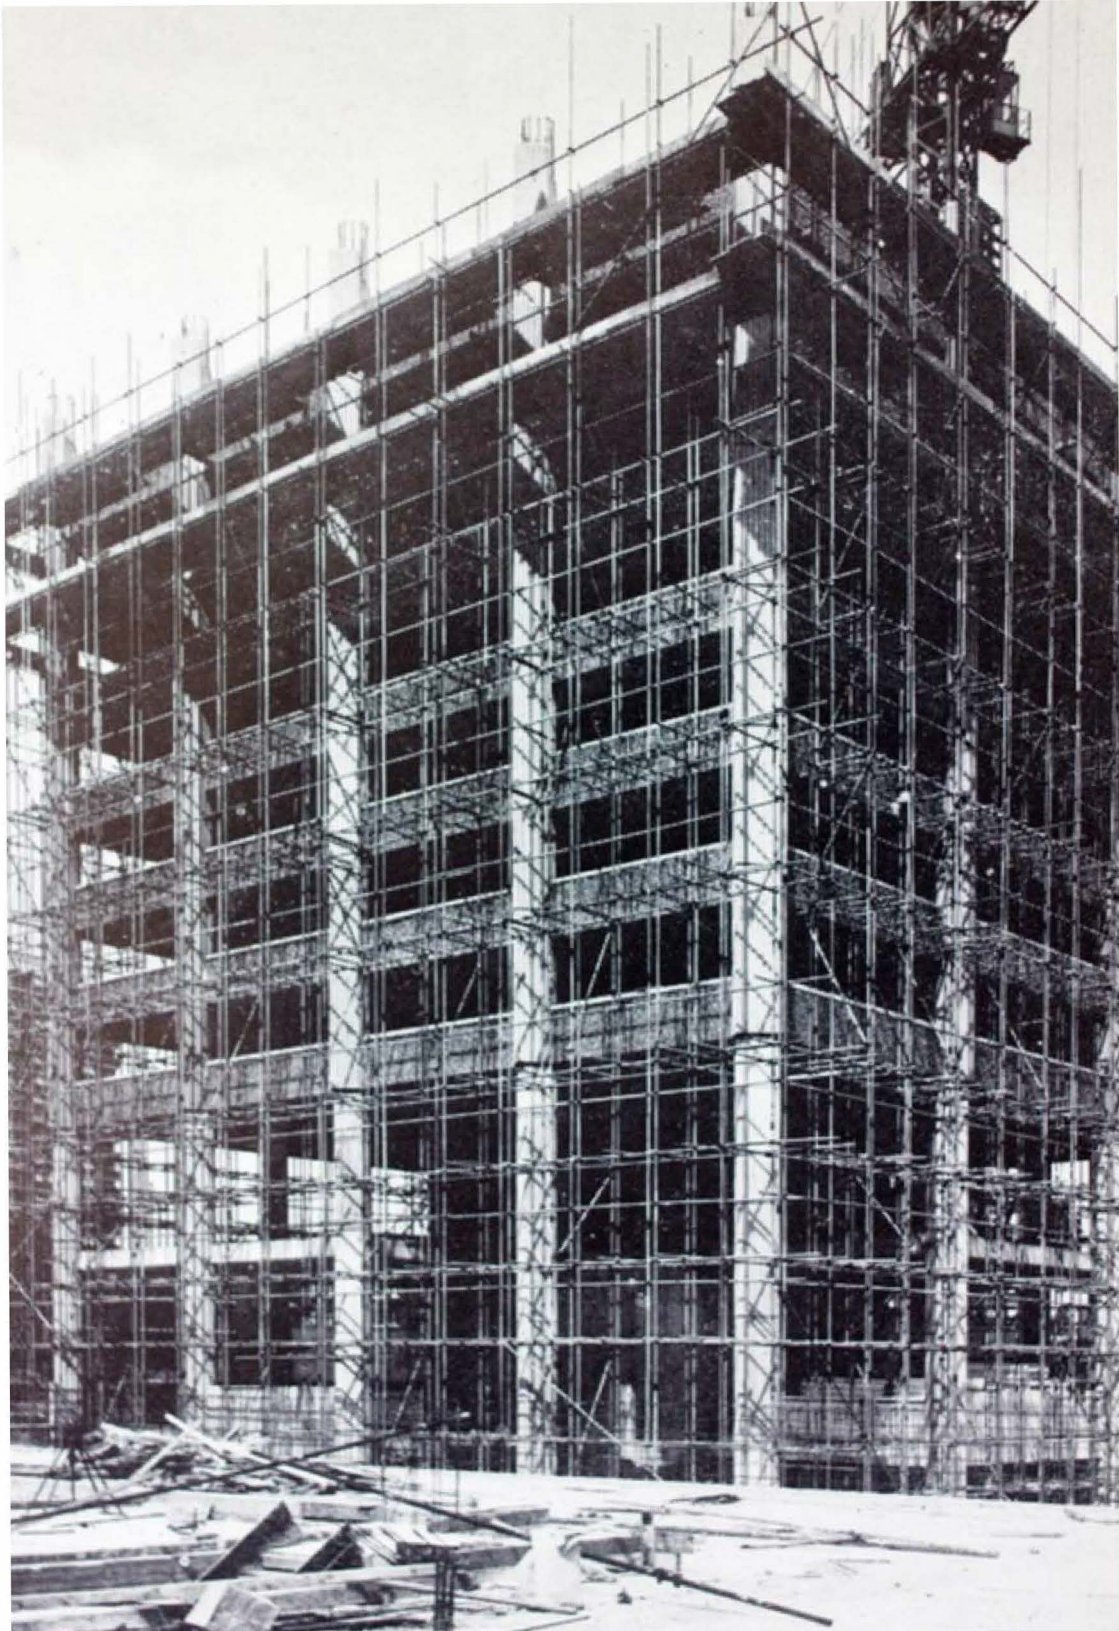
Existing Building During Construction

Photos showing construction of Grenfell Tower and reproduced from unknown architectural magazine, early 1970s.

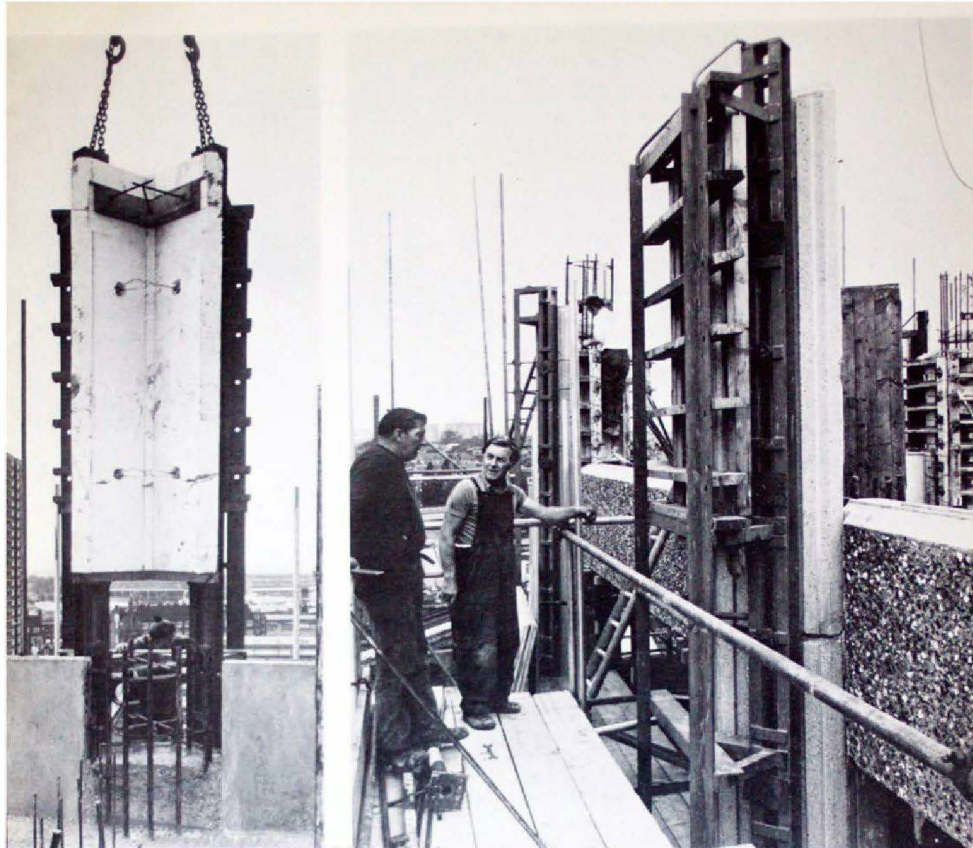
Existing Perimeter Columns during Construction

Photographs taken at the time of construction show that these columns were formed using precast concrete outer skins, this formed the external finished face of the columns. Internally the columns have been formed using traditional in situ formwork. The internal cover to these columns was seen to vary from 35 mm to over 100mm depending on the location observed. The in situ concrete column allows all reinforcement from the outrigger walls, and spandrel panels to be tied together. Refer to anecdotal photos located in appendix D.
