RISK ASSESSMENT OF MULTI OCCUPANCY BUILDINGS

Development of the Risk Assessment Procedure and Spreadsheet

National Grid

Document No.: 138038

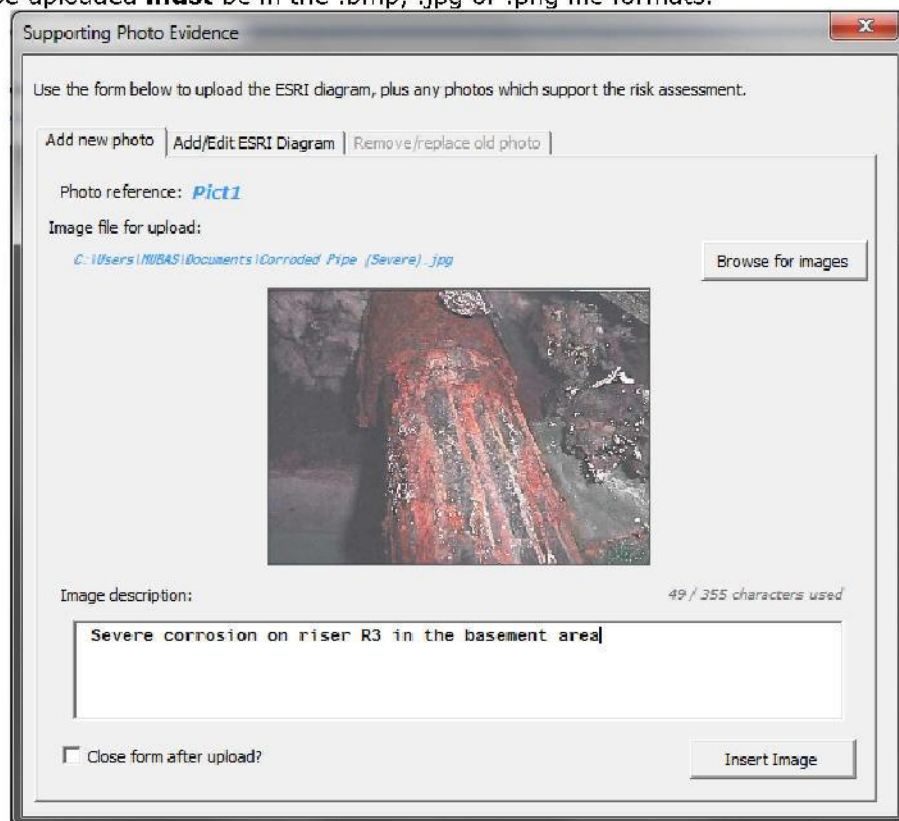
Upload Photos/ESRI diagram

- The below form will appear when the above button is pressed.
- Photos to be uploaded **must** be in the .bmp, .jpg or .png file formats.
