Rodney Hancox
Gas Engineering
Grenfell Tower Inquiry

Rodney Hancox
Gas Engineering
Cathy Kennedy
Grenfell Tower Inquiry

Introduction

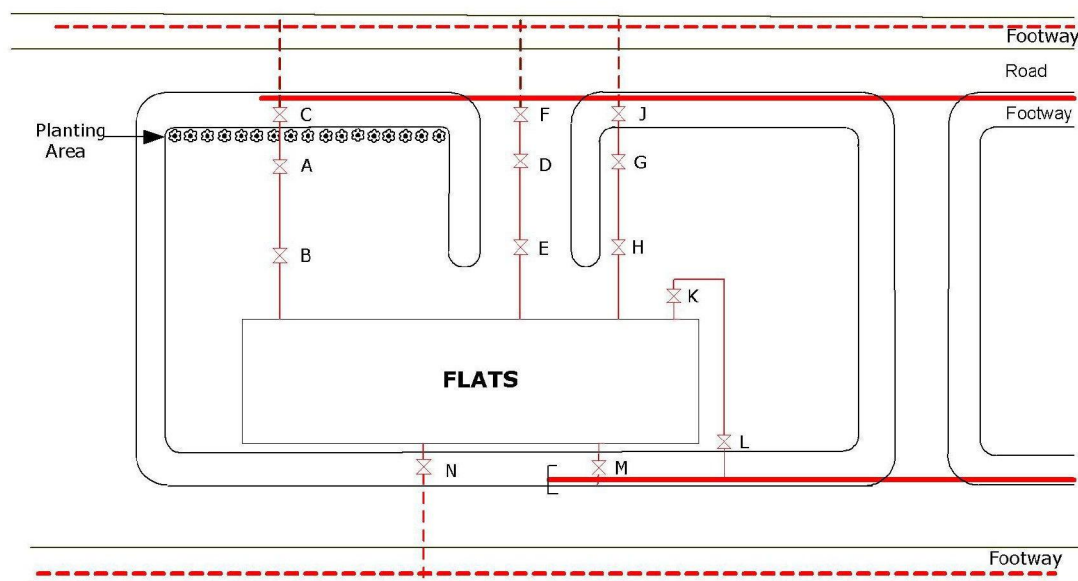
Fig. 2 – Typical PIV Locations

52. PIVs may be located in the footway forming part of the public highway under the control of the local Highway Authority or in the curtilage of the Multi-occupancy Building.

53. In Figure 2 above locations C, F, J, N and M are located in the public highway. PIV valve boxes in these locations are at risk of being lost or discarded as a result of resurfacing works and/or kerb re-alignment carried out by the Highway Authority. In

addition they are at risk of being lost or discarded as a result of work including reinstatement, carried out by other utilities. In each of these cases the Building Owner or their representative has no responsibility for or control over such works.

54. In Figure 2 above locations A, B, D, E, G, H, K and L are located within the curtilage of the building. Valve boxes in location A, in the planting area are at risk of being lost or discarded as a result of enthusiastic gardening or being overgrown by weeds if the planting area is left unattended.

55. In Figure 2 above valve boxes in locations B, D, E, G, H, K and L are at risk of being lost or discarded as a result of resurfacing works carried out on the instructions of the building owner.

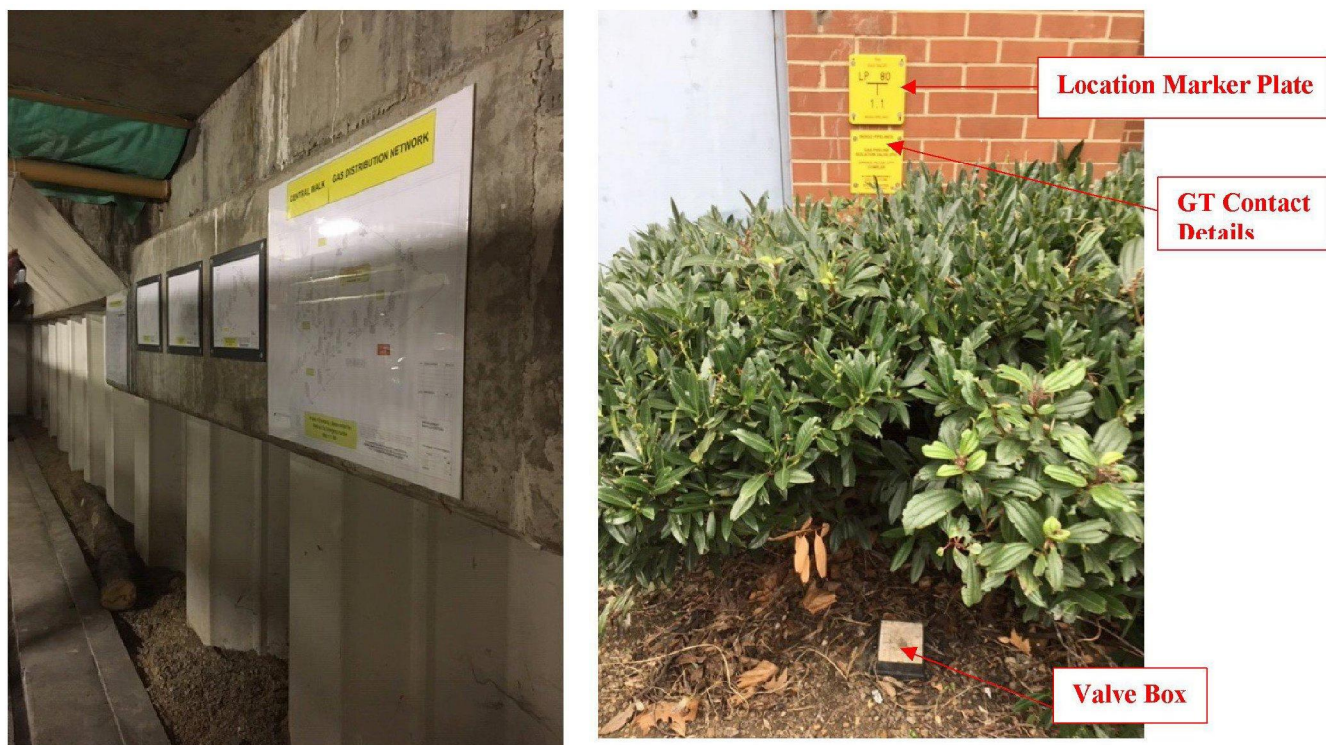
Fig. 5 – Plans and Marker Plates {RHX00000013}

Intervention Report with Gas Transporters and other stakeholders such as IGEM were the following examples of good practice of on-site plans and marker plates which had been installed following successful engagement with building owners etc. Such plans and marker plates would assist the Gas Transporter's Emergency Service to locate the PIV and make the situation safe with the minimum of delay when responding to a gas incident.
