**Grenfell Tower – fire safety investigation:
The fire protection measures in place on the night of the fire, and conclusions as to:**

**the extent to which they failed to control the spread of fire and smoke;
the extent to which they contributed to the speed at which the fire spread.**

**Phase 1 Report – Section 2
Conclusions and Next Steps**

**Fire Safety Engineering
5th November 2018**

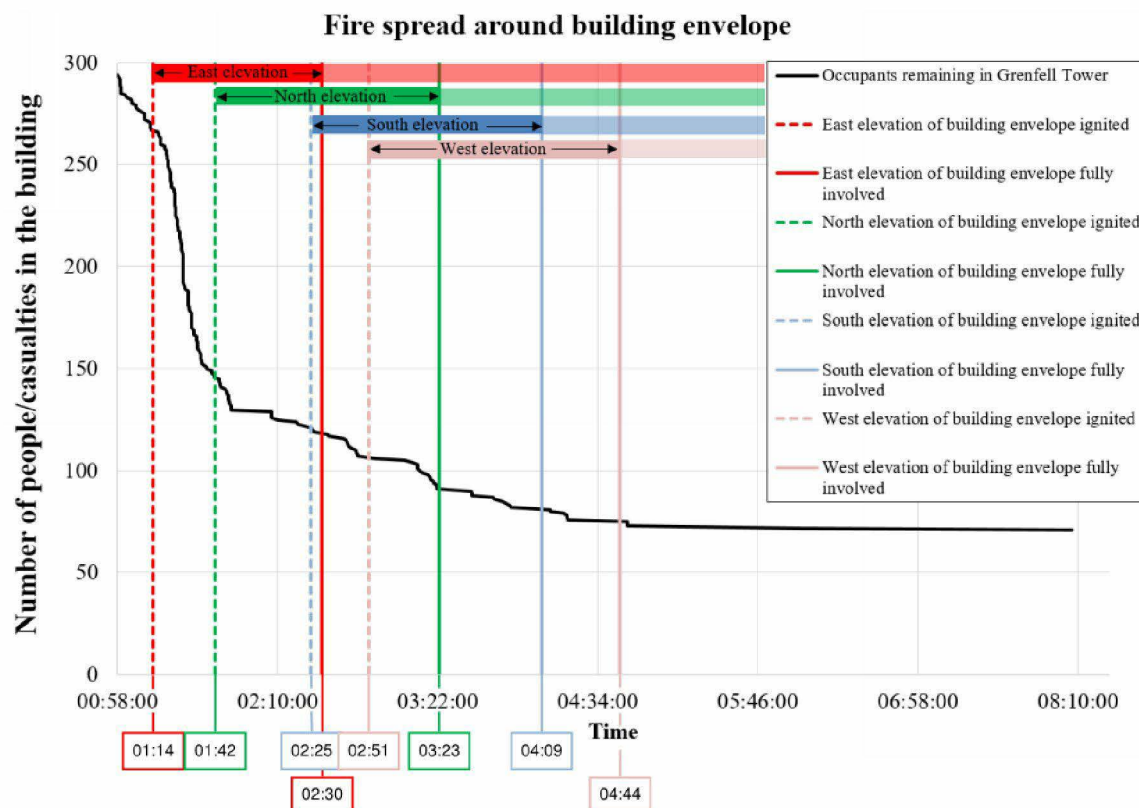
- 2.14.23** The solid coloured bars on the top of the figure represent the duration from ignition of an elevation to its full involvement.

Figure 2.1: Critical times of fire spread around building envelope and remaining occupants in building (based on data extracted from MET000080463, updated in MET00016072 and MET00012593) at those times

- 2.14.21** **Timeline of external fire spread**
- 2.14.22** I have derived the time each external wall elevation ignited and the time that elevation was fully involved in fire and I have then compared this data with the number of remaining occupants in Grenfell Tower in Figure 2.1.

2.14.24 At 02:06, a Major Incident was declared by the LFB. At that time, both the East and North elevation had ignited and 164 occupants, approximately 56% of the total building occupants, had evacuated.

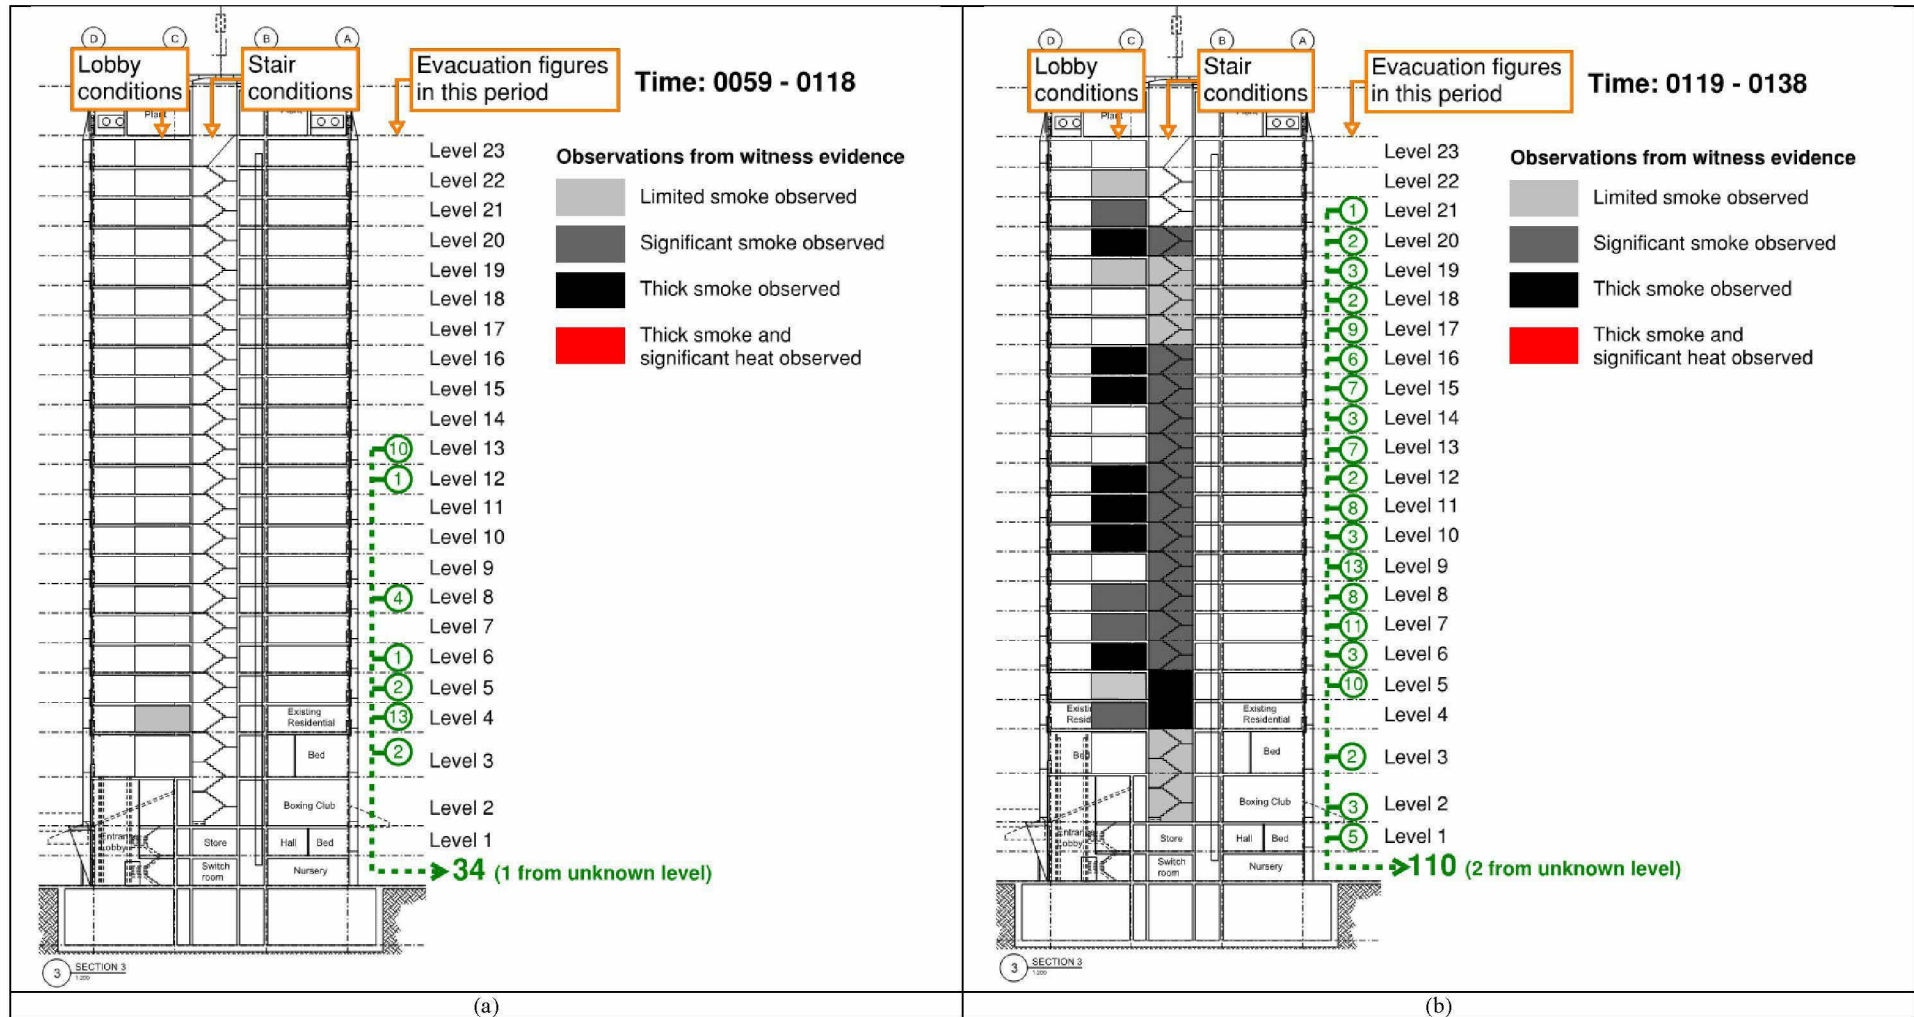
Figure 2.2 Summary description of the conditions within the stairs collated from resident and fire fighter witness evidence between (a) 00:59 -01:18 and (b) 01:19 -01:38

2.14.29 00:59 – 01:18 [Figure 2.2 (a)]:

- 2.14.31** The stair is described by fire fighters and residents as being clear of smoke.
- 2.14.32** **01:19 – 01:38 [Figure 2.2 (b)]:**
- 2.14.33** Smoke reported is reported in 14 out of 20 lobbies (L4-23) by this time. The smoke report in these 13 lobbies is described as ranging from hazy and light on Level 22 to thick and black on Level 16.

- 2.14.35** **Note:** it is during this period that some residents were observed walking up the stair as a result of conditions lower in the stair being perceived as “*too smoky*” or being told by others to “*go back*”.

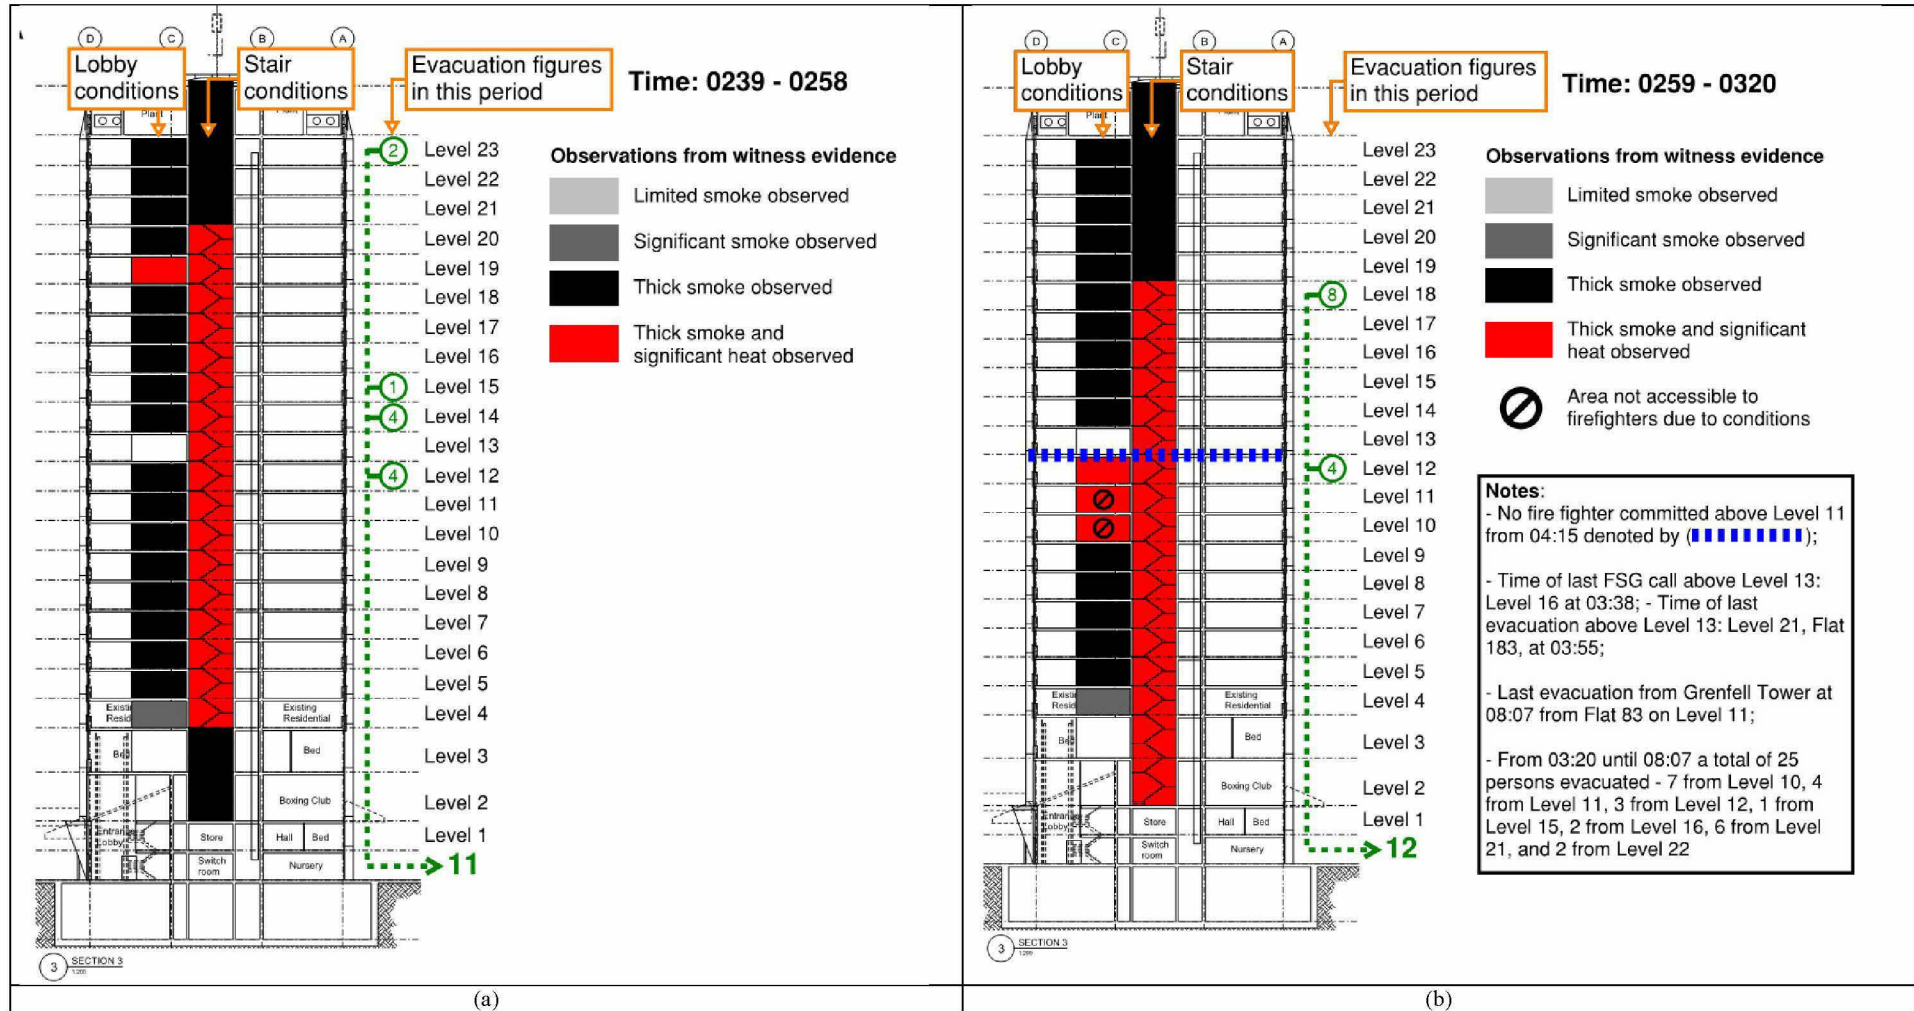
Figure 2.4 Summary description of the conditions within the stairs collated from resident and fire fighter witness evidence between (a) 02:39 -02:58 and (b) 02:59-03:20

2.14.45 02:39 – 02:58 [Figure 2.4 (a)]:

2.14.46 The number of smoke affected lobbies remains at 19 out of 20; conditions are thick, black smoke with high temperatures.

2.14.47 From Level 23 down, in the stairs, residents describe zero visibility and residents at Level 12 and 14 describe extreme heat, with conditions described as “roasting” or “sweltering”.

2.14.49 After 02:59 [Figure 2.4 (b)]:

2.14.50 The number of smoke affected lobbies remains at 19 out of 20; conditions are thick, black smoke with high temperatures. Temperatures in 2 lobbies (L10 and 11) are described as extreme as to be inaccessible by fire fighters.

2.14.51 Fire fighters and residents describe the stair conditions deteriorating from Levels 5 – 7 upwards. The smoke in the stair is described as thick black with zero visibility. Residents and fire fighters describe intense heat within the stair *“like the heat that comes out of an oven and blasts you in the face”*.

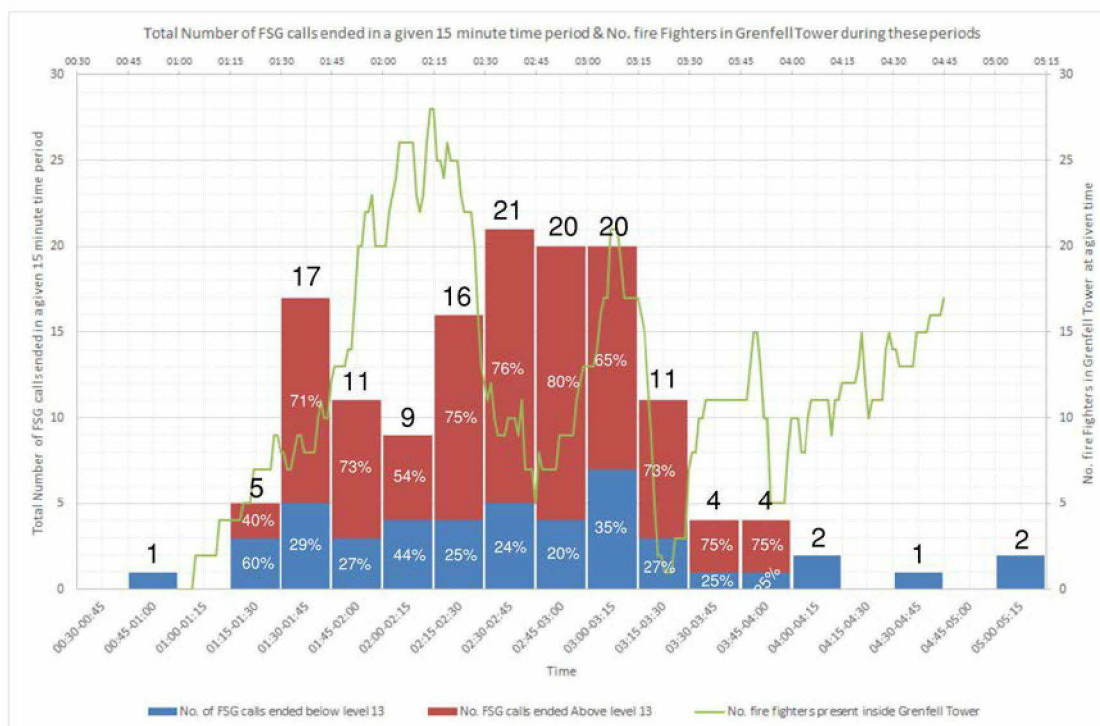
- 2.17.2** Figure 2.5 shows the total number of FSG calls which ended during 18 No. fifteen minute intervals between 00:45 and 05:15. For each interval the proportion of FSG calls made from above and below Level 13 is also shown.

- 2.17.3** The number of firefighters deployed beyond the Bridgehead in Grenfell Tower during these intervals is also plotted.

Figure 2.5 The number of FSG calls (by end time in 15 min intervals) and number of fire-fighters beyond the Bridgehead of Grenfell Tower

2.17.4 The pattern observed in the total number of FSG calls is as follows in Section 2.17.5 – 2.17.13).

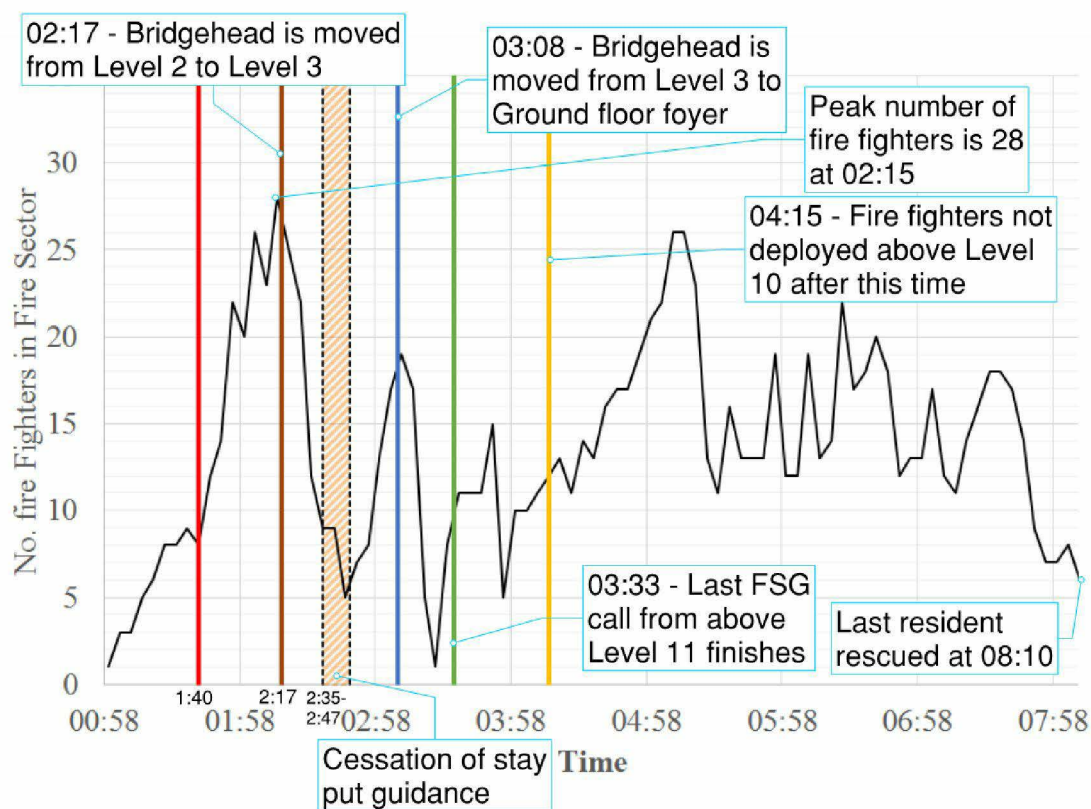
Figure 2.6: Active resources available to the LFB in the Fire Sector

2.18.15 Figure 2.6 shows the active resources available to the LFB in the Fire Sector and therefore available for internal fire-fighting and search and rescue operations (i.e. operations beyond the Bridgehead).

2.18.14 I have analysed the data available regarding fire fighter entry to the Tower, during each of the Incident Commander time slots.
