Date: 15 October 2018
To: Cathy Kennedy
Deputy Solicitor
Grenfell Tower Inquiry
From: J. Duncan Glover
Re: Damage Assessment: Fourteen Exhibits
Case: Grenfell Tower Fire

Laboratory examinations were performed on fourteen Exhibits. The purposes of the examinations are to assess arc damage, if any, and in some cases to examine wire stranding.

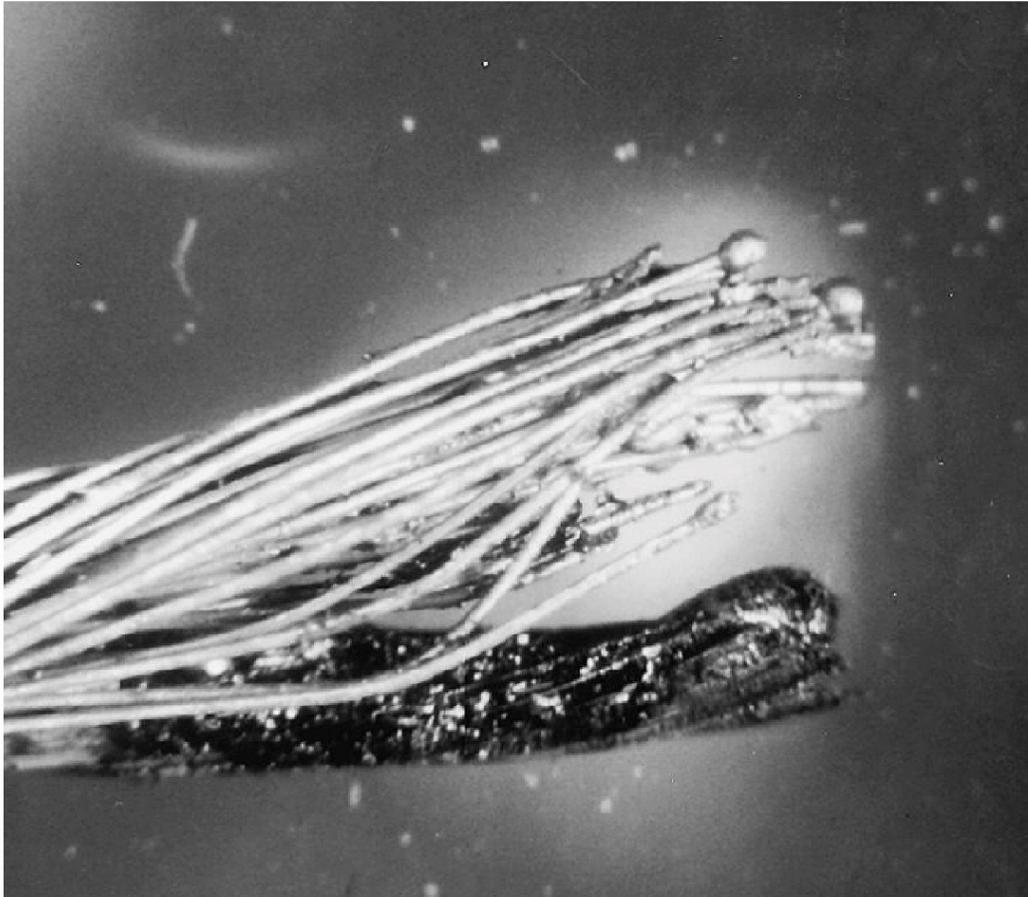
Figure 7. Stranded copper lamp cord severed by a short circuit [NFPA 921 Figure 9.10.2.2]

Figures 1 through 7 excerpted from NFPA 921-2017 show the results of arc damage to copper conductors as follows: (a) notches in the sides of the conductors (Figures 1 and 2); or (b) rounded or irregular shaped beading on the end of a severed conductor (Figures 3 - 7) [NFPA 921 Section 9.11.1.2].

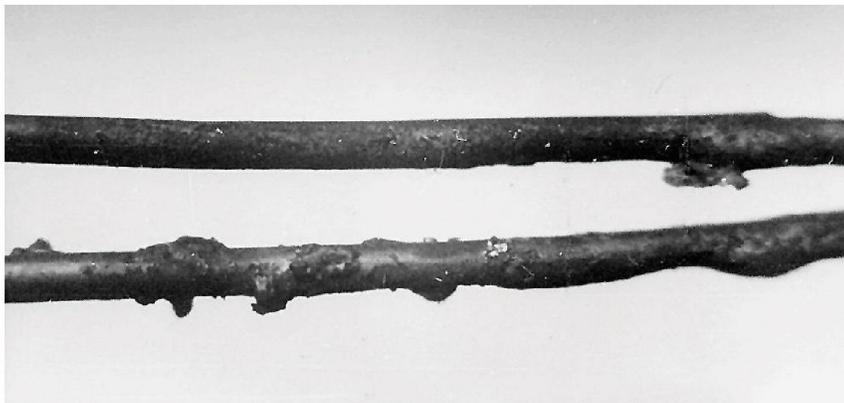
When exposed to fire or glowing embers, copper conductors may melt (the melting temperature of pure copper is 1085°C/1984°F). At first, there is a blistering and distortion of the surface, as shown in Figure 8 [NFPA 921 Section 9.10.6.2].

Figure 8. Copper conductors fire-heated to the melting temperature, showing regions of copper flow, blistering and surface distortion [NFPA 921 Figure 9.10.6.2(a)]
