THE GRENFELL TOWER INQUIRY

EXHIBIT TNG/7

Grenfell Tower 9497						GREEN HIGHLIGHT - VERY GOOD STANDARD	YELLOW HIGHLIGHT - NOT YET ACTIONED							CALL OUT RISK			POTENTIAL COST OF CALL			DATE RECTIFIED	
No of Inspections	Item Number	DATE OF INSPECTION	BLOCK / FLOOR / PLOT	LOCATION	ISSUE DESCRIPTION / STANDARD	PICTURE	JSW / SUB CONTRACTOR	Underlining Issue	SNAGGED Y / N	COMMISSIONED	HANDED OVER	GOOD PRACTICE	LOW	MEDIUM	HIGH	LOW	MEDIUM	HIGH			
9	1	17/11/2015	Flat 44	Hall way	22mm pipework at high level is not in the clips

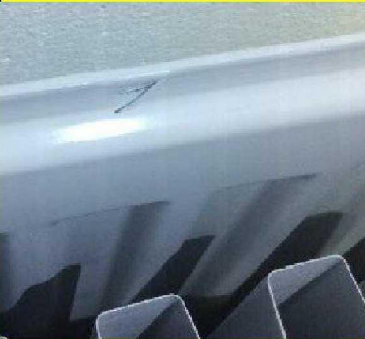
Stanley Mec	Pipework poor	N	N	N			1			1				
9	2	17/11/2015	Flat 16	Lounge	Radiator has very sharp strips of metal sticking out the top of the radiator which looks like swarf, radiator needs changing

Item 1&2 please ensure all radiators are checked closely for this manufacturing defect

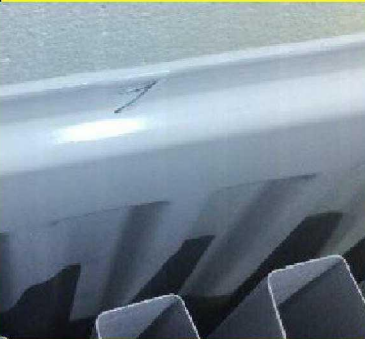
JSW	Manufacture	N	N	N				1		1				
9	3	17/11/2015	Boxing gym	Boxing gym	Radiator has very sharp strips of metal sticking out the top of the radiator which looks like swarf, radiator needs changing
